INEEL/EXT-99-00669

June 1999

# Identification of the Specific Mechanism by which the CO<sub>2</sub> System in Building TRA-648 Accidentally Discharged

**Lockheed Martin Idaho Technologies Company  
Idaho Falls, Idaho 83415**

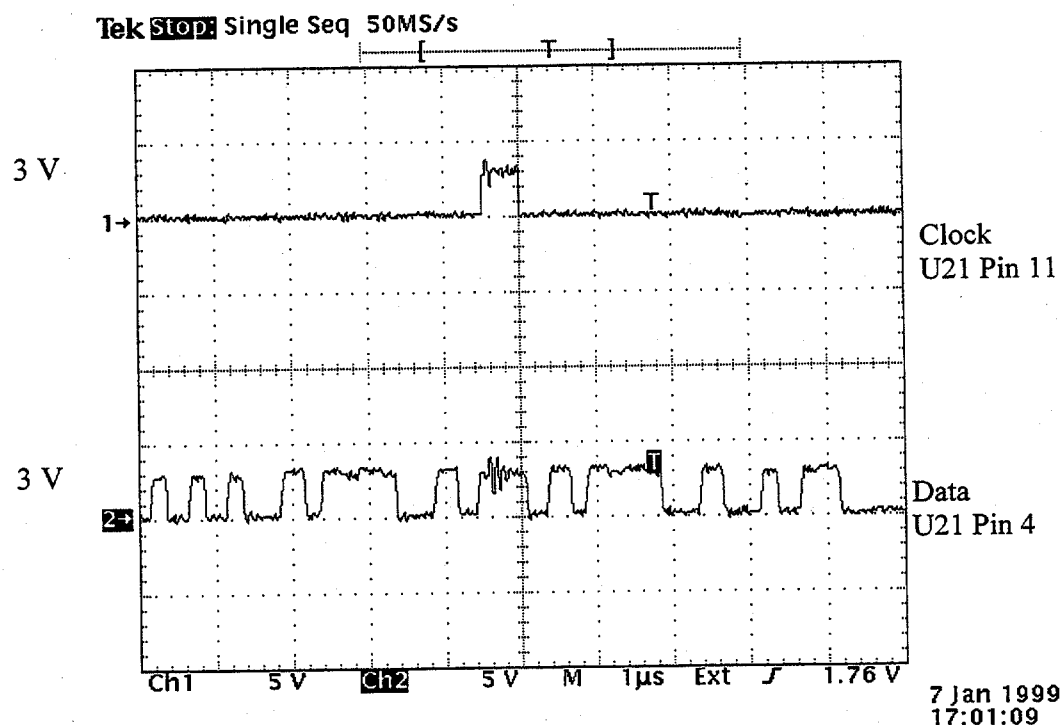
**Figure 2-8.** Oscilloscope traces when Bell Circuit 2 activated after AC power was disconnected.

**2.2.2.3 Unexpected, Undesired, Dangerous Operation of Bell Circuit Initiated by AC Power Loss.** Figures 2-8 and 2-9 were taken at Tronamix, Inc. laboratory during unexpected, unwanted operations of Bell Circuit 2 that activated the Kidde electric control head 24 VDC (part number 890181) installed on Bell Circuit 2. In each case:

- The undesirable operation was initiated when AC power was disconnected from an AFP-200 panel
- Simultaneous high signal on a data pin of U21 coincided with a high-going signal on the clock pin of U21
- No detectors or manual stations were in alarm
- Solenoid circuits were software disabled
- Standby batteries were connected to a NR45 external battery charger installed with the AFP-200 panel per Notifier instructions<sup>9</sup>
- Peak signals were 3 volts or less (corresponding to the voltage on the +5 volt power bus at the time of activation).

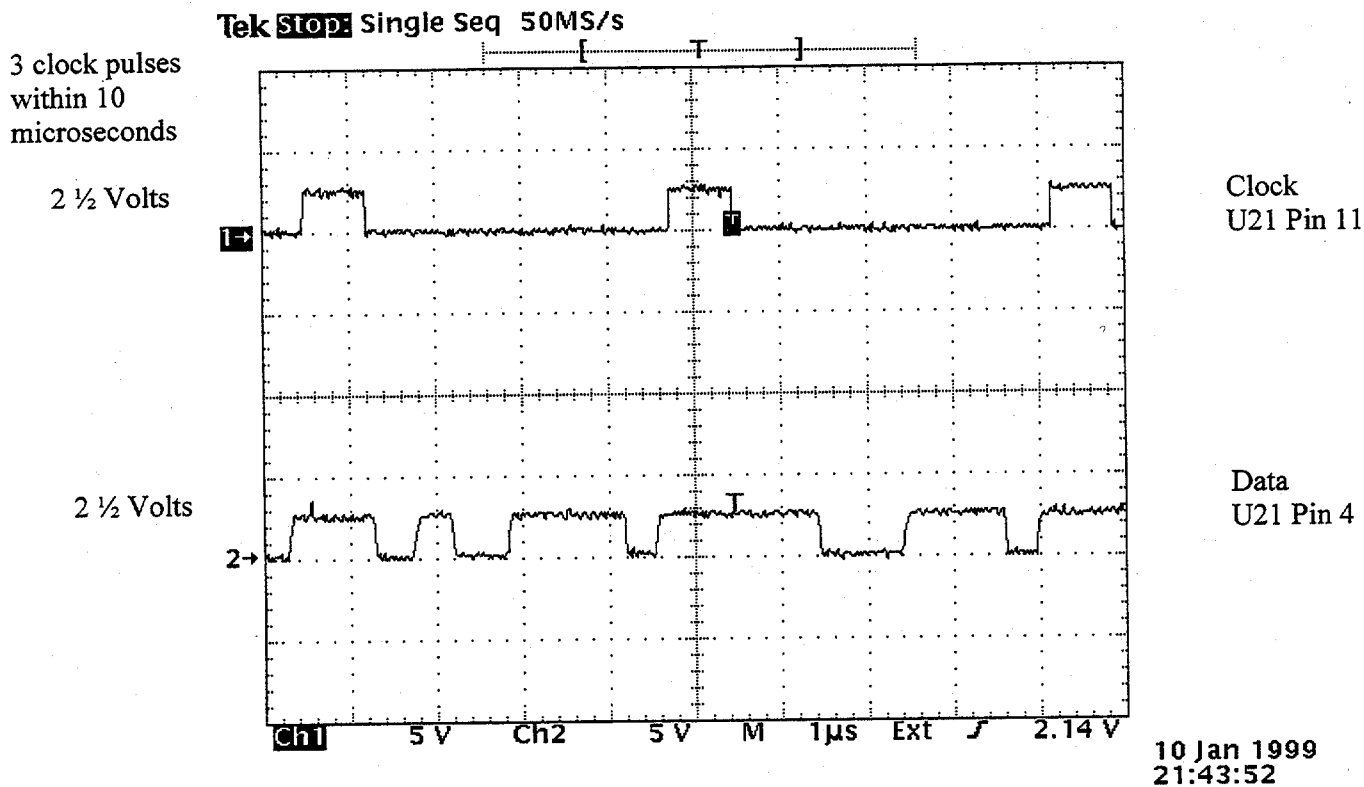
**Figure 2-9.** Oscilloscope traces show three clock pulses within 10 microseconds.

In Figure 2-9, spurious signals occur on the clock pin—three high clock signals are noted within 10 microseconds. Normal clock pulse spacing was measured on the subject AFP-200 panel as 250 milliseconds. The lower trace is the data bus to Pin 4 of chip U21; the upper trace is the signal on Pin 11 (clock pin) of chip U21. The spurious signals followed removal of AC power from the AFP-200 panel and caused operation of the Kidde electric release connected to Bell Circuit 2.

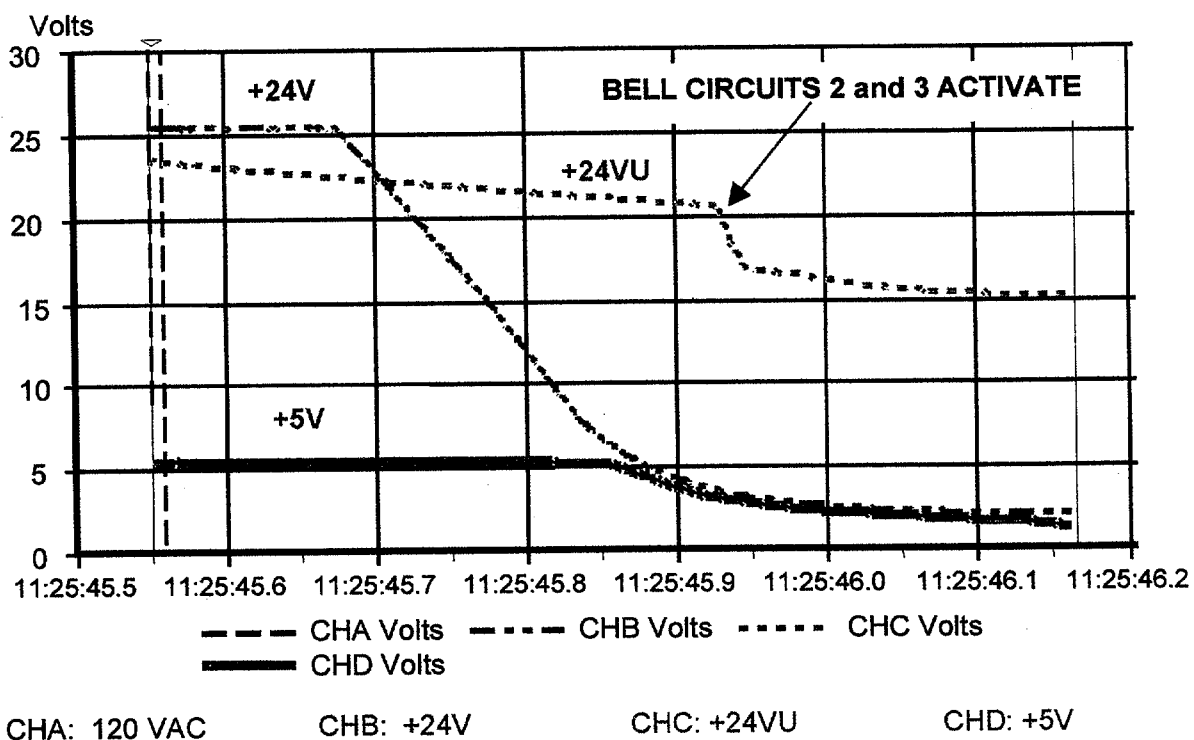
**Figure 2-10.** Dranetz recording shows decay of DC voltages after AC power loss with external charger installed. Bell circuits activate.

**2.2.3.1 Recording of DC Voltages After Loss of AC Power.** Figure 2-10 shows a Dranetz meter recording taken from the AFP-200 panel at TRA-648 configured with standby batteries connected to an external battery charger. The 120 volts AC power to the panel was disconnected and drops to zero volts at approximately 11 hours 25 minutes 45.55 seconds. In less than one-half second after AC voltage to the panel is zero, Bell Circuits 2 and 3 activated. The Kidde control heads connected to Bell Circuits 2 and 3 operated.

The bell circuit activation was initiated solely by disconnecting AC power to the AFP-200 system. No detectors, manual stations, or other initiating devices in the system were in alarm.

Note that voltage on the +24 V bus decayed to about 4 volts at the time of the bell circuit activation. The +5 V bus had decreased to approximately 3 volts at the time the Kidde control heads operated. Note also that the voltage on the +24 VU bus was over 20 volts at the time of the activation.

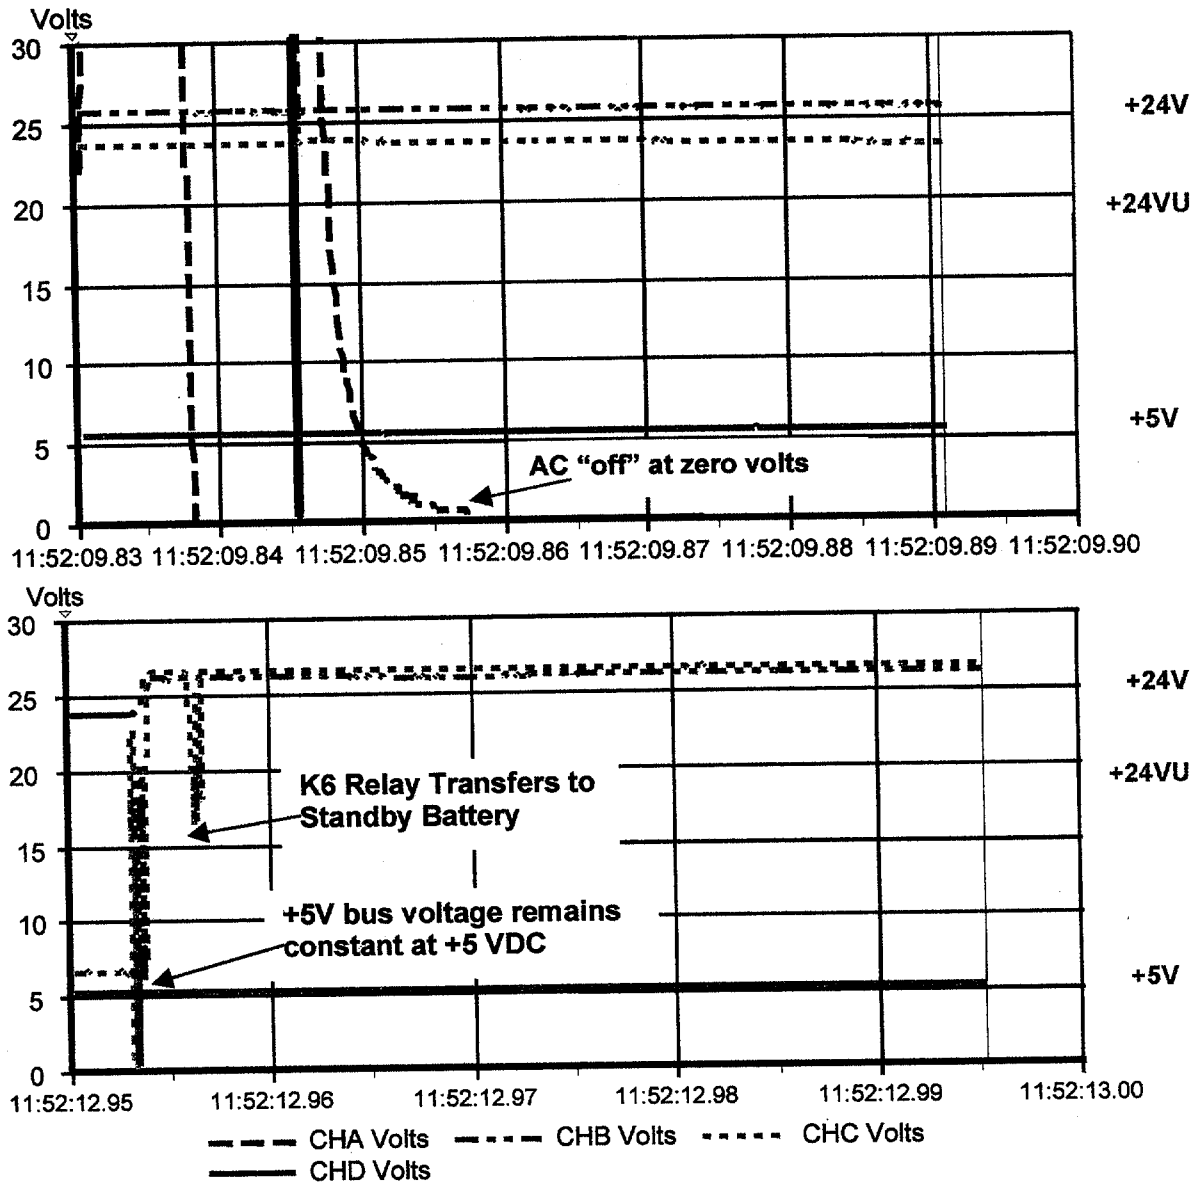
A Dranetz meter recording of the DC voltages within the AFP-200 panel with a good charged standby battery connected to the internal charger is shown in Figure 2-11.

If a good, charged standby battery is connected directly to the internal battery charger in the AFP-200 panel (no external battery charger installed), a slight decay in the +24 V voltage was observed but no decay in the +5 V voltage was measured. Since the +5 V voltage remains normal, the microprocessor is not subjected to lower than specified operating voltages. Random activation of the bell circuits was not observed in this panel configuration.

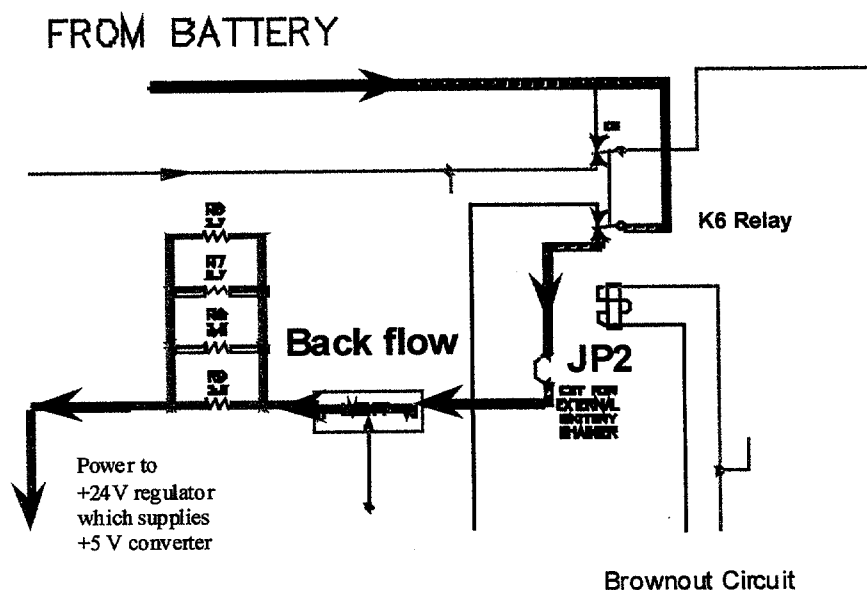
**Figure 2-14.** Internal battery charger—AC disconnected—K6 has not yet transferred its contacts.

**2.2.3.4 Back-Flow Through VR3 Maintains Voltage.** Review of the AFP-200 power supply circuit drawing does not show a traditional electrical path by which the voltage on the +24 V bus is maintained during the time between loss of AC voltage and transfer of the K6 relay contacts. The apparent mechanism to maintain this voltage bus is shown in Figure 2-14. The back-flow path through VR3 supplies nominal 24 volts to VR2 after AC power is lost, before relay K6 transfers.

With nominal 120 volts AC supplying the AFP-200 panel, approximately 40 volts DC is supplied by the power supply rectifier/filter circuits to the input leads on voltage regulators VR2 and VR3. When AC power is disconnected, the input voltage to these regulators decreases. As the voltage from the rectifier circuits decrease, with the panel configured as shown in Figure 2-14, current from the standby batteries back-flows through VR3 and thence to the input lead on VR2, the 24 volt supply regulator. This back-flow maintains the input voltage to VR2 at or above a nominal 24 volts—VR2 is able to maintain a nominal 24 volt level on the input pin of VR4. VR4 is able to maintain 5 volts to the microprocessor circuitry and other semiconductor components. No spurious signals were observed under these conditions.

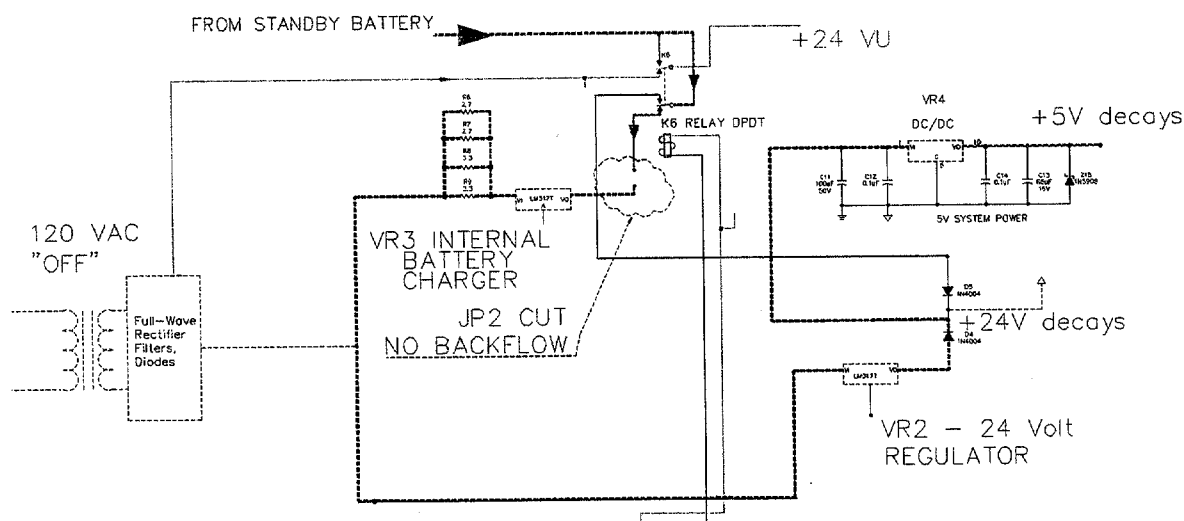
**Figure 2-15.** With JP2 cut, the back-flow path from standby battery to the input of VR2, the 24 volt DC regulator, is eliminated.

With JP2 cut, the back-flow path from standby battery to the input of VR2 is broken (see Figure 2-15). The voltage decay described above occurs after AC power is lost before relay K6 transfers. The spurious signals described above are generated. Undesired activation of the bell circuits occurs on a random basis. The occurrence of activation is random because the signal generation by the microprocessor circuits under low voltage conditions becomes erratic.

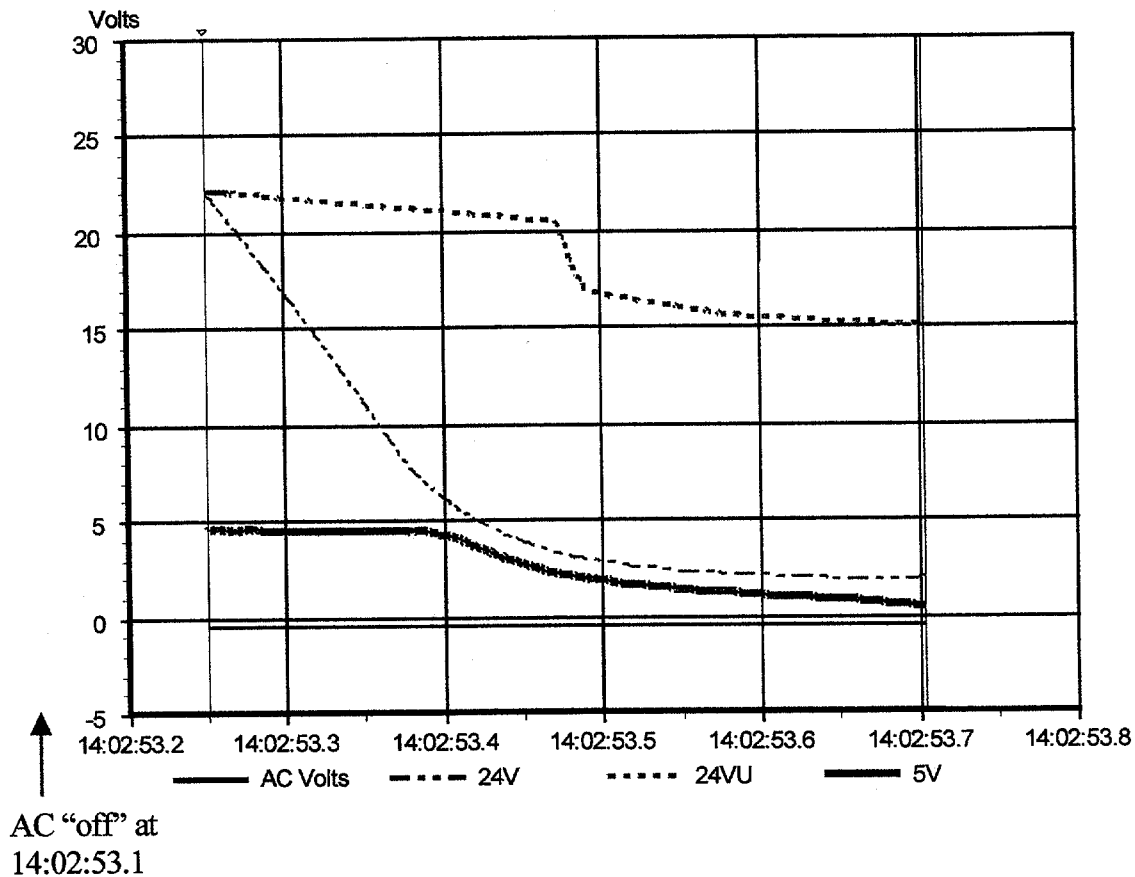
**Figure 2-16.** Dranetz recording shows voltage decays.

Figure 2-16 shows that within a fraction of a second (0.15 sec) after AC power goes to zero volts, decay of the voltage on the +24 V bus is evident. As the +24 V bus drops below about 7 volts, decay of the voltage on the +5 V bus is evident. As +5 V decays to approximately 3 volts, spurious signals are observed on U21 pins (see Figure 2-17). The +24 VU decays slowly until the bell circuits are activated—the change in slope of the +24 VU decay curve indicates flow of electrical energy to the Kidde electric discharge heads.

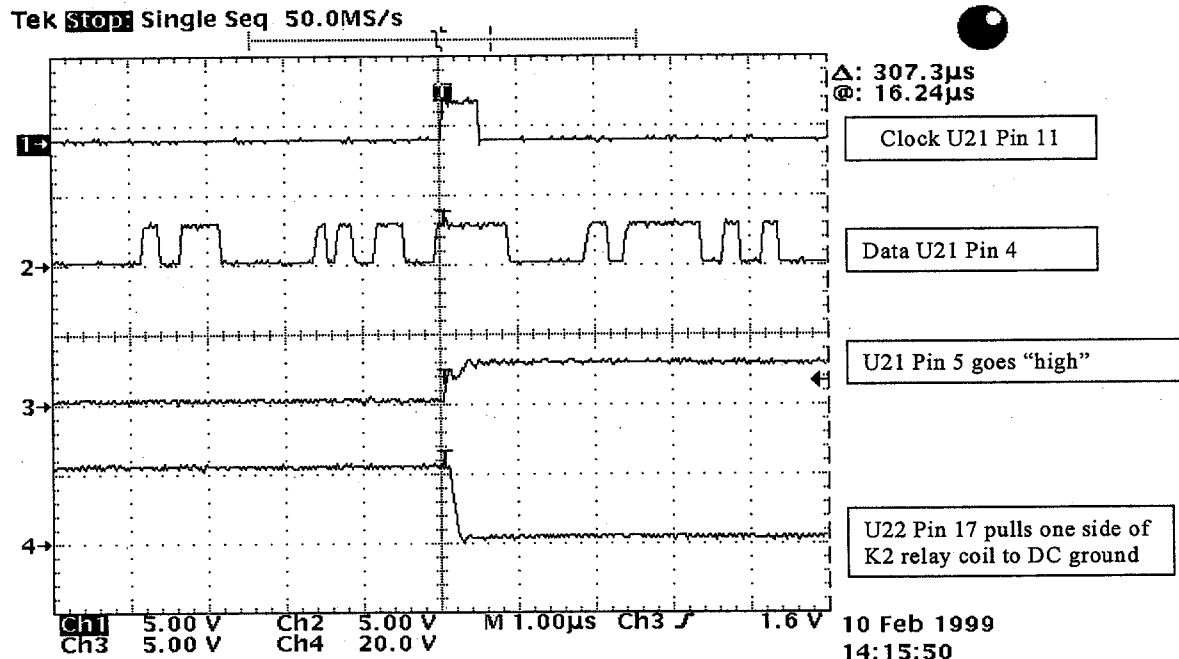
**Figure 2-17.** Oscilloscope traces from AFP-200 panel in TRA-648.

Figure 2-17 shows a high pulse on U21 Pin 4 coincident with a high-going pulse on U21 Pin 11. These pulses activate the associated flip-flop circuit in U21 causing U21 Pin 5 to go high. The high output on U21 Pin 5 is input to U22 Pin 2. The high signal on U22 Pin 2 causes U22 Pin 17 to pull one side of the K2 relay coil toward DC ground. This energizes relay K2.

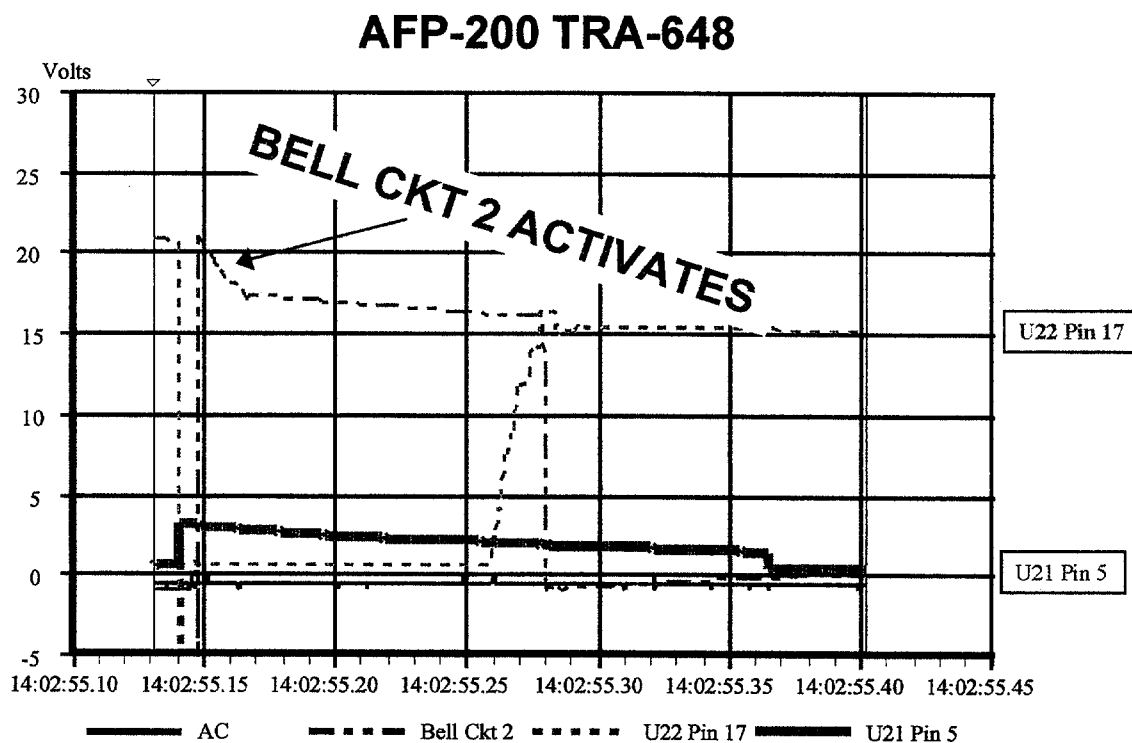
**Figure 2-18.** Dranetz recording shows Bell Circuit 2 activates.

Figure 2-18 also records the high signal on U22 Pin 2 and the resulting signal on U22 Pin 17. The resulting activation of Bell Circuit 2 is likewise recorded. U21 Pin 5 output goes high causing U22 Pin 17 to pull one side of the K2 relay coil to DC ground. Voltage on Bell Circuit 2 reverses from approximately -2 volts supervisory status to +24 volts activated status. The high voltage pulse on Bell Circuit 2 lasts approximately one-eighth second. The strength and duration of the pulse is sufficient to activate the Kidde electric control head connected to Bell Circuit 2. The Kidde control head discharges the CO<sub>2</sub> system.

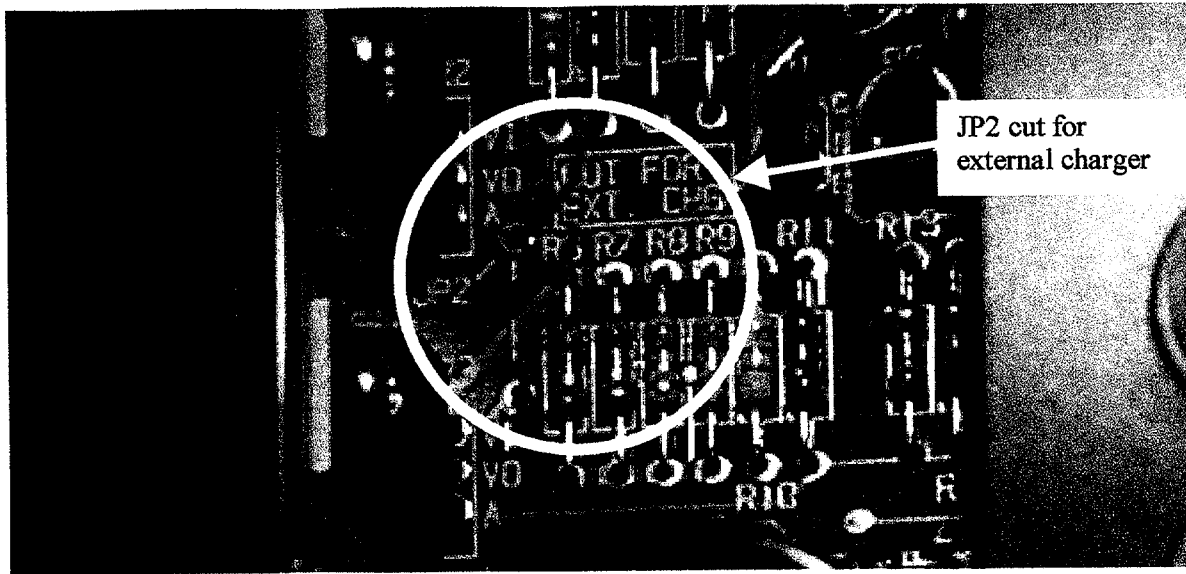
**Figure 2-19.** The AFP-200 printed circuit board instructions to cut JP2.

The AFP-200 panel printed-circuit board has "CUT FOR EXT. CHG" imprinted next to Jumper JP2 (see Figure 2-19).

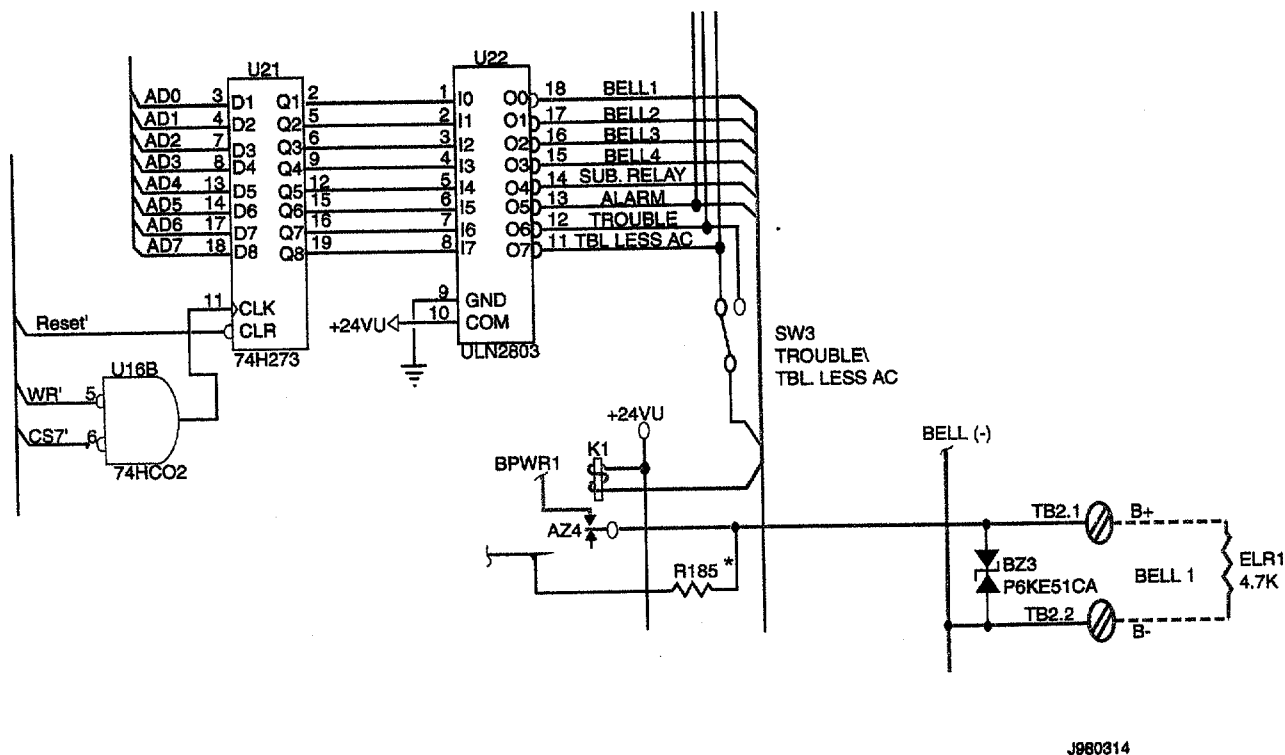
**Figure B-2.** The energy stored on the capacitors on the +24 VU bus is adequate to operate the solenoids.

The +5 V bus powers the microprocessor U5 and the associated chips including the D flip-flops U21. The outputs of the D flip-flops drive the high current darlington transistors U22. The U22 chip is powered by the +24 VU bus. The outputs from U22 drive the K-series Relays (K1, K2, K3, and K4), which in turn connect power to the release solenoids. The K-series relays are powered by the +24 VU bus. Refer to Figure B-2.

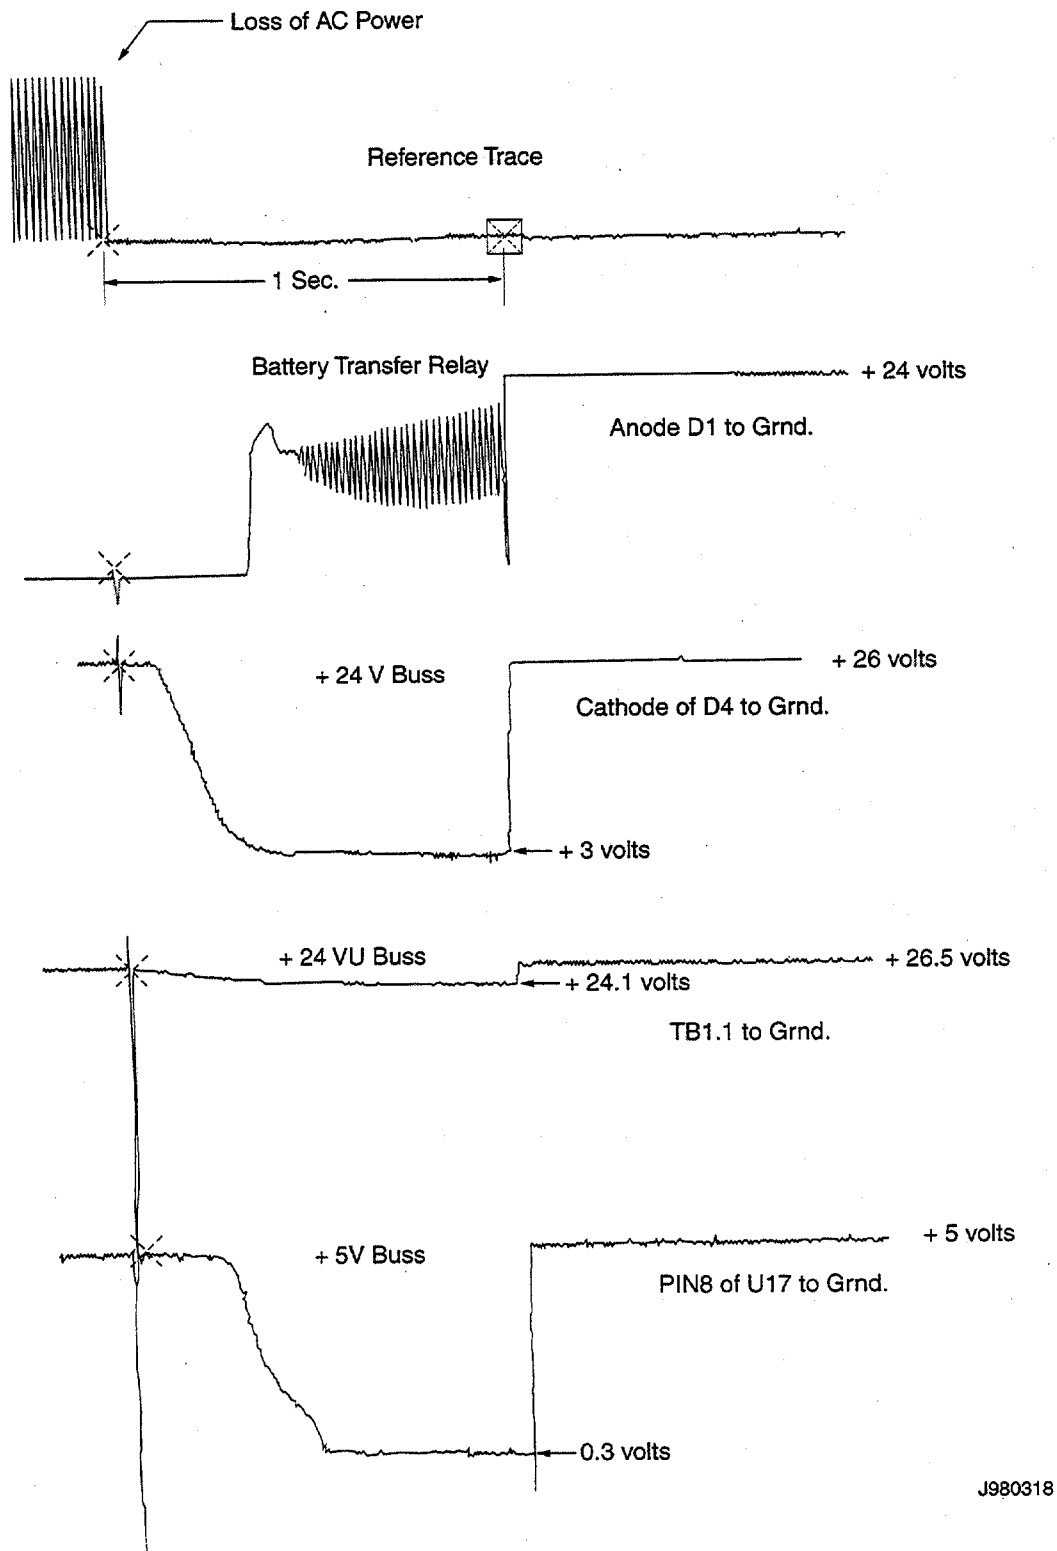
**Figure B-4.** Voltage traces on important leads.

Another important set of recorded voltage traces displayed on Figure B-4 shows spurious *select pulses*. These traces were recorded on a digital storage oscilloscope at MET Labs in Baltimore, MD while the AFP-200 panel was at 115°F. The AFP-200 panel was equipped with a NR45 charger and an AVPS24 power supply. The top trace shows the declining +5 V bus after loss of AC power. The bottom trace shows the *select pulses*. The first and second *select pulses* appear at the observed regular 250-millisecond rate; however, the second *select pulses* is lower in amplitude. *Select pulses* labeled 3 and 4 appear at reduced amplitudes at approximately 28 and 36 milliseconds after the second *select pulse*. These *select pulses* occurring out of the normal timing sequence could produce a false "fire" signal to start the chain of events leading to false operation of the release solenoids.
