FINAL REPORT
OF
SL-1 RECOVERY OPERATION

SL-1 Project
Idaho Test Station
General Electric Company
July 27, 1962

United States Atomic Energy Commission
Contract No. AT (10-1) 1095

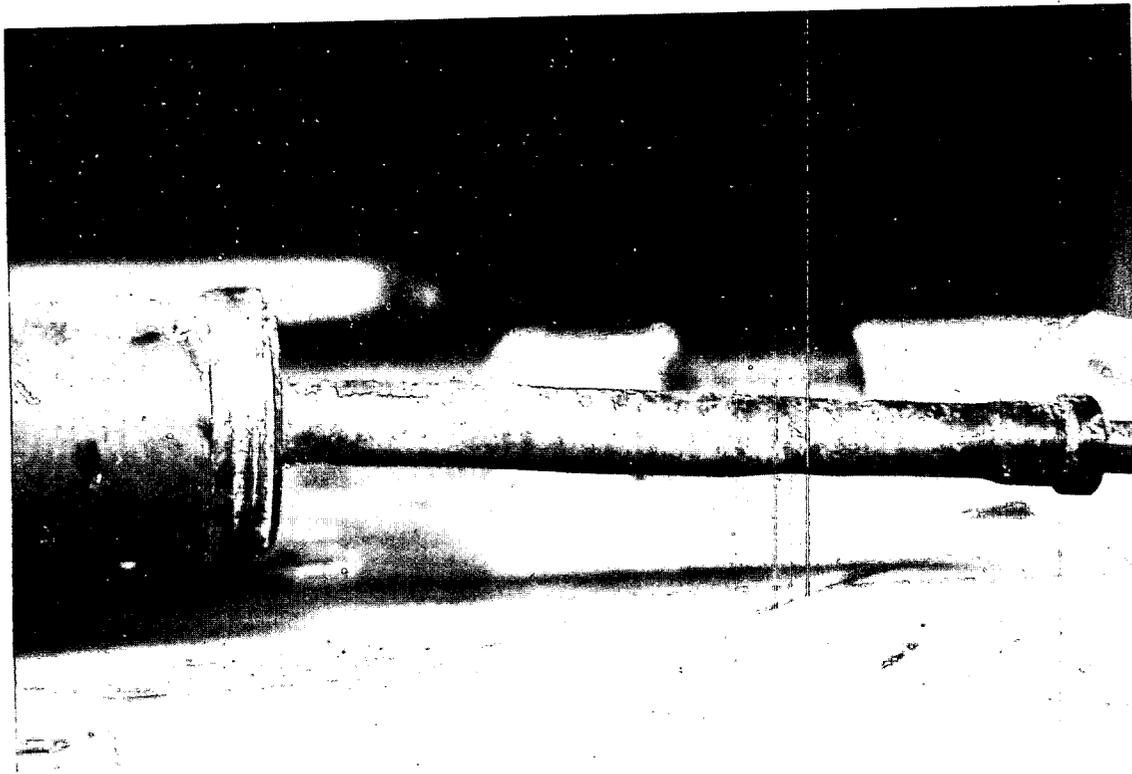
Fig. III-4, Shield Plug #9, guide tube collapse and white surface deposits.

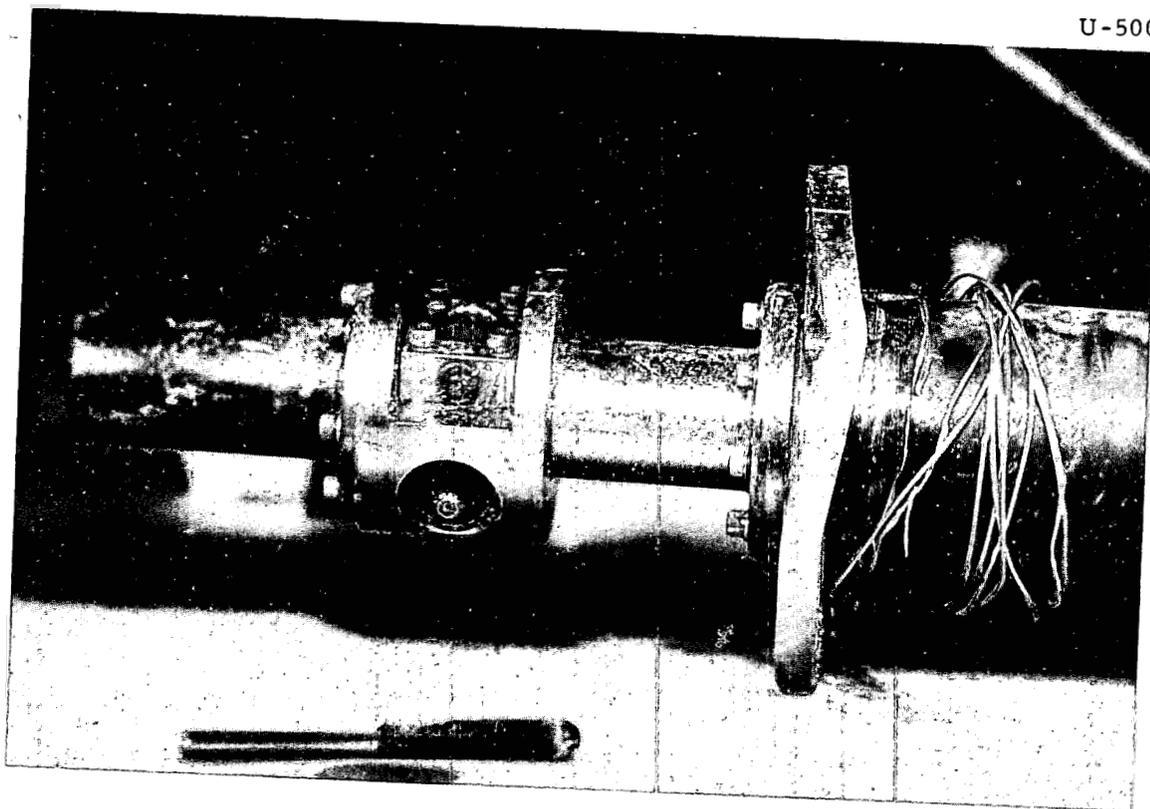
Fig. III-6, Shield Plug #9, upper section, showing flange deformation, surface deposit and ruptured gaskets.

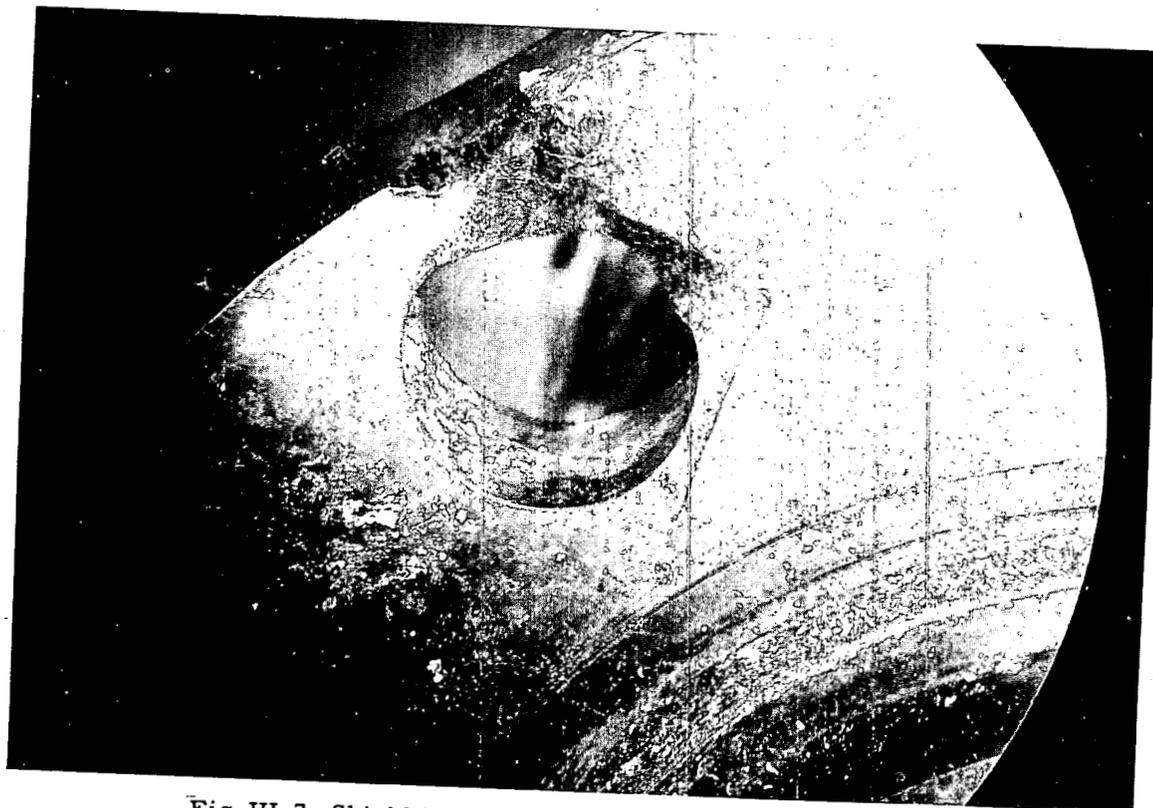
Fig. III-7, Shield Plug #9, imprint on bolt hole from impact against corner of condenser.

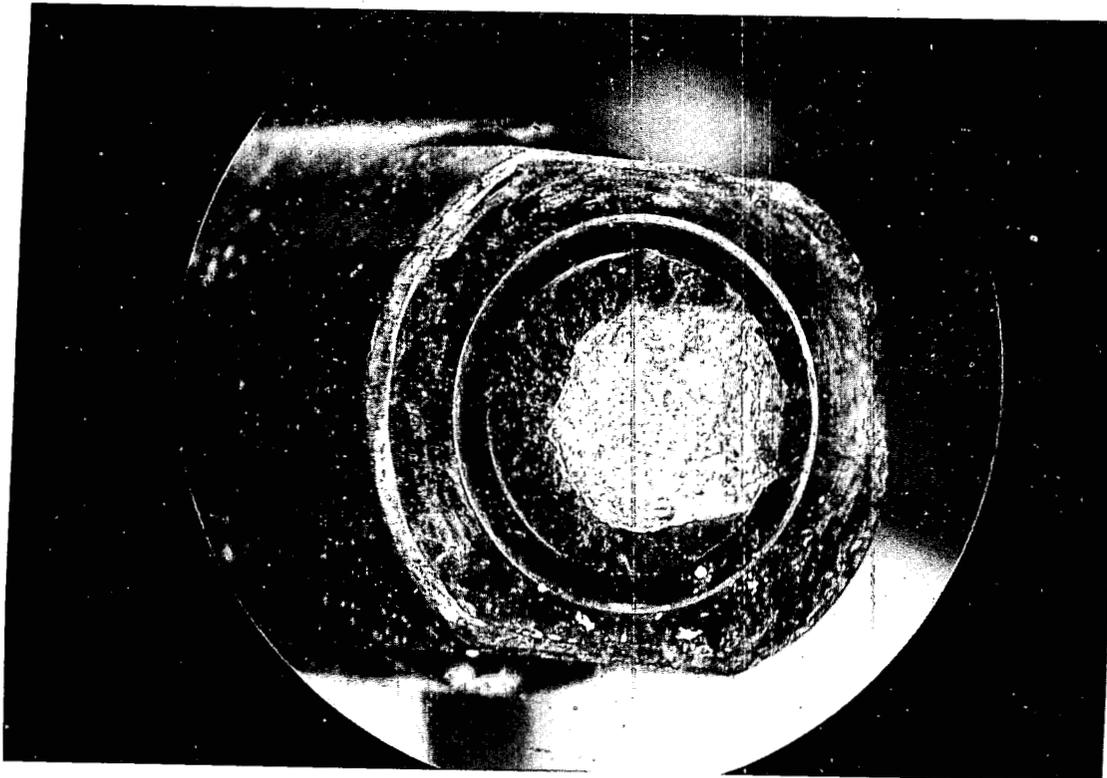
Fig. III-9, Shield Plug #9, extension rod, showing fatigue area and fracture.

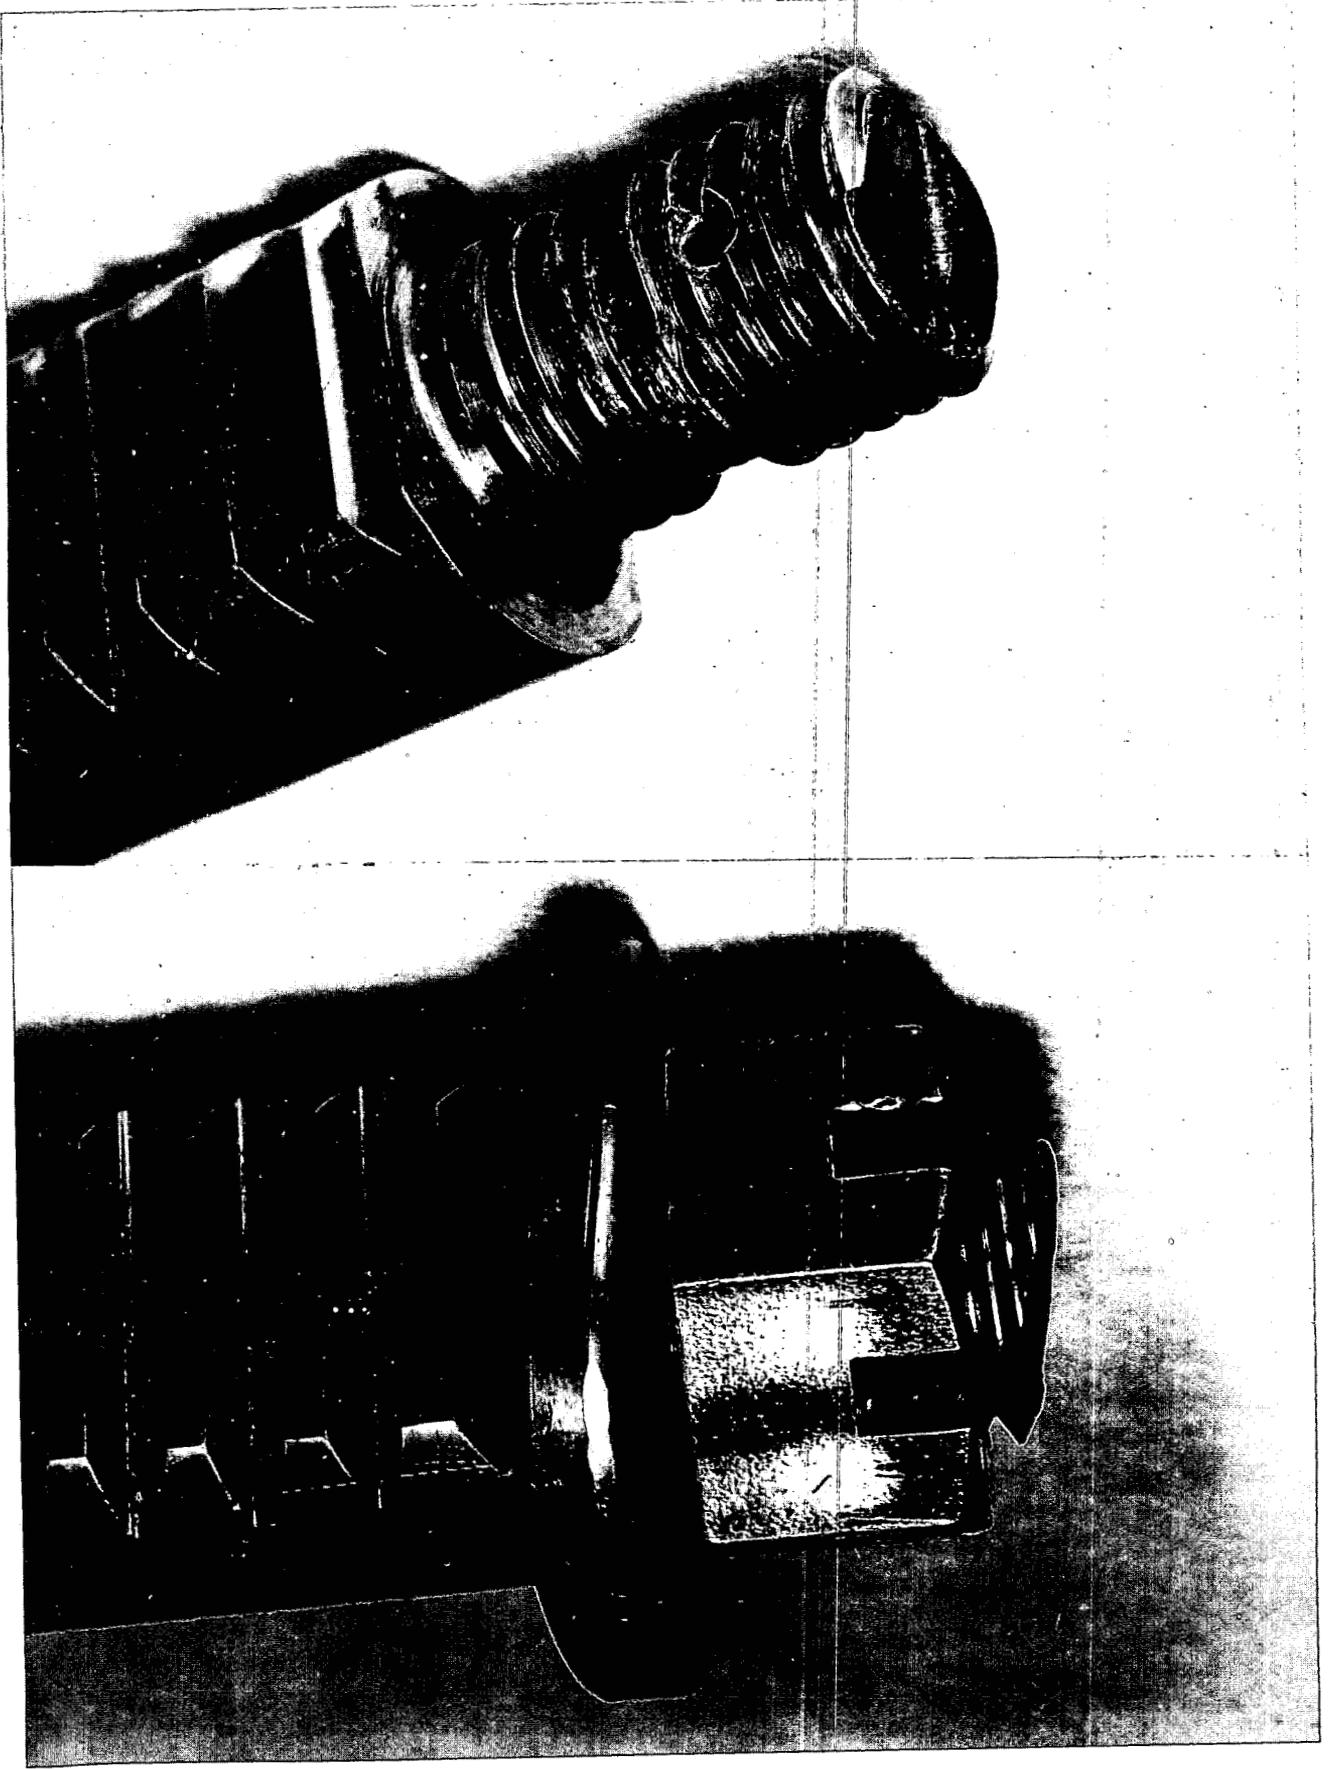
Fig. III-11, Shield Plug #9, top of rack, nut and washer. Galled thread (pre-incident) was one major identification feature.

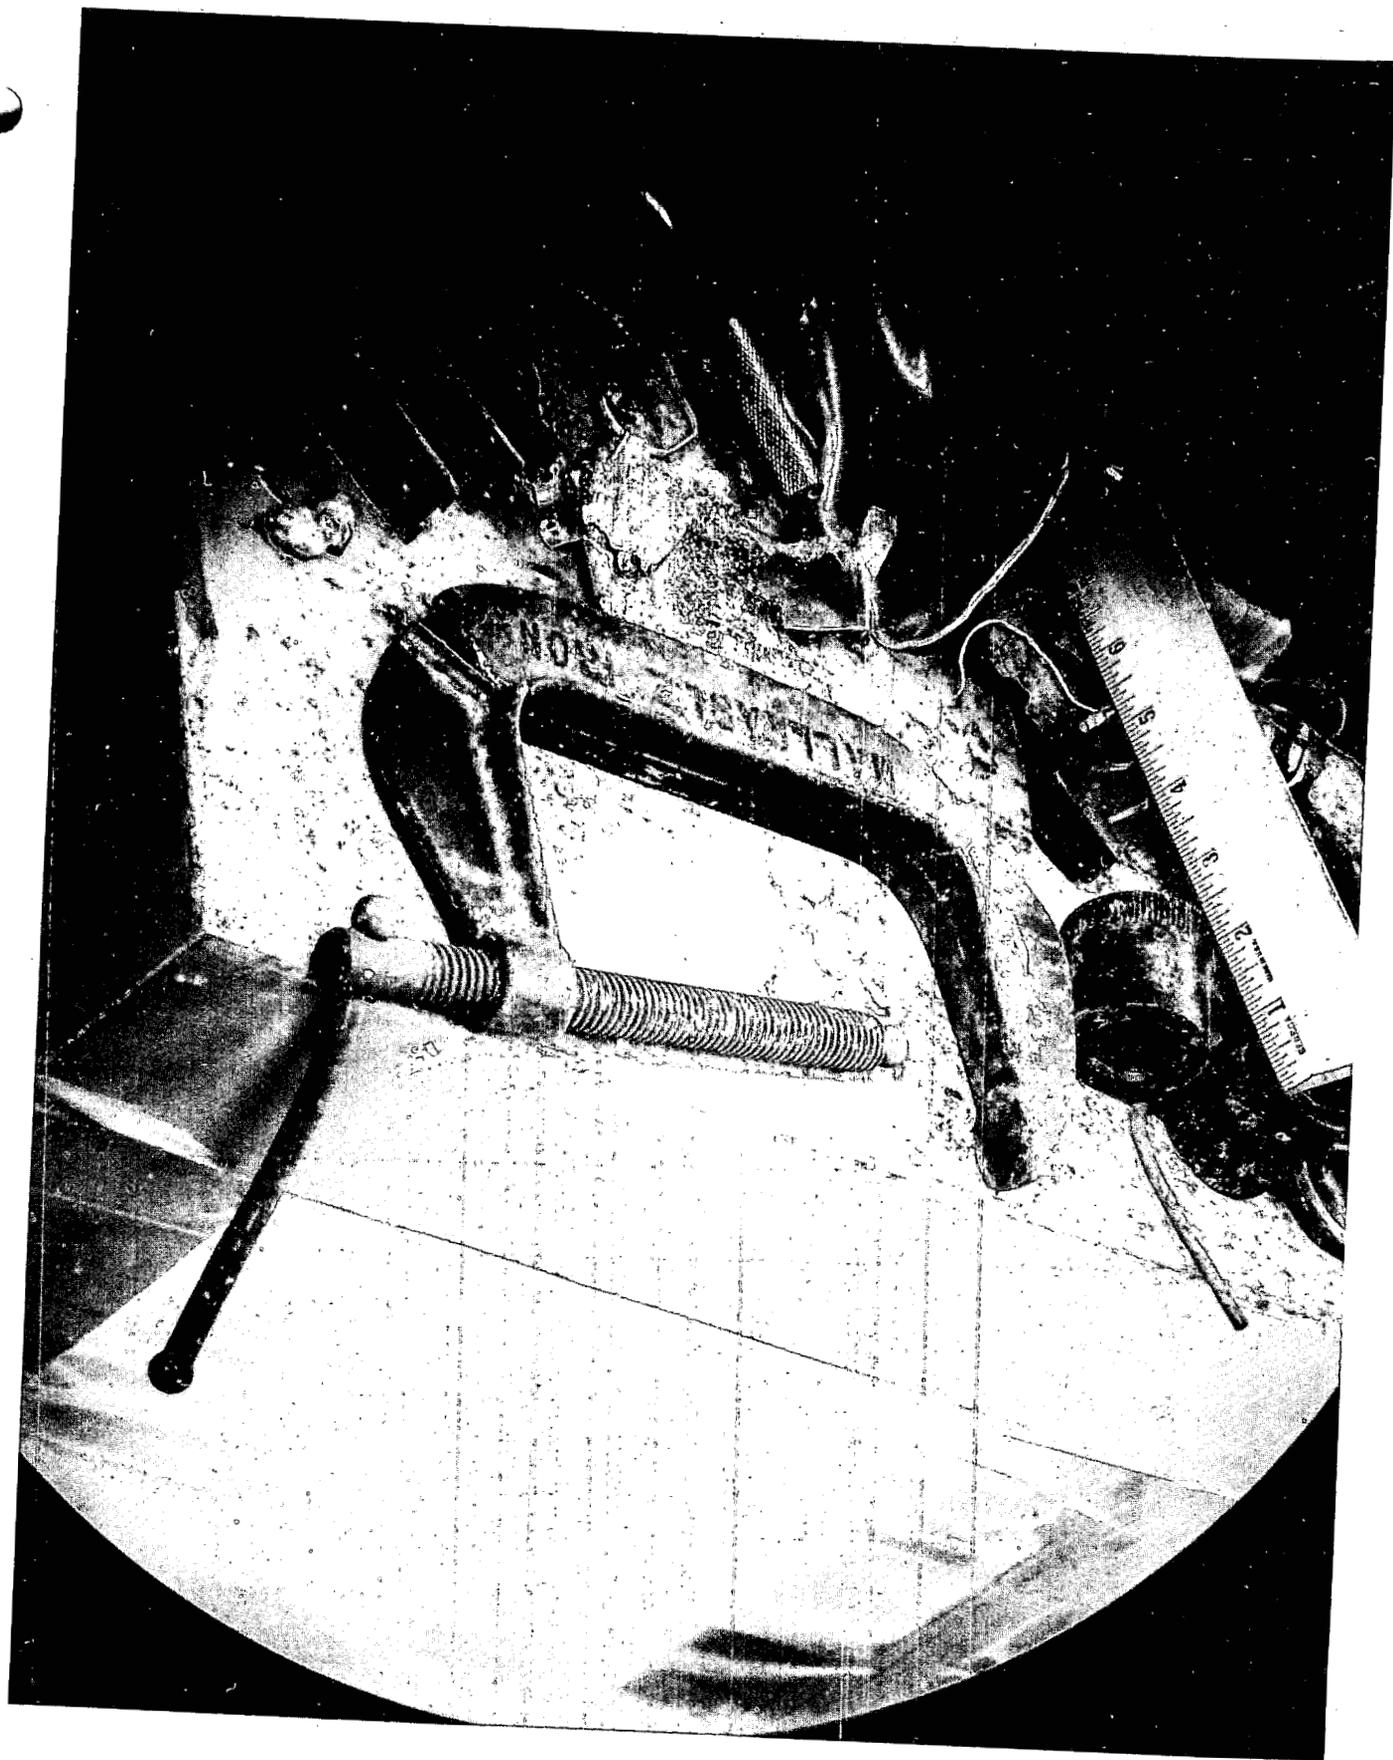
Figure III-18, Broken C-Clamp Recovered
from Fan Room Floor

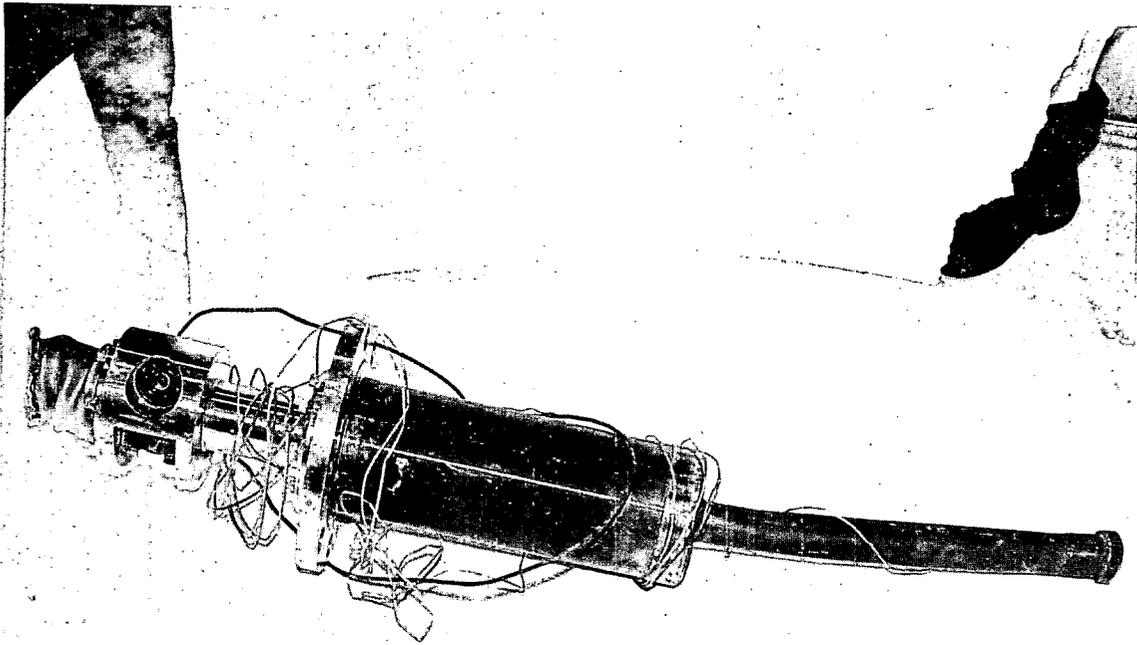
Figure III-19, Shield Plug #1, showing Damage to Spring Housing, Flexitallic Gaskets, and Guide Tube

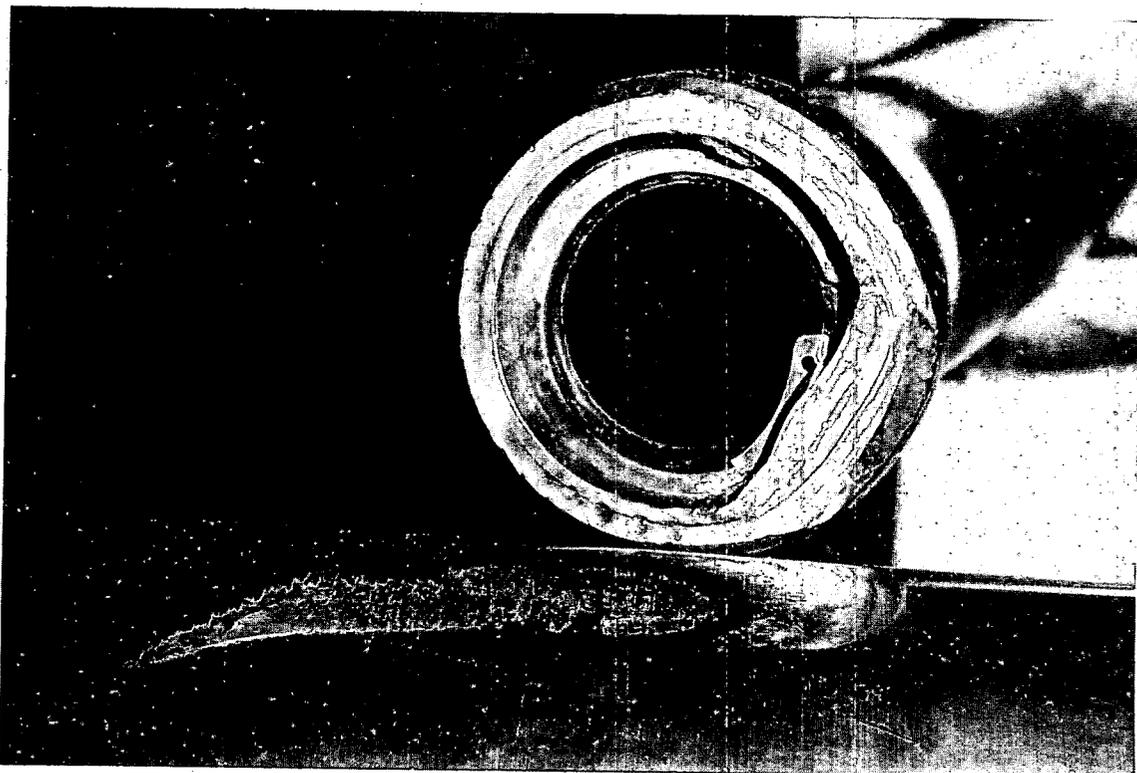
Figure III-20, Shield Plug #1, Matching Imprint of Shield Plug Body #7 with Imprint on End of Guide Tube, Shield Plug #1

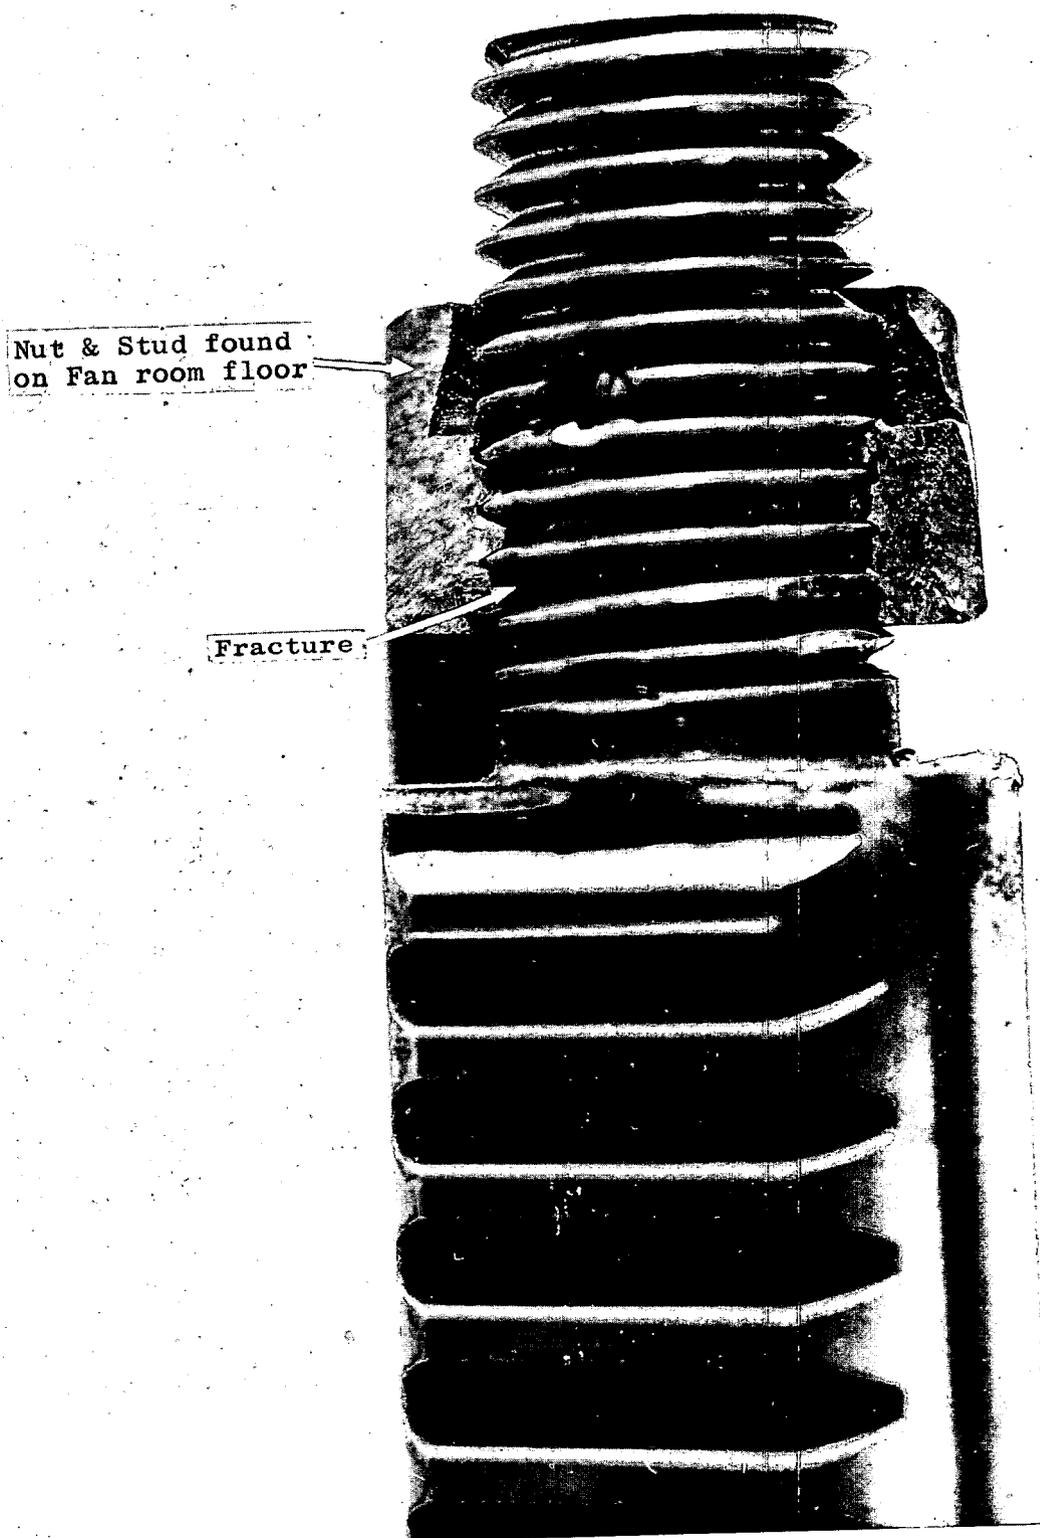
Figure III-23, Shield Plug #3, Mating of Fractured
Nut Retained in Stud with Fractured End of Gear Rack

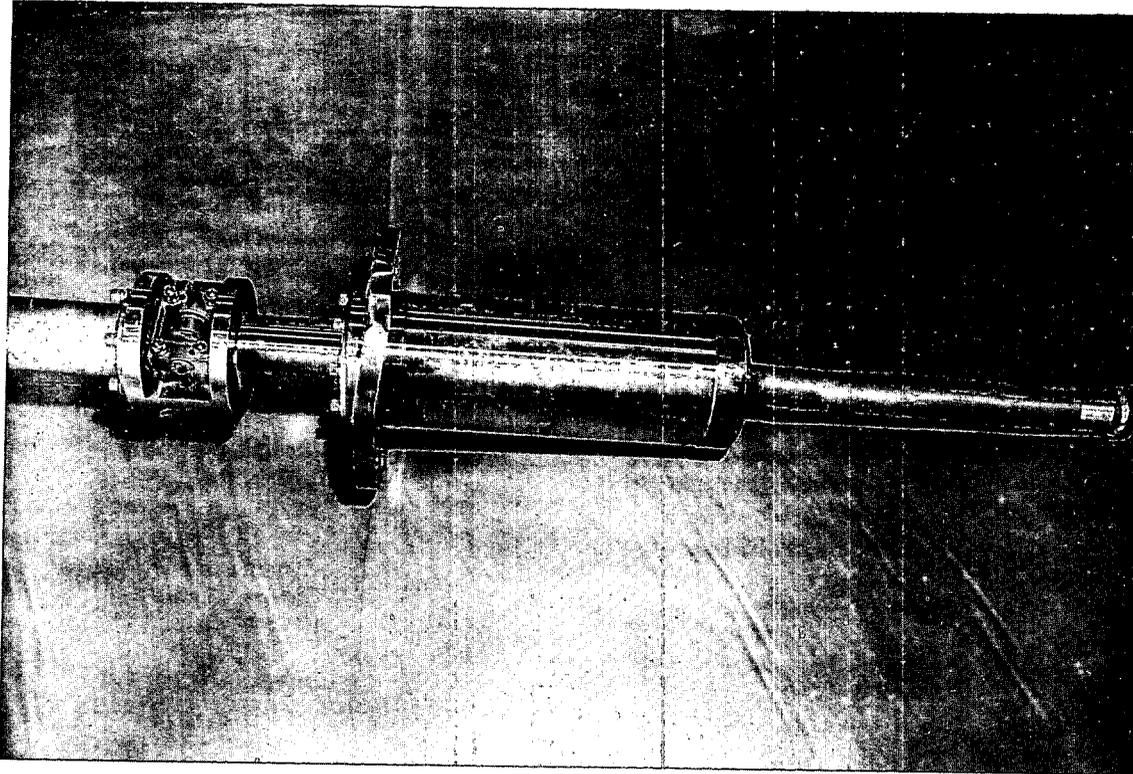
Figure III-24, Shield Plug #4, Showing Flange Deformation and Guide Tube Collapse

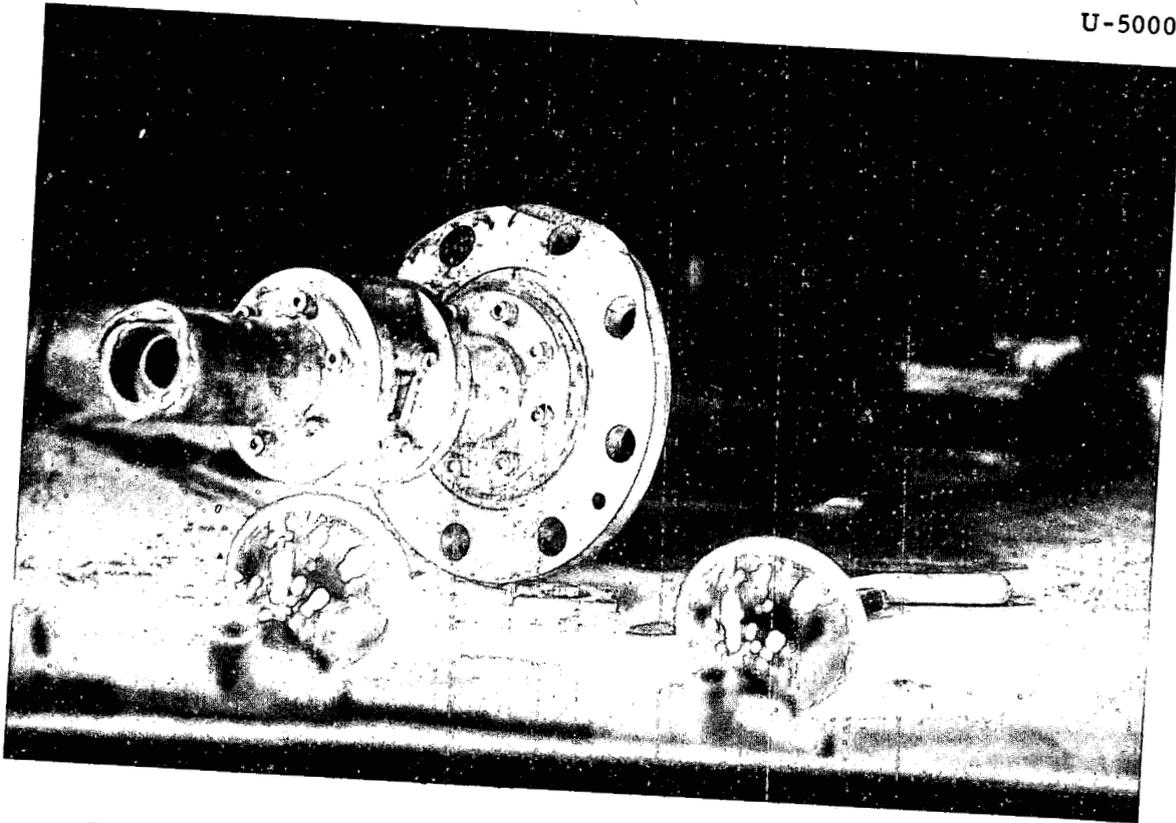
Figure III-26, Showing Spring Housing and Flange Deformation and Guide Tube Collapse

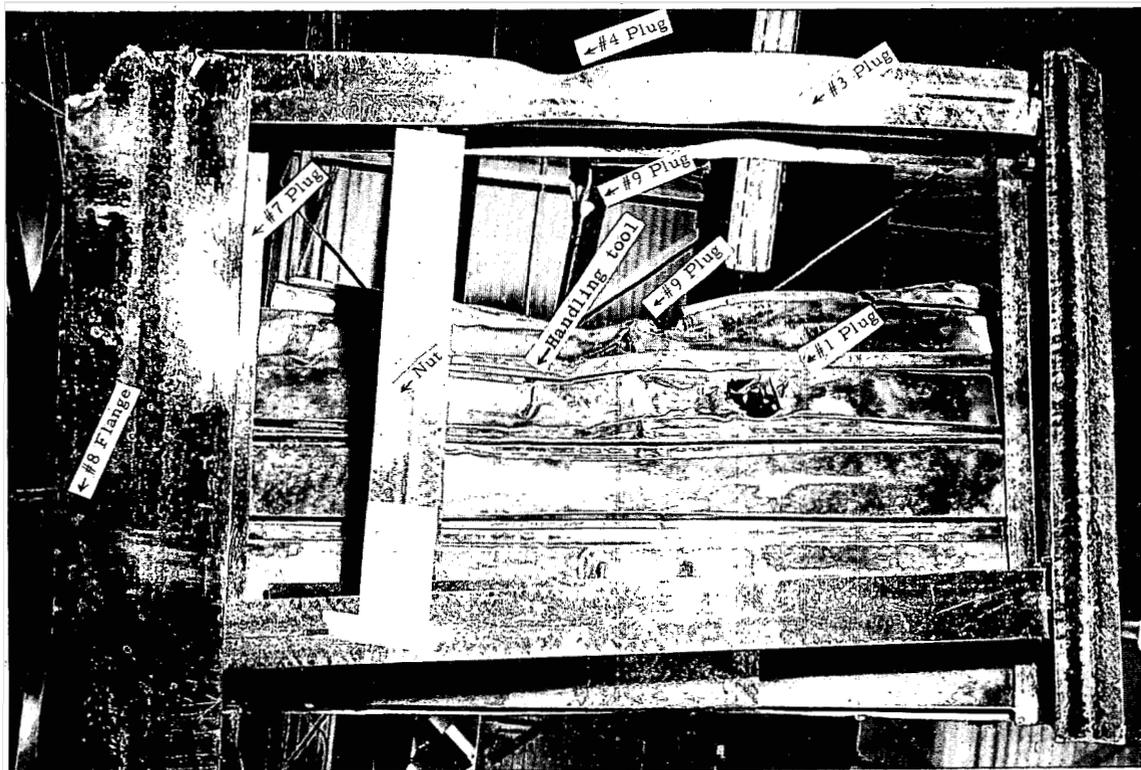
Fig. III-30, Section of fan room floor, showing areas of damage.

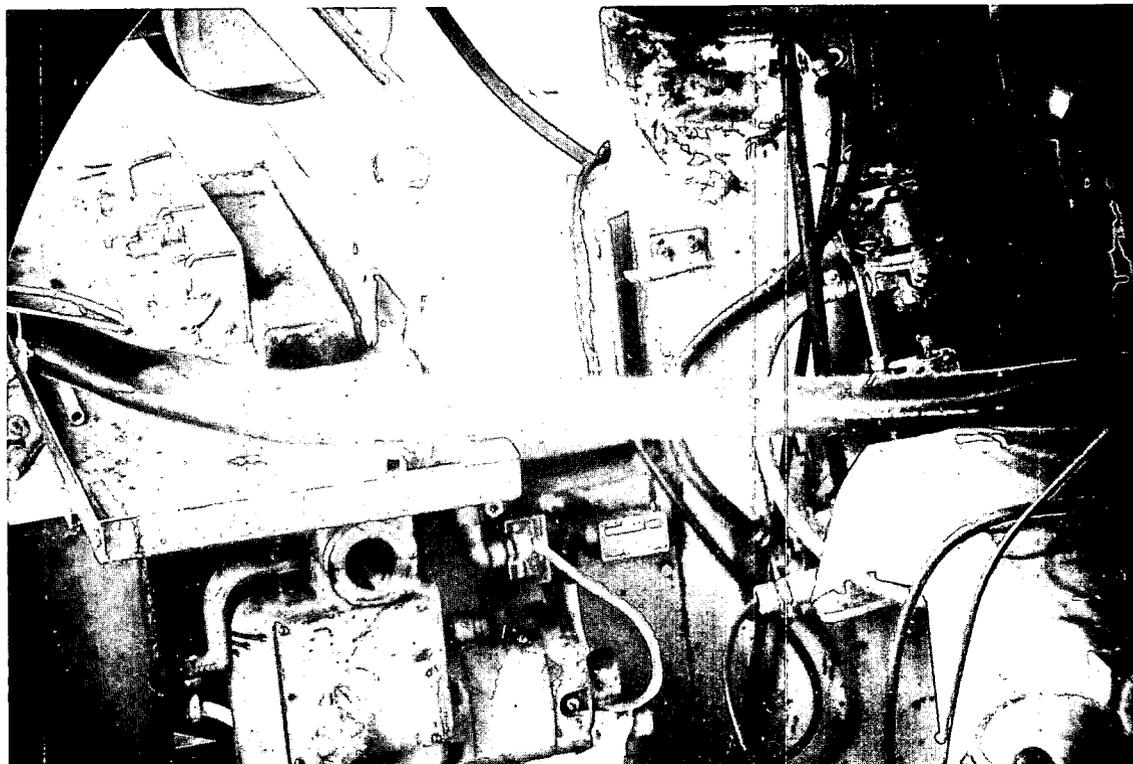
Fig. III-33, Collapsed stillwell pipe.

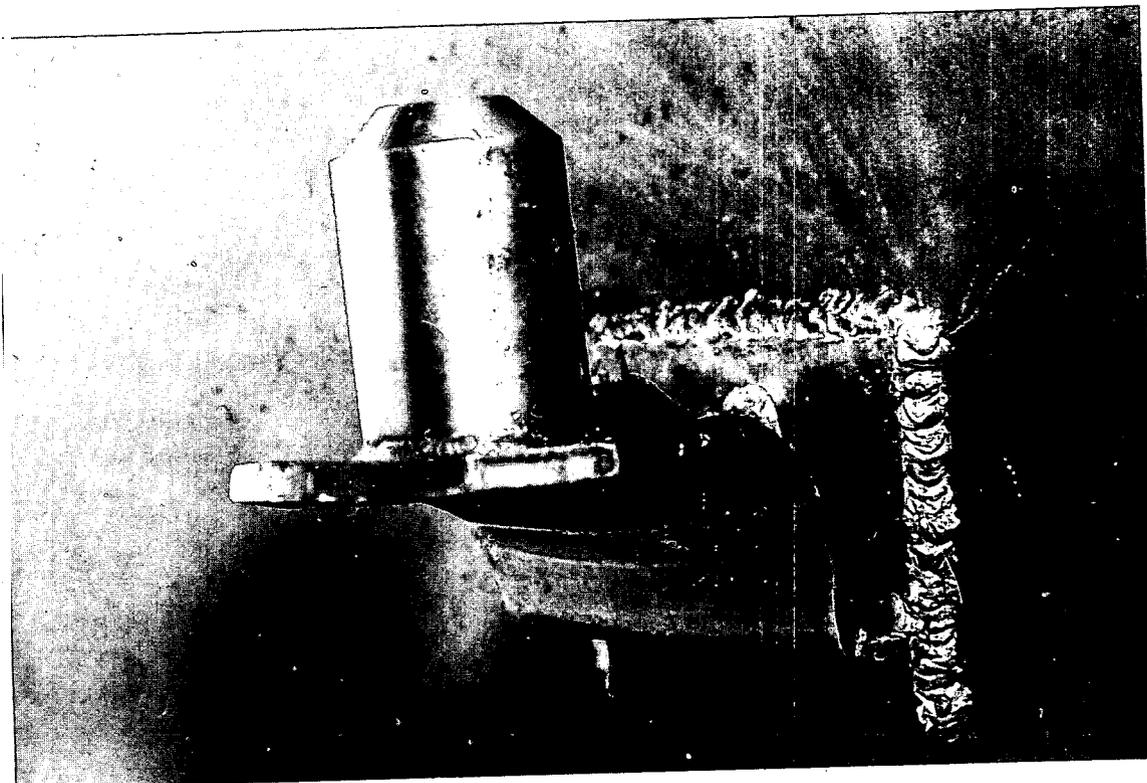
Fig. III-35, Fractured weld, auxiliary stillwell guide pin support bracket.

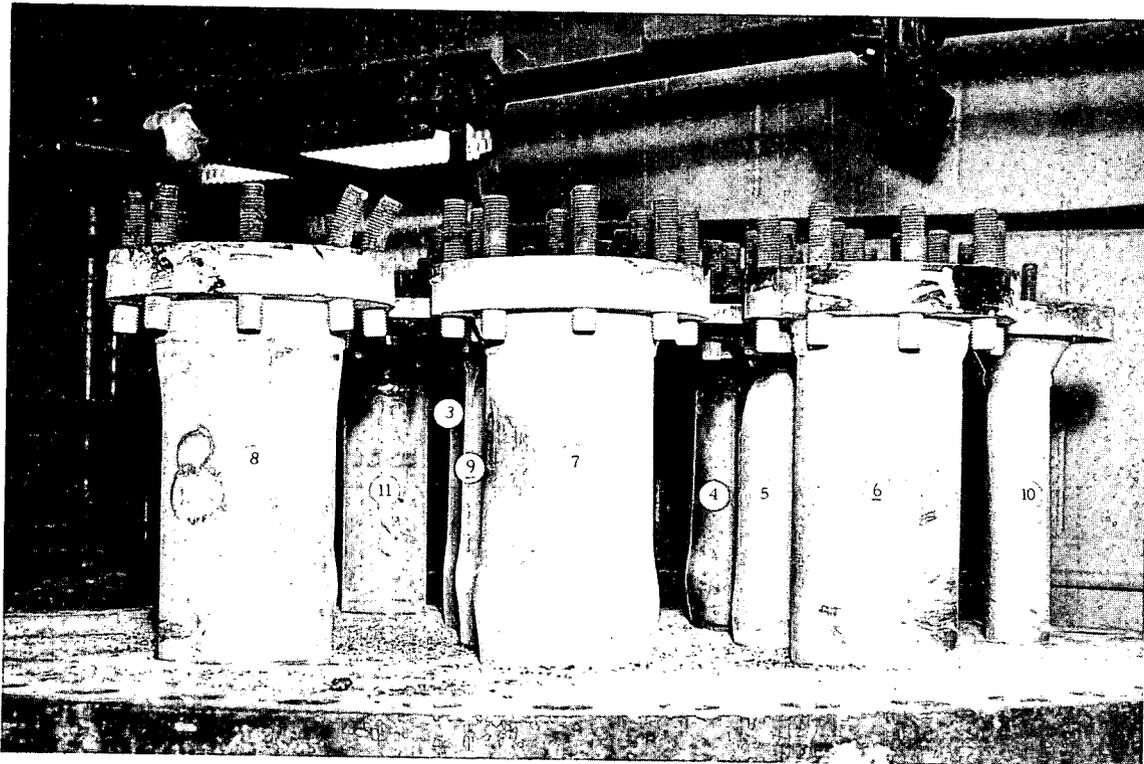
Figure III-37 Deformation of pressure vessel head nozzles

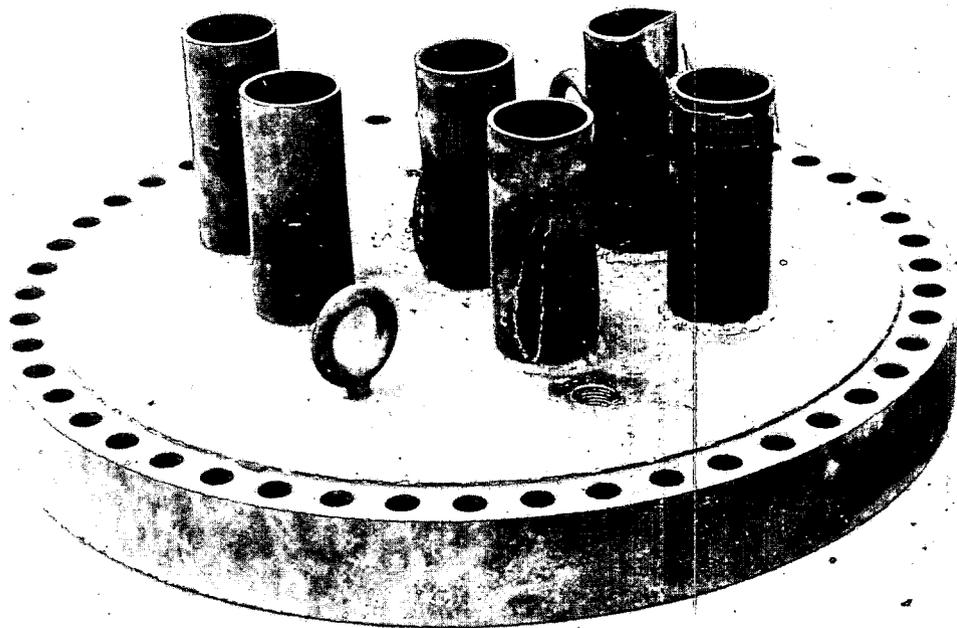
Figure III-40 1/4 scale model of pressure vessel head, showing damage to nozzles

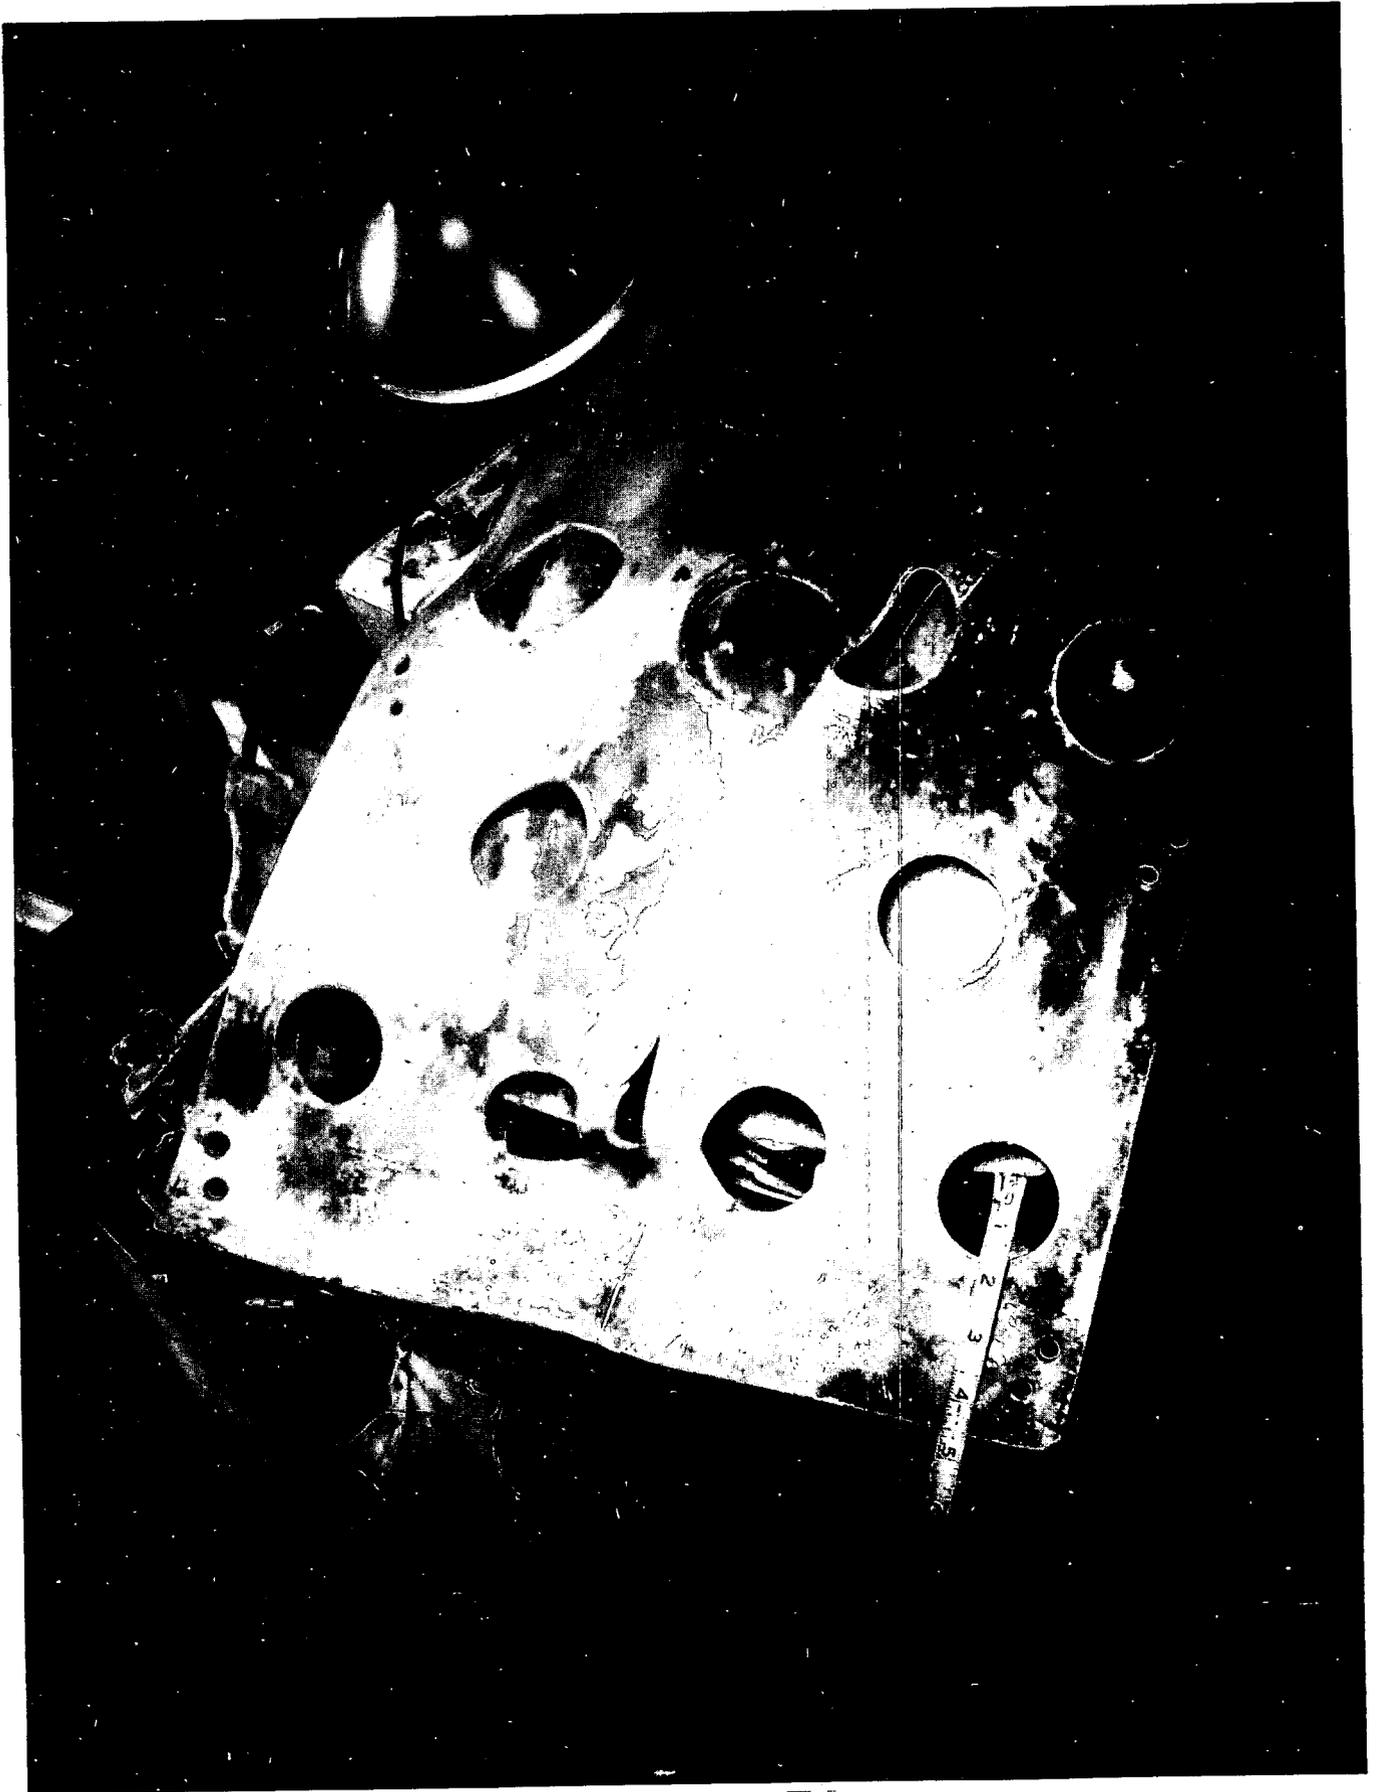
The recovery of the central control rod, locked in its shroud at the 20-inch withdrawn position and with evidence of no relative motion after seizure, definitely established the condition which made the reactor supercritical. The reactor was not normally operated with only the central control rod withdrawn, but from the limited critical experiment data available for this rod configuration, it is estimated that the reactor would have been critical with the central rod withdrawn to 16.7 inches. At the 20-inch position, the reactivity would have been $(2.4 \pm 0.3)\% \Delta k/k$.

Figure III-58, Control Blade #9 bound in its shroud.

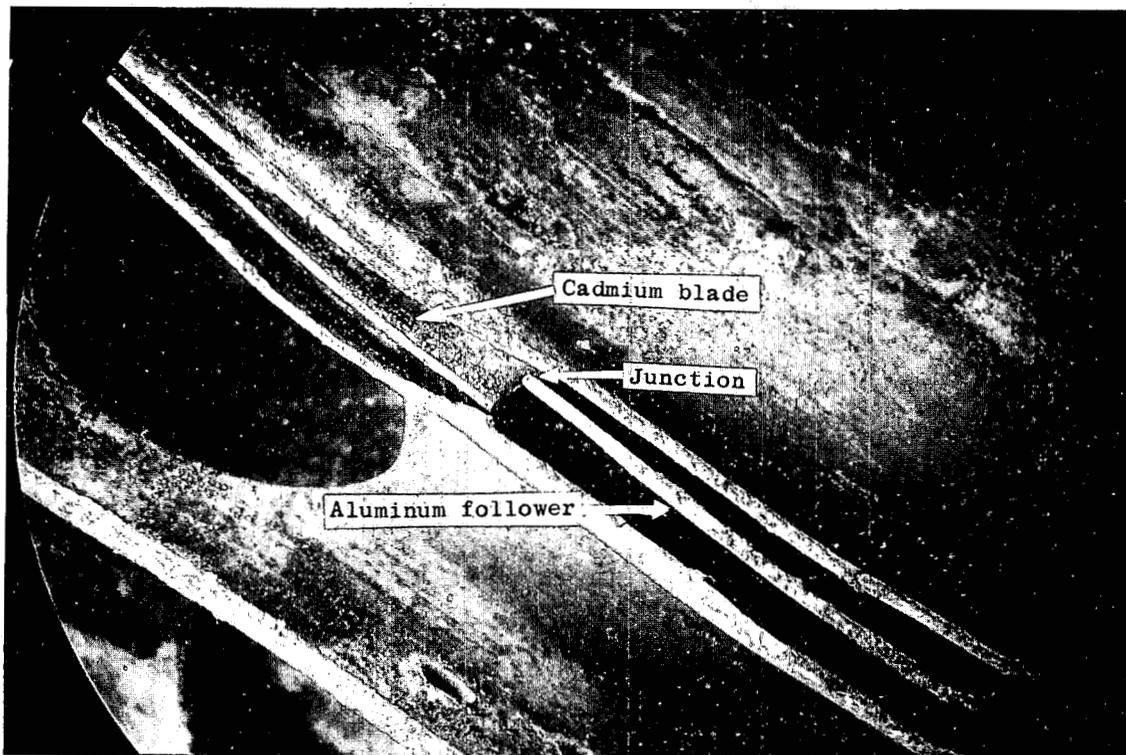
Figure III-61 Cadmium blade showing weld seam separation

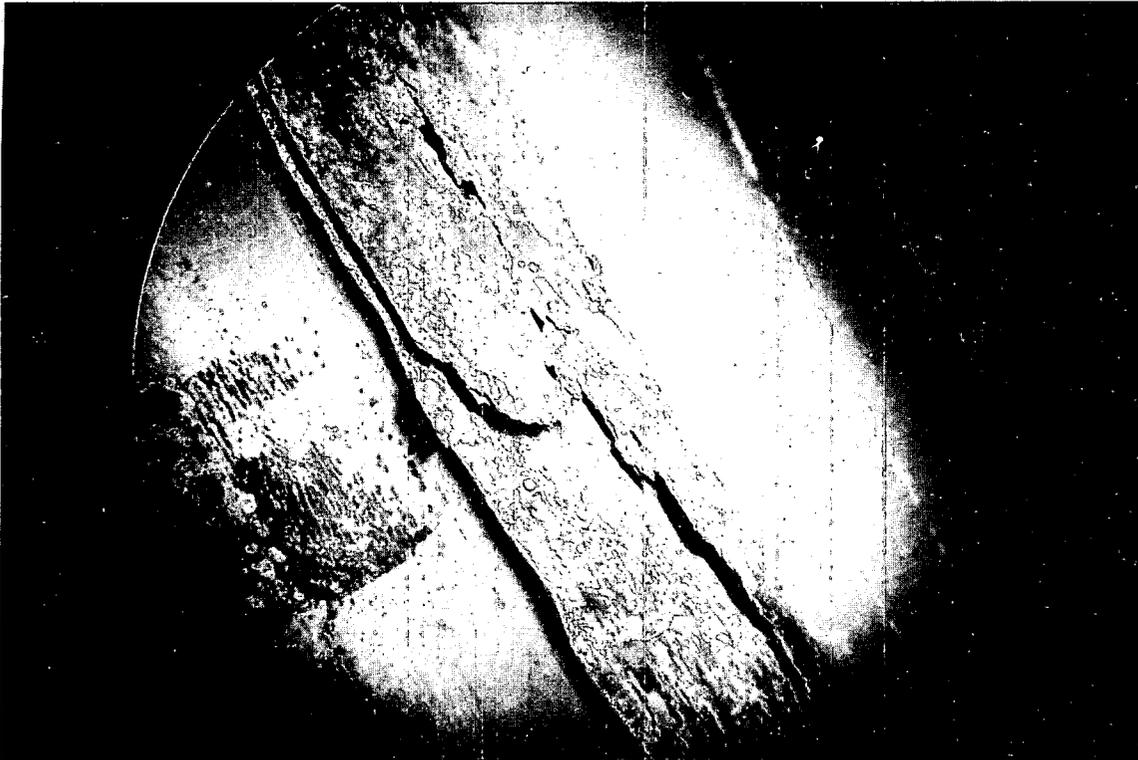
Figure III-66, Corrosion and Deterioration of Boron Strip on Fuel Element #45 Side Plate

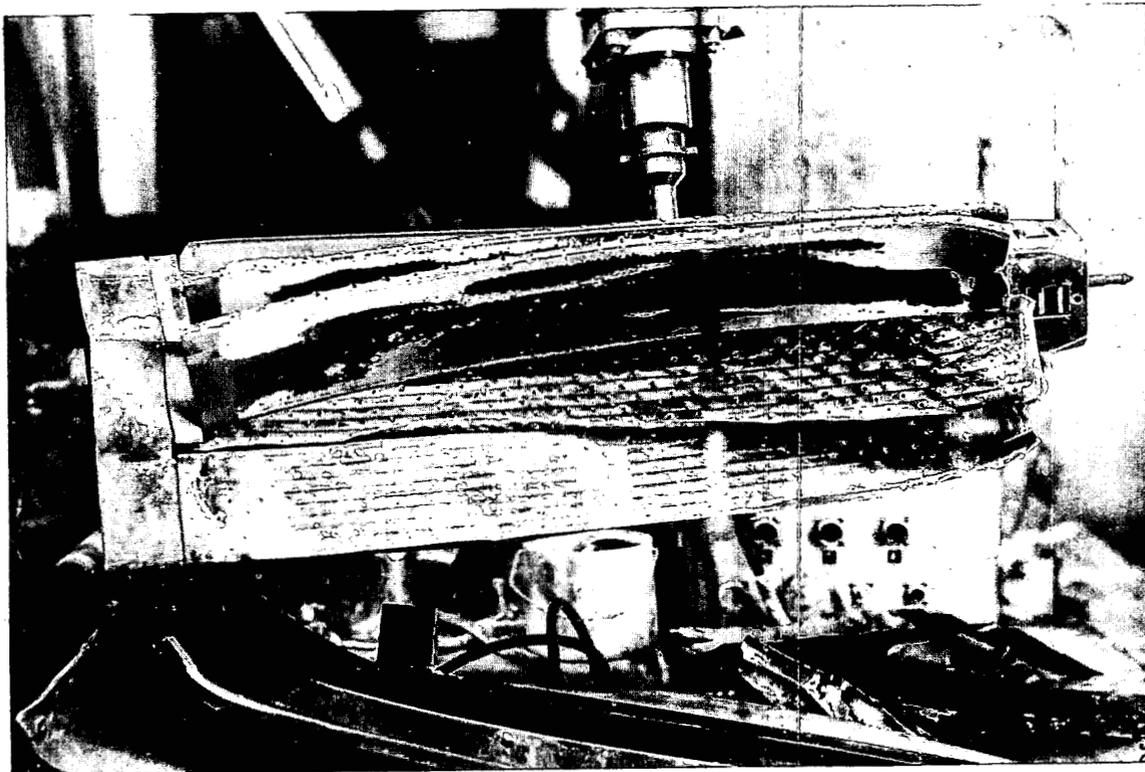
Figure III-79 Fuel Elements #60 and 18, Showing Heat Affected Areas
