FINAL REPORT
OF
SL-1 RECOVERY OPERATION

SL-1 Project
Idaho Test Station
General Electric Company
July 27, 1962

United States Atomic Energy Commission
Contract No. AT (10-1) 1095

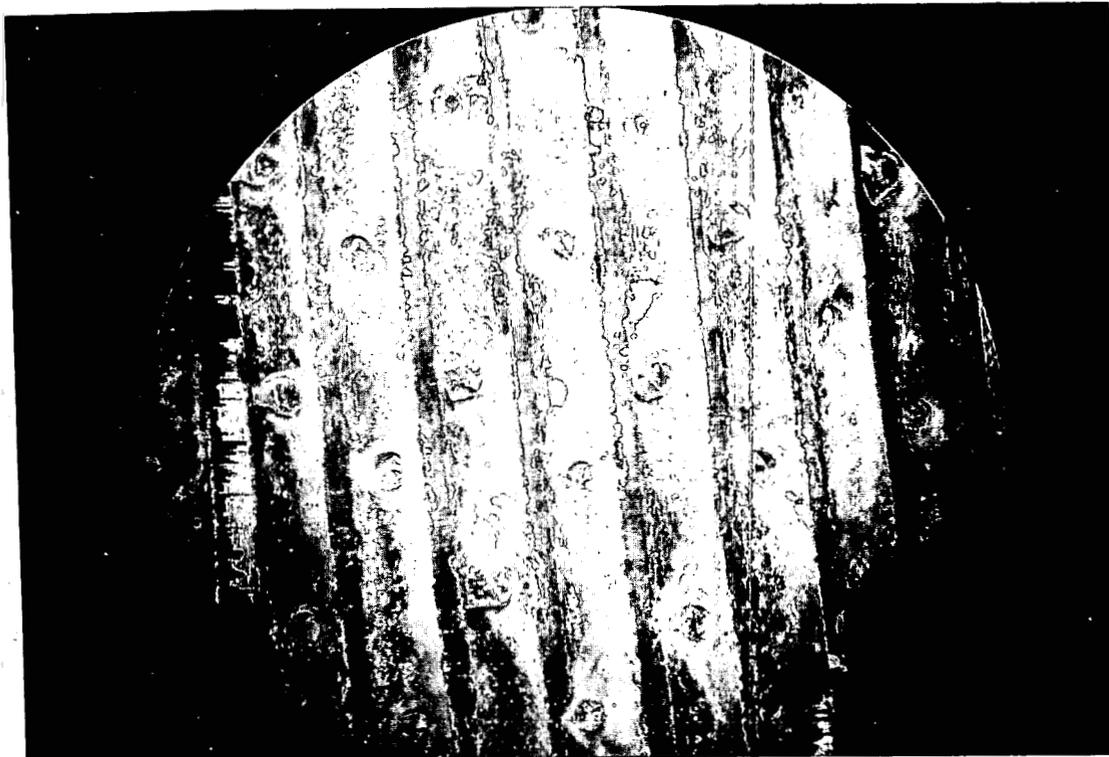
Figure III-80 Fuel Element Side Plate Showing Fracture of Spot Welds
