**REPORT OF
INVESTIGATION COMMITTEE
ON
AEC INVESTIGATION
OF ACCIDENTAL X-RAY
EXPOSURE AT HASL, NY
ON FEBRUARY 4, 1974**

(Conclusions and Recommendations)

REPORT
OF
INVESTIGATION COMMITTEE
ON
AEC INVESTIGATION OF ACCIDENTAL
X-RAY EXPOSURE AT HASL, NY, NY,
ON FEBRUARY 4, 1974

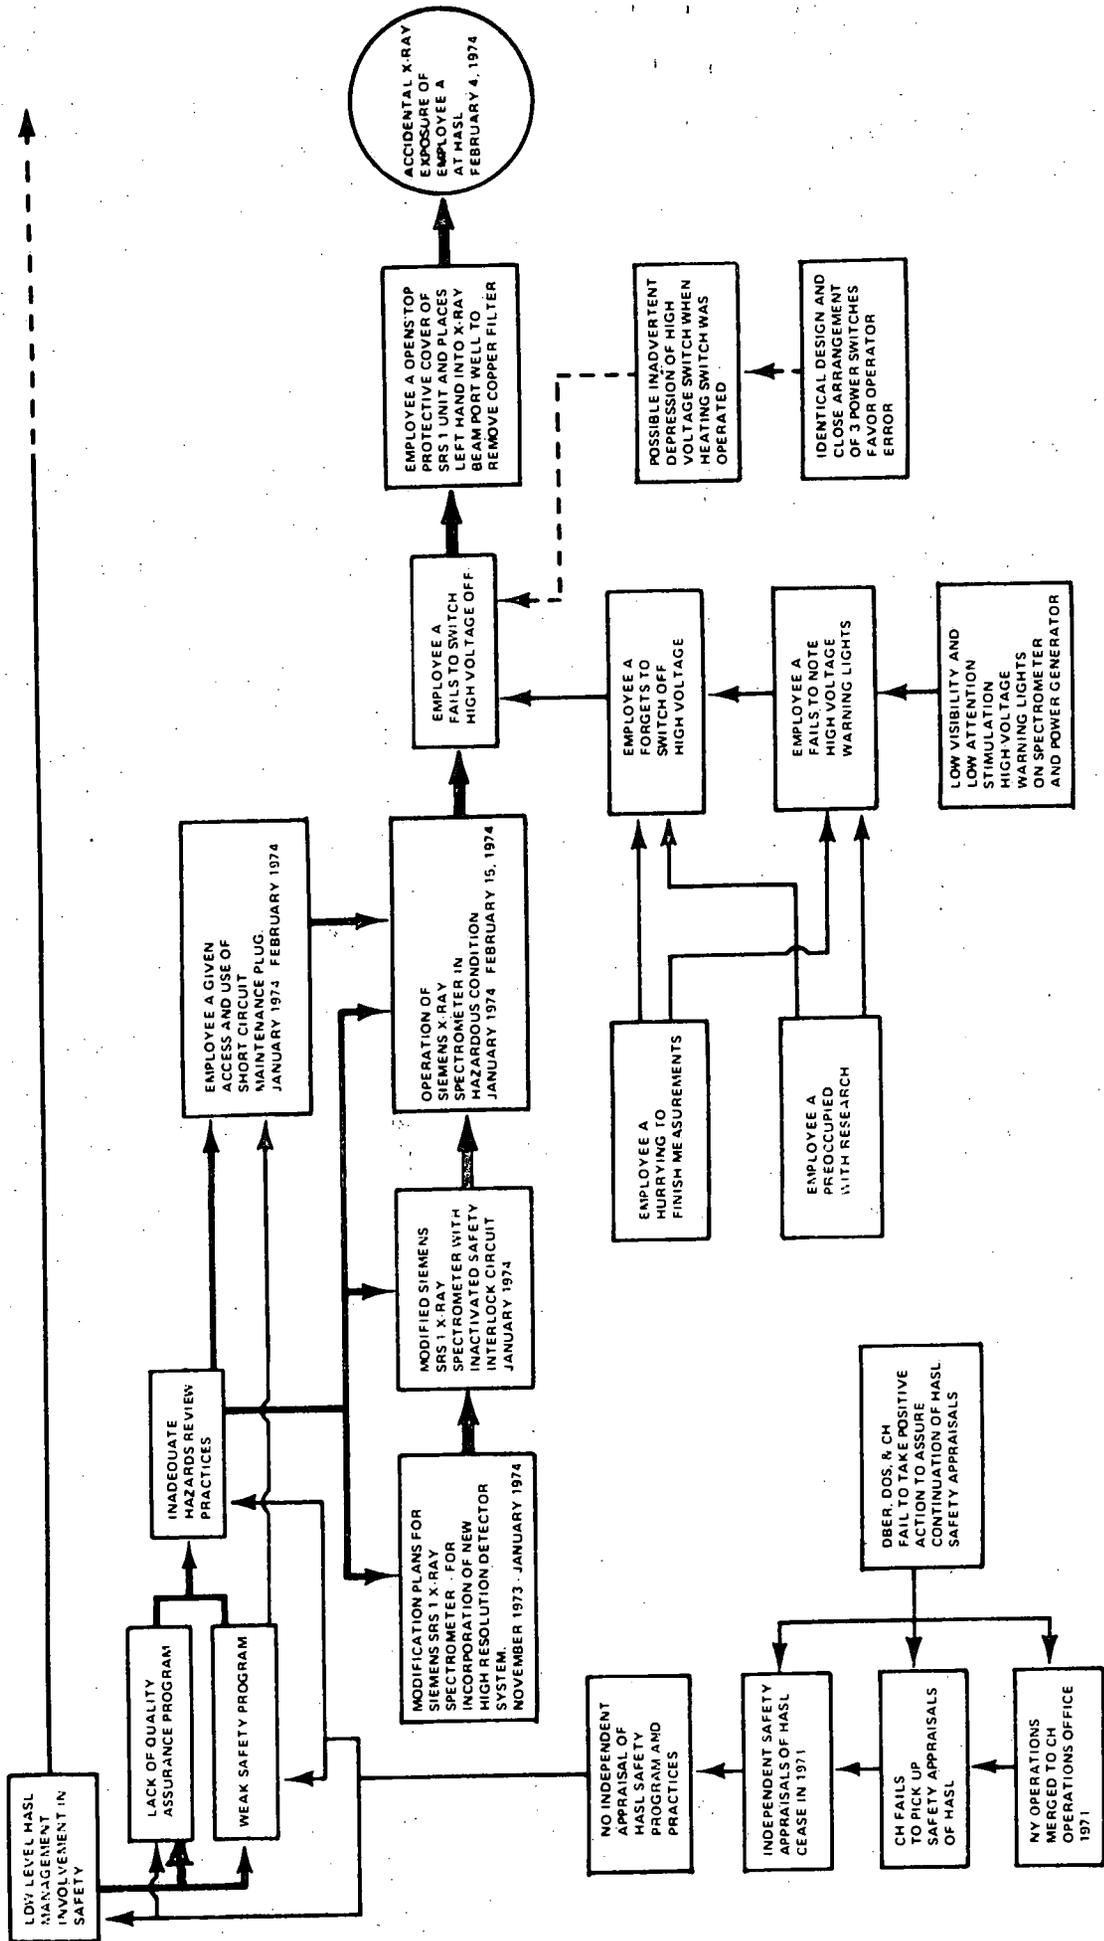
II. Figure 33. CAUSAL FACTORS FLOW CHART
 ACCIDENTAL X-RAY EXPOSURE AT HASL
 FEBRUARY 4, 1974

The immediate cause of the accident was the operation of the spectrometer in a modified configuration that caused inactivation of the safety interlock circuit and allowed x-ray tube operation with the protective top cover of the unit open. The employee inadvertently put his left hand close to the x-ray beam port thinking that the unit was switched off. A series of management oversights at both field and Headquarters levels contributed to the accident. At HASL, weak quality assurance and safety programs that do not provide for systematic, timely safety review of ongoing, proposed, new, or modified operations or equipment were contributory. Headquarters and CH failed to take positive action to assure the continuation of the independent safety appraisals of HASL that ceased in 1971 when NY was merged to CH. Human engineering factors related to poor location and visibility of warning lights were also contributory, and the design of the power control switches may have been contributory.

A series of causal factors operating for various periods of time combined sequentially to produce the accidental x-ray exposure at HASL on February 4, 1974. Figure 33 is a Flow Chart depicting the sequence of Causal Factors.

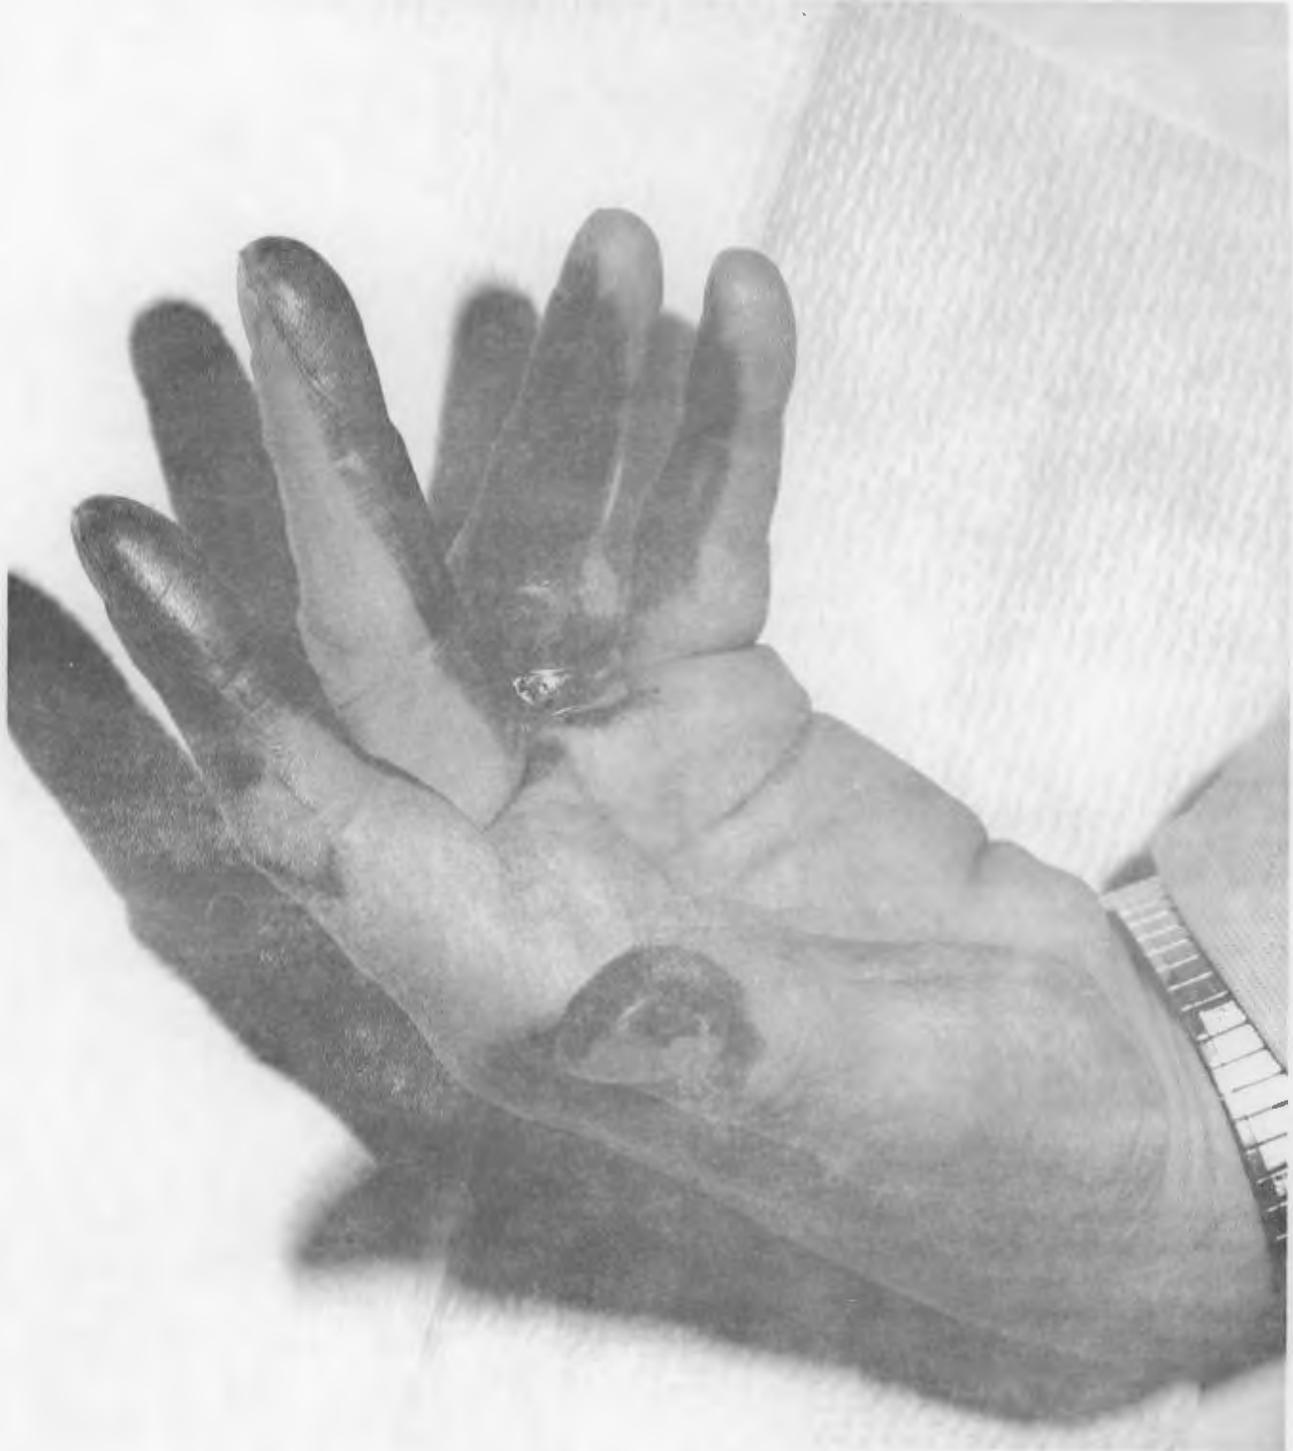
Clinical evaluation of the injuries to the left hand indicate a probable loss of the tip of the index finger and possible loss of tissue and function of other fingers. No clinical consequences are expected from the exposures to other parts of Employee A's body. Employee A gave a clear description and demonstration of the position assumed by the left hand and fingers in removing the copper filter from the narrow confines of the open specimen chamber and x-ray beam port well. The Committee verified that this position was the easiest and most natural hand position, and that other positions made it either very difficult or impossible to get the hand into the beam port well. A comparison of the injury lesions on the hand with the hand and finger position described and demonstrated by Employee A, shows that the distribution of the lesions is congruent with the established hand position. Figures 34 to 36 show pictures of a hand mouldaged to simulate the actual distribution of the lesions. These pictures demonstrate the congruency of the lesions with the established hand and finger position. Note that Figure 36 explains why the back of the third finger received no serious injury. It was effectively shielded by the copper filter. Dosimetry studies have shown that the copper filter attenuates the x-rays by a factor of 10, although it does cause some hardening.

Figure 34. LEFT HAND MOULAGE TO SIMULATE THE X-RAY INJURIES

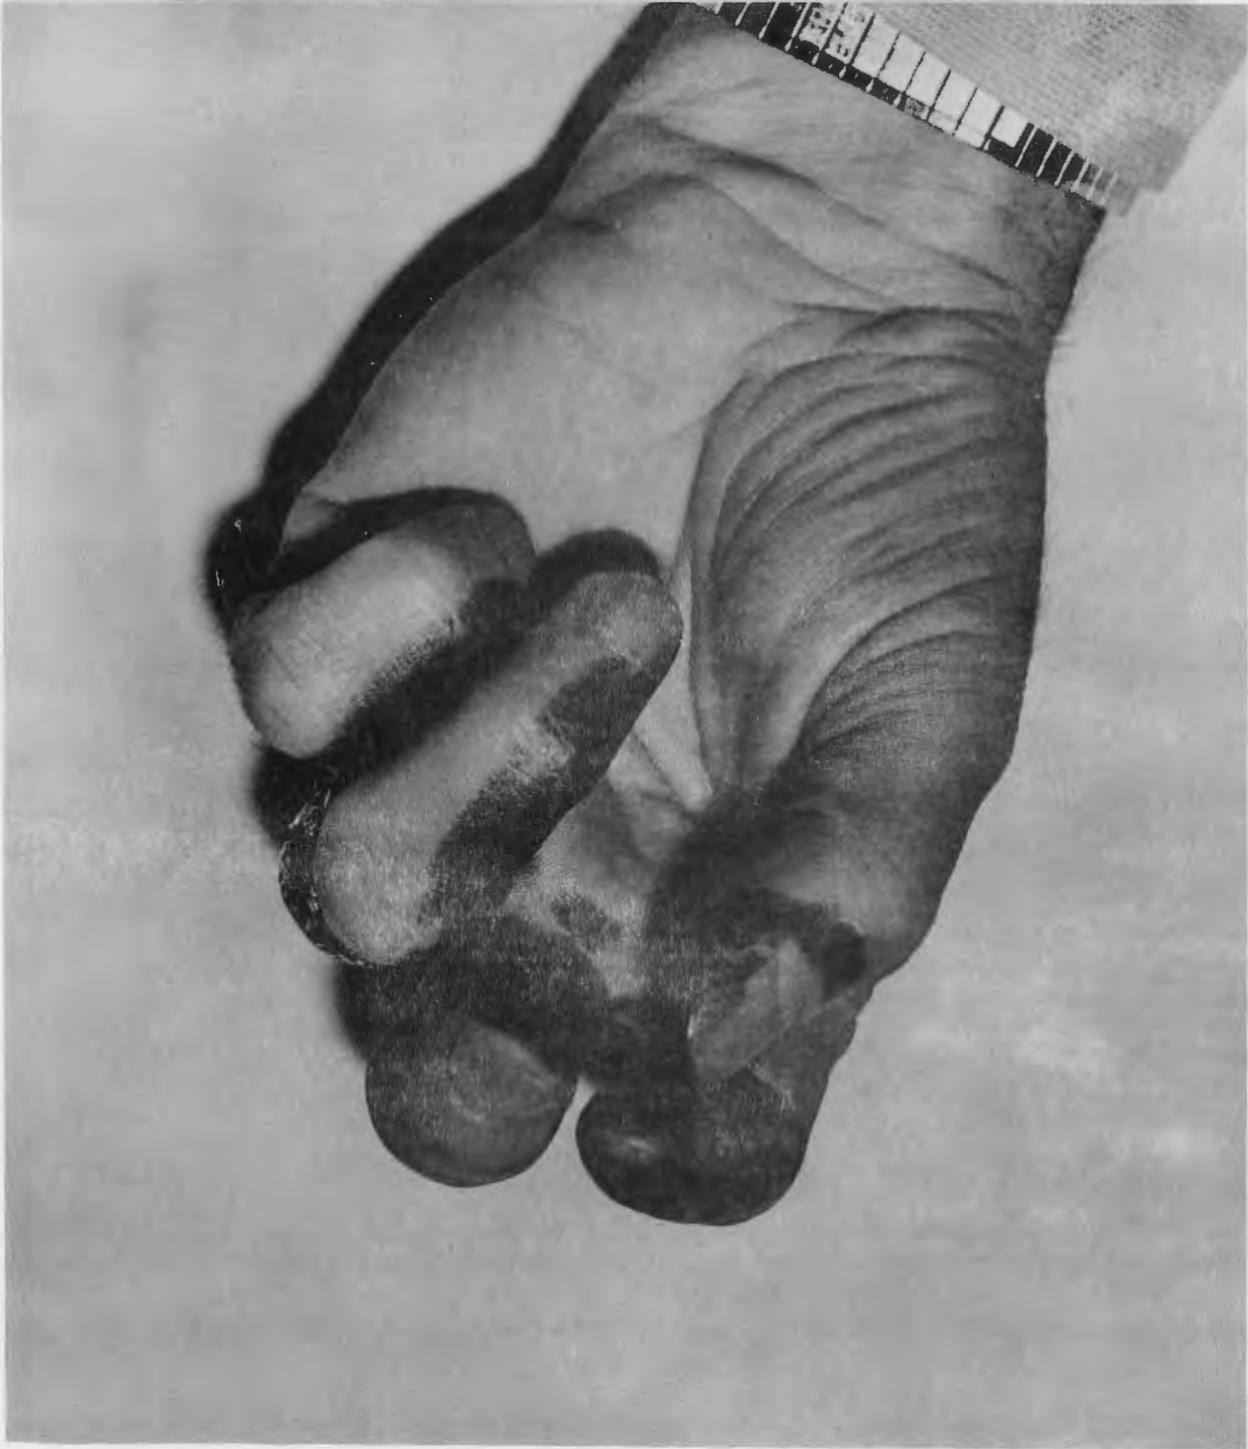
copper filter and expose a part or all of the x-ray beam port hole. The offset position of the hole toward the front of the SRS Unit greatly favors the left index finger getting directly over the bare beam port hole when the operator is standing at the left front corner of the SRS Unit and reaching into the beam port well with the left hand.

The fact that the lesions (injuries) of the left hand are congruent with the hand and finger positions described and demonstrated by Employee A convinces the Committee that this was how the actual exposure of the left hand took place.

**Figure 35. MOULAGED LEFT HAND SHOWING FINGER POSITION AT TIME OF EXPOSURE.
VIEW AS SEEN FROM X-RAY BEAM PORT.**

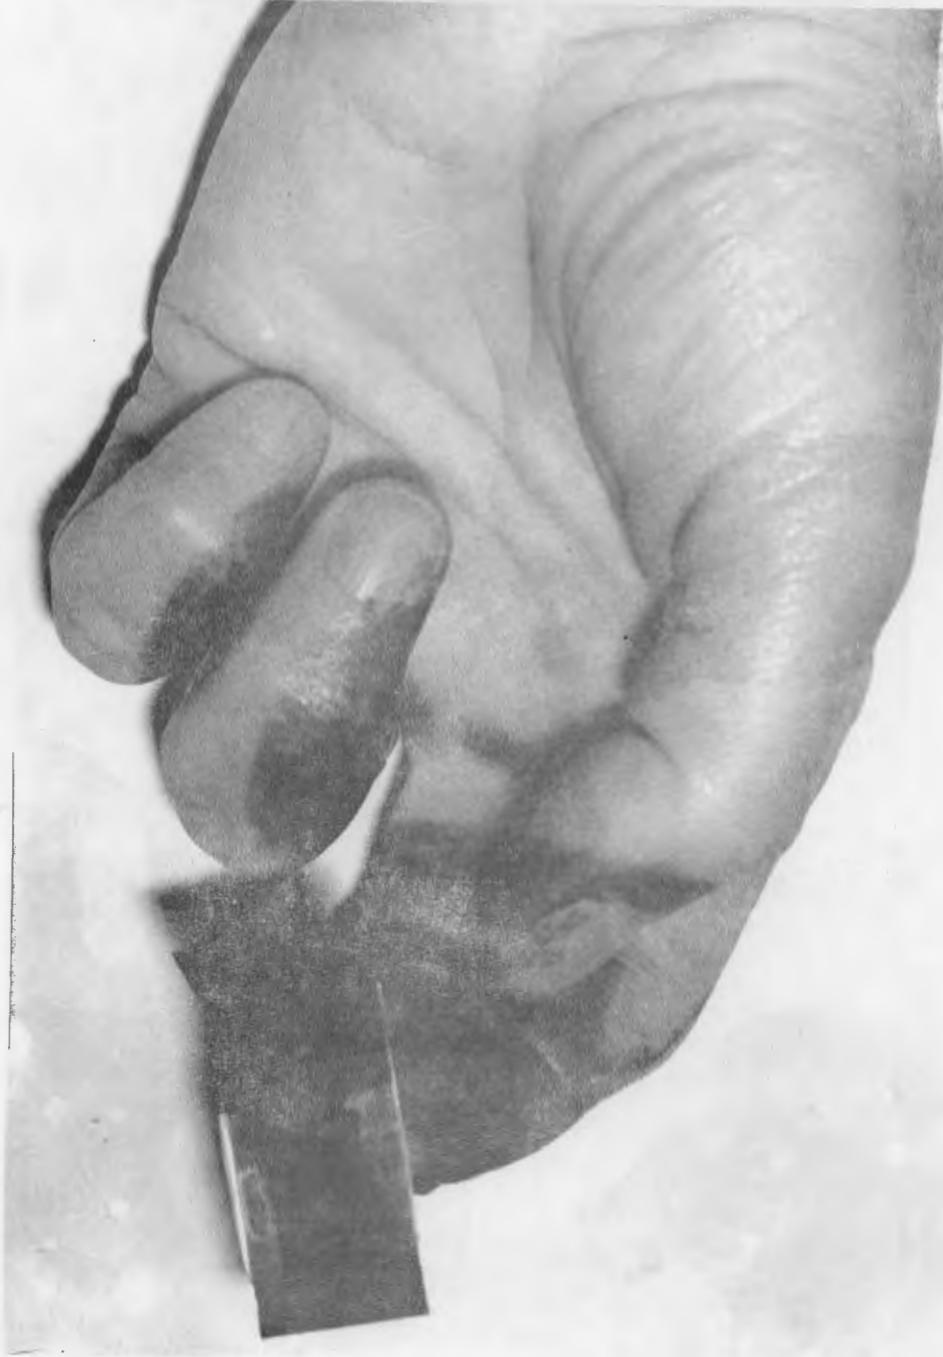
There is considerable room in the x-ray beam port well for side to side movement of the two fingers holding the plastic "handle" on the copper filter. Just a slight movement is enough to displace the

Figure 36. MOULAGE LEFT HAND HOLDING THE COPPER FILTER.
