SL-1 ACCIDENT

ATOMIC ENERGY COMMISSION  
INVESTIGATION BOARD  
REPORT

JOINT COMMITTEE ON ATOMIC ENERGY  
CONGRESS OF THE UNITED STATES

JUNE 1961

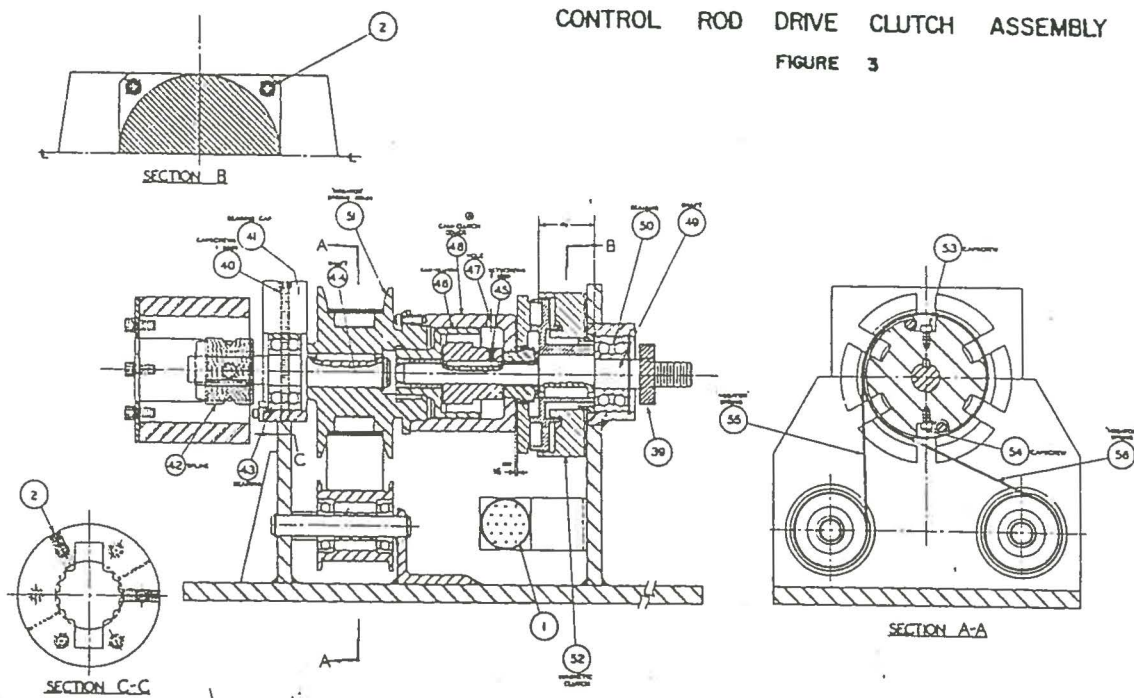
FIGURE 3

# CONTROL ROD DRIVE CLUTCH ASSEMBLY

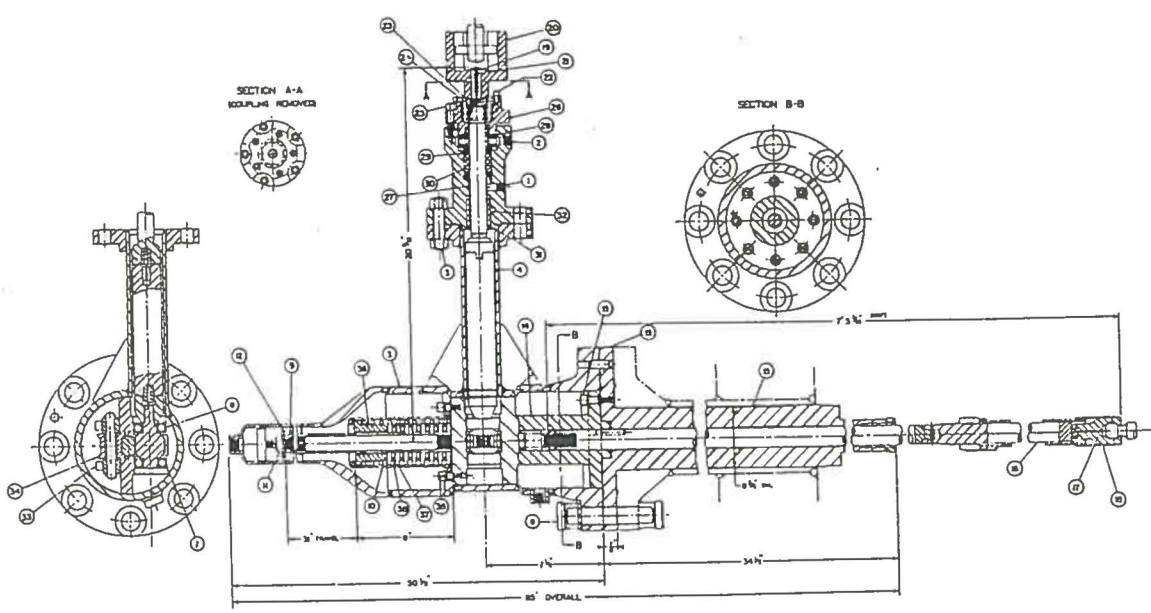
FIGURE 4

# CONTROL ROD DRIVE
