## **CHARACTERIZATION OF DEGRADED EBR-II FUEL FROM THE ICPP-603 BASIN: NATIONAL SPENT NUCLEAR FUEL PROGRAM FY 1999 FINAL REPORT**

ANL-00/9

Engineering Division

April 2000

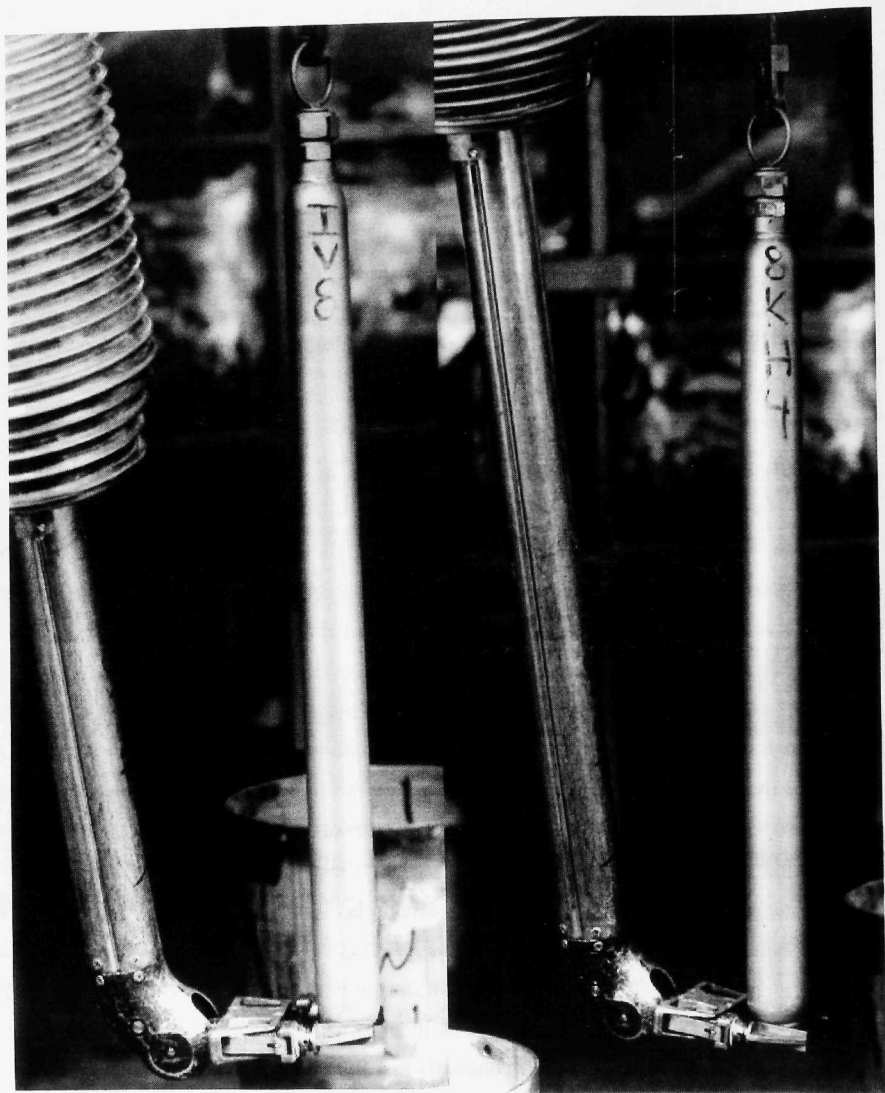
The two overpack containers were opened in HFEF and the 16 fuel containers retrieved for characterization. The general external condition of the 16 fuel storage containers was good. No obvious evidence of general corrosion, pitting or handling damage could be seen. Figure 1 shows containers IV-8 and KH-4 as photographed through the hotcell window. The ID numbers written with a felt marker pen are still visible after ~16 years in the pool water. Each of the 16 containers was visually examined and data recorded pertaining to the tightness of the hexagonal nut which seals the lid. A fiducial mark had been applied prior to fuel loading that showed the hotcell technicians at ANL-W where the lid should be positioned for "finger" tightness. Once the fuel was loaded in the hotcell the lid was tightened with a wrench 1/6 of a revolution beyond finger tightness. Table II shows the degree of tightness of the lids. All of the containers which neutron radiographs proved to be water filled had loose lids as judged by the alignment of the fiducial mark and lid retightening behavior. One container (IE-8), which later proved to be essentially full of water, had a lid which was a full turn less than "finger" tight. All of the DR series containers, (later judged dry in the neutron radiographs), had tight lids with fiducial marks that lined up correctly per the original procedure. The loose lids were manually tightened shortly after receipt in order to insure safe handling and containment during examination.

Figure 1. Photograph of the IV-8 and KH-4 containers as-received at HFEEF

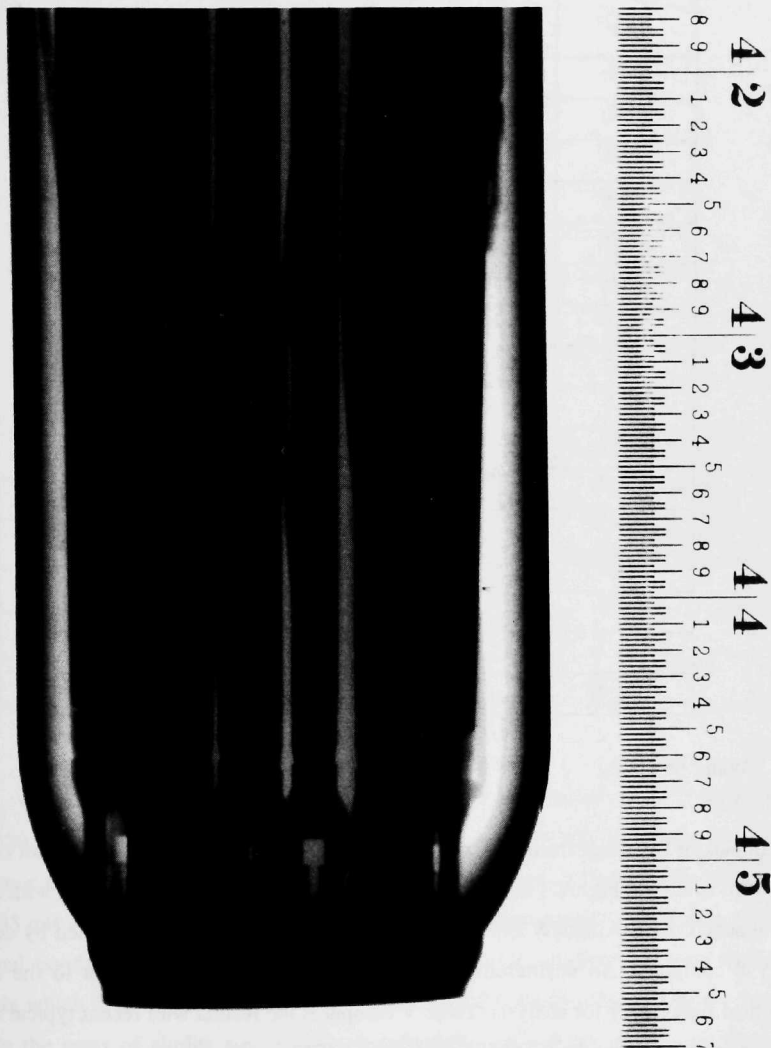
Figure 2. Neutron radiograph of the bottom of container DR-2, showing it to be still dry

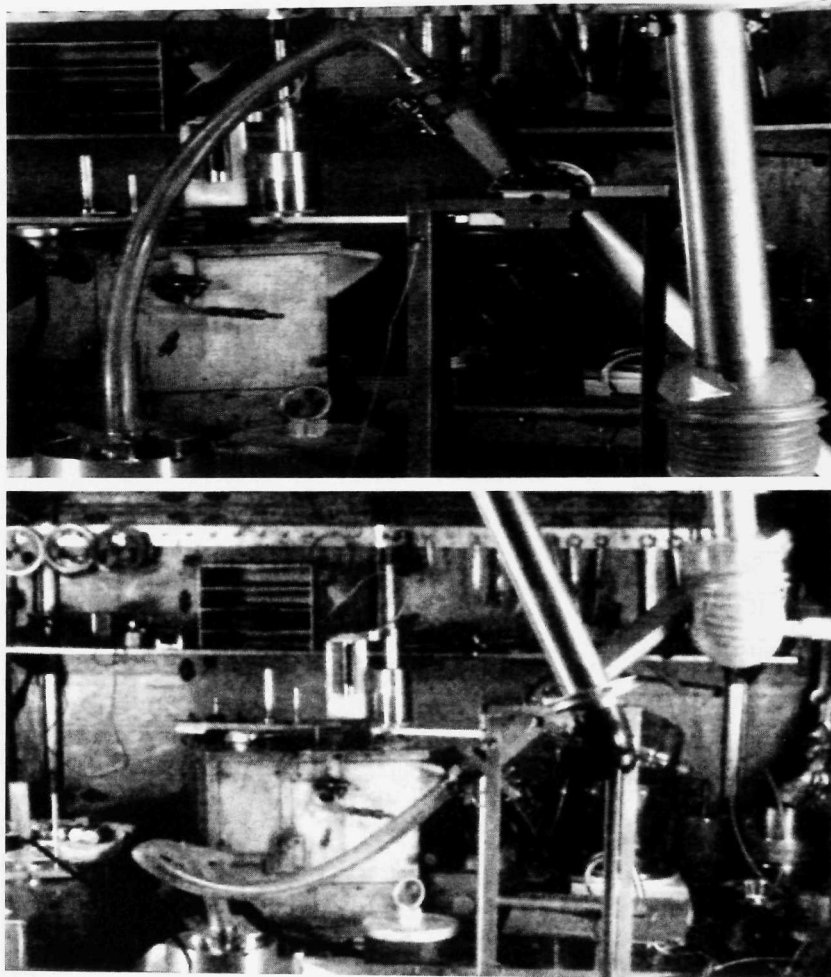
Samples of the water from the two shipping overpack containers and from fuel container IV-8 were analyzed. Figure 3 shows the IV-8 container in the tipping apparatus with a Tygon hose attached. Approximately 243 ml of lightly discolored water was collected by decanting the IV-8 container. An unfiltered sample was taken by syringe and sent to the ANL-W Analytical Laboratory for analysis. Table V compares the results with recent typical analyses obtained for water from the ICPP-603 pool at the INEEL.

Figure 3. In-cell operation of draining the water from the IV-8 container

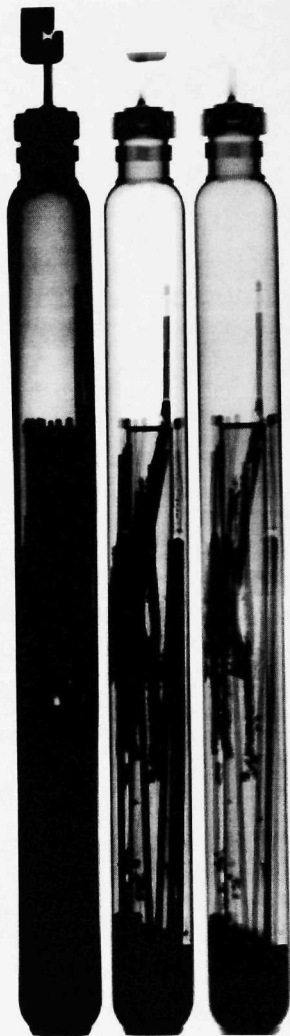
Fuel container IV-8 was re-capped after draining the water and re-radiographed. Figure 4 shows the radiographs before and after draining the water, illustrating the masking effects of the water. The water depth was ~ 25 cm (10 in.), covering ~2/3 of the fuel column height. The two images at left are thermal neutron images, while that at right is an epithermal neutron image. The right hand images show severe fuel corrosion and the resulting layer of fuel debris in the bottom of the container. It appears that 6 of the 12 elements have lost the lower half of their fuel columns to this debris bed. Close inspection of the neutron radiograph showed the cladding rupture to be a wide serrated crack running lengthwise along the various fuel elements. Though tipped to 45 degrees below horizontal for draining, the debris bed appears to have remained essentially intact, with no trace of loose fuel particulate left on the side of the container. This was somewhat unexpected because of the normally flocculent nature of the corrosion products. Fuel cladding rupture and fuel alloy corrosion has also obviously taken place in the fuel column region in the gas headspace above the high water line. A number of the elements also contain water trapped within their plenum regions above the fuel column and high water level. Figure 4 shows this feature as the dark region in the plenum between the fuel column and upper cladding closure weld. Note that the element protruding up above the rest has plenum water that has actually increased in depth between the initial and final radiographs.

Figure 4. Neutron radiographs of the IV-8 container, before (left) and after draining (two at right)

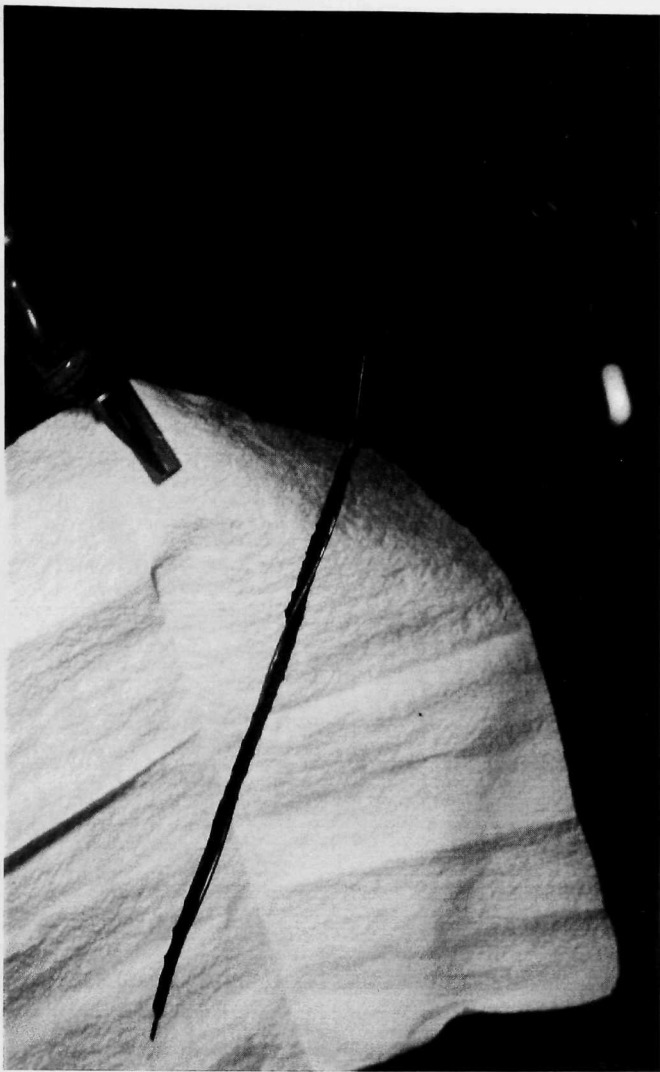
Figure 5. EBR-II fuel element removed from the IV-8 container

cut at 16 inches. Figure 5 shows this element after removal. Loose, coarse fuel oxide powder was found clinging to the cladding and inner container surface. This dark brown/black particulate appeared to have a consistency similar to that of damp beach sand as it was remotely handled in-cell. A 10 gram sample was obtained and sealed in a SADD-Z type sample container for transfer to the Analytical Laboratory via the pneumatic transfer system. The serrated nature of the longitudinal cladding breach, which ran the whole length of the fuel region, was evident. The remaining 11 elements were not easily pulled from the container and the second circumferential cut was made. Figures 6, 7 and 8 show various views of the fuel during removal from the container. The cylindrical central post seen in the figures is part of the container's configuration and the elements surround it concentrically in random fashion. With considerable manual force on the remote slave-manipulators, 8 of the remaining elements were eventually pulled from the debris bed, leaving 3 firmly stuck in place. The solid, almost cement-like nature of the debris bed was unexpected and it suggests uranium oxide particulate resulting from immersion corrosion may not be so easily dispersible outside of the fuel container.

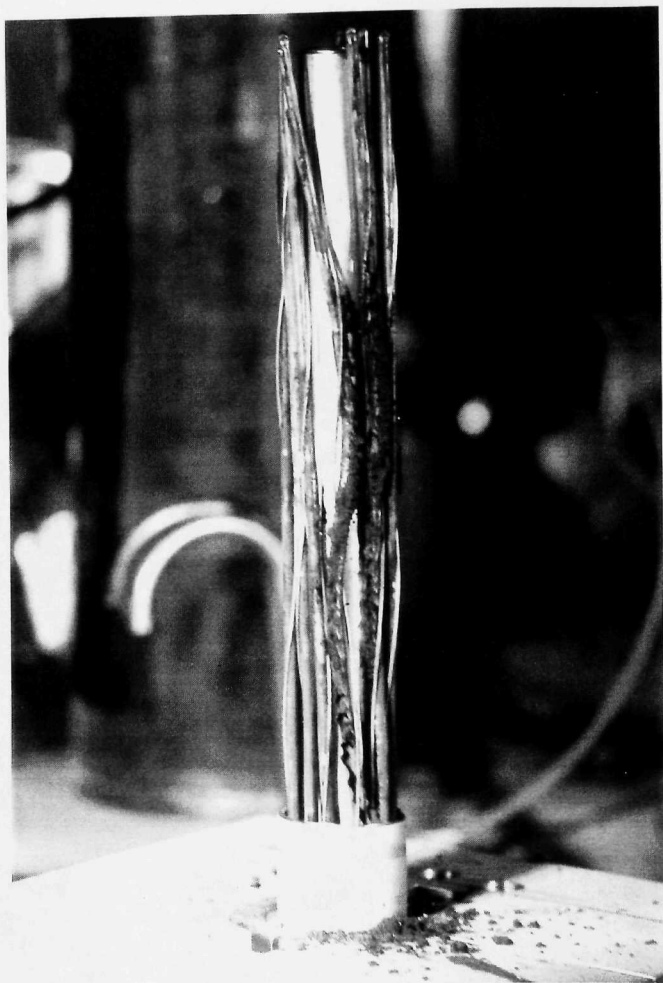
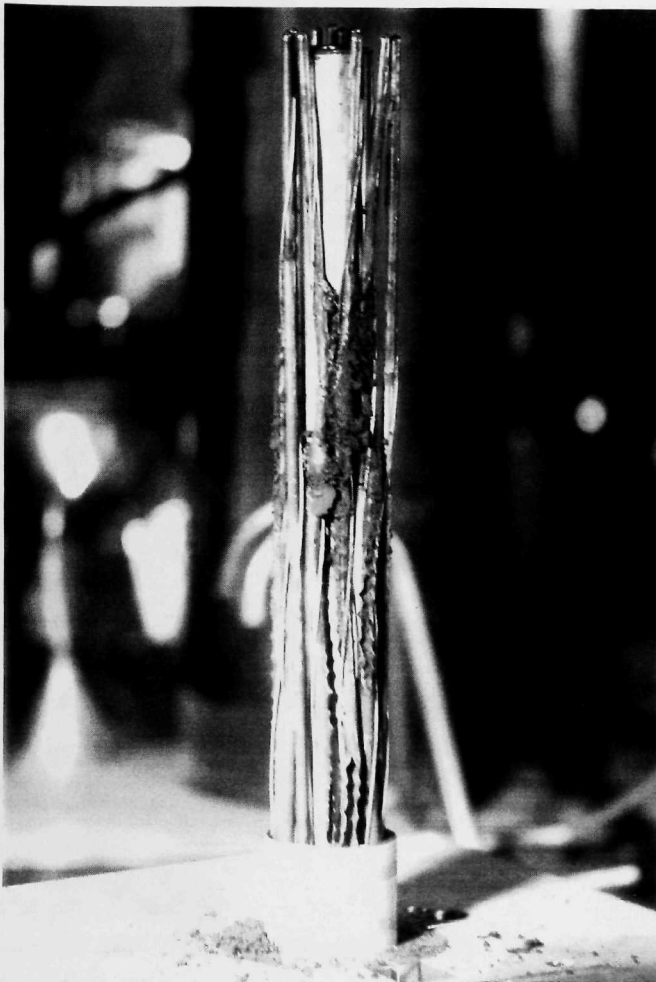
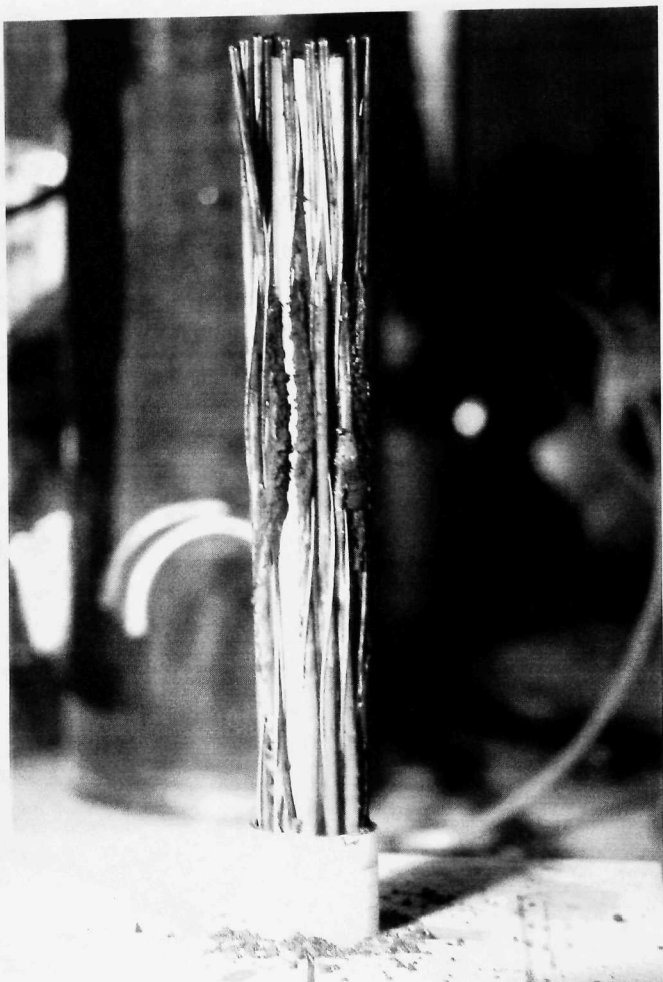
Figure 6. Degraded EBR-II fuel exposed for examination after cutting open the IV-8 container

Figure 7. Degraded EBR-II fuel exposed for examination after cutting open the IV-8 container

Figure 8. Degraded EBR-II fuel exposed for examination after cutting open the IV-8 container
