**Color Photographs
Of The Three Mile Island Unit 2
Reactor Containment Building:
Volume 1—Entries 1, 2, 4, 5, 6**

October 1981

**EG&G Idaho, Inc.
Idaho Falls, Idaho 83415**

This report is a collection of the 308 color photographs taken during the first six entries into the Three Mile Island Unit 2 Reactor Containment Building (July 1980—February 1981). The

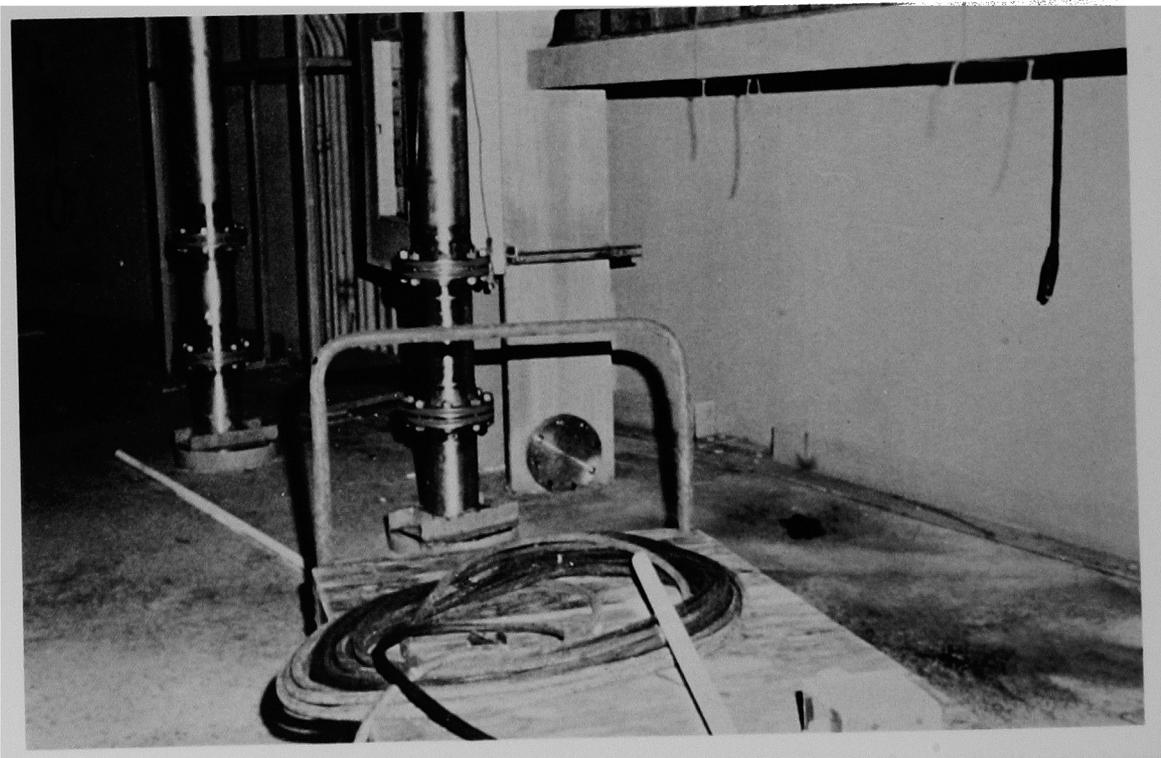
Figure 8 (1A). Coiled hose on north end of card; reactor building spray lines in background.

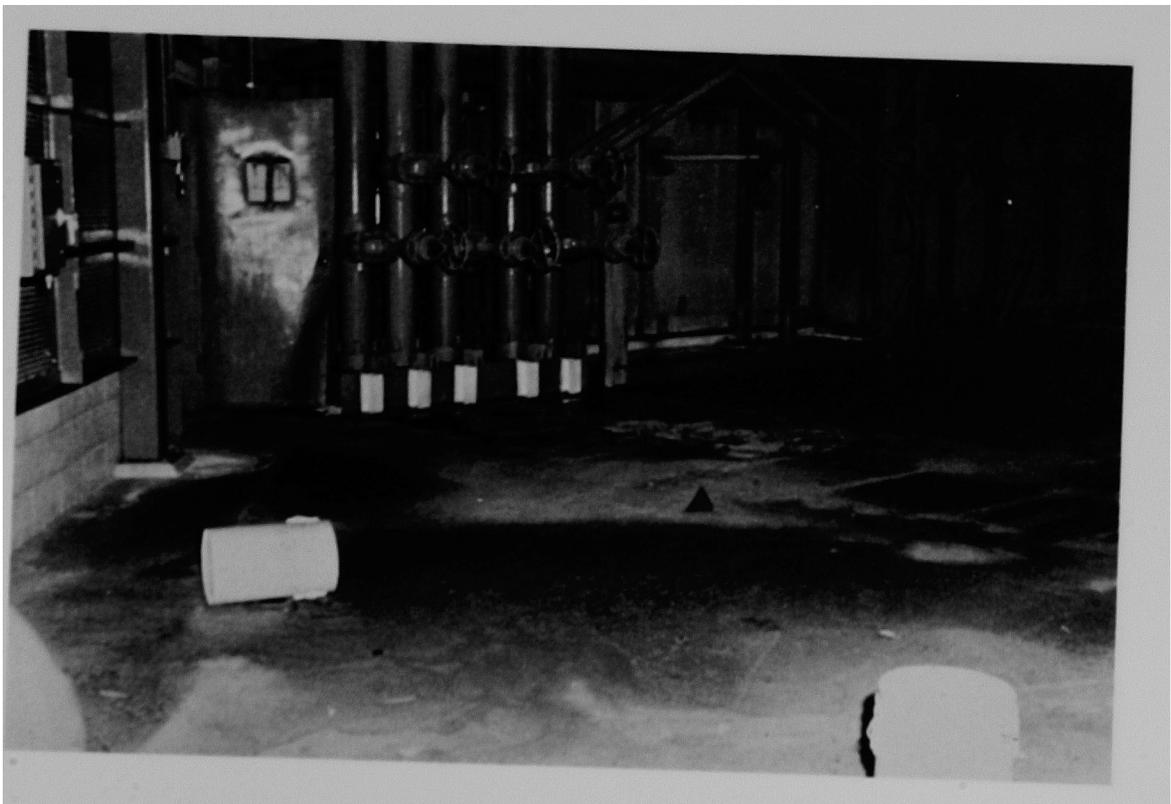
Figure 18 (1A). Floor; enclosed stairway door left, air coolers background right.

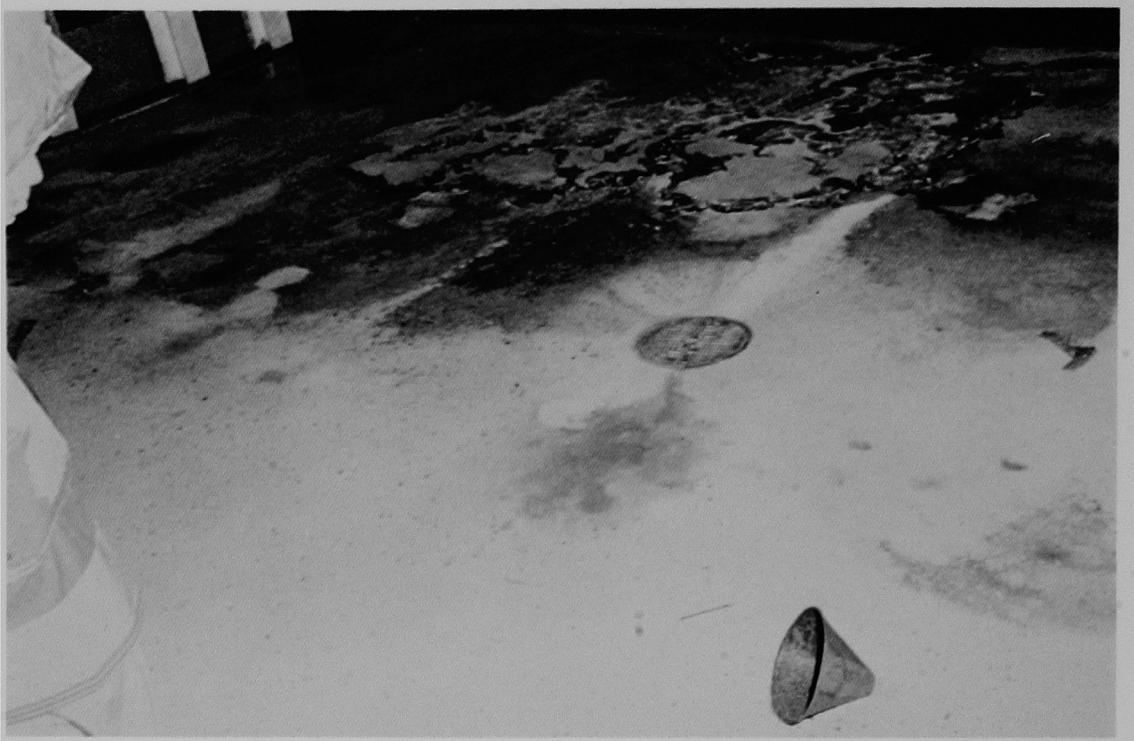
Figure 19 (1A). Floor drain and rusted funnel (center detail of Figure 18).

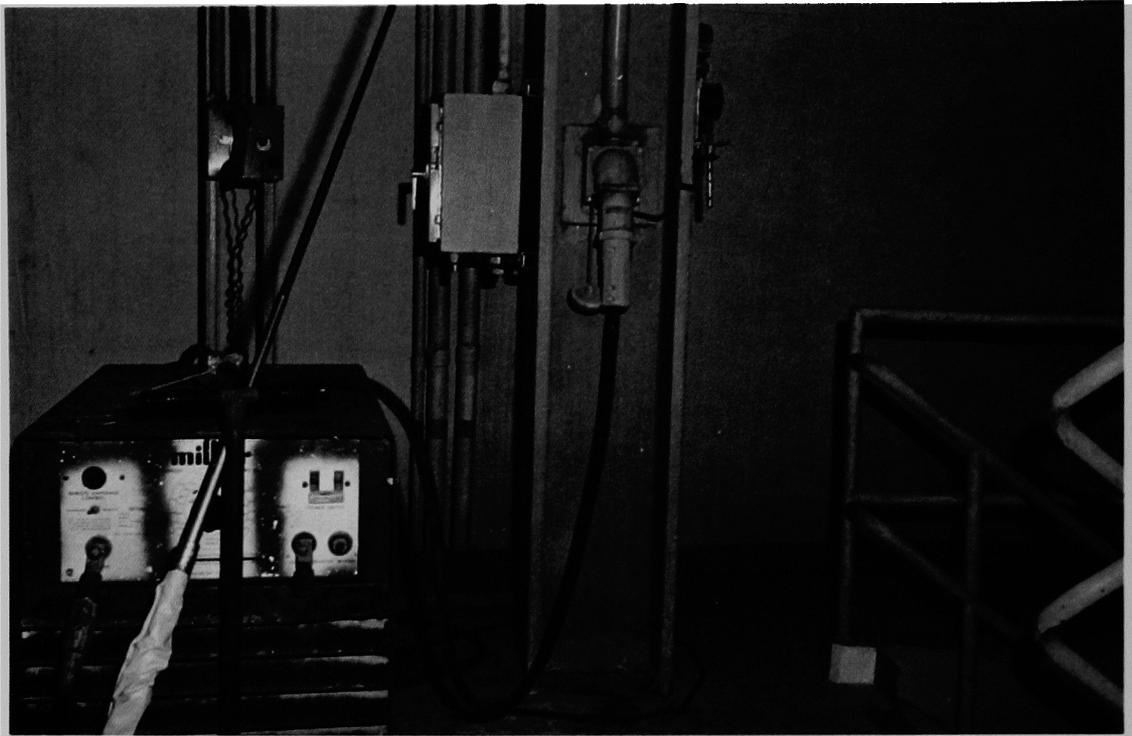
Figure 54 (2A). Rusted welding box; Gai-tronic phone in background, open stairway at right.

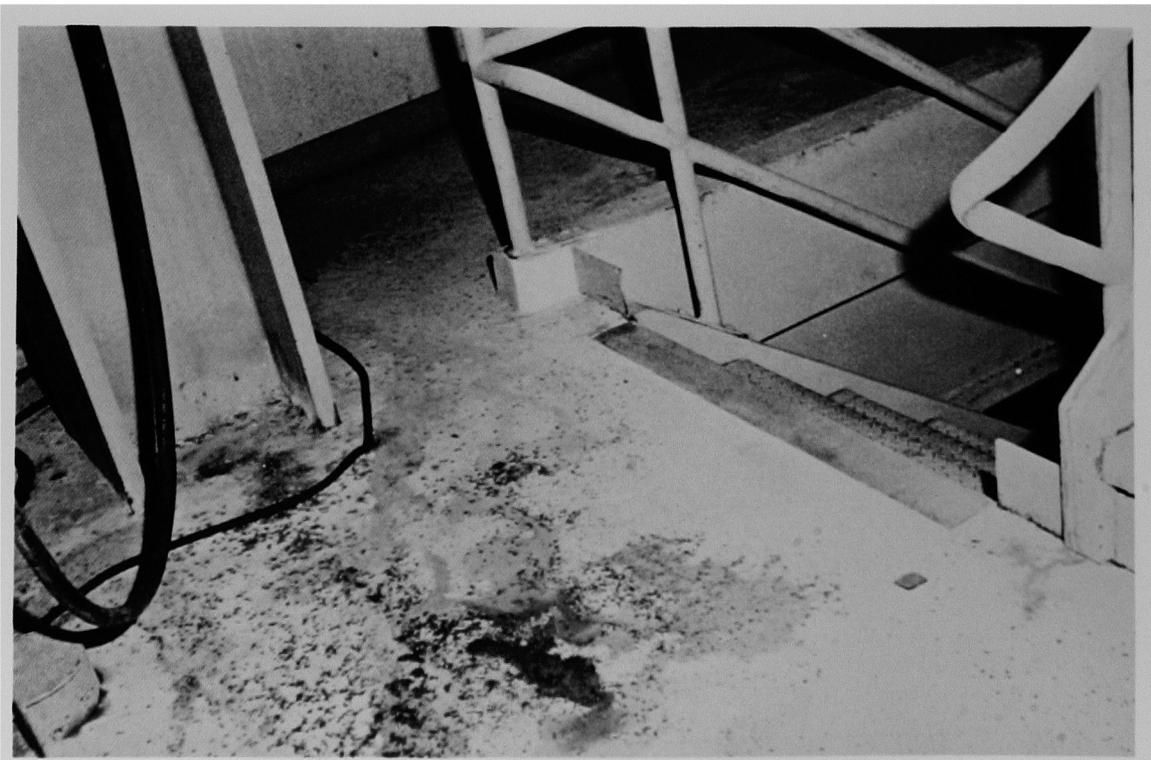
Figure 55 (1A). Stains on floor at entrance to open stairway.

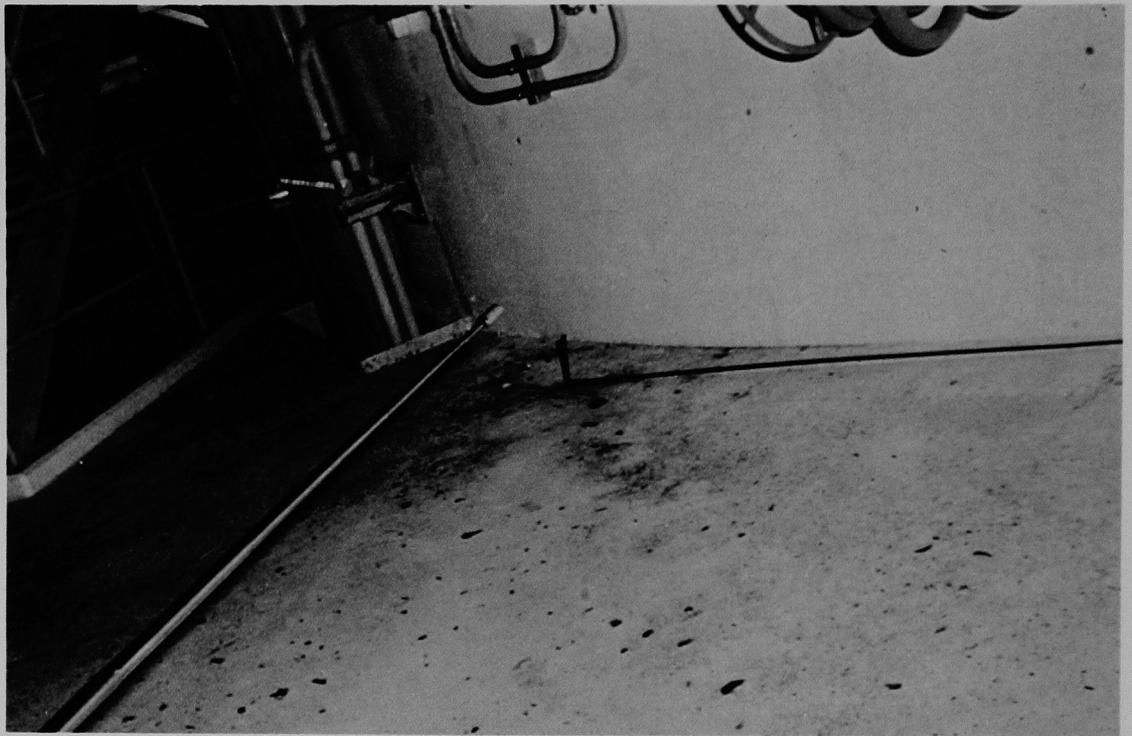
Figure 58 (1A). Broken glass on floor (teletector probe appearing from left corner of photograph).

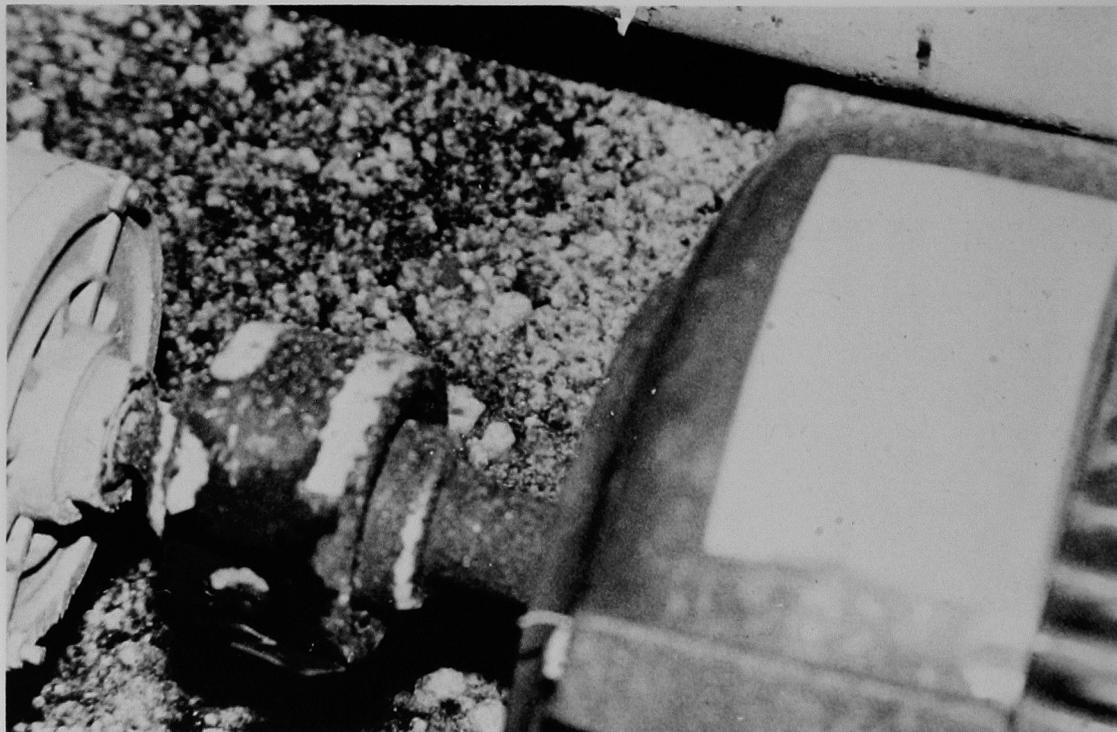
Figure 224 (5B). Rusted coupling and motor on auxiliary fuel handling bridge (see Figure 222).

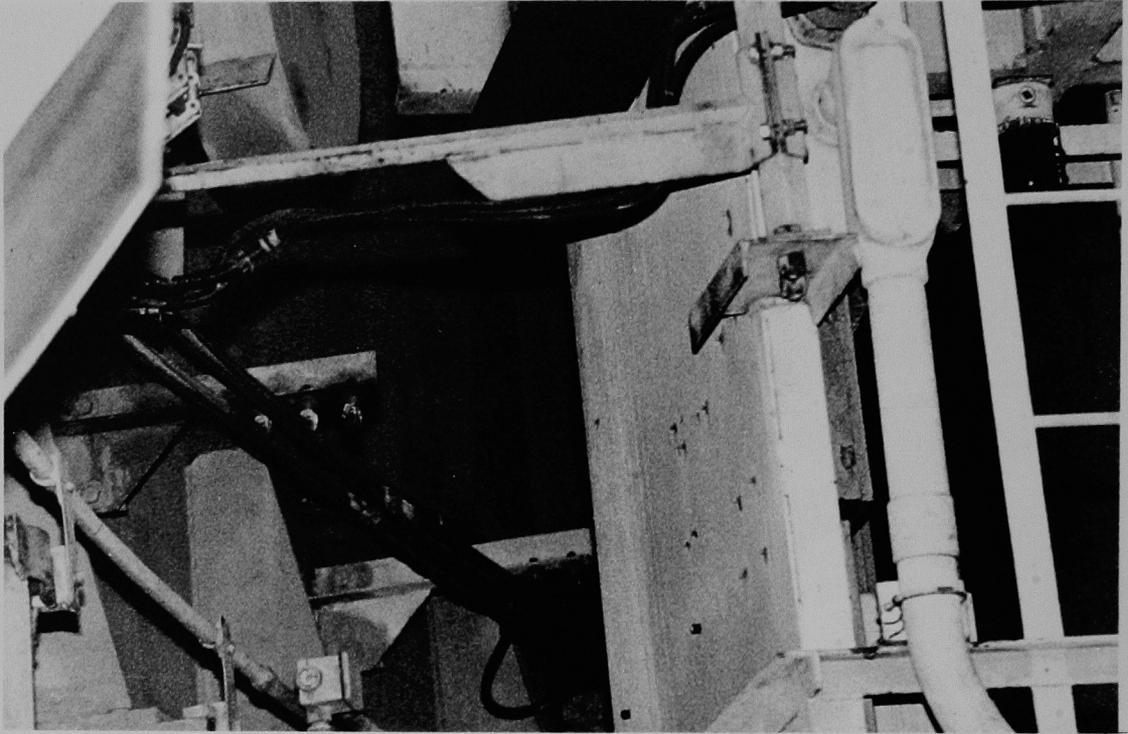
Figure 278 (5B). Polar crane power buss bars (note that one is missing, having dropped to operating deck).

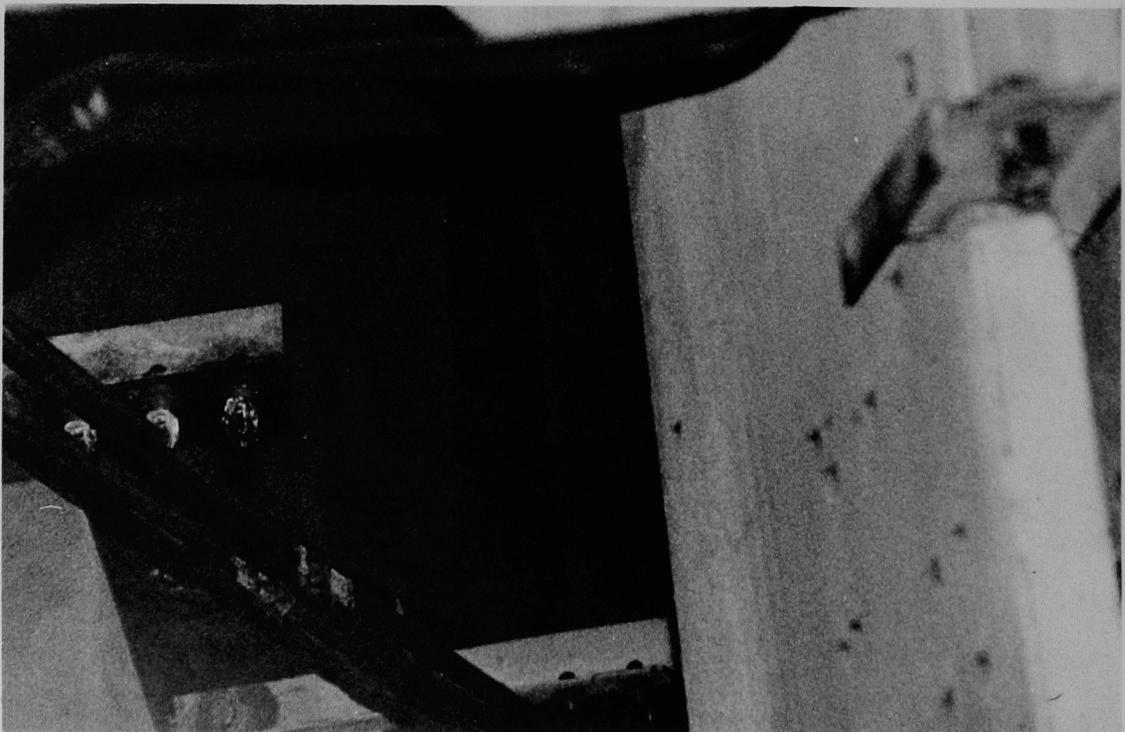
Figure 279 (5B). Closer view of the power buss bars (cf. Figure 278).

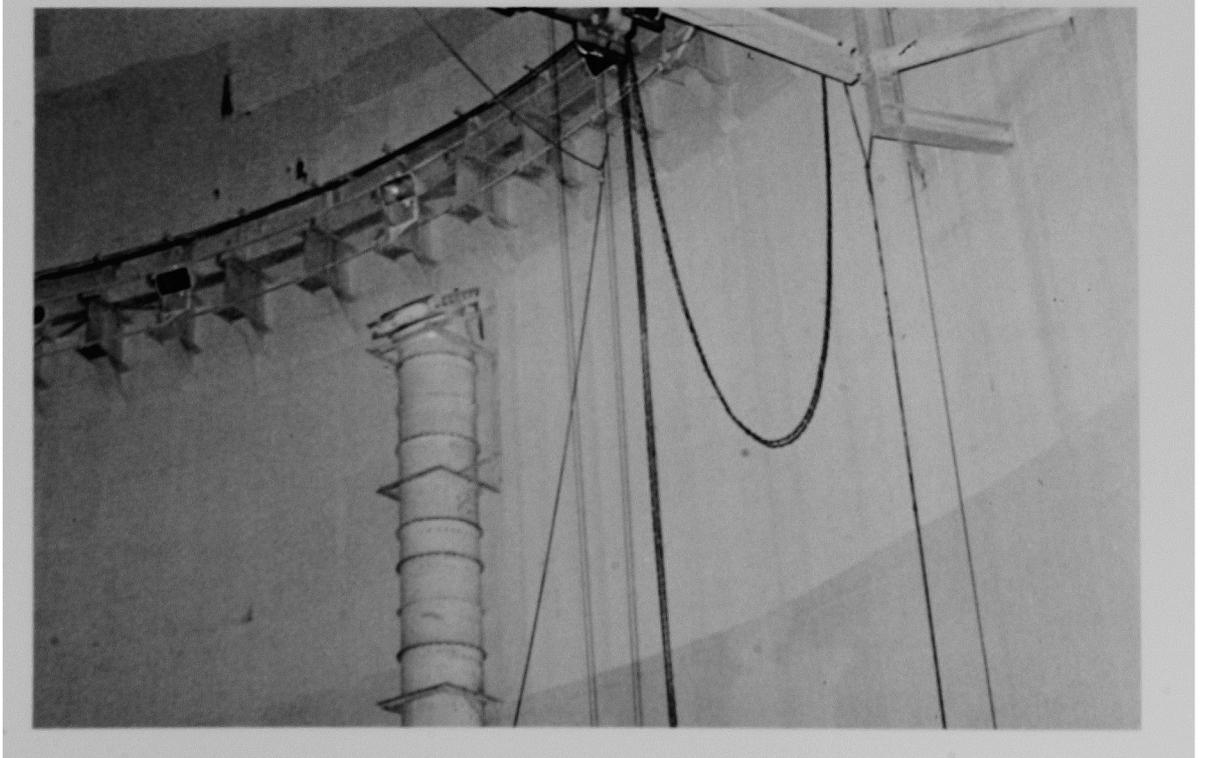
Figure 285 (4). Top of the ventilation duct; job crane right. (Note that not all lights circling the containment are on.)
