General Public Utilities • Electric Power Research Institute • U.S. Nuclear Regulatory Commission • U.S. Department of Energy

Examination Results of the Three Mile Island Radiation Detector HP-R-211

October 1981

Sandia National Laboratories
Albuquerque, New Mexico 87185
and
Livermore, California 94550

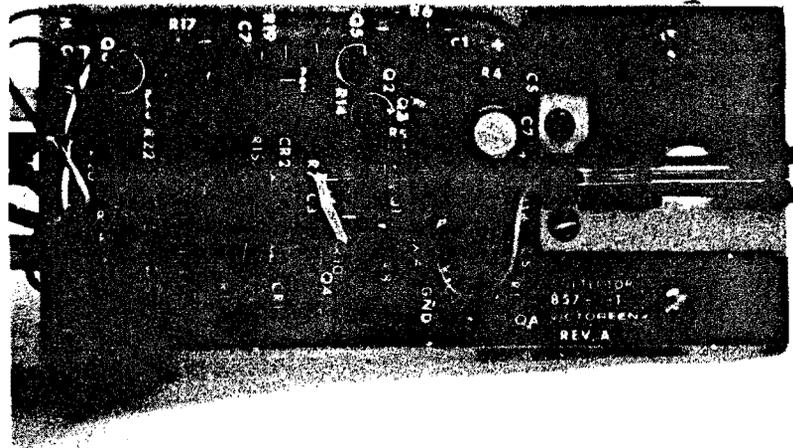
FIGURE 7. HP-R-211 Circuit Board. This picture shows the actual circuit board as removed from the housing. Notice the clean, uncorroded appearance. The GM tube is shown on the right end.

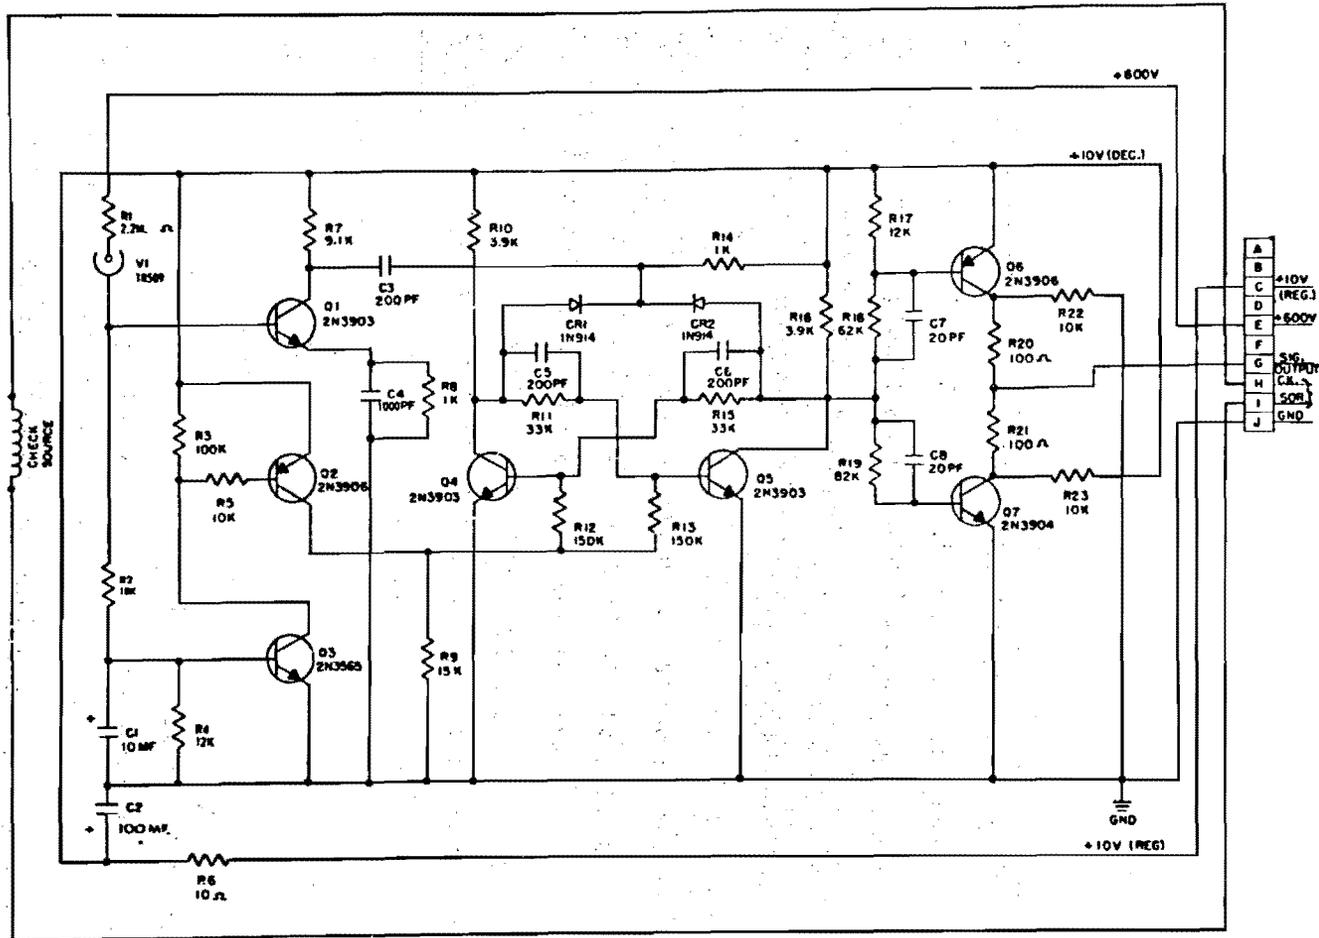
1. The mode of failure of HP-R-211 was confirmed to be a low impedance fault between the collector and emitter leads in transistor Q6 in the detector output circuit. The transistor failed because of catastrophic, non-annealing, punch-through from collector to emitter caused by high voltage breakdown and energy deposition. Substantial evidence indicates that this occurred at least partially when the reactor building sprays were initiated some 10 hours into

FIGURE 9. Detector Schematic. The GM tube and antijam circuits are on the left, the flip-flop is in the center and the output driver is on the right side of the schematic. Transistor Q6 failed.

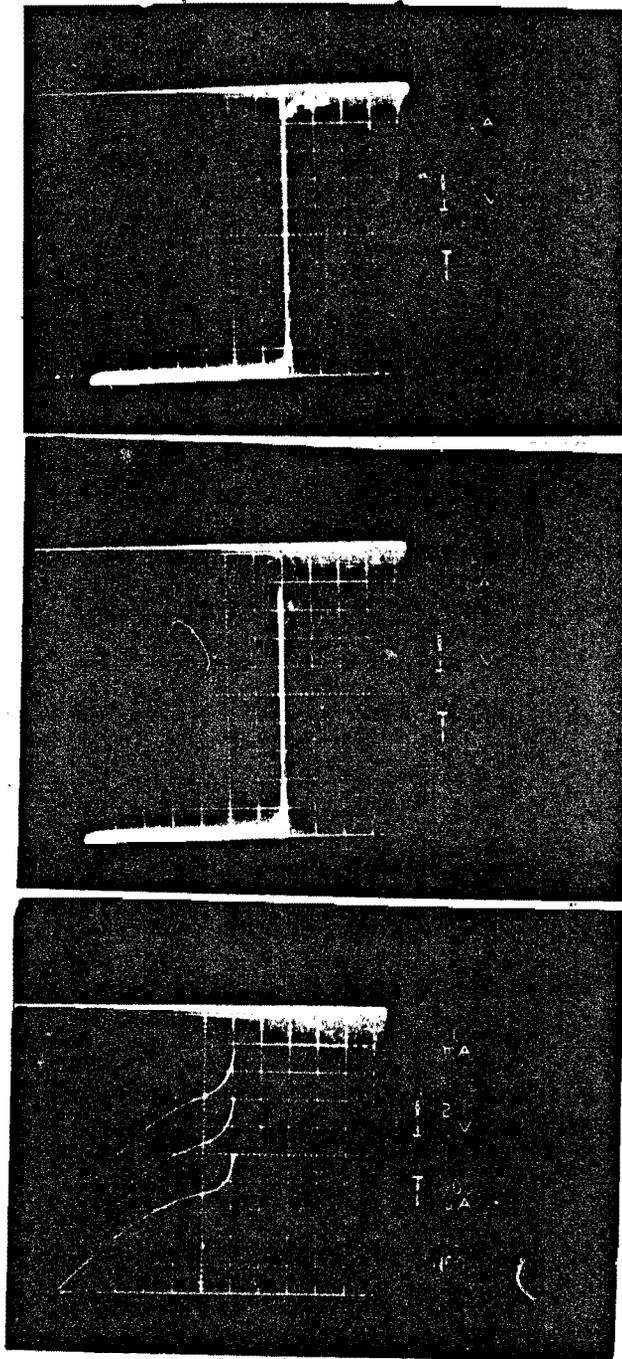
Following tests at the Sandia gamma range facility, the detector was opened, node voltages were measured, and the failure was diagnosed. Transistor Q6, a Motorola 2N-3906, was removed and found to exhibit a 163 ohm collector-to-emitter shunt resistance. No other circuit abnormalities were found. Figure 12 shows several of the more important transistor Q6 characteristics as measured on a curve tracer. The collector current characteristics show the presence of an approximate 160 ohm slope on any given base current curve. The transistor gain and the base-emitter junction characteristics are all proper. The presence of this apparent shunt resistance is consistent with the passive tests due to the nominal 100 ohm current-limiting resistor R20 in series with the collector of Q6. The Motorola 2N-3906 is a general purpose 350 mW, epoxy encapsulated PNP transistor which is designed to operate with a maximum collector current of 200 ma. The collector to emitter breakdown voltage is rated at 40 V. The epoxy case was removed by grinding the surface away until the semiconductor chip cavity was exposed; normal solvents were ineffective. The chip shown in Figure 13 has a large amount of foreign material on the surface (not due to the grinding operation, since an additional coating of RTV-like material had to be removed). The metallization is shown removed in Figure 14, and a punch-through defect exists under the center emitter finger. Probes were in fact made of each finger, and the failure was electrically isolated to the middle finger. This type of failure is typically caused by high voltage breakdown from collector to emitter and a subsequent transient surge current. The energy deposited is enough to destroy the normal lattice structure and actually diffuse aluminum metallization into the lattice to cause a resistive path. Had the transistor been overheated through high power dissipation over a long period of time, much of the metallization would probably have been melted. As it is, however, the defect points to a rapid transient.

FIGURE 12. Transistor Q6 Characteristics. The top curve is BVCBO, middle curve is BVEBO and lower curve is collector current characteristics. The effect of the 163 ohm anomaly is seen as the slope of the collector current characteristics for any particular base current of the family.

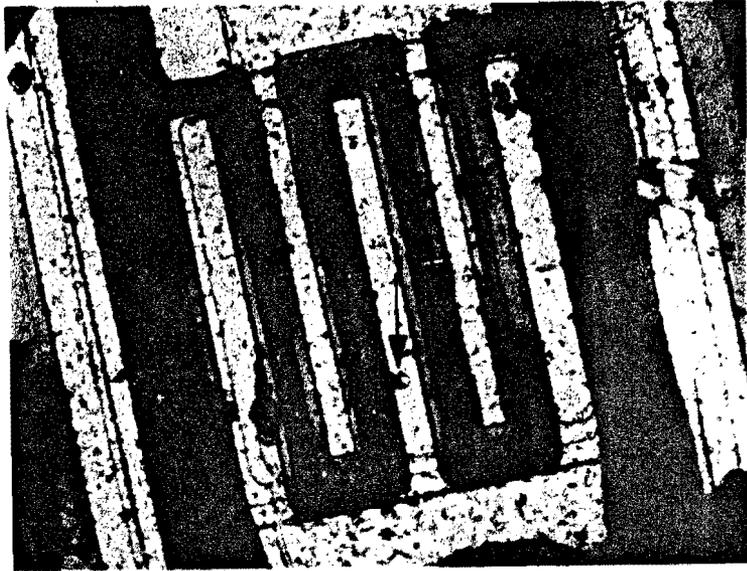
FIGURE 13. Q6 metalization. The punch through defect is apparent even through the emitter metalization (three fingers). This photograph was taken after chip probe but before the metalization was stripped. Notice the large amount of foreign material present.

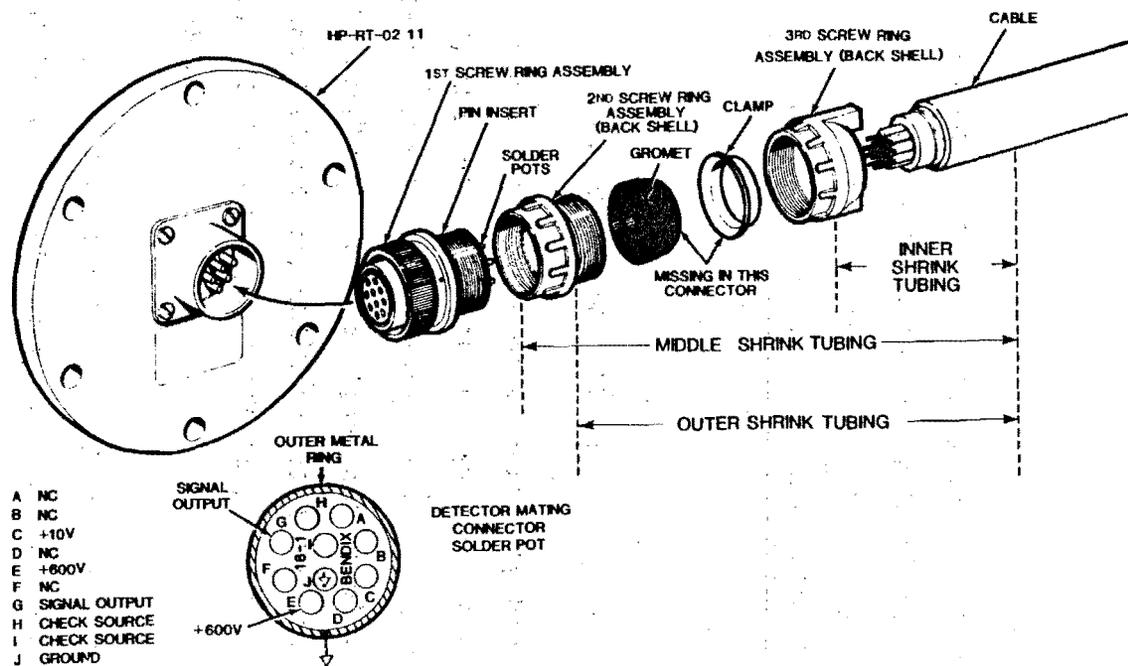
During the removal of the detector from the containment building, the GPU technician was unable to unscrew the connector from the detector, even with the aid of channel-lock pliers. While attempting to loosen the connector, he applied downward pressure on the detector, and it broke free of the cable. The detector, connector first screw-ring assembly, and pin insert were removed as one piece. Figure 15 gives an exploded view of the connector assembly and pin connections. Later examination of the free cable end after its removal revealed the second and third connector screw-ring assemblies to be mated and encased along with the cable end in Raychem WCSF heat-shrink tubing. This tubing was tightly molded to the connector part and covered at least the lower 20 cm of cable. In fact, three layers of heat-shrink tubing were used as shown in Figure 15 to produce what appears to be a good, watertight seal between the connector and cable. Since he did not attempt to rotate the detector to unscrew it when he could not turn the connector, apparently the second screw-ring was not mated or mated by less than one thread to the threaded insert. Corrosion on the connector insert and inside the second connector screw-ring indicates exposure to steam or liquid. Scanning electron microscope (SEM) and energy dispersive spectroscopy (EDS) studies made on the insert around the solder pots were inconclusive in the search for sodium there (because of instrument limitations on the detection of low Z elements).

FIGURE 15. HP-R-211 Connector Assembly. The second screw-ring assembly was apparently not screwed onto the pin insert.

A chemical analysis was not performed. We believe that steam and/or NaOH/B spray entered the connector backshell through the loose-fitting insert-to-second screw-ring junction.

the accident. Spray and/or steam apparently entered the connector assembly where the detector and cable mate and caused the 600 volt GM tube power line to short, momentarily, to the signal output line. The connector backshell does not look as though it was properly mated to the connector insert. This, and the orientation in which the detector was mounted provided an entryway for the moisture. To prevent this from occurring in the future, we recommend that Victoreen detectors of this and similar types be mounted with the connector below the housing and that the connector backshells be potted. Even more fundamentally we question the need for having anything other than a sensor inside the containment building. Wherever possible, active electronics should be located outside containment.

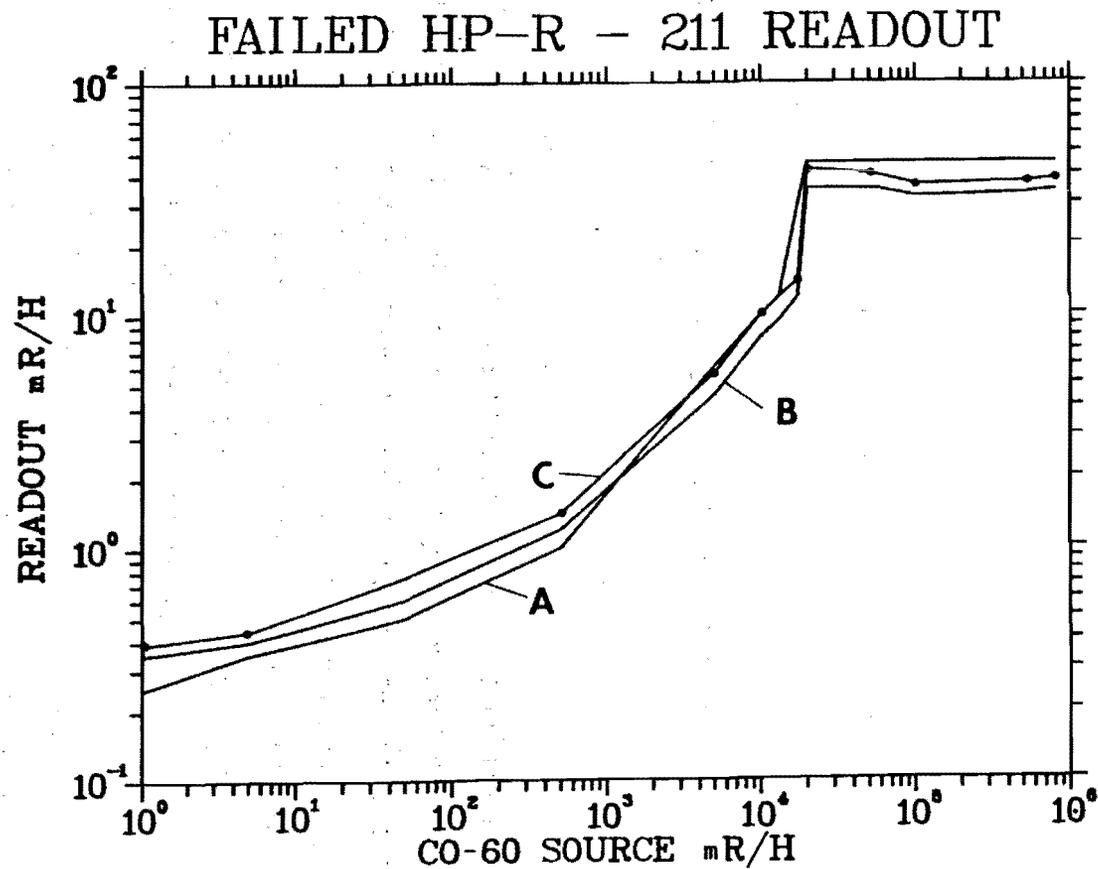
FIGURE 18. HP-R-211 Characteristics. The detector was exposed to a Co-60 source upon arrival at Sandia and produced the output shown. Curve A is for the condition of nominal detector supply voltages, Curve B is for low voltages, and Curve C is low-voltage, ratemeter corrected. These data were taken without 152 m cables or line capacitance equivalents used.

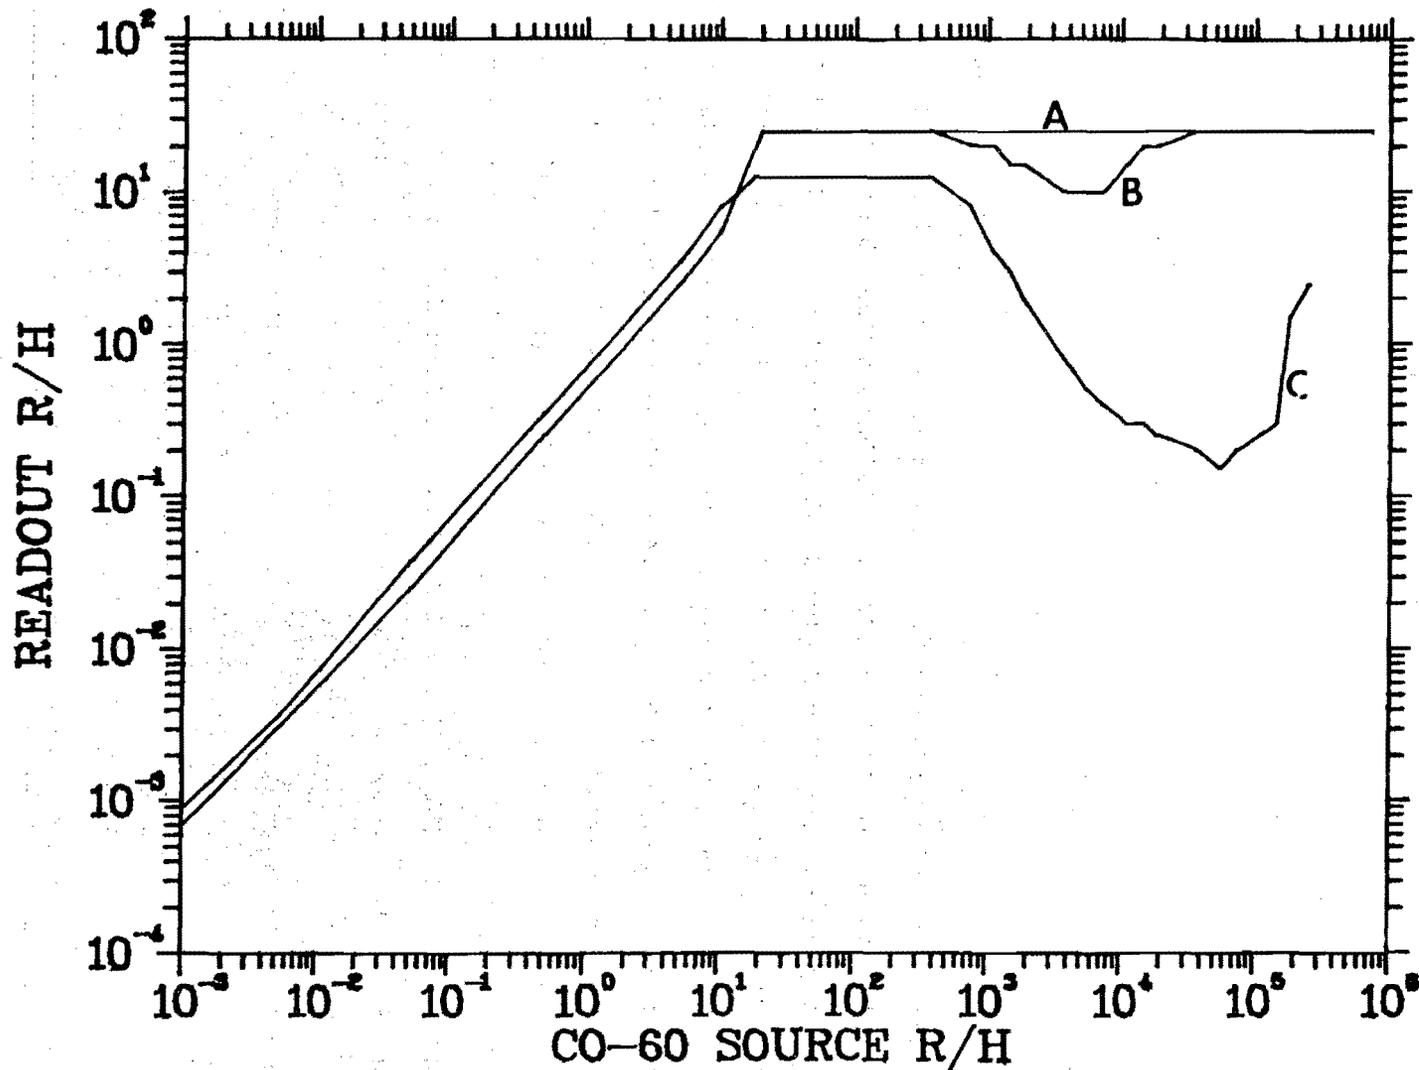
2. The repaired, but degraded, detector exhibits a radiation level indication which becomes multivalued when it is exposed to radiation levels in the 10^3 to 10^6 R/H range. Instead of remaining pegged at its maximum 10^4 mR/H indication in this range, the readout begins to decrease at 10^3 R/H, reaches a minimum at approximately 50×10^3 R/H, and then begins to increase thereafter. This characteristic is caused by detector to cable impedance mismatches and is accentuated by long cable lengths and radiation degradation of detector transistors and the GM tube. This could present a hazardous situation in a reactor LOCA wherein radiation degraded detectors may indicate radiation levels to be significantly lower than they actually are. Changes in circuit design and/or the use of more radiation tolerant transistors can correct this problem.

FIGURE 21. Multivalued Readout. Curve A shows the Test detector response to the Co-60 source when a short cable is used to connect the detector to the ratemeter. Curve B gives the response when 152m of coaxial interconnect cable are used. Curve C gives the HP-R-211 response using 152m interconnect cable. The response is seen to be multivalued when long cables are used, especially for the degraded detector.
