# EXAMINATION RESULTS OF THE THREE MILE ISLAND RADIATION DETECTOR HP-R-213

Jeoffery M. Mueller

Sandia National Laboratories  
Albuquerque, New Mexico 87185

November 1982

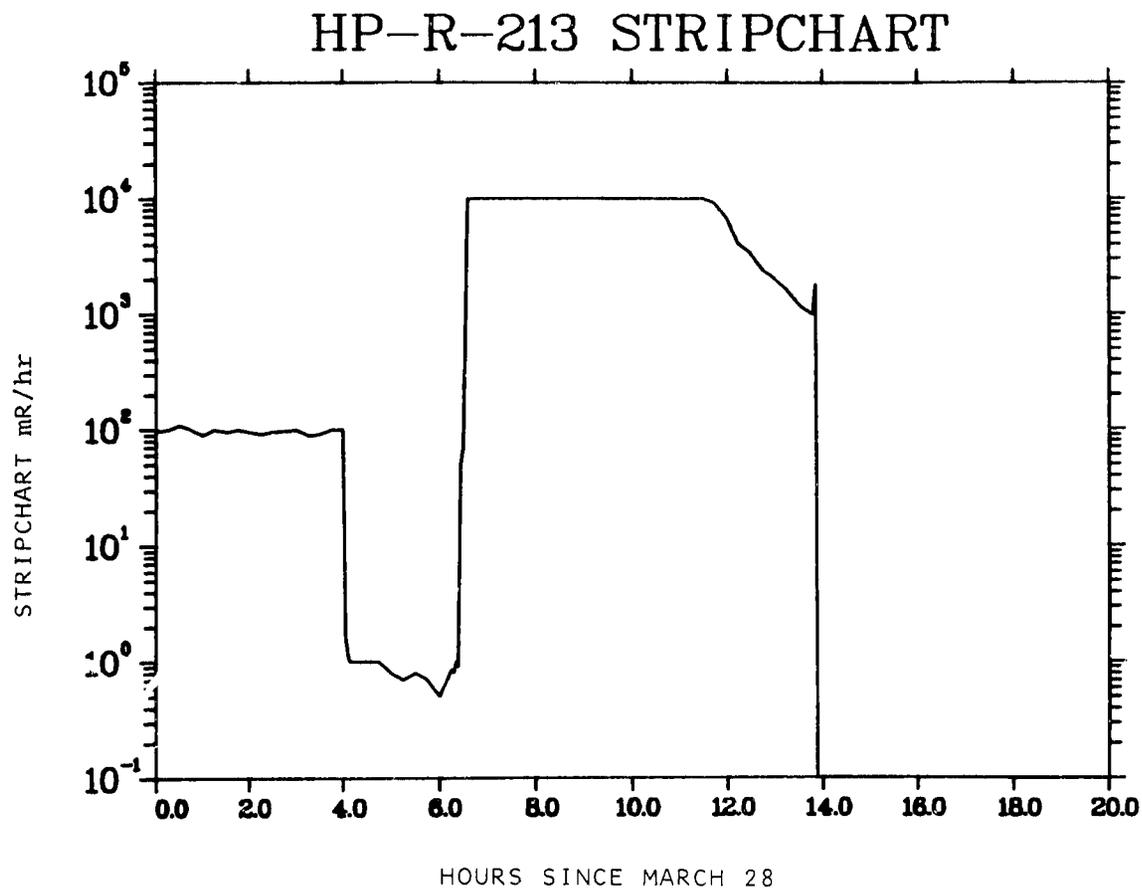
1. The stripchart recording of HP-R-213 indicates that the detector failed at or near the time of the hydrogen burn (Figure 1). The examination of the failed detector showed the cause of failure to be a cracked GM tube. Due to the presence of numerous chips and scratches around the glass-to-metal seal, the glass was apparently in a weakened state prior to the hydrogen burn. It is likely that the tube failed as a result of the mechanical shock imparted to the entire detector assembly by the hydrogen burn. It is less likely that the tube failed because of the change in atmospheric pressure. The glass thickness and printed circuit board mounting method should allow a good quality tube to withstand substantially higher shocks; i.e., no inherent weakness in the present design can be identified. It is recommended that tighter quality controls be instituted to prevent this type of failure in the future.

FIGURE 1. HP-R-213 STRIPCHART. This record shows the radiation levels measured by HP-R-213 during the first 20 hours of March 28, 1979. Reactor trip occurs at 4:00 AM, and the first evidence of fuel failure or shine can be seen at approximately 6:24 AM. Detector HP-R-213 was the first containment area monitor to indicate abnormal radiation levels. The anti-jam circuit operates properly until about 11:45 AM at which time an apparent drop in radiation level occurs. I suspect this to be caused by radiation damage to the detector resulting in "multivalued" behavior<sup>1</sup>. The detector output drops sharply to minimum scale at the time of the hydrogen burn where it remained until it was taken out of service.

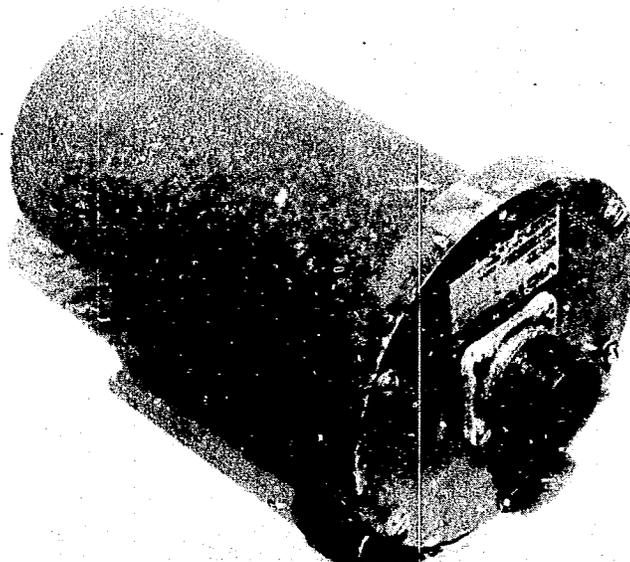
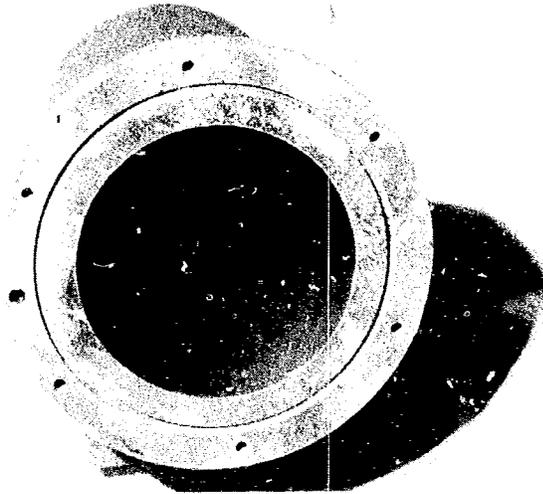
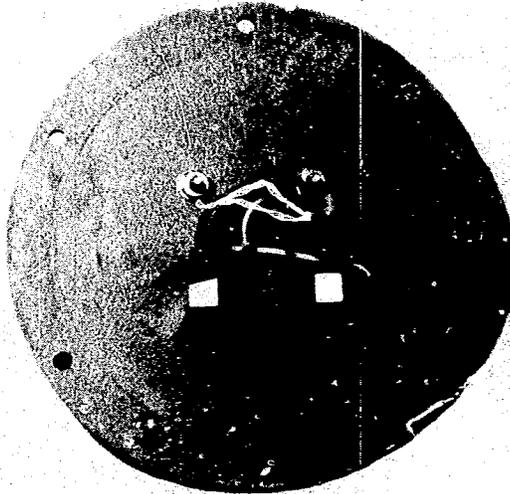
The detector outside case shows the same pitting and corrosion around the connector as was seen in HP-R-211 (Figure 3 through Figure 6); however, this is normal when the environment it was exposed to is considered. The O-ring seal did a good job, even though it had some damage where it was apparently pinched at some time (Figure 7). Swipes taken on the inside of the canister indicate that no radioactive materials leaked in to contaminate the printed wiring assembly. A microscopic examination of the printed wiring assembly showed it to have solder flux around most of the solder joints (Figure 8 and Figure 9).

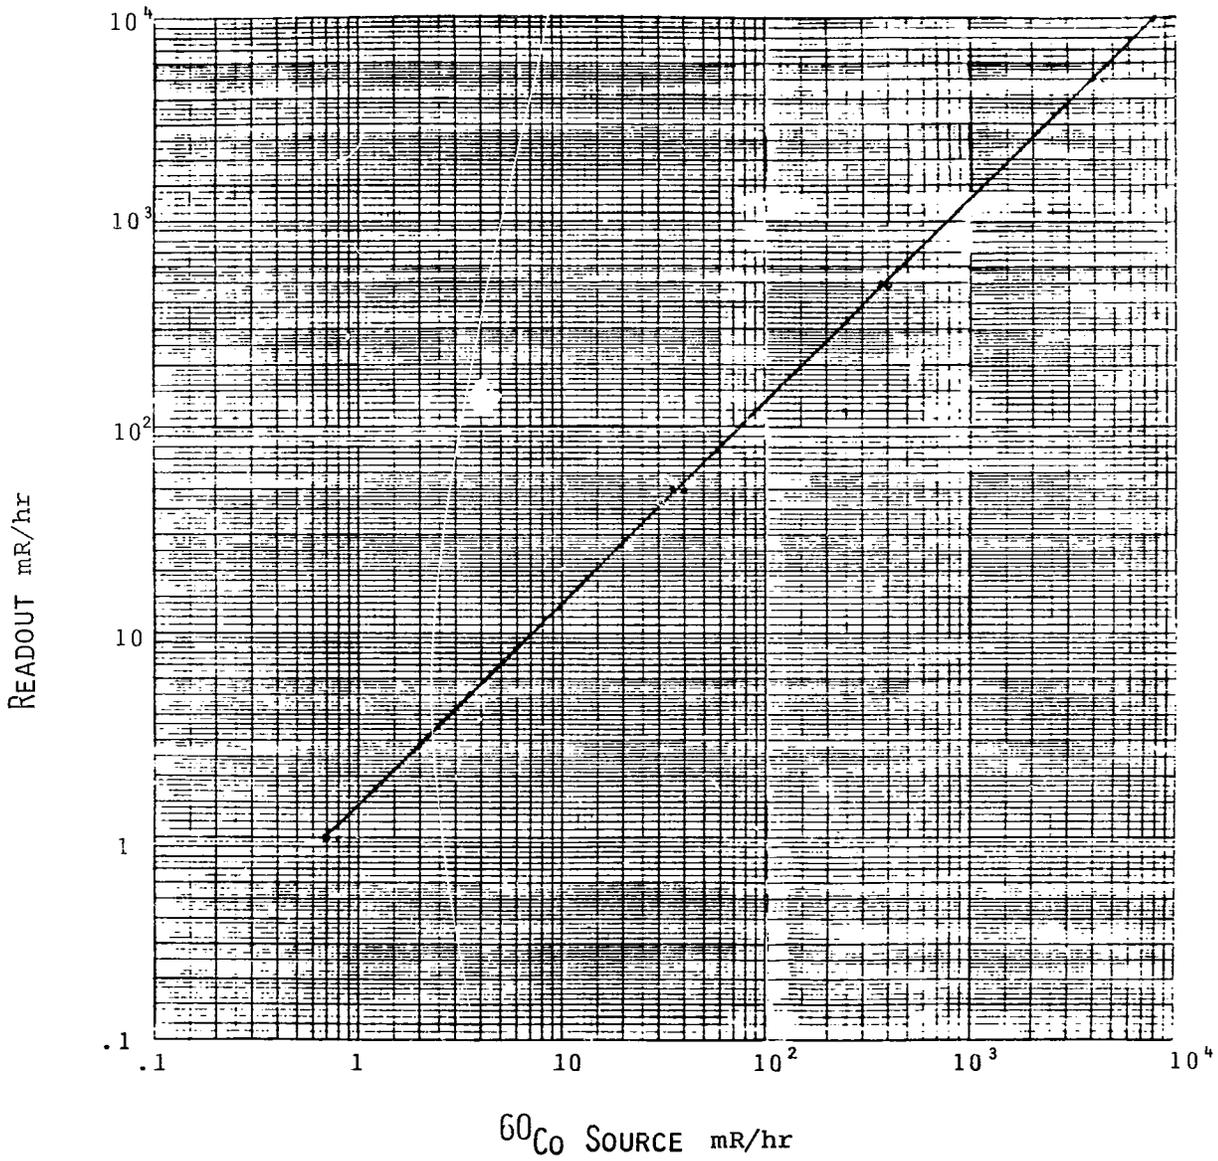
FIGURE 11. REPAIRED HP-R-213 DETECTOR RESPONSE WITH A REPLACED GM TUBE

2. The GM tube from the test detector was placed in the HP-R-213 detector circuit. The detector then functioned normally when exposed to gamma radiation up to 20 R/hr.
3. I estimate the total gamma radiation dose accumulated by this detector to be approximately  $9.9 \times 10^5$  rads.

The faulty GM tube was replaced, and the detector was observed to function normally. Using the new GM tube, the detector was exposed to  $^{60}\text{Co}$  at the Sandia Vertical Range Facility. The detector output reading versus input  $^{60}\text{Co}$  source level is shown in Figure 11. The detector operates properly over its normal 0.1 mR/hr to 10 R/hr range. The error in radiation measurement is caused by not calibrating this detector with the ratemeter. The anti-jam circuit was activated at an input level of 17.5 R/hr. The detector was exposed to radiation levels as high as 600 R/hr with and without 150 meters (492 feet) of RG58 coaxial cable in the SIG output line. Appendix A shows the sequence of events performed in troubleshooting the detector.<sup>3</sup>

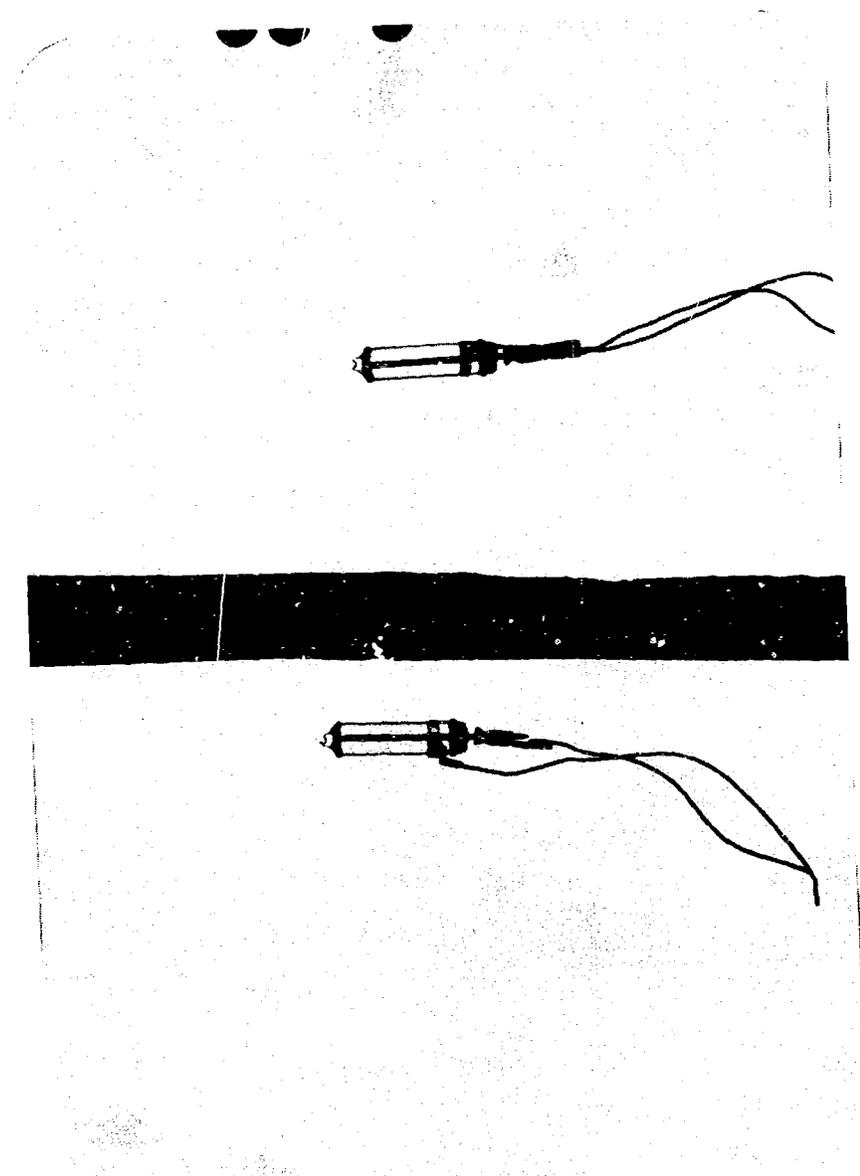
FIGURE 12. X-RAY OF GM TUBE.  
TOP VIEW IS ROTATED 90° FROM BOTTOM VIEW

The GM tube was initially examined under a microscope and was found to have chipped glass around the seal between the glass and the chrome-iron cathode cylinder. Several scratches were on the glass seals also; however, no "breaks" were obvious. The tube was then x-rayed to determine if the anode was out of position. The x-ray shown in Figure 12 shows the anode to be properly positioned. A leak test was made to

determine the integrity of the tube's seal. In this test one end of the tube was exposed to helium at a pressure of one atmosphere while a vacuum was drawn on the other end of the tube. The presence of helium was then looked for. A small leak was detected in this way. When the tube was later removed from its protective housing the anode end simply fell off. It appears that one of the glass scores had weakened the glass to the point that the hydrogen burn shock caused the crack to propagate to the point of releasing the neon and helium gas and bromine or chlorine quench gas.
