# METALLURGICAL EXAMINATION OF, AND RESIN TRANSFER FROM, THREE MILE ISLAND PREFILTER LINERS

John W. McConnell, Jr.  
Howard W. Spaletta

Published August 1984

EG&G Idaho, Inc.  
Idaho Falls, Idaho 83415

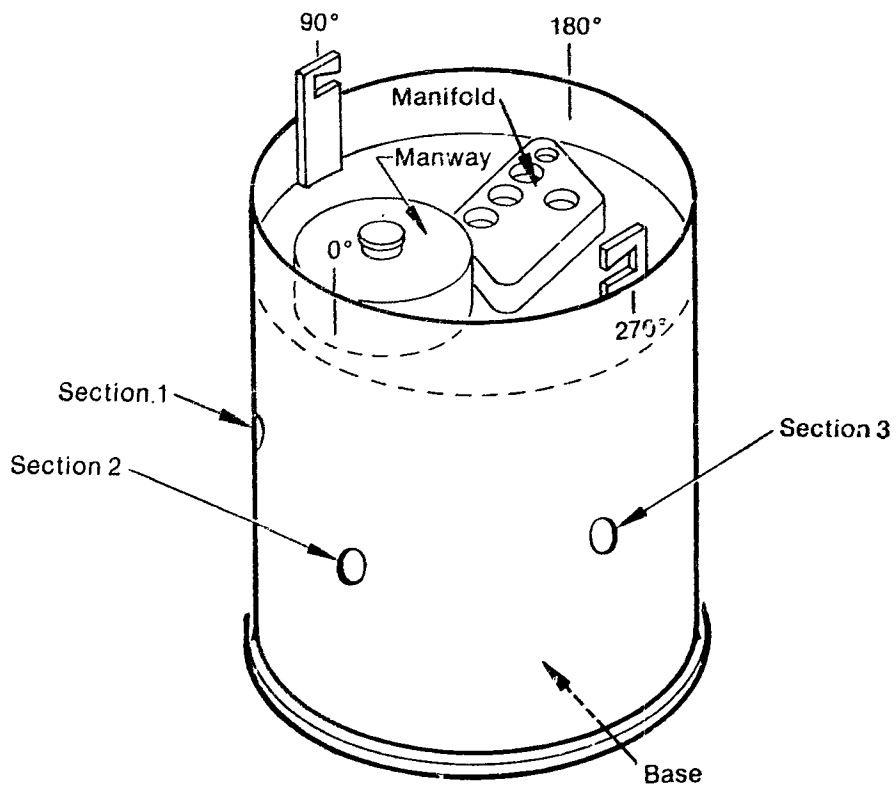
Figure 2. View of liner PF-3 showing locations where metal sections were removed.

Section 1. Section 1 was removed from the center of the grounding area for the conductivity probe, about 30 in. from the bottom of liner PF-3, 45-degrees clockwise from the manway (see Figure 2). The internal coating had been removed mechanically from that area of the liner. After decontamination by rinsing with mineralized water, contact readings of 35 R/h  $\beta$ - $\gamma$  were measured. Visual examination of the interior surface of the section revealed a heavy deposit of corrosion products and residual resin (Figure 12). The high radiation readings required remote examination of this section in the TRA Hot Cells. Some corrosion products were lost while remotely preparing specimens from Section 1.

Section 3. Section 3 was removed from the sidewall of liner PF-3, 90-degrees counterclockwise from the manway, about 30-in. above the bottom of the liner (see Figure 2). That elevation corresponded to the top surface of the resin. Visual examination of the interior surface of Section 3 revealed numerous coating blisters and areas where coating was not adhering to the base metal and had spalled (Figure 15). Light corrosion products under an adherent coating and heavily corroded areas under blisters were observed (Figure 16). The adherent coating is about 0.005-in. thick.

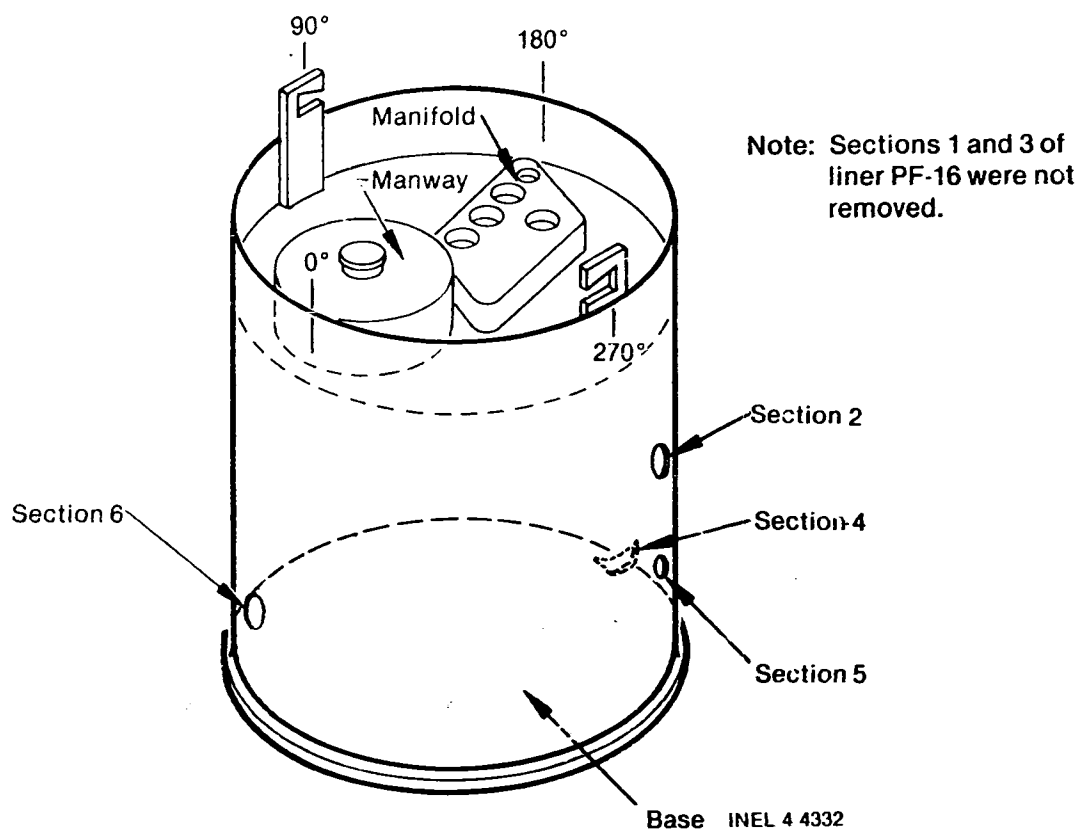
Figure 3. View of liner PF-16 showing locations where metal sections were removed.

Section 4. Section 4 was removed from the junction of the sidewall and bottom of liner PF-16, about 150-degrees counterclockwise from the manway (see Figure 3). Visual examination of the interior surface of Section 4 revealed numerous blisters in the coating on both the interior surface of the bottom plate and cylindrical wall of the liner (Figure 30). Metallographic specimens were prepared from this section at the locations shown in Figure 31. Figure 31 shows the lack of adherence of the coating to both the internal wall of the liner and surfaces of the welds joining the sidewall to bottom plate. Those welds were made in single passes, joint preparations were not machined prior to welding, and there is a gap

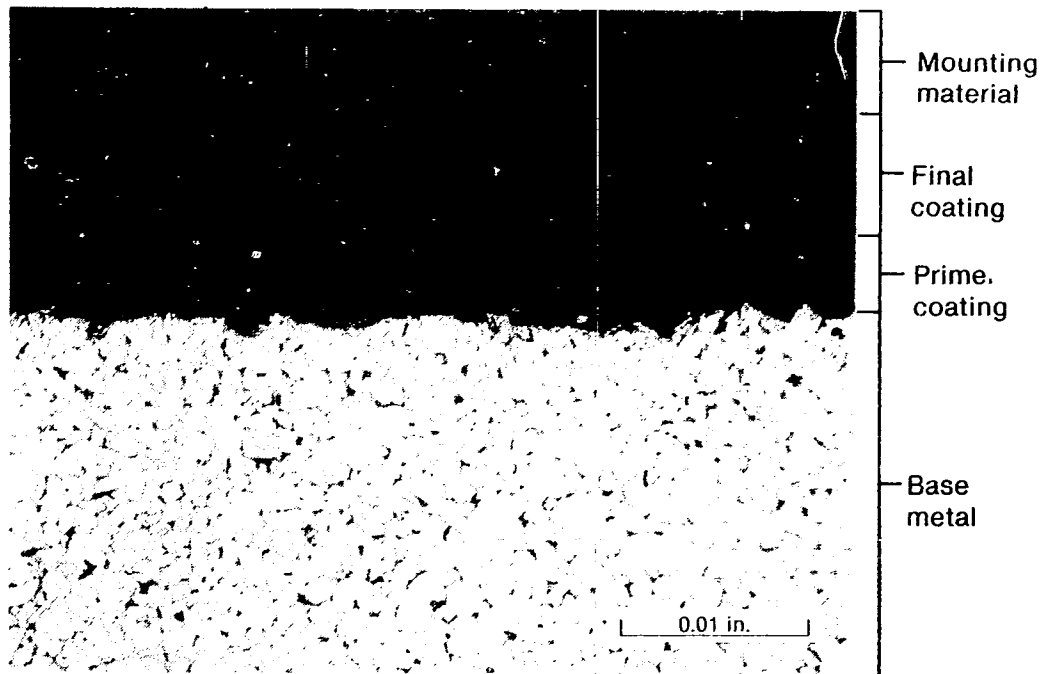
INEL 4 4358

Figure 10. Photomicrograph normal to the coated surface of Test Plate 1.

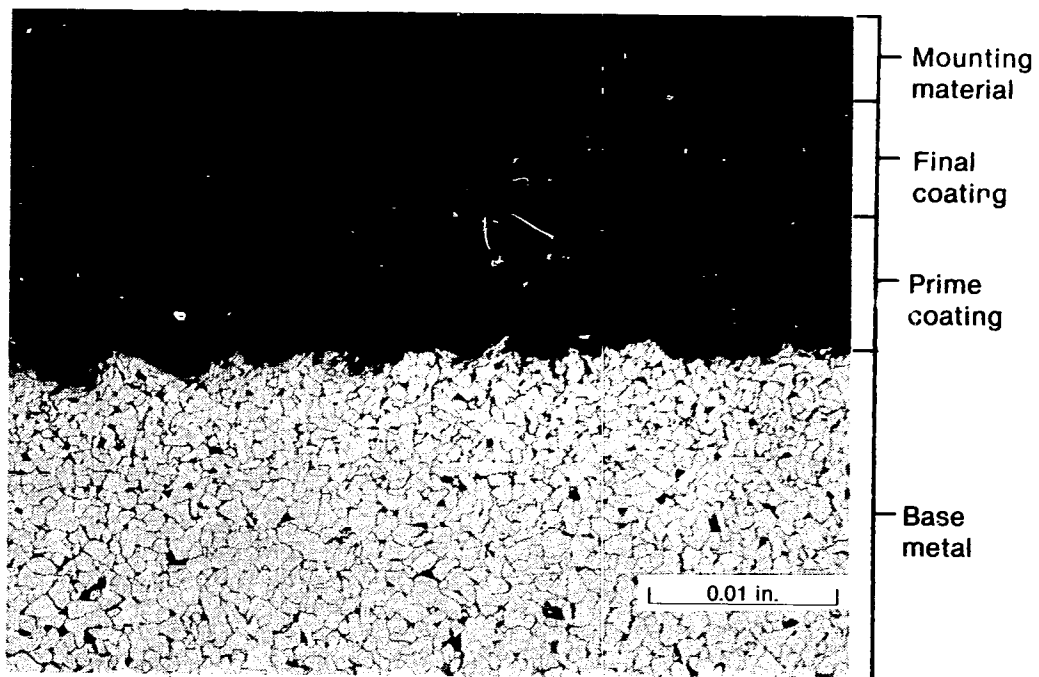
INEL 4 4356

Figure 11. Photomicrograph normal to the coated surface of Test Plate 1A.

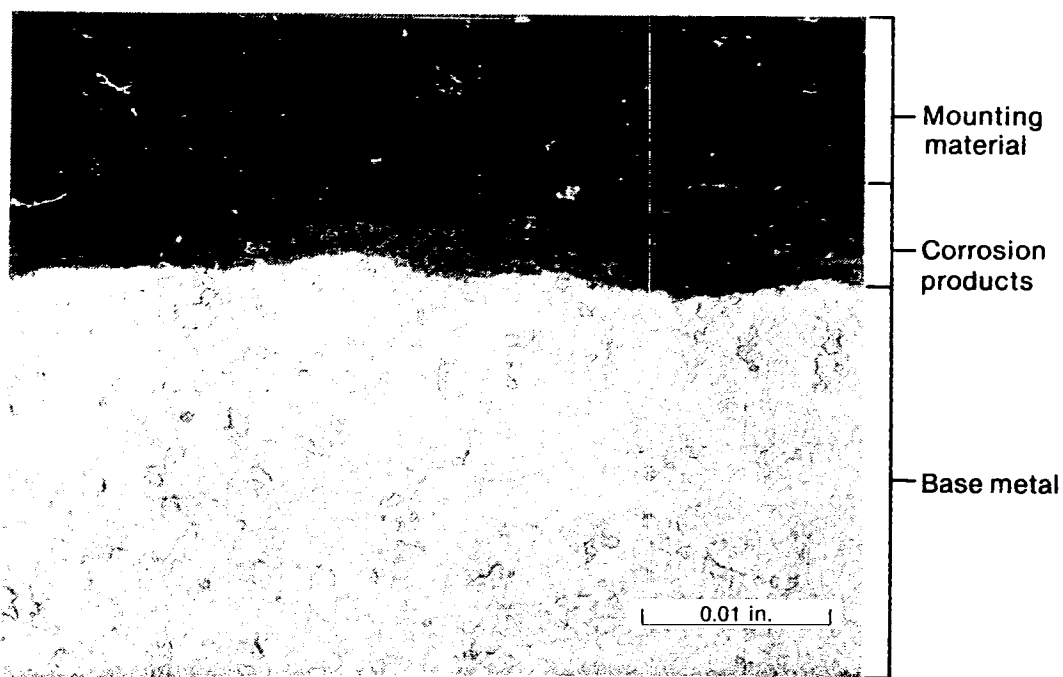
INEL 4 4348

Section 1, Specimen 1-B--Figure 13 is a typical photomicrograph normal to the uniformly corroded interior surface observed for Specimen 1-B. No evidence of pitting or pitting-type corrosion was evident. A normal fine-grained (ASTM grain size No. 8 or finer) structure was observed in the base metal (Figure 14). No interior coating was

Figure 13. Photomicrograph normal to the interior surface of Section 1 from liner PF-3 showing the uniformly corroded surface.

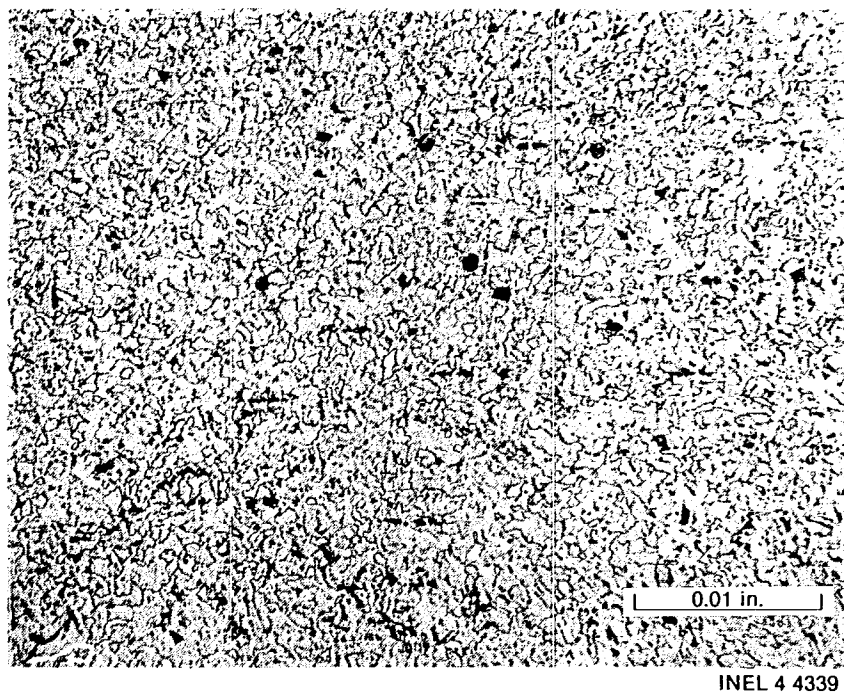
Figure 14. Photomicrograph of Section 1 from liner PF-3 showing a normal fine-grained (ASTM No. 8 or finer) base metal.

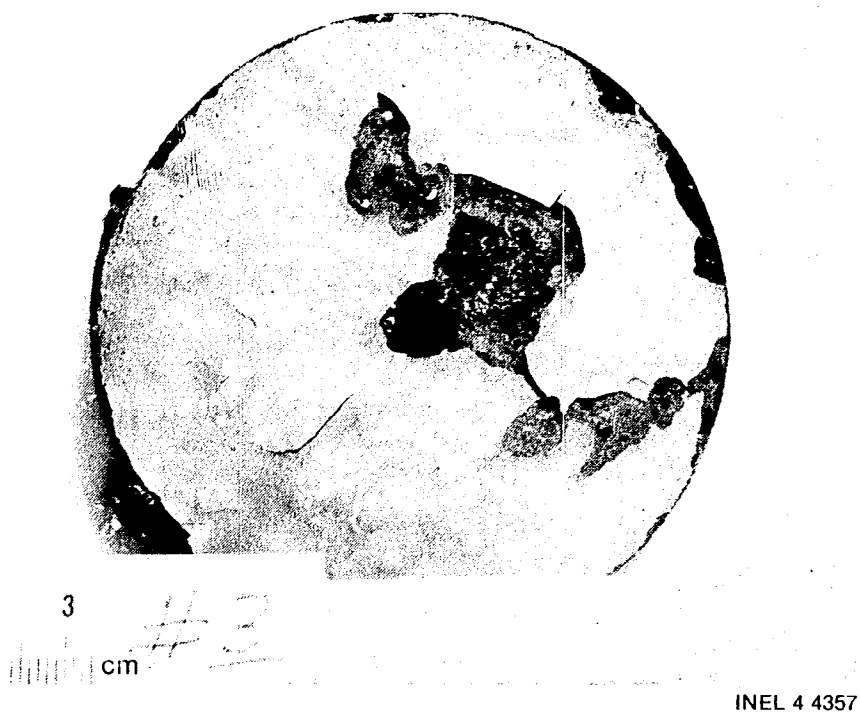
Figure 15. Photograph of the interior surface of Section 3 from liner PF-3 showing coating blisters and areas where coating is missing.

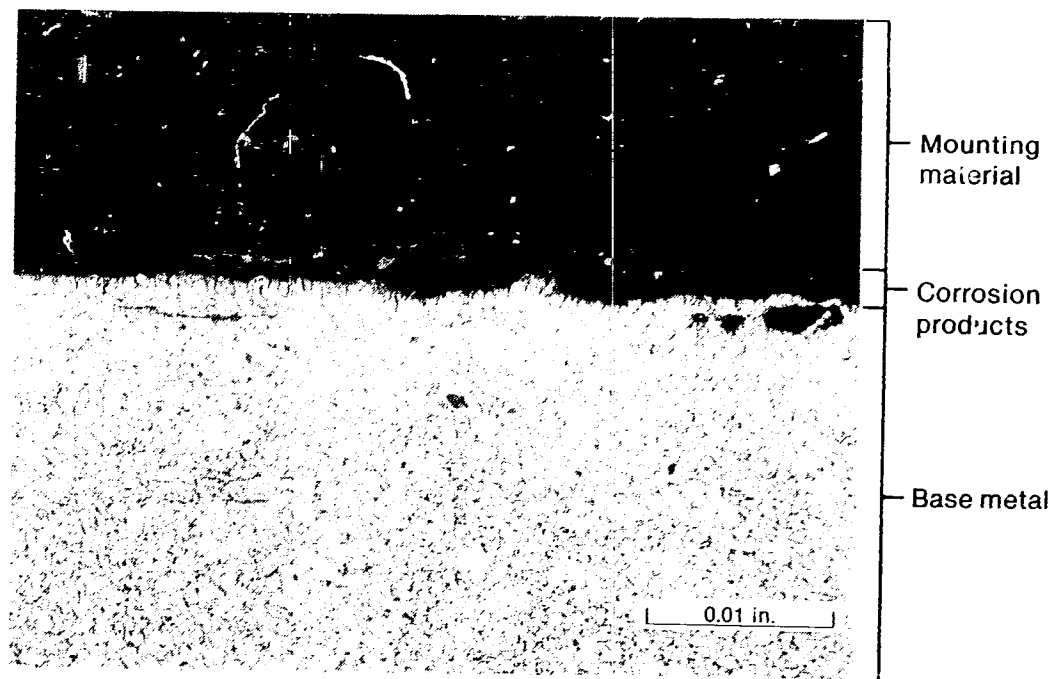
INEL 4 4352

Figure 16. Photomicrograph normal to the interior surface of Section 3 from liner PF-3 showing corrosion products in an area where coating had spalled.

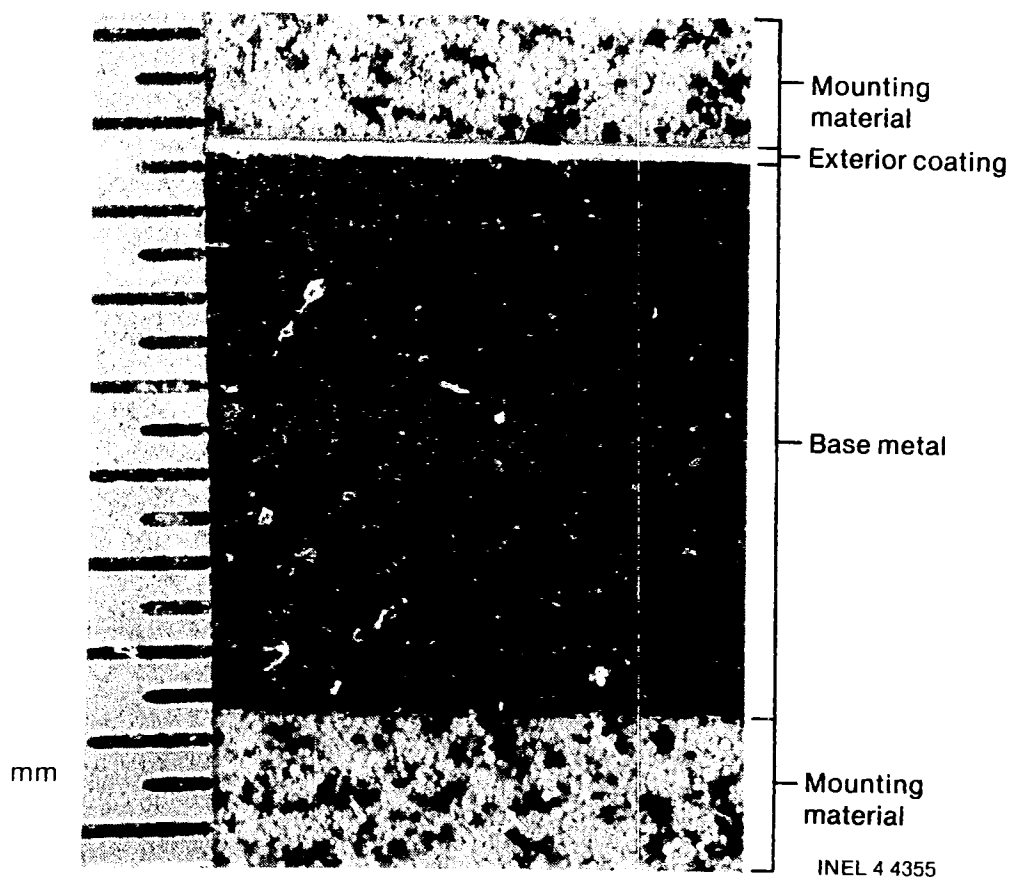
INEL 4 4355

Section 3, Specimen 1-B--The exterior surface of this specimen was examined at 100 magnification (Figure 17), and a heavy exterior phenolic coating of at least three layers was observed. Examination of the exterior surface at higher magnifications revealed corrosion products (about 0.0005-in. thick) between the coating and base metal, with a total coating thickness of about 0.010-in. (Figure 18). Evidence that the coating had been applied over previously present corrosion products is indicated by layers of coating between the base metal and corrosion products (Figure 19).

Figure 17. Photomicrograph normal to the wall of Section 3 from liner PF-3 showing the exterior coating and lack of coating on the interior surface.

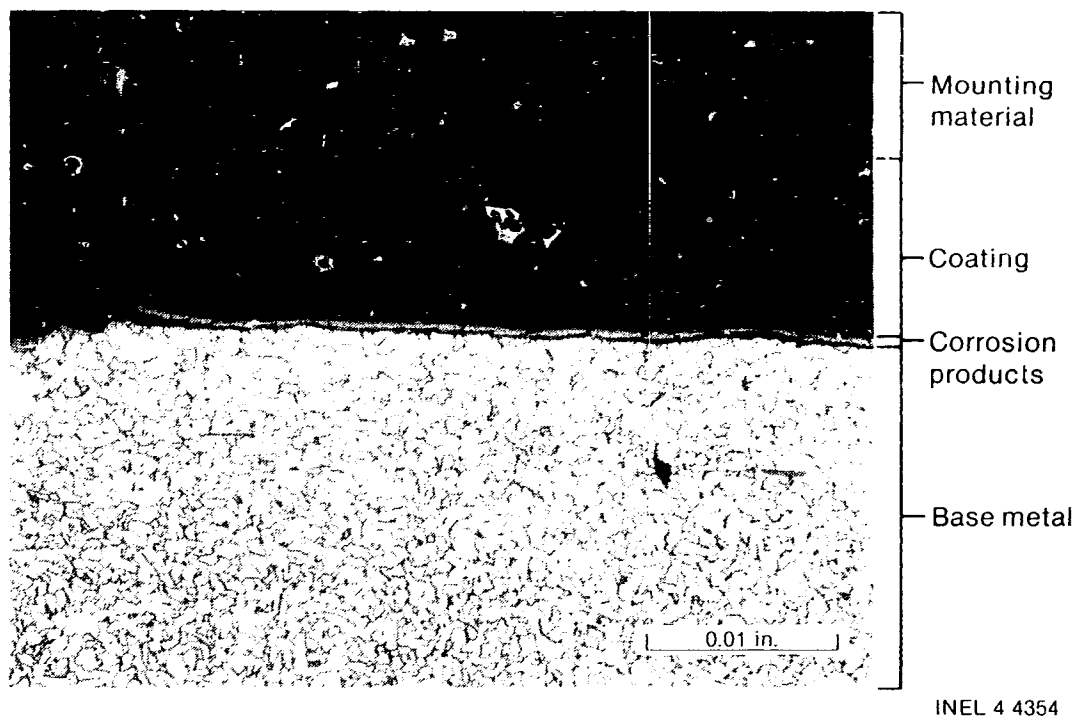
Figure 18. Photomicrograph normal to the exterior surface of Section 3 of liner PF-3 showing corrosion products between the base metal and coating.

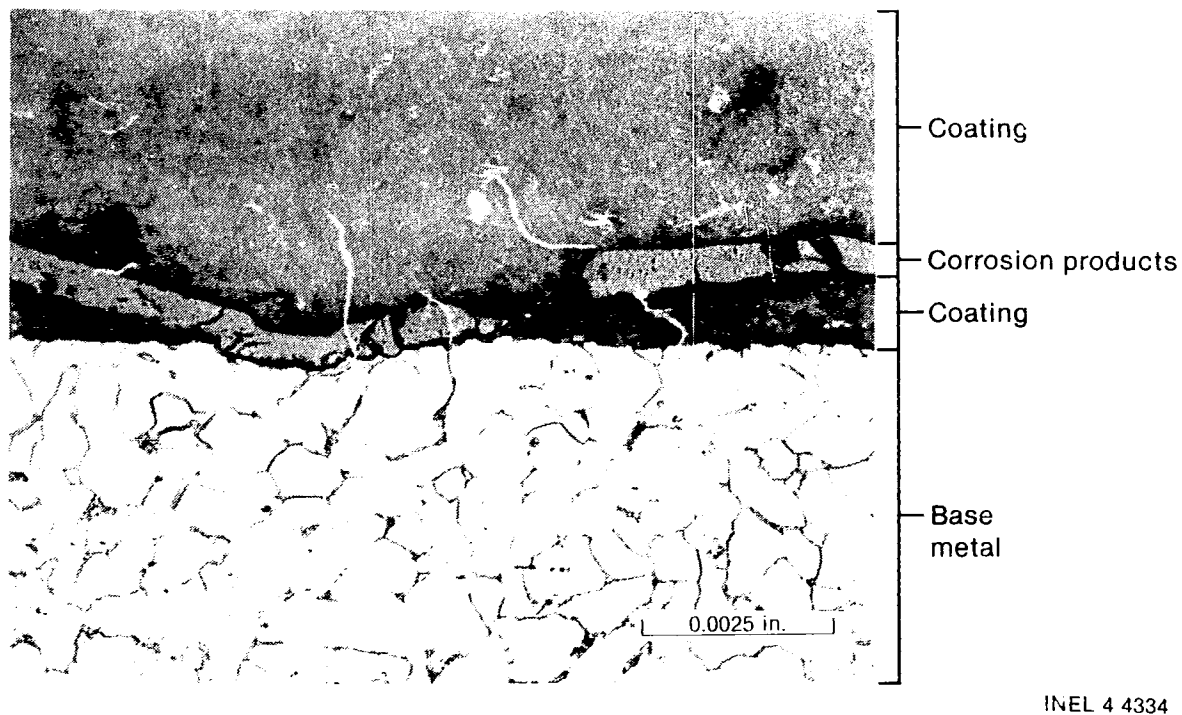
Figure 19. Photomicrograph normal to the exterior surface of Section 3 of liner PF-3 showing coating between the base metal and corrosion products.

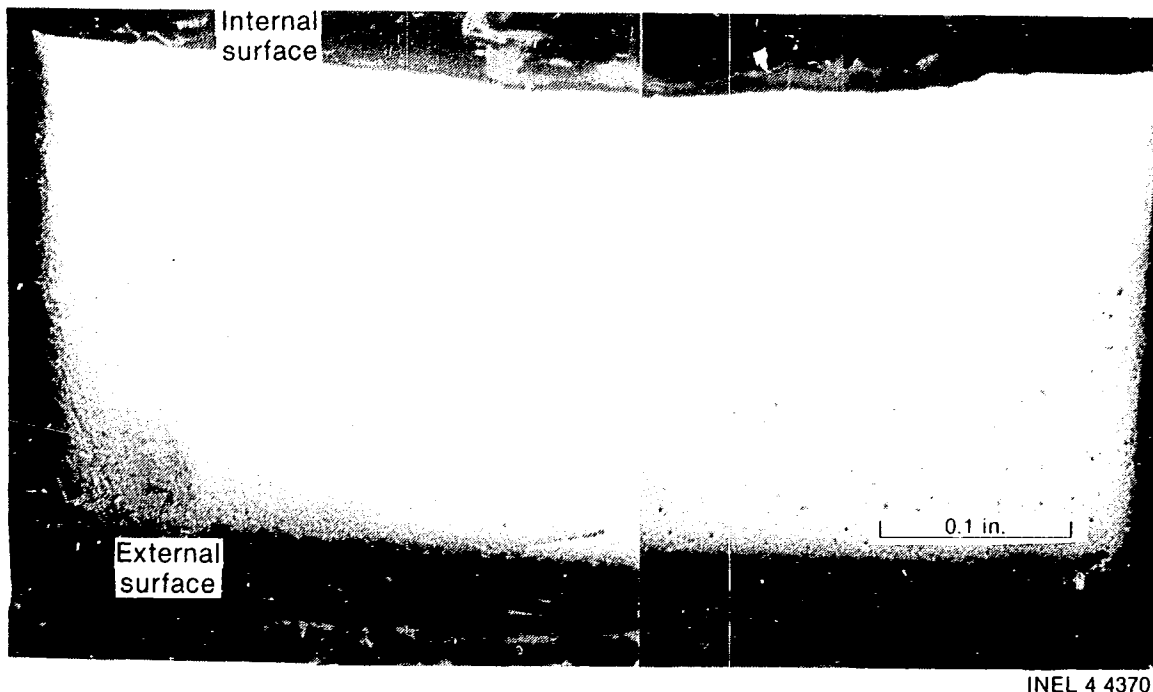
INEL 4 4370

Figure 20. Photomicrograph of Section 1, Specimen 1B (a vertical section from liner PF-3 normal to the grounding area for the conductivity probe) showing the horizontal depression on the internal surface.

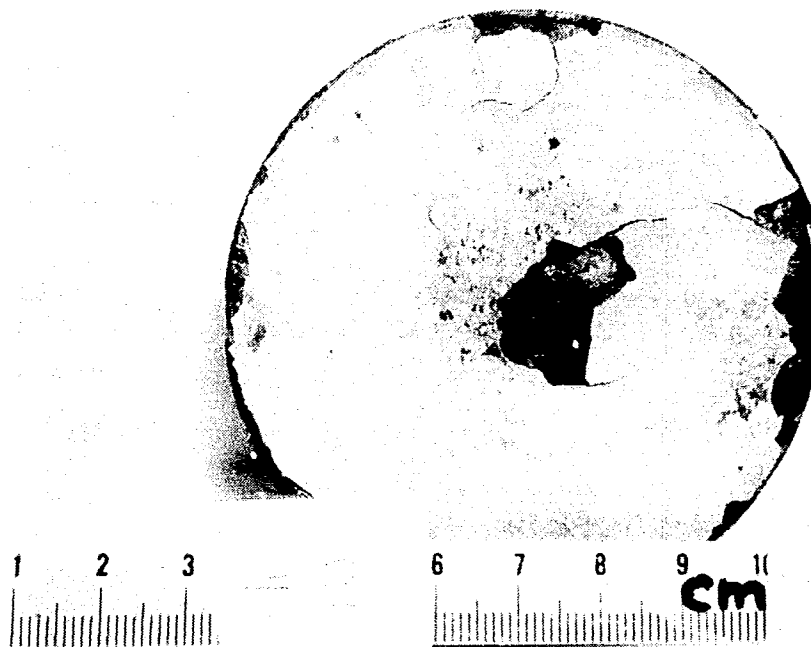
INEL 4 4338

Figure 21. Photograph of the interior surface of Section 2 from liner PF-3 showing coating blisters and areas where the coating is loose.

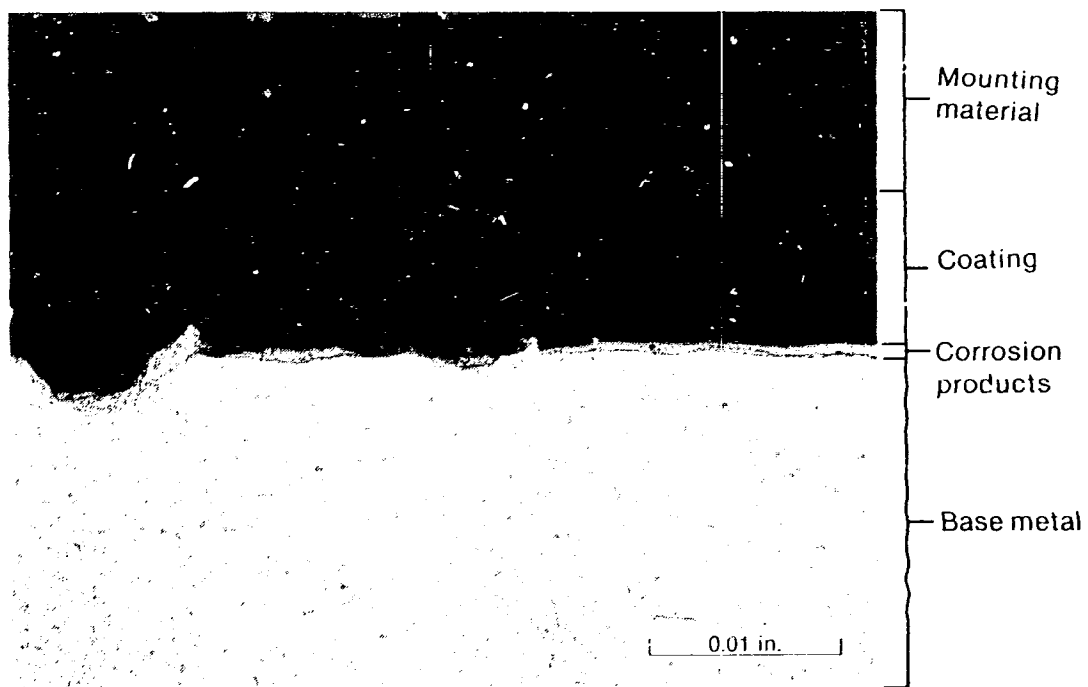
INEL 4 4344

Figure 22. Photomicrograph normal to the interior surface of Section 2 from liner PF-3 showing a surface discontinuity in the base metal.

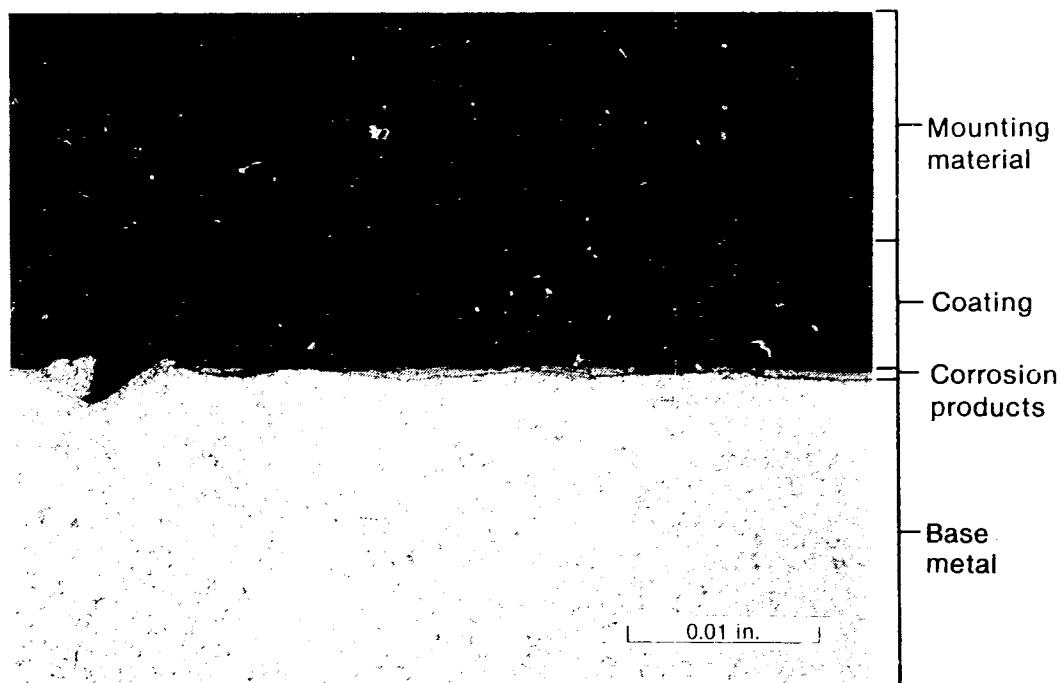
INEL 4 4345

Figure 23. Photomicrograph normal to the interior surface of Section 2 from liner PF-3 showing surface discontinuity in the base metal and an area where the coating is adhering to the base metal with no corrosion products.

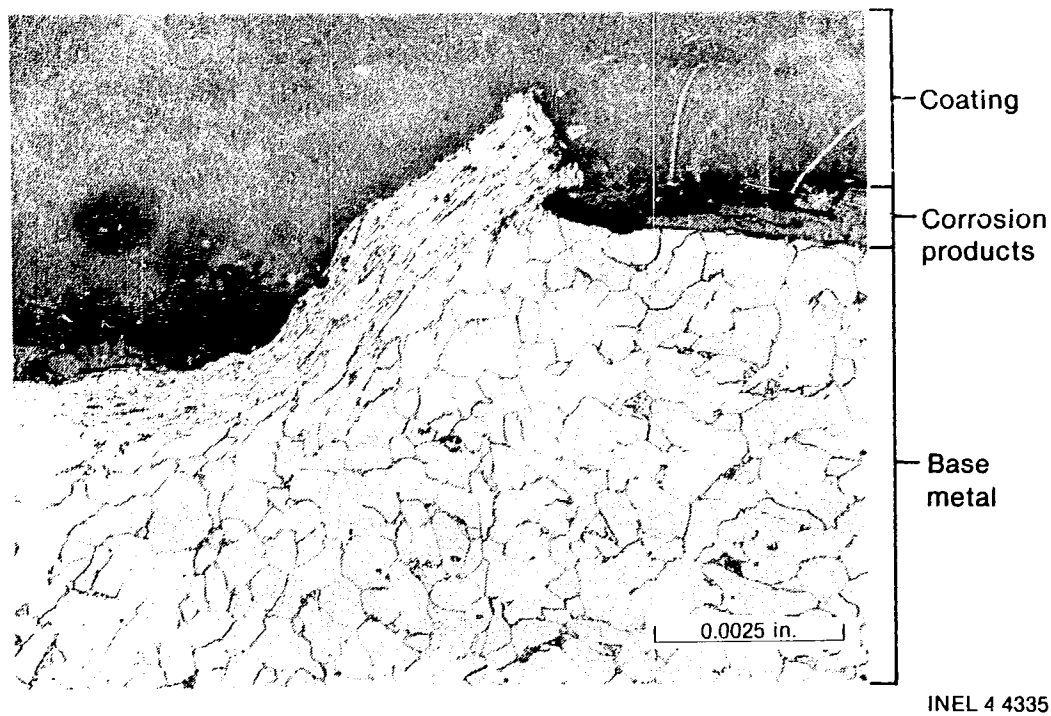
adhering to both the base metal and corrosion products, which indicates the surface had been gouged before application of the coating (Figure 24). Total coating thickness was measured at between 0.006 and 0.009 in.

Figure 24. Photomicrograph showing greater detail of discontinuity identified in Figure 22.

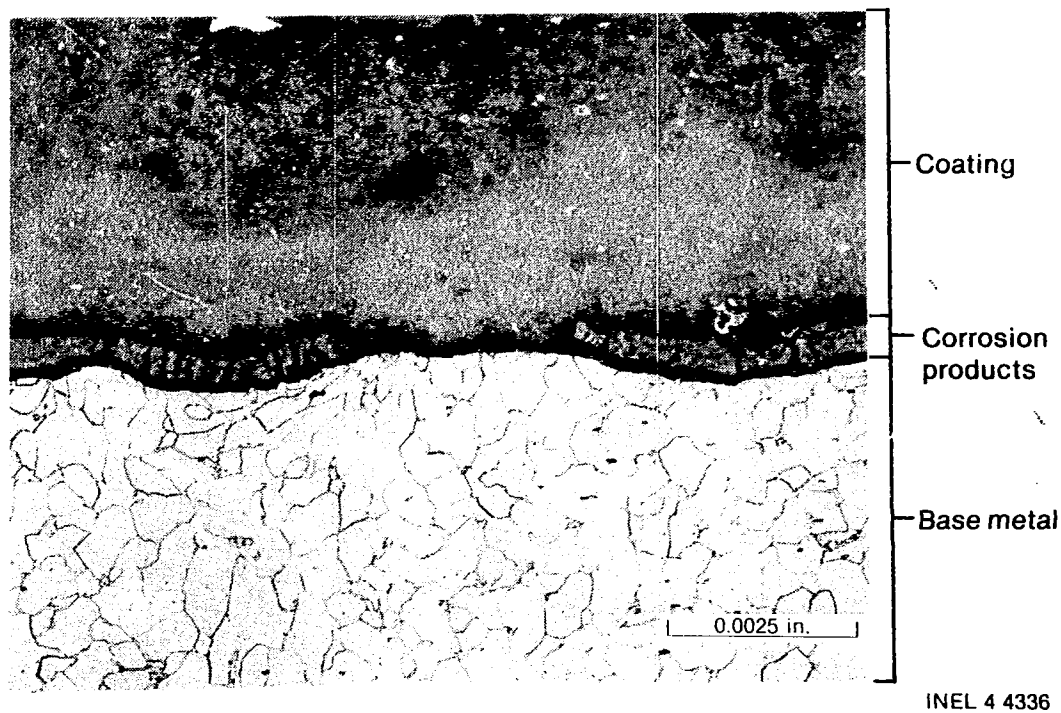
Figure 25. Photomicrograph normal to the interior surface of Section 2 from liner PF-3 showing corrosion products adhering to the base metal and coating and an area where the coating is adhering to the base metal.

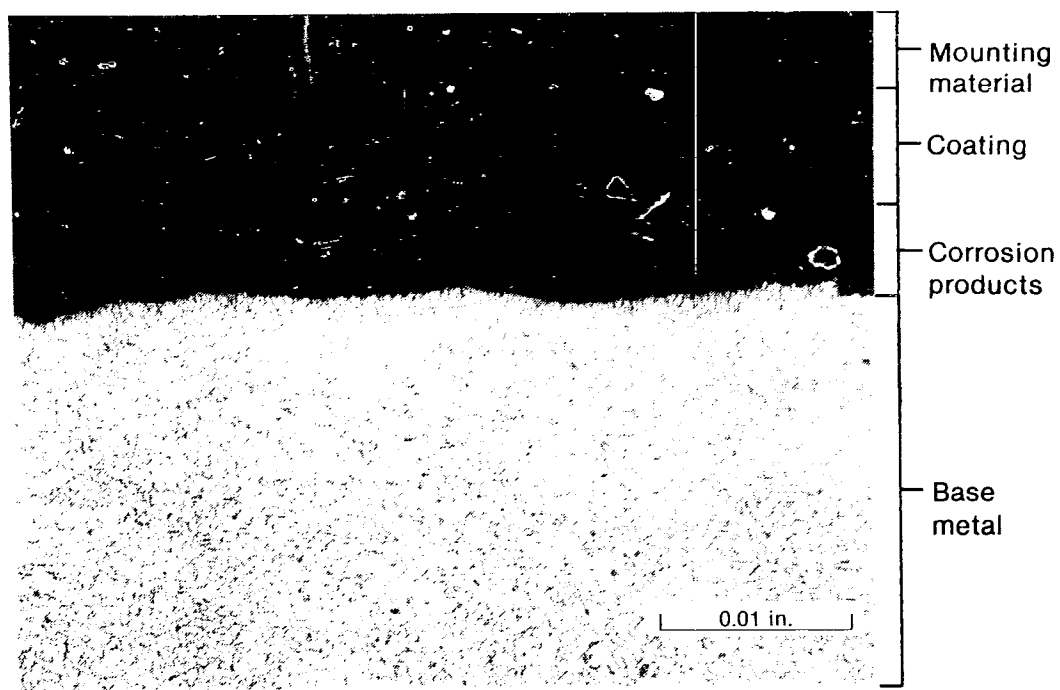
INEL 4 4371

blister revealed corrosion products about 0.004-in. thick between the coating and base metal (Figure 26). Examination of another area of Specimen 2 showed corrosion products adhering to the base metal and not the coating (Figure 27).

Figure 26. Photomicrograph normal to the interior surface of Section 2 from liner PF-3 showing a cross section through a coating and base metal.

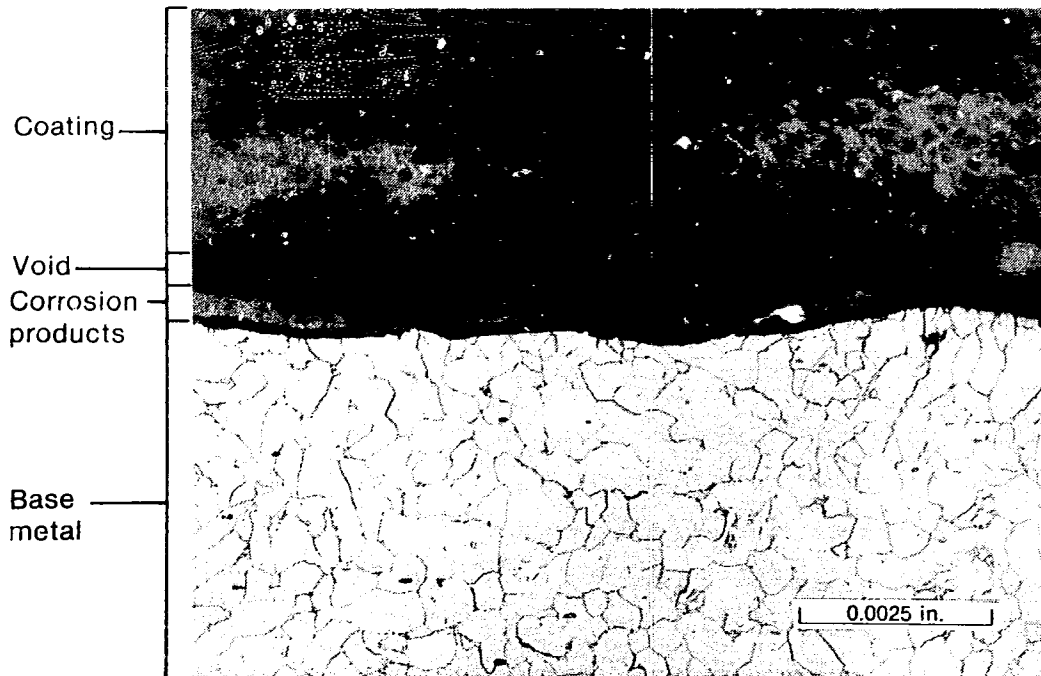
INEL 4 4337

Figure 27. Photomicrograph normal to the interior surface of Section 2 from liner PF-3 showing corrosion products adhering to the base metal and not the coating.

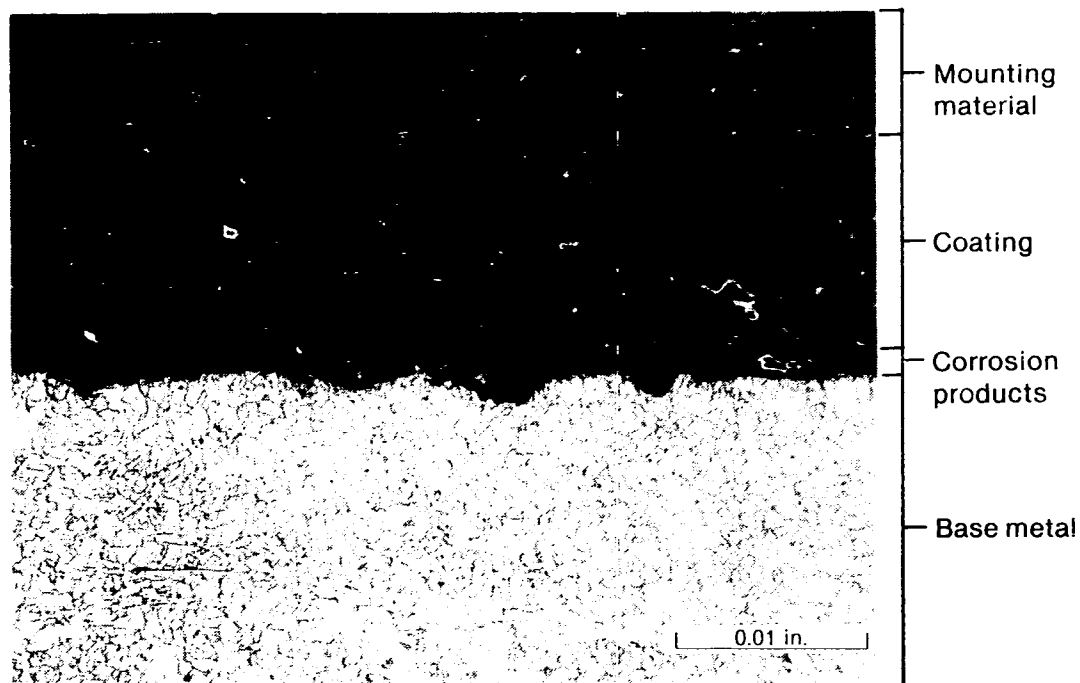
INEL 4 4346

Figure 29. Photomicrograph normal to the interior surface of Section 2 from liner PF-16 showing corrosion products between the coating and base metal.

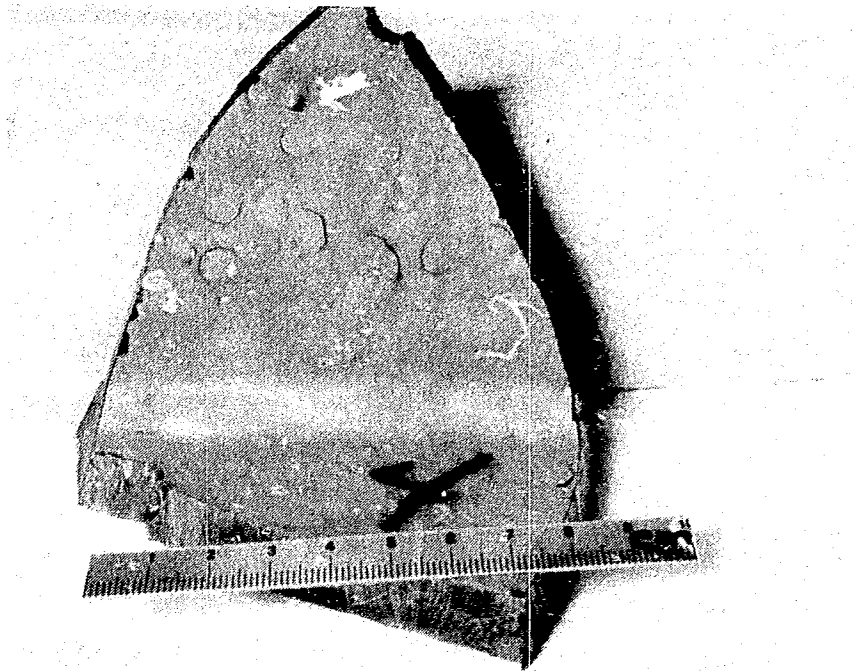
INEL 4 4342

Figure 30. Photograph of Section 4 from liner PF-16 showing blisters on the interior surfaces of both the bottom and sidewall of the liner.

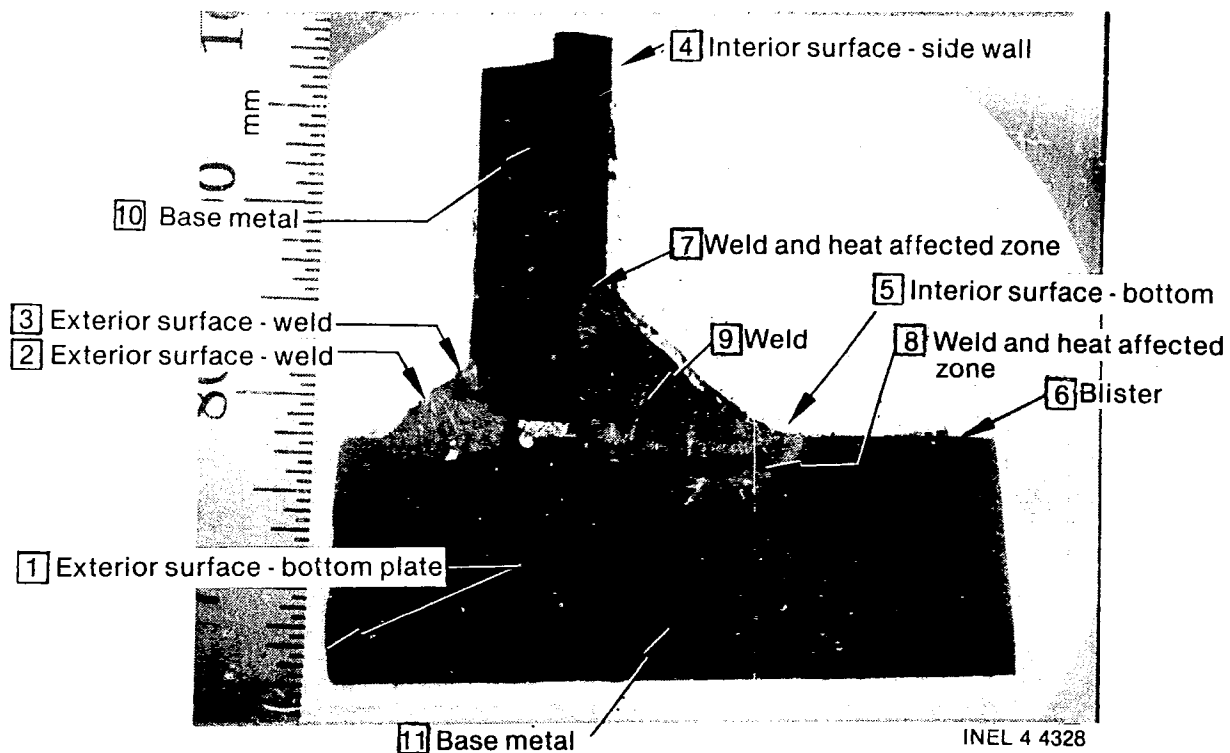
Figure 31. Photograph of vertical section (Section 4 from liner PF-16) through the bottom plate to sidewall joint showing loose coating on the internal wall and surfaces of the welds. Note that the weld joints were not prepared prior to welding, and the welds were made with single passes for both the outside and the inside weld fillets. Location of metallurgical specimens from Section 4 are indicated.

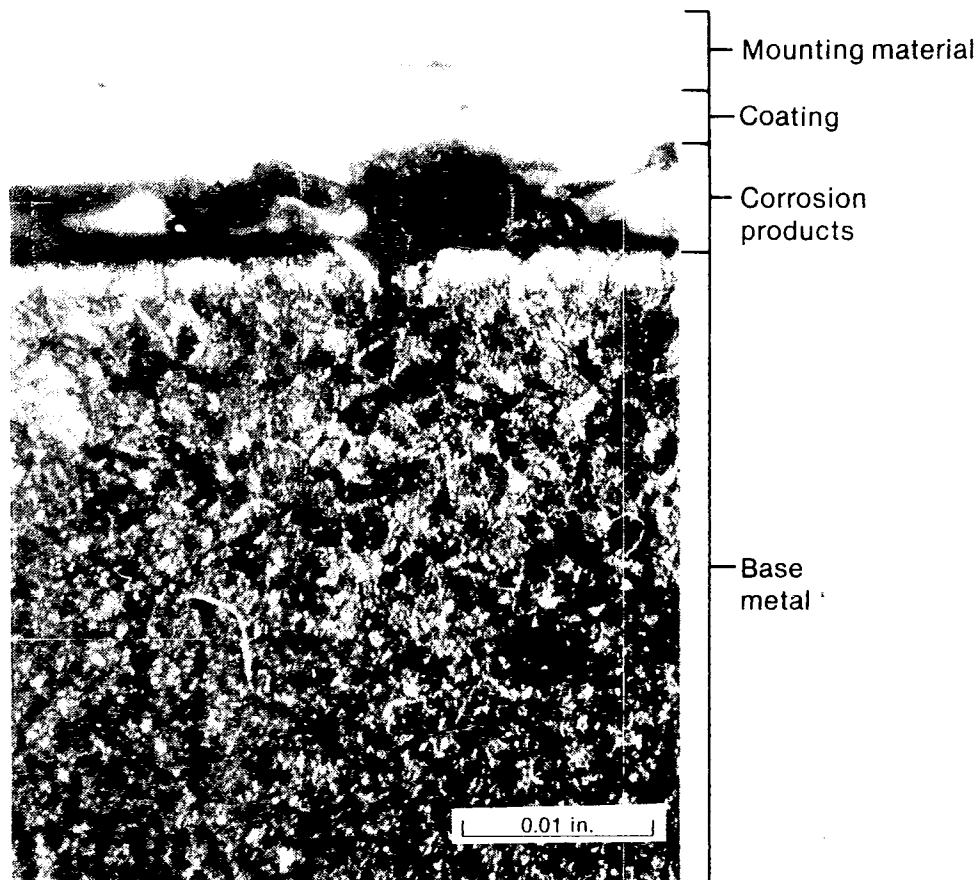
INEL 4 4341

Figure 32. Photomicrograph normal to the exterior of Section 4, Specimen 1 from liner PF-16 showing corrosion products between the coating and base metal (specimen illuminated with polarized light).

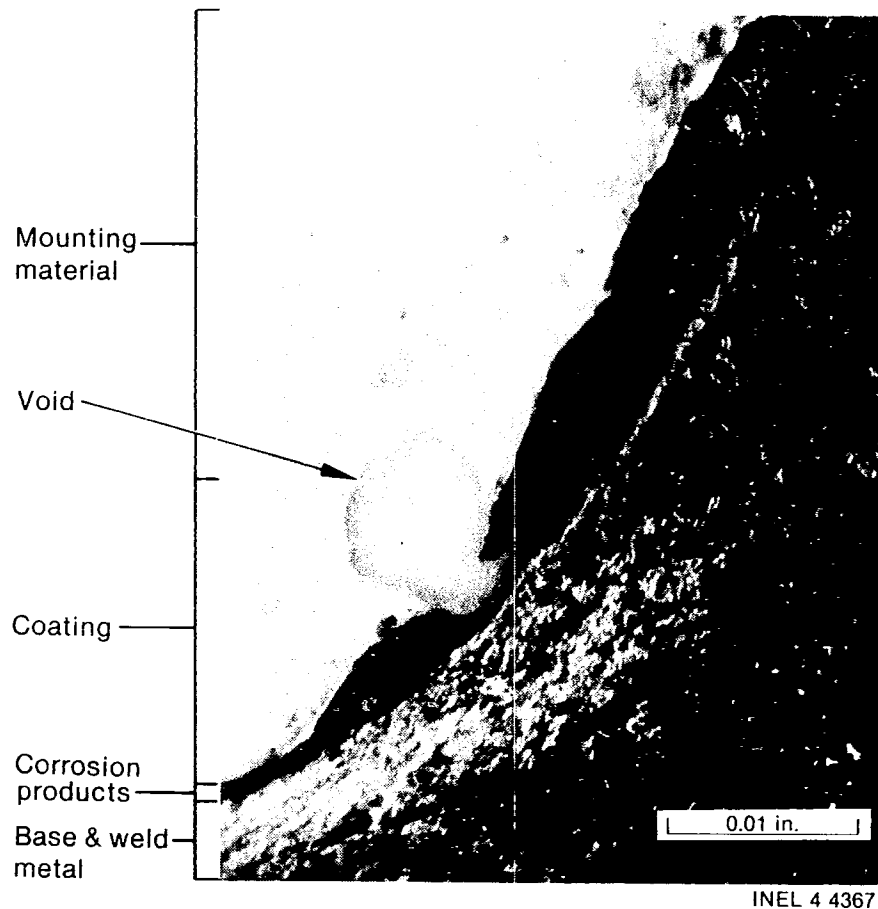
Figure 33. Photomicrograph of Section 4, Specimen 2 from liner PF-16 (made normal to the exterior weld surface) showing corrosion products between the coating and weld fillet and porosity in the coating (specimen illuminated with polarized light).

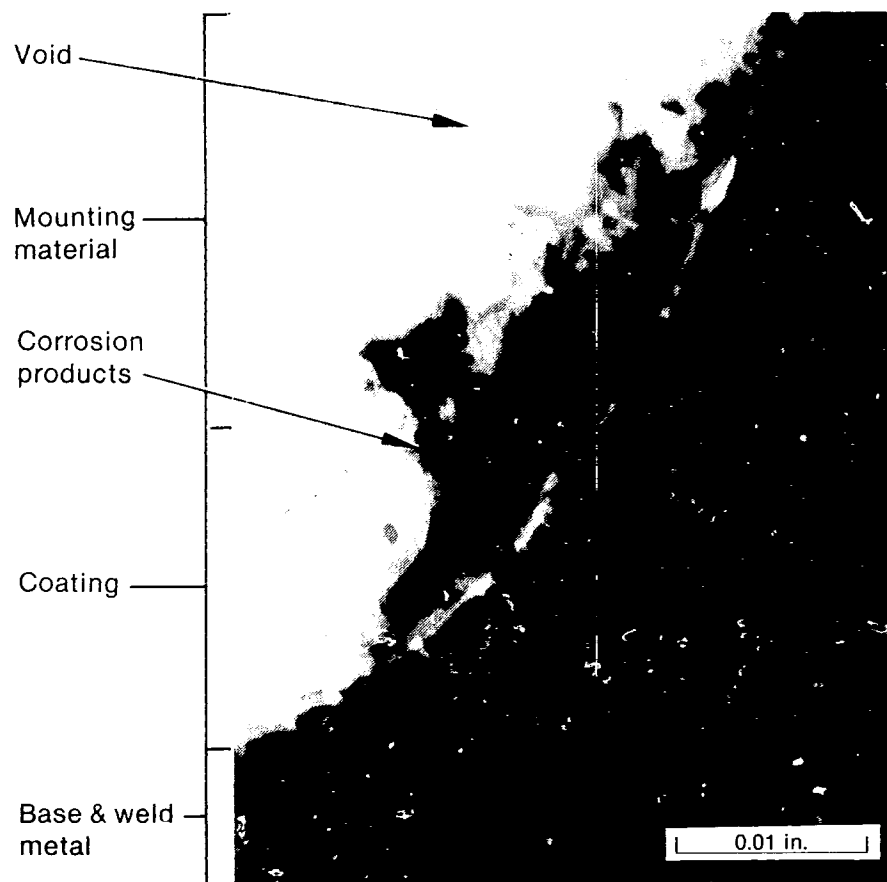
INEL 4 4369

Figure 34. Photomicrograph of Section 4, Specimen 3 from liner PF-16 (made normal to the exterior weld surface) showing corrosion products at the weld surface extending into the coating (specimen illuminated with polarized light).

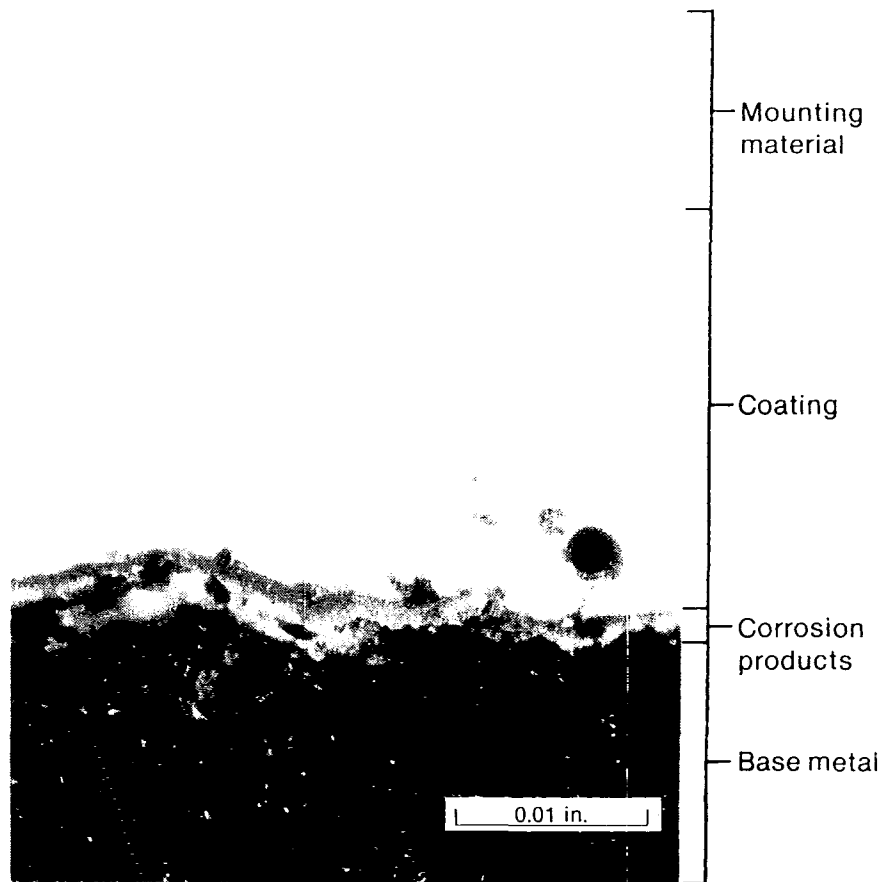
INEL 4 4368

Figure 35. Photomicrograph of Section 4, Specimen 4 from liner PF-16 (made normal to the interior surface of the sidewall) showing a heavy coating, corrosion products between the coating and base metal, and a surface gouge or scratch in the base metal (specimen illuminated with polarized light).

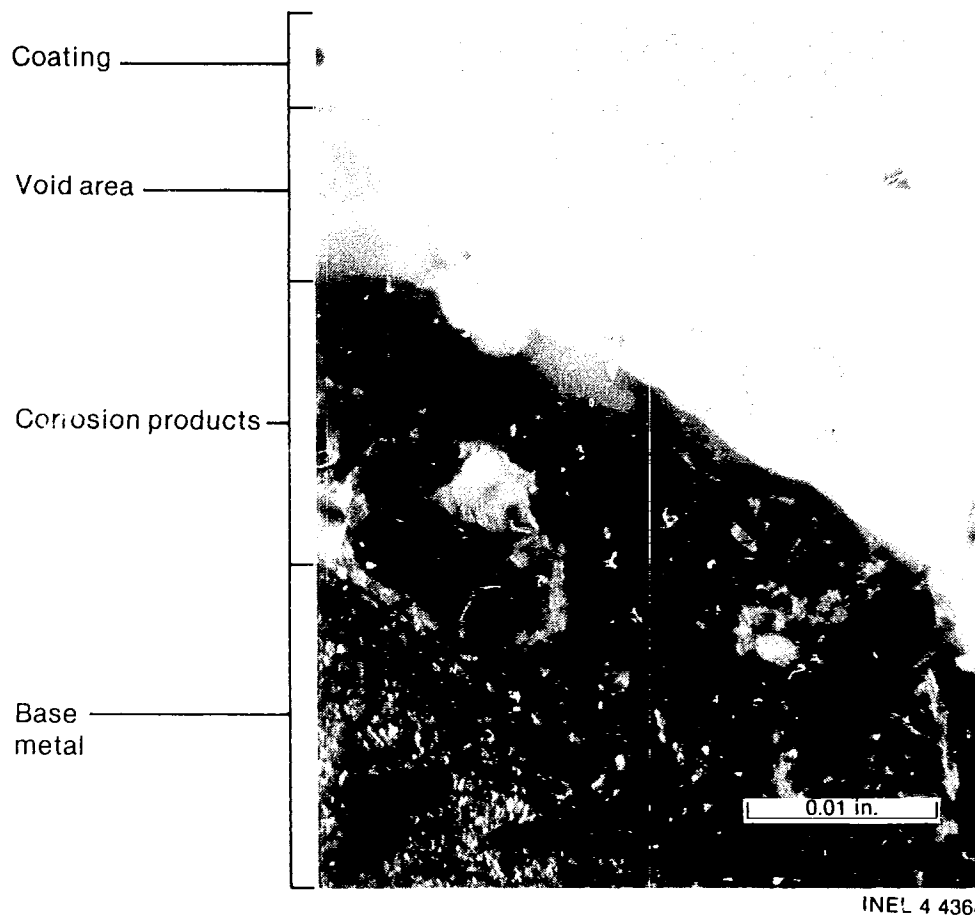
Figure 36. Photomicrograph of Section 4, Specimen 5 from liner PF-16 (made normal to the interior weld surface) showing separation between the coating and surface of the weld. Some corrosion products are evident in the separation (specimen illuminated with polarized light).
