# METALLURGICAL EXAMINATION OF, AND RESIN TRANSFER FROM, THREE MILE ISLAND PREFILTER LINERS

John W. McConnell, Jr.  
Howard W. Spaletta

Published August 1984

EG&G Idaho, Inc.  
Idaho Falls, Idaho 83415

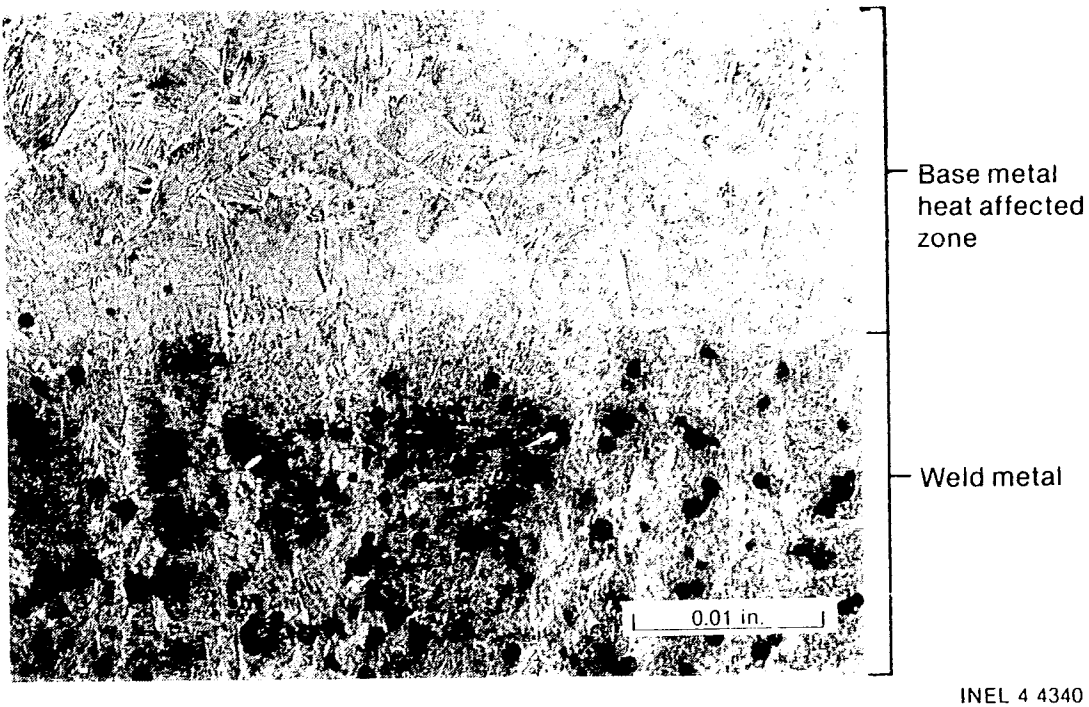
Figure 38. Photomicrograph of Section 4, Specimen 7 from liner PF-16 showing the heat affected zone in the liner wall and weld deposit. The dark spheres are voids or nonmetallic inclusions in the weld deposit.

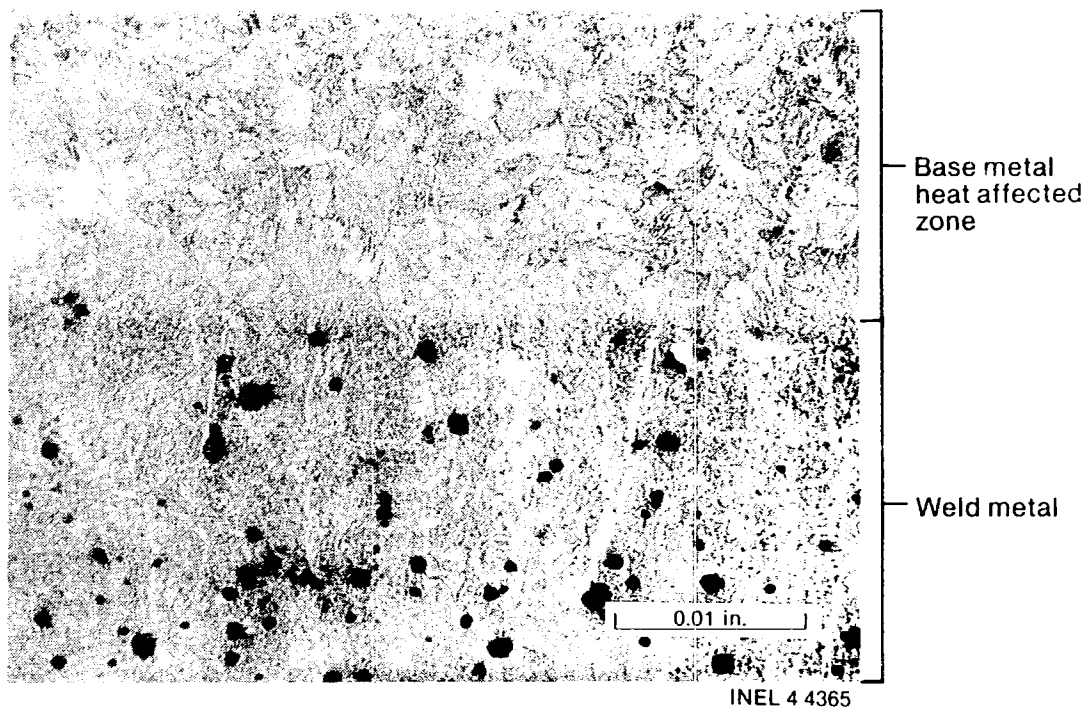
Figure 39. Photomicrograph of Section 4, Specimen 8 from liner PF-16 showing the heat affected zone in the liner bottom plate and weld deposit. The dark spheres are voids or nonmetallic inclusions in the weld deposit.

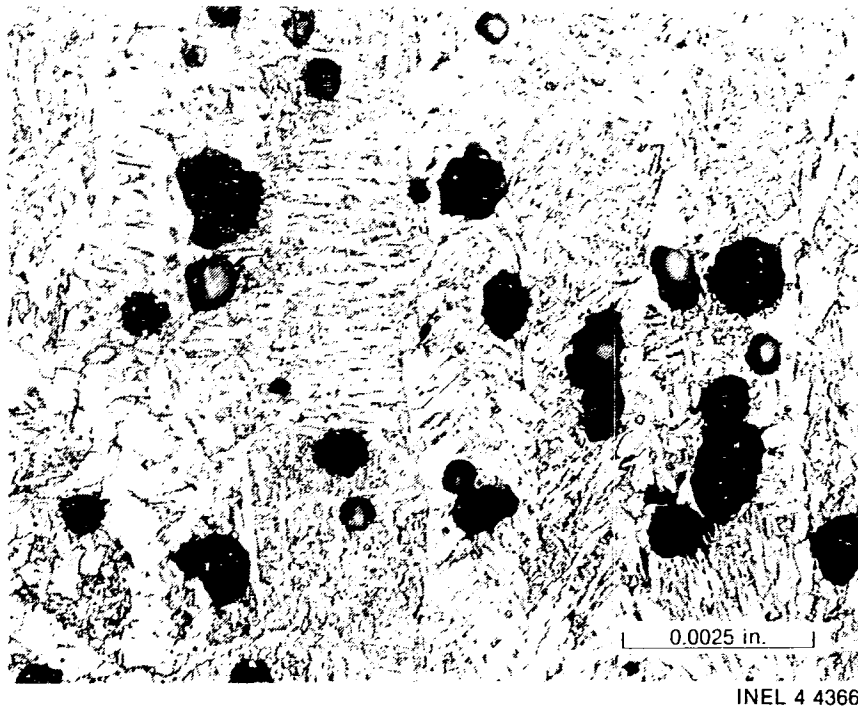
Figure 40. Photomicrograph of Section 4, Specimen 9 from liner PF-16 showing voids and nonmetallic inclusions at the center of the inner weld.

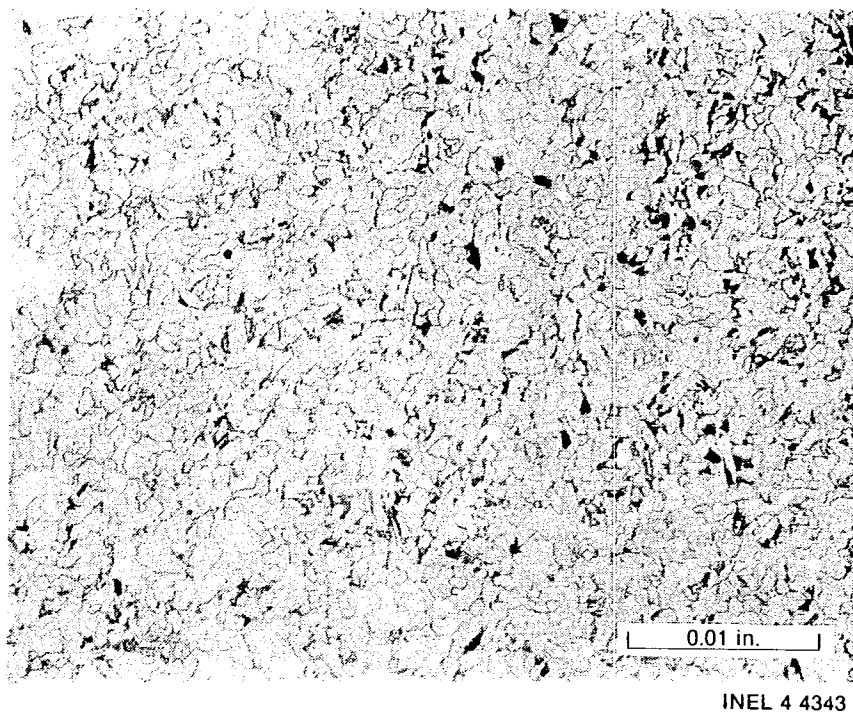
Figure 41. Photomicrograph taken from the liner wall of Section 4, Specimen 10 from liner PF-16 showing a fine-grained (ASTM grain size No. 8 or finer) base metal.

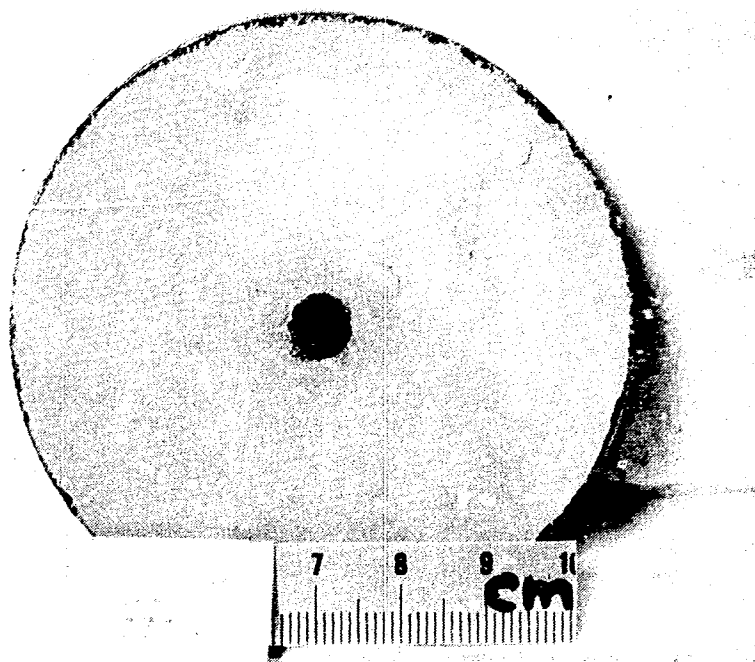
Figure 43. Photograph of the interior surface of Section 5 from liner PF-16 showing an adherent, nearly defect-free coating.

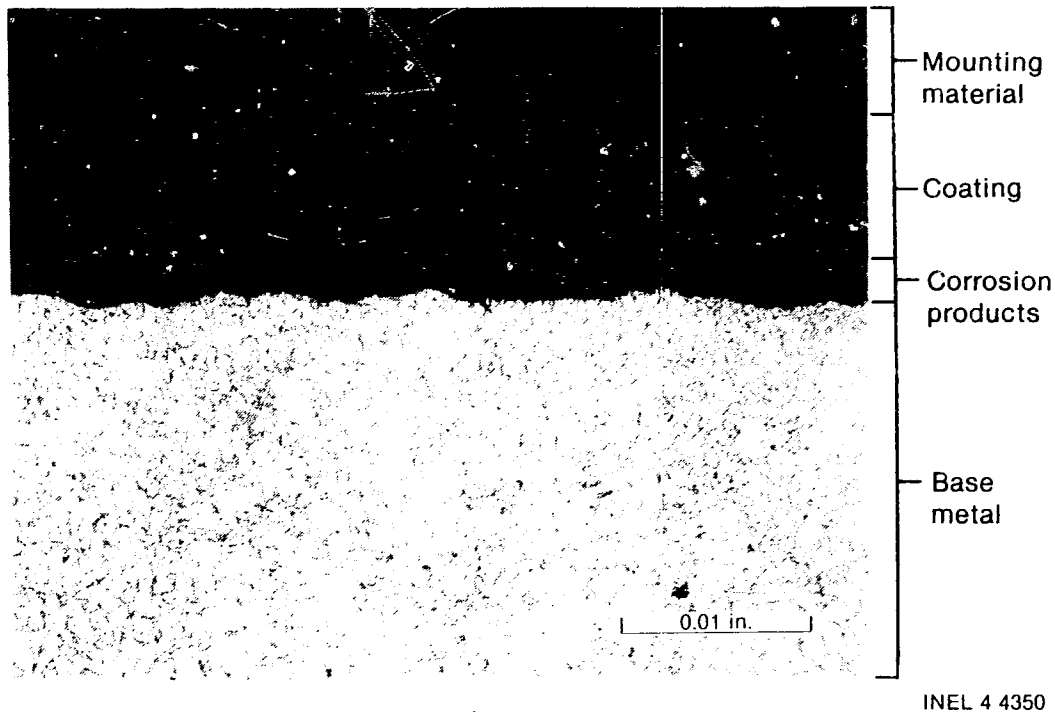
Section 5, Specimen 1--Examination of Specimen 1 revealed some corrosion products (about 0.0015-in. thick) between the coating and base metal and a coating thickness of about 0.010 in. (Figure 44). Further examination using polarized light (Figure 45) revealed coating (light colored material) between the corrosion products (medium dark lines) and base metal (dark granular area), which indicates that the coating had been applied over the corrosion products.

Figure 44. Photomicrograph normal to the internal surface of Section 5 from liner PF-16 showing some corrosion products between the coating and base metal interface.

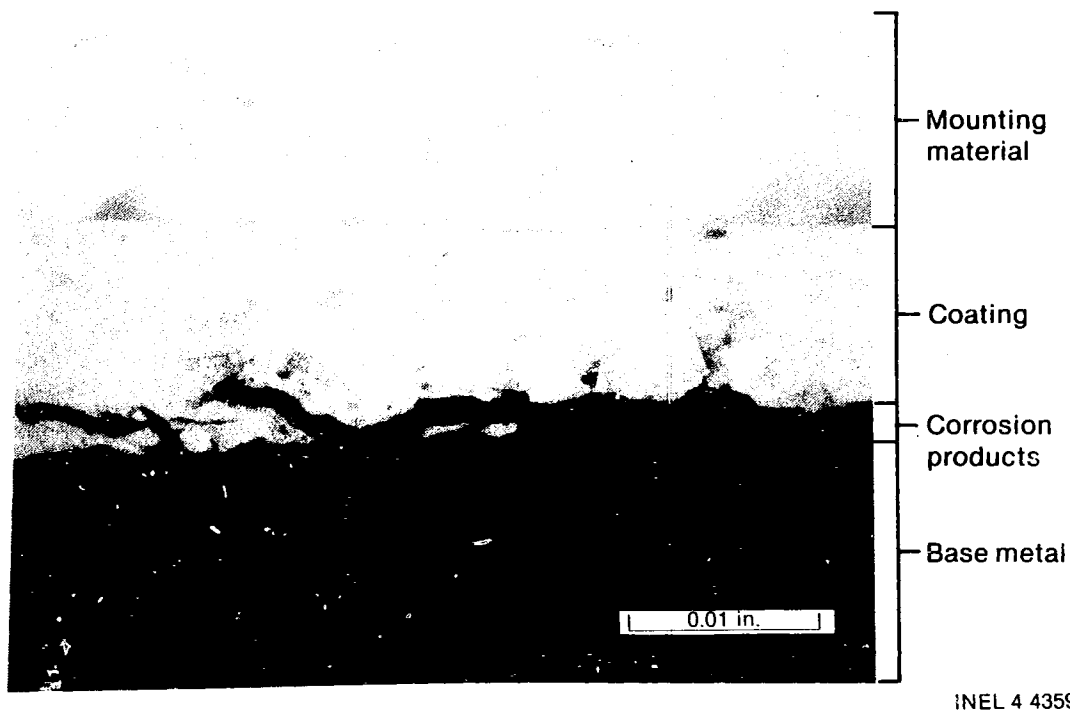
Figure 45. Photomicrograph normal to the internal surface of Section 5 from liner PF-16 showing coating between the base metal and corrosion products (specimen illuminated with polarized light).

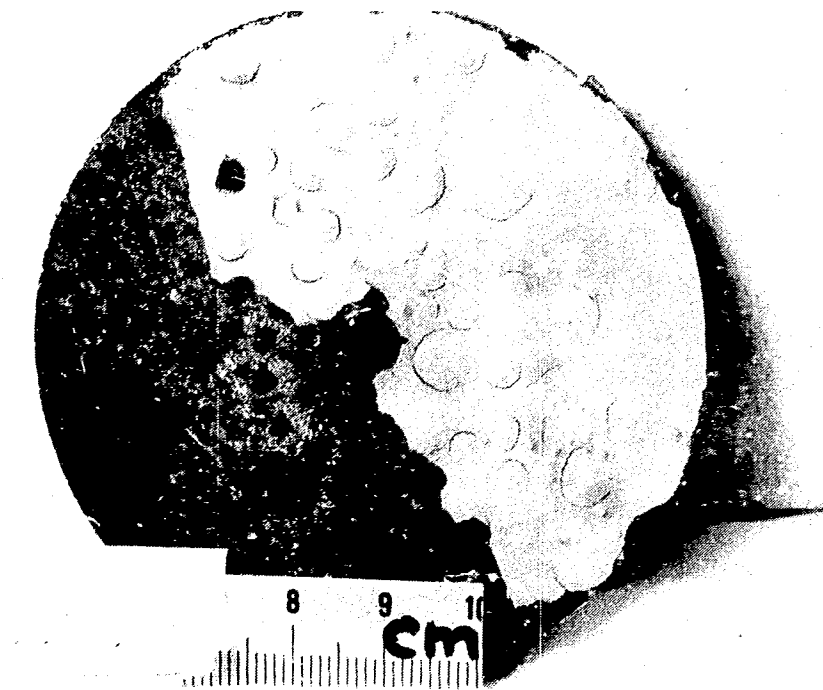
INEL 4 4333

Figure 46. Photograph of the interior surface of Section 6 from liner PF-16 showing blisters and exposed base metal.

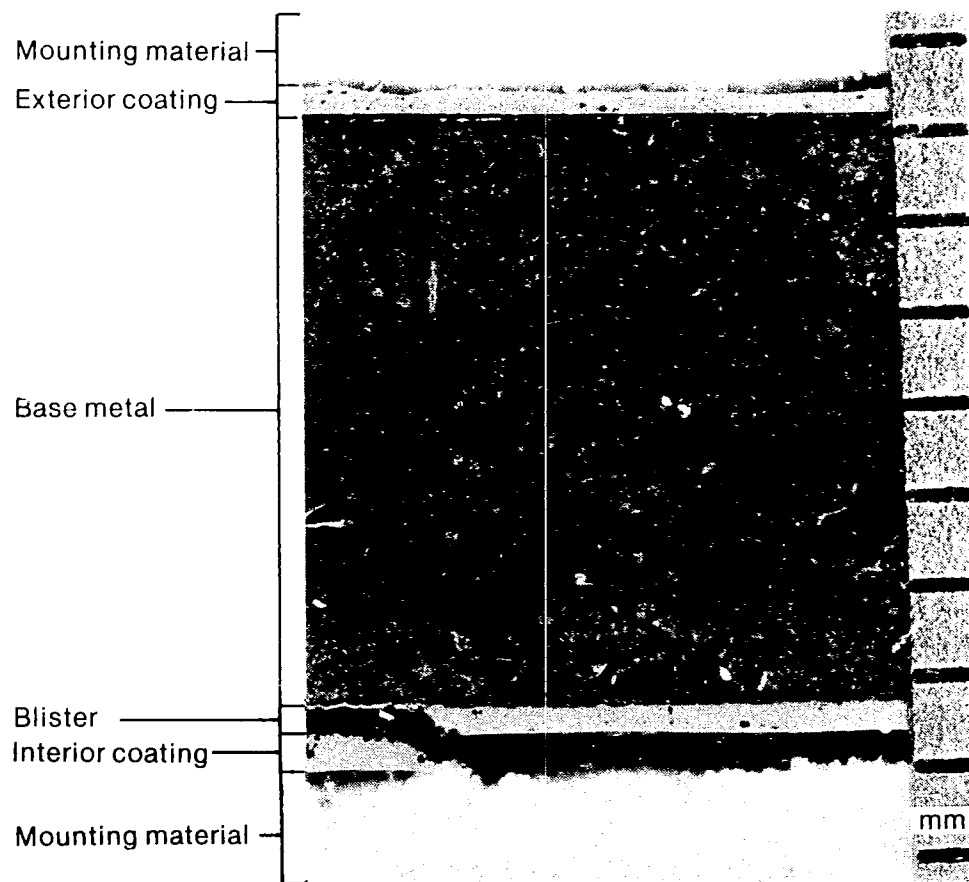
INEL 4 4347

Figure 47. Photomicrograph normal to the wall of Section 6 from liner PF-16 showing coating on the interior surface (bottom) and exterior surface (top). The coating at bottom left is breached at the edge of a blister.

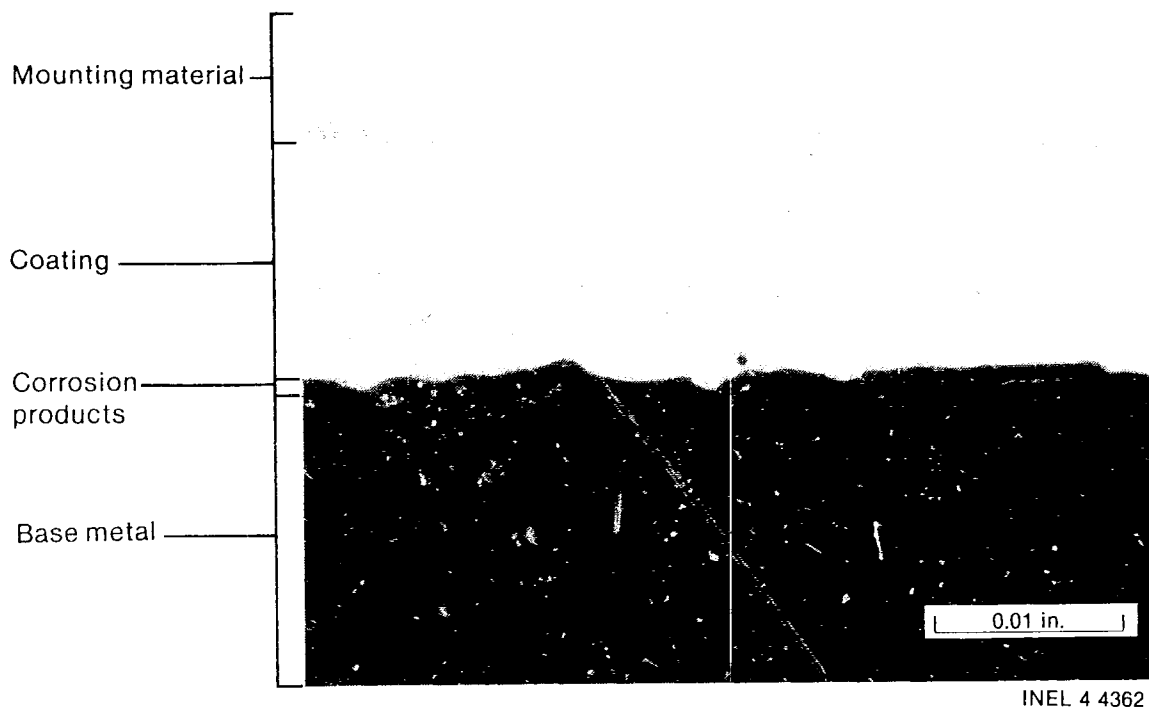
Figure 48. Photomicrograph normal to the internal surface of Section 6 from liner PF-16 showing corrosion products between the coating and base metal (specimen illuminated with polarized light).

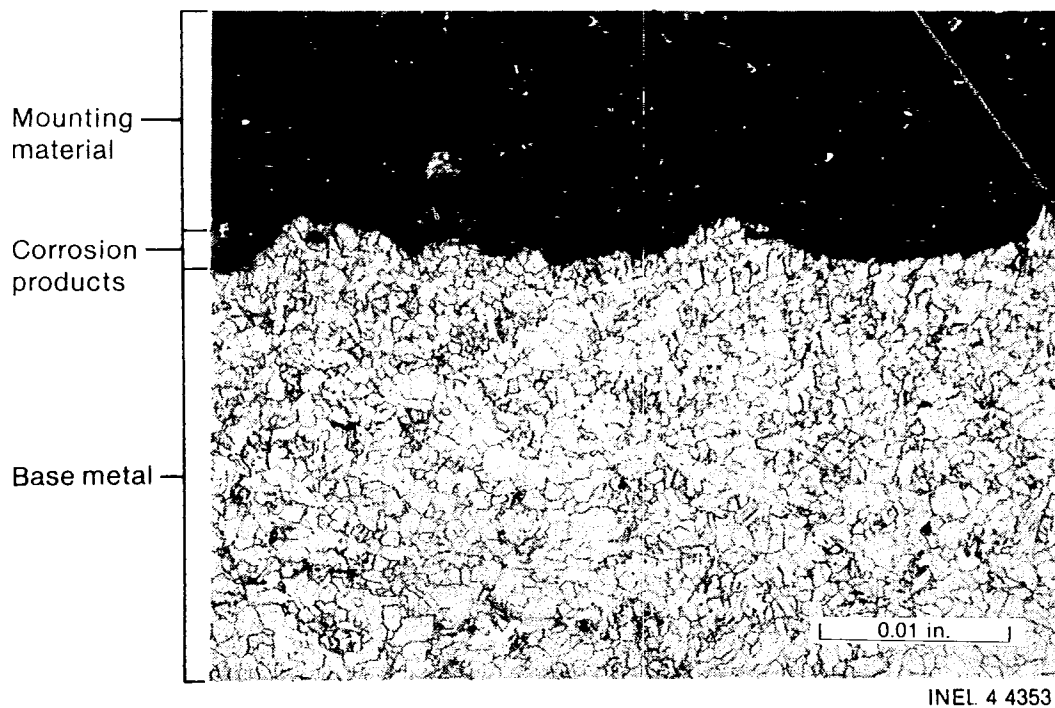
Figure 49. Photomicrograph normal to the internal surface of Section 6 from liner PF-16 showing corrosion products in an area where coating has spalled. Note discontinuity at right edge.

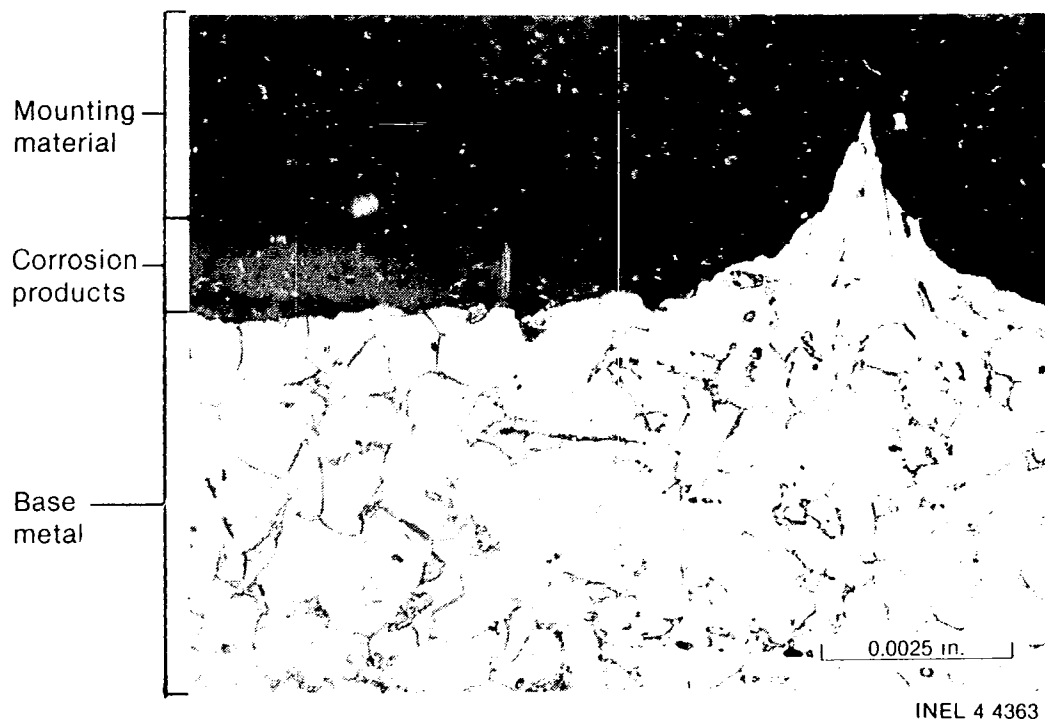
Figure 50. Photomicrograph showing greater detail of the discontinuity identified in Figure 49.
