QUICK LOOK REPORT  
ENTRY 3  
THREE MILE ISLAND UNIT 2  
OCTOBER 16, 1980

Bechtel Northern Corporation/  
General Public Utilities Nuclear Corporation

This report summarizes tasks performed during the third entry at Three Mile Island Unit 2. During the entry into containment, which was made on October 16, 1980, additional beta, gamma, and neutron surveys were performed to supplement data obtained on previous entries. In addition, several maintenance tasks were completed including testing the operation of both equipment hatch doors, replacing a loose parts monitor system pre-amplifier, and removing a source range monitor. The five-man entry team accomplished these tasks in about 1-1/2 hours.

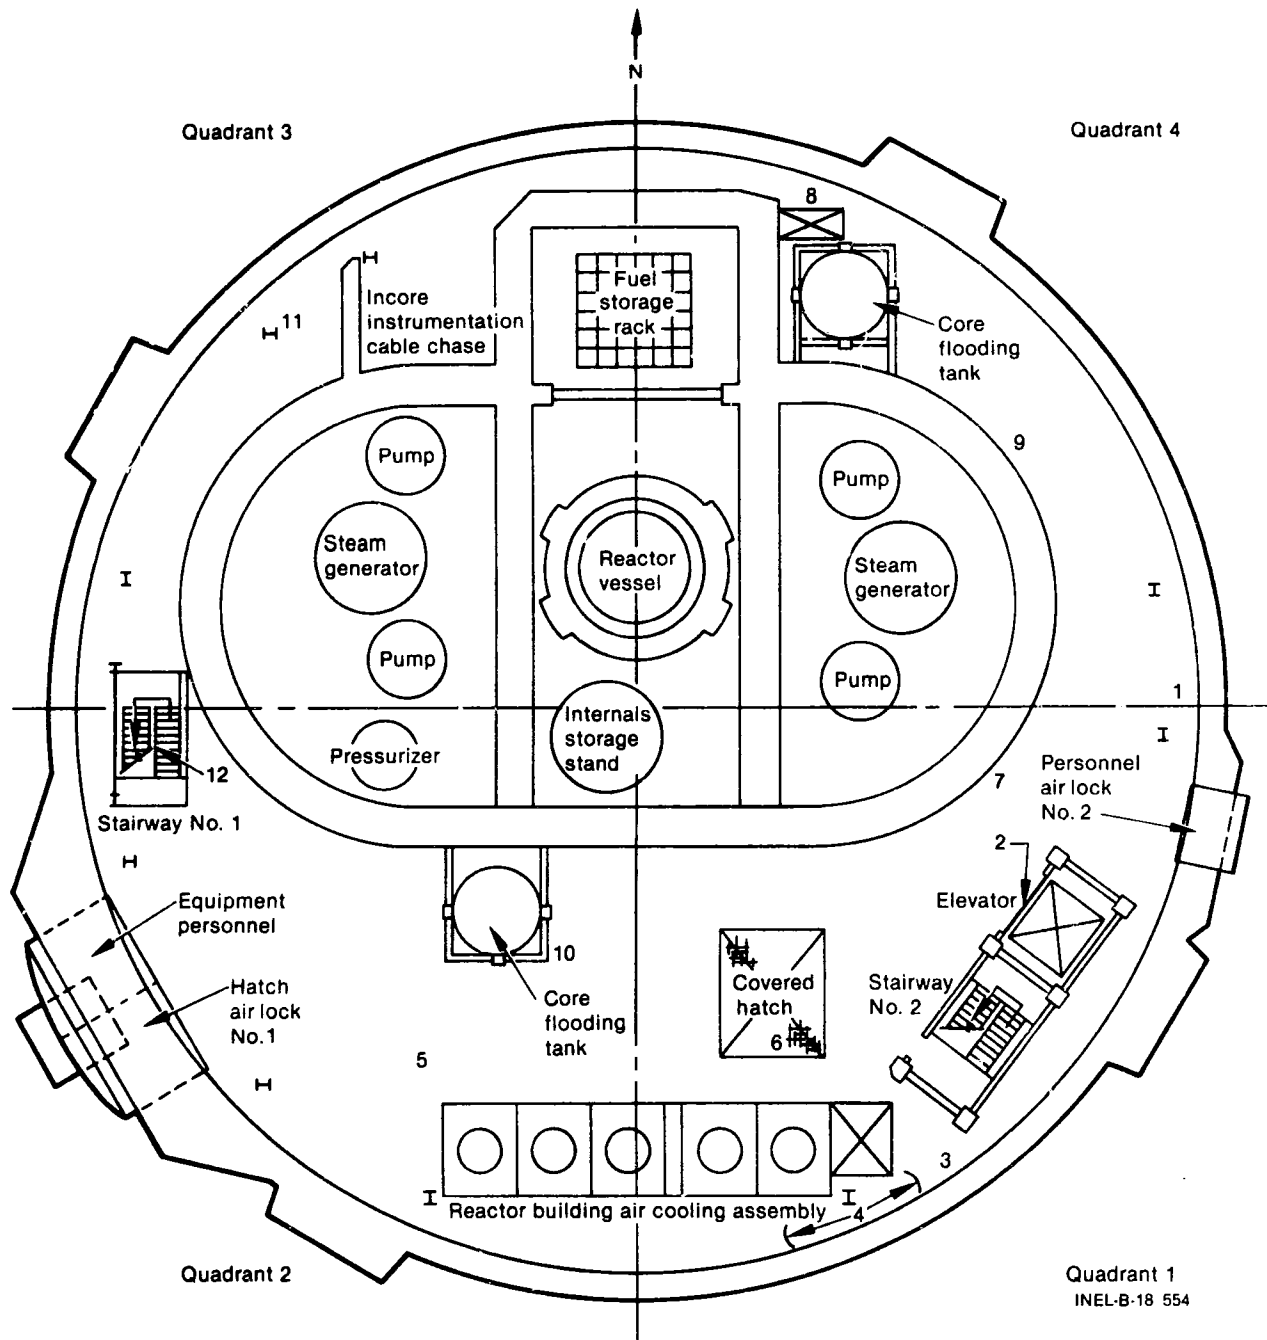
Figure 1. Elevation 305, Entry 3 task locations described by William (Sam) Griffith.

My name is Sam Griffith. Today five of us went inside the Unit 2 Reactor Building. We went down the ramp to the northwest side (1)<sup>a</sup> and removed some cabling from a dolly which was on a cart. We put herculite down on it and set equipment on top. We noticed that the upper portion of the elevator on Elevation 305 was bowed out approximately 6 inches from the lower door (2). Pete Keegan and I conducted a survey behind the elevator shaft and air coolers. At first, it seemed like we weren't going to get back there (3), but we were able to get there by crawling. When we got to the other side (4), we found out we needed to retrace our path to exit because the other passage out was too narrow. We went back by crawling through all the angle iron (4). It was just large enough for us to pass.

There was no detectable beta radiation that I could find on any of the floor drains behind the air coolers. The floor area from about the B to the E fans was covered with mud. It looked like river mud. There was a lot of water there as well. We came back (5) and proceeded to climb the front side of the air coolers. Right between the A and B fan, the gamma reading jumped to 2 rem/hr. I believe it was from the covered hatch (6). At the other end, the readings were much lower, but I don't remember the levels. It is recorded on the survey.

At this point, Larry Eberly looked like he was completing work on the source range box. I came down the ladder (5) and Pete Keegan remained to do his swipe survey. Larry and I went over to the first vibration monitor pre-amp box (7). He began work while I went around to do the pictures of the A Core Flood Tank. I wanted to get rid of the camera as soon as possible. Continuing to survey, I crawled back behind the CRD cable chase and over in the direction of the transfer chute tubes (8). There were no significant dose rates over there. I did notice that at different points around the steel liner, the gap in the floor varies from 4 to 12 inches wide on both sides. The reading there is 1.5 rem/hr gamma and no beta. The A Core Flood Tank is very dark and contact readings on the core flood piping and make-up lines are the same as the general area readings. That is not the case with the B tank which was much higher at 5 rem/hr. There is a lot of dirt and scale underneath the A tank.

Larry came over and opened up the second vibration monitor pre-amp box. I took a swipe on the inside of the box. Larry went back to the personnel hatch. In the meantime, Pete had come over and scaled to the top of the A Core Flood Tank. When he came back down, we went around to meet Richard (Rick) Croll (10). Pete tried to climb to the top of the B tank and I went towards the incore instrumentation cable chase. The dose rates in this area from what I have seen so far are the lowest on Elevation 305 (11).

It measured somewhere around 100 mrem/hr back here at the chase itself. Direct shine from the water is anywhere from 8 to 10 rem/hr 5 feet from the open stairwell as it shoots past the landings (12).

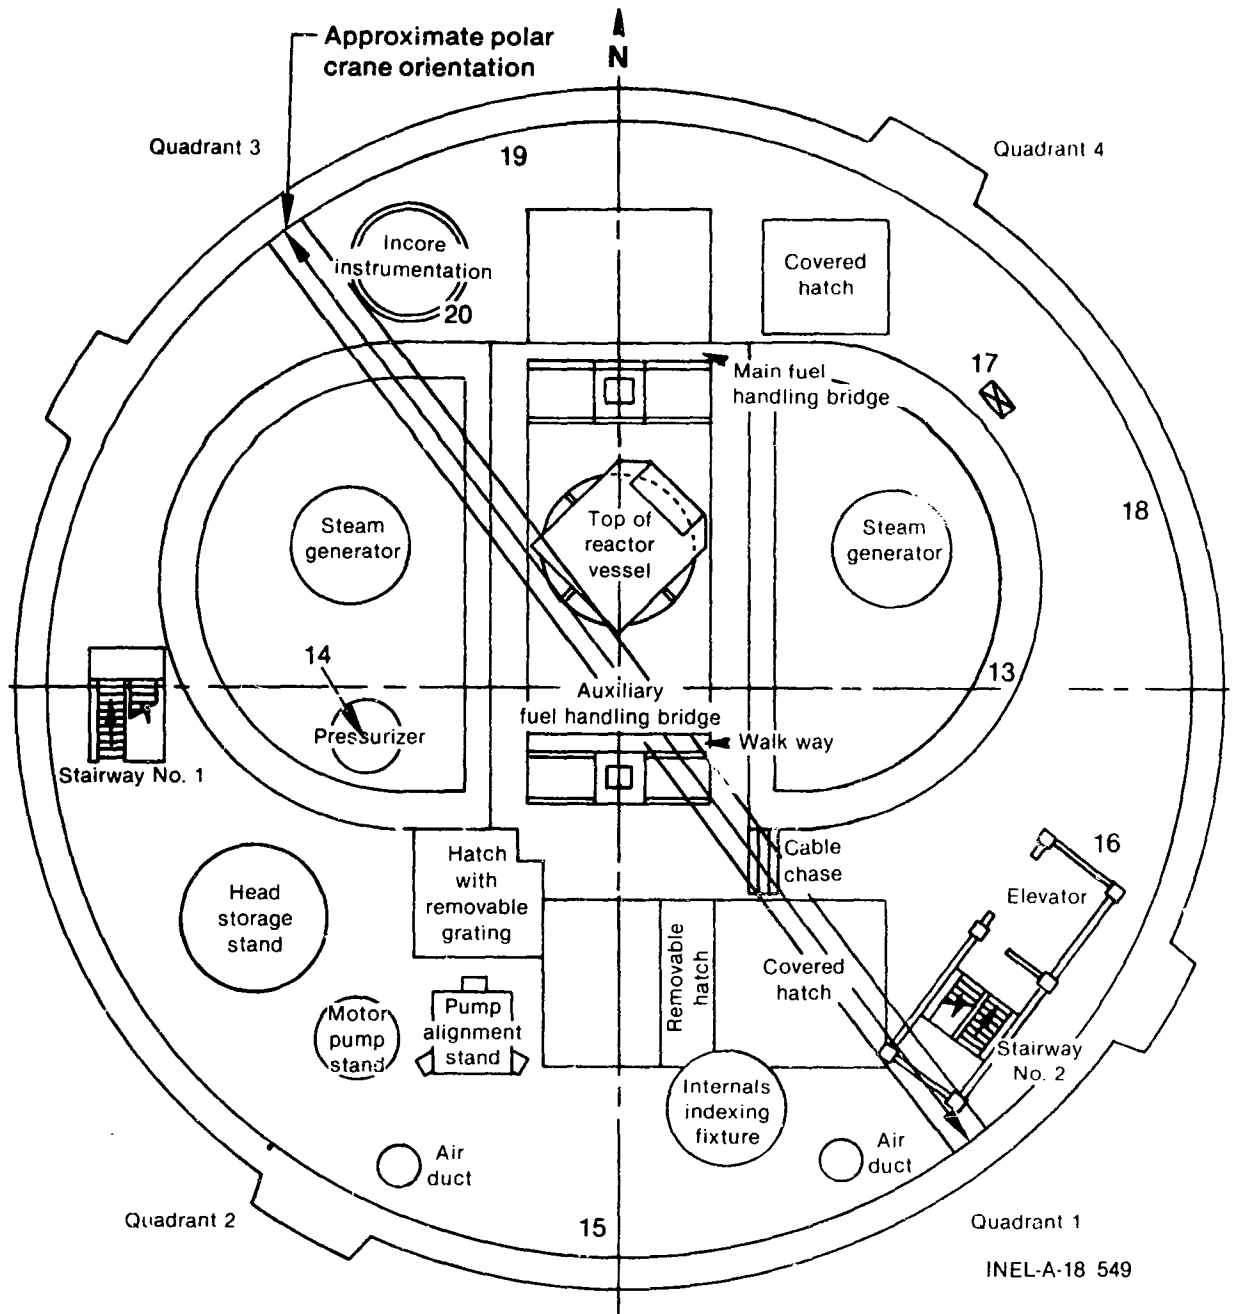
Figure 2. Elevation 347, Entry 3 task locations described by William (Sam) Griffith.

The polar crane is easily visible, but its hard to identify where the wires in question come from. The trolley crane cables seem to be intact. The crane is sitting somewhat like this. We took two panoramic pictures. The first is a shot looking at the B D-ring (13),<sup>a</sup> and the second is looking towards the pressurizer (14).

We went back downstairs to Elevation 347. Coming over to the top of the B Core Flock Tank, we noticed that the grating was not tied down and it should be movable by about three men. It's a pretty thick grating. You can see piping and valves underneath the grating, but I didn't take a photograph due to the poor lighting. I did get a picture of the D-ring wall just opposite the pressurizer where it looks like the burn mark was coming through the penetration. It is not tygon tubing or rope, but a wire, probably the three conductor type. We proceeded back and picked up the RO-7, left inside last entry, off the pump stand. I then took three pictures each of the telephone (15) and crushed drum (16). We came over to the A and got one picture looking towards the main fuel handling bridge. After coming back, I got a picture of what was believed to be the sand blasting equipment. It looks to me like a small demin water tank or something else mounted to the wall. There were some gauges associated with it. It is located in this area (17) where the tool boxes usually sit.

The plastic wrapped around the long reach tools was melted away (18). We picked up two steel brackets that hold on the polar crane cables, and two rubber insulators that go over those brackets. Also I brought out a piece of rubber insulation off the polar crane cable and an aluminum piece from the cable. I am not certain what the second object is. I took a picture of the 626 penetration (19) which was surrounded by debris from the

drilling. Rick Croll found a very high beta over the top of the incores (20) closest to the cavity. It looked like there were a couple sets of PC's laying on the floor. There was definitely a white chemical buildup on the floor around the incores on this side (20). We came back down to Elevation 305, moved the cart over to the ramp, removed all the equipment, set it in the airlock, and departed. It was comfortable in there. The lighting was good, and I did not become exhausted.

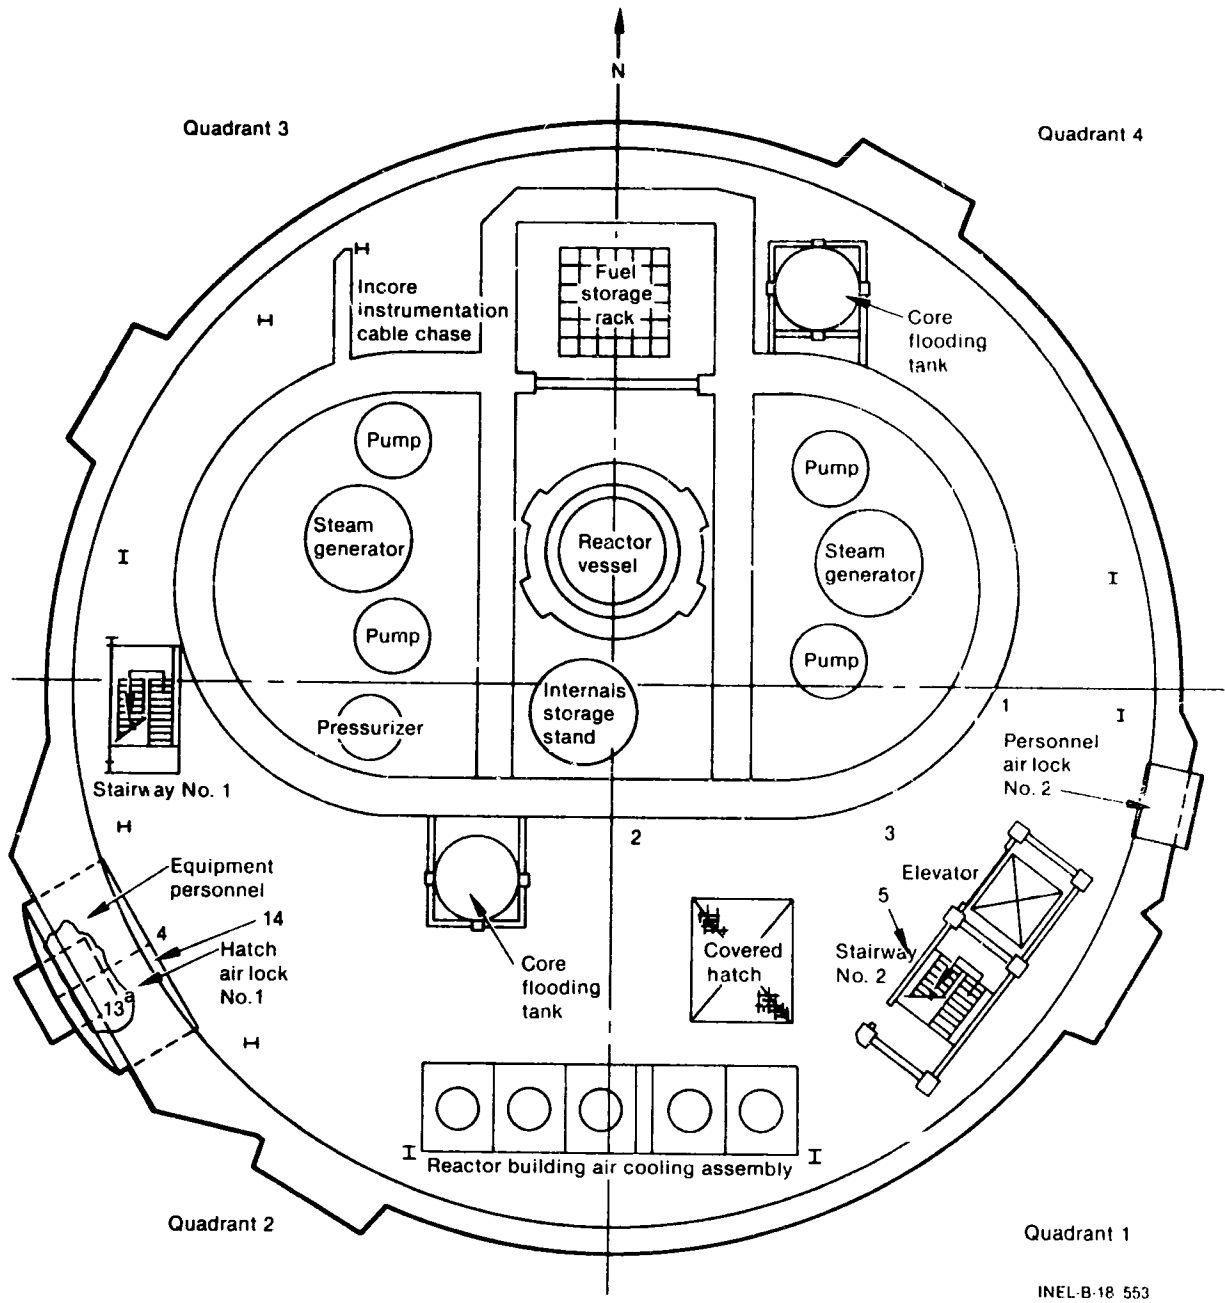
Figure 3. Elevation 305, Entry 3 task locations described by Richard Croll.

I am Rick Croll. Today I entered the Unit 2 Reactor Building as one of the party of five. Initially Larry Eberly and I walked over to the vibration detector to verify it (1)<sup>a</sup> was in sight of the air handling equipment. Then we both walked over to the source range monitor (2), swiped the outside, did a radiation survey around it, and Larry opened it up. I walked part of the way back over to the personnel airlock (3), motioned to Guy Wise to follow me, and we went over to the equipment airlock (4). While he was working on that, I discovered my camera would not work. I spent a lot of time trying to make it work and still don't know what is wrong with it. By then Guy had opened the door. I went in to do a survey carrying the oxygen monitor. Initially it alarmed and we both came out. We notified the command center and waited a couple of minutes while it cleared. Then Guy went back in, and I worked on the camera some more, but still didn't get it to work. Having thought that the equipment airlock was fixed, we both came over to the personnel airlock. When we were informed by radio that it wasn't fixed, we both went back over again. Then Guy went in the airlock, shut the inner door, and I surveyed around it and in between the stairs and the air cooling assembly. Then Guy came out of the airlock. The first time he was in, when the door was open, I wiped of the door seal. As he said, it wiped clean. Then when he came out the second time, we both went over to the personnel airlock. Larry was already there.

a. Puddle of water > 50 gallons

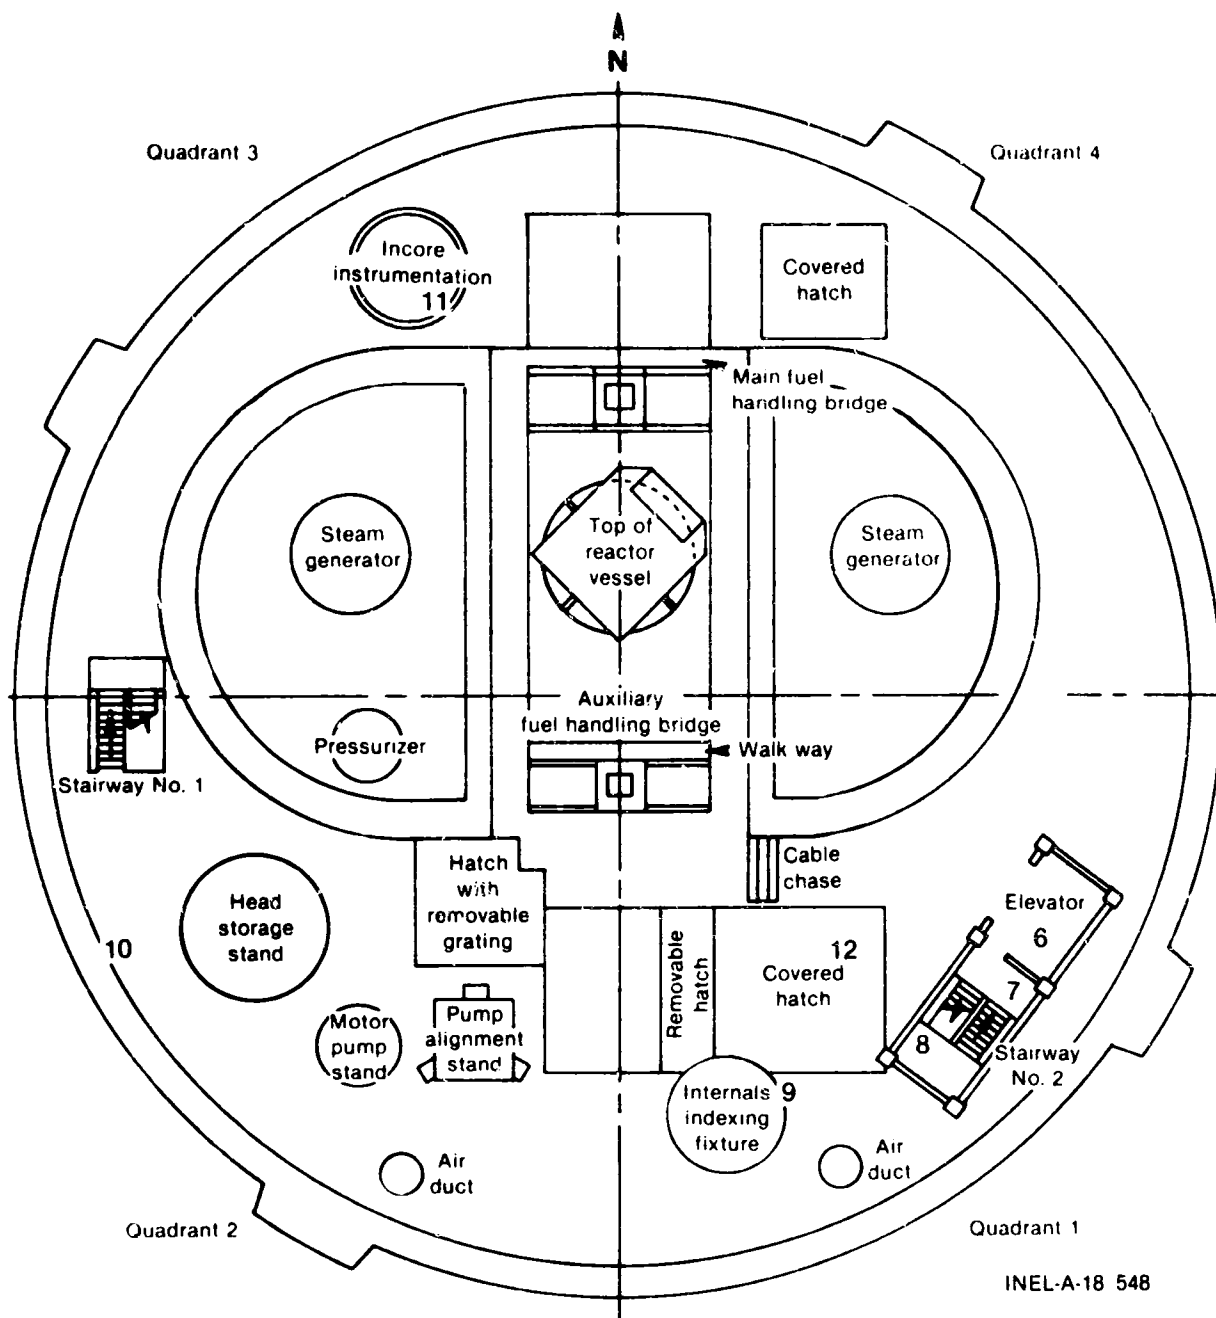
Figure 4. Elevation 347, Entry 3 task locations described by Richard Croll.

I dropped off the camera and oxygen monitor. Sam Griffith and I went up to Elevation 347 taking the PNC-4 detector (5). When we got to the top of the stairwell, we went in the elevator machine room (6).<sup>b</sup> Like Sam had previously said, it looked clean in there. There was a small partially

melted yellow bag in the corner. I couldn't tell what it was. It looked like there was an air duct up along the top where the blackened grating was on the outside.

We then left the room and climbed the ladder (7) over to the roof of the elevator. We looked around, but couldn't tell where this wire came from. It's pretty dark all the way up to the top of the dome. The dose rate over in this general area of HP-R-214 (8) was about 200 mrem/hr. Then we went down to Elevation 347. What we thought were cable laying over here were tandem copper bars (9) from the top of the dome. It looked like there was some kind of insulation that had been burned off. Over here by the jib crane boom support (10) was a piece of cable. There is cable thruway about 15 feet high with a piece of cable running through it and dangling to the floor. The penetration was marked S-20. I couldn't see anyplace where the other end of it may have come from. It was just hanging there. We then walked around the rest of the Elevation 347. The only high reading I got was in the southeast part of the incore instrumentation area (11). It was 2 rem/hr gamma and greater than 20 rad/hr beta. I am not sure of the number exactly anymore.

Other than that, there was just some miscellaneous items here and there that we picked up. There were no other survey readings that were out of the ordinary. After we collected the items, we came back over here to the stairwell and took a reading with the PNC-4 (12). It was less than 50 counts per minute. We went downstairs and out the personnel airlock. During the equipment hatch (13).<sup>a</sup> Again, I am not sure of the reading exactly, but I think I remember it was about 100 mrem/hr gamma, 400 mrad/hr beta. Further out away from the pit (14), it was about 200 mrem/hr gamma indicating at least part of that was background. I did not check a beta reading further out.

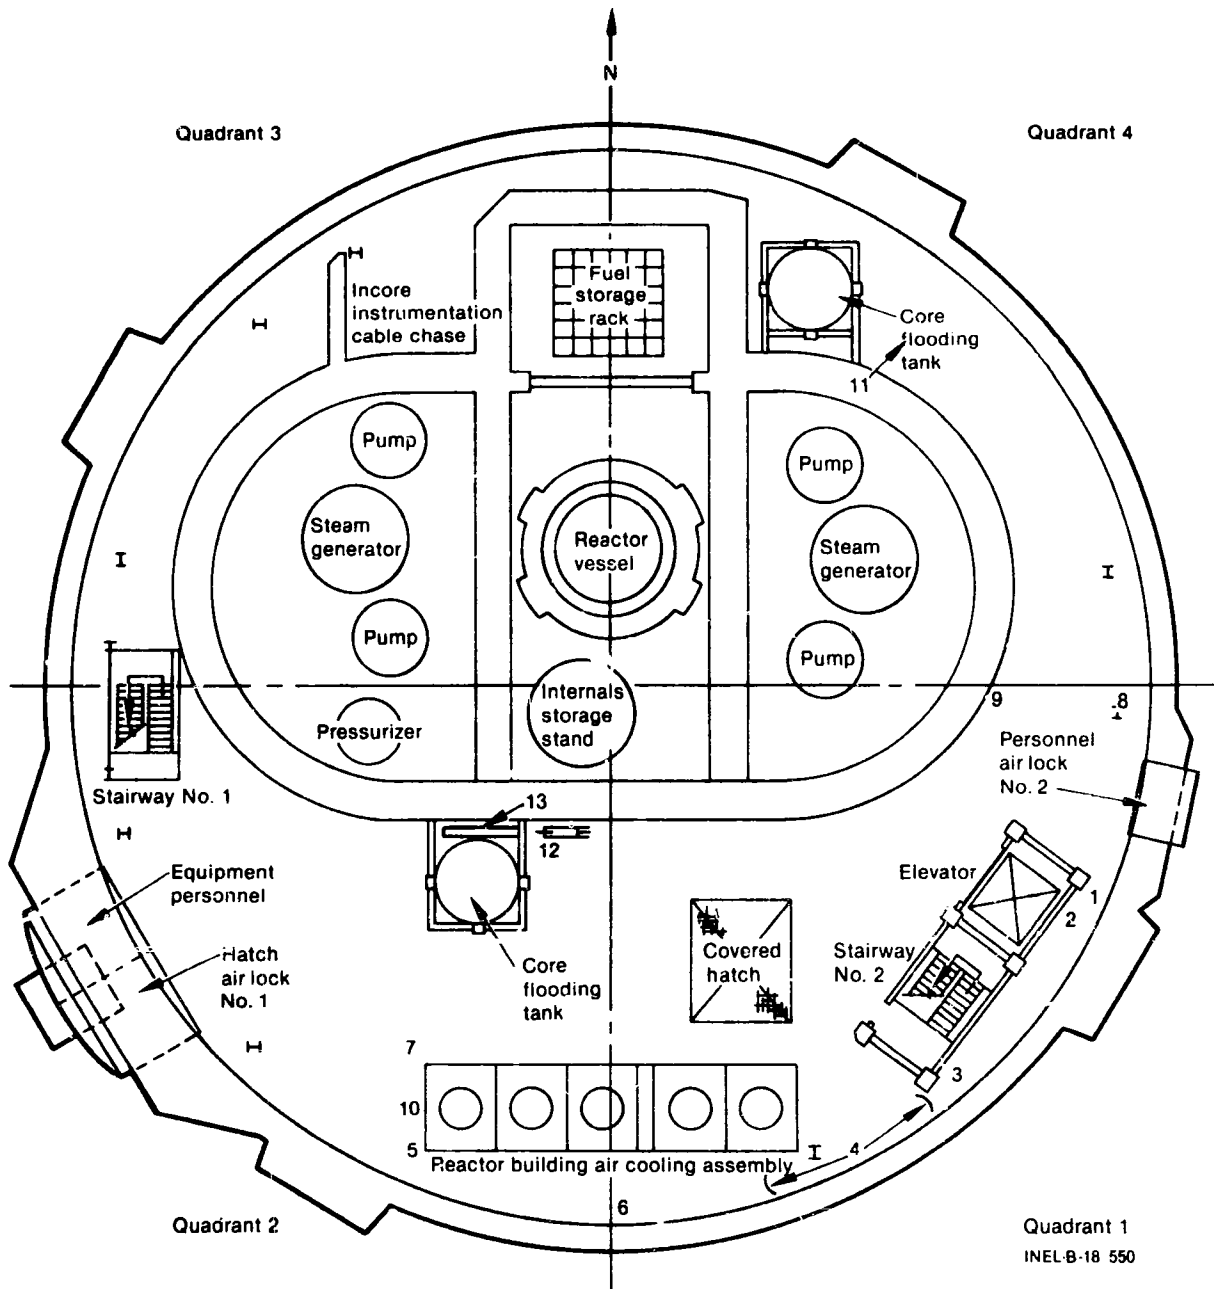
Figure 5. Elevation 305, Entry 3 task locations described by Peter Keegan.

My name is Peter Keegan. I went into the Unit 2 Reactor Building today. Initially upon entry, Sam Griffith layed down the herculite on the dolly and I was supposed to put down the E-530-N, but it was strapped underneath my airhose so it couldn't be removed. I was going to lay down the spotlight, but it was also strapped underneath my airhose so I couldn't put that down. I took the teletector from Sam Griffith and went behind the elevator shaft to start surveying (1).<sup>a</sup> The general area is about 200 mrem/hr right behind the elevator shaft (2). The first drain back there is reading about 2 rem/hr about six inches off the floor. I went down to the end of the elevator shaft and the stair number 2 (3), and it was just about 200 mrem/hr all the way along back there. It was so congested there (4) that I decided to come back out and go around and see if I could find an easier entrance to get behind the air handling units, before we decided to go back that way. While Sam was still out setting up his equipment, I walked out around in front of the elevators and looked in between the stairwell and the air handling unit A. It looked even tighter than location (4). I walked around to the end of the air handling unit E. There is another piece equipment on the end there not in this diagram (5). That piece of equipment comes within 6 inches of the wall, and it was impossible to get in back that way. So that time I tried to radio in that it didn't look like we were going to be able to get through back there, but my radio wasn't functioning very well. I tried to get that word to Sam Griffith, and about that time we decided to go back behind the stairs again and try to get through to the maze of angle irons. Then we did go around the round ducting (4) as Sam Griffith said and went back behind the air handling units, and took measurements along there (6). The space along the wall almost from the air handling unit A through air handling unit D is reading just about general area (about 200 mrem/hr). At the end of air handling unit E, the crack reading goes up to about 2 rem/hr. I assume there is

something underneath that is blocking the shine that is coming up from air handling unit A through D, then you have an open shot down to the water down and around E. The general area down there also goes up about 100 mrem/hr. The general area down towards E is 300 to 500 mrem/hr, and it is 200 to 300 mrem/hr the rest of the way around. We couldn't get out that way so we came back out around the elevators and did our lower survey along the front of the air handling units. Sam Griffith went up onto the top and commenced his survey (7), and I went back and got the two smears from the dolly (8). About that time Larry Eberly was ready for Sam, so Sam left and went over to help Larry (9). I went up onto the catwalk with the teletector and the general area readings up there are from 300 mrem/hr at E, up to about 2 rem/hr down around A, and up. I extended the teletector as high as it would reach, but I could just get the teletector up over the top of the air handling units. It is 1200 mrem/hr constant all the way down all five units. Around the end of E, this unit (10) just goes up to that catwalk level, allowing you to step over there physically. There is no walkway or anything built, but it would be physically possible to get over there where the general area is about 1100 mrem/hr.

Next I climbed over the handrails and took the two smears on air handling units B and D. Then I came down with Sam Griffith and we went around to Core Flood Tank A, and climbed up to the short ladder. I performed radiation surveys with the E-530-N. Contact readings on the Core Flood Tank down 3 to 5 feet from the bottom of the tank were 5 to 10 mrem/hr contact facing the tank and 50 to 70 mrem/hr contact with the probe turned. Then I proceeded up the ladder, crossed over on to the long ladder that went up to the next landing, taking contact readings there. The contact readings were 15 to 17 mrem/hr facing the tank and 50 mrem/hr turned around. I went all the way up to the top of the tank, and the general area measured almost constant using the E-530-N at 50 mrem/hr. Most general area contact readings on everything were 50 mrem/hr.

I think the valve numbers WDG-168 and -169, a double isolation valve, had tygon tubing coming out. It looked like it had had a yellow poly sleeving over it. This had come out from the near the top of the Core Flood Tank A, run across the grating and down the long ladder. This was

melted and there was just blobs of it on each of the ladder steps. It had just partially melted off of the valves and it was laying there melted across the grating. I came on down the Core Flood Tank (11), went back around with Sam Griffith to Core Flood Tank B and climbed up the two ladders of Core Flood Tank B (12). The readings at the first ladder landing were around 300 mrem/hr general area on the first landing and 150 mrem/hr general area on the second landing. The contact readings facing the tank were 10 to 15 mrem/hr and facing away from the tank were 90 to 100 mrem/hr. At the top of the second landing on the Core Flood Tank 1B, there was tygon tubing coming down the wall of the D-ring (13). It had been taped about every 10 feet. In between the tapings it had been melted off and bent over until it was hanging there. I came down, went back over to the personnel hatch.

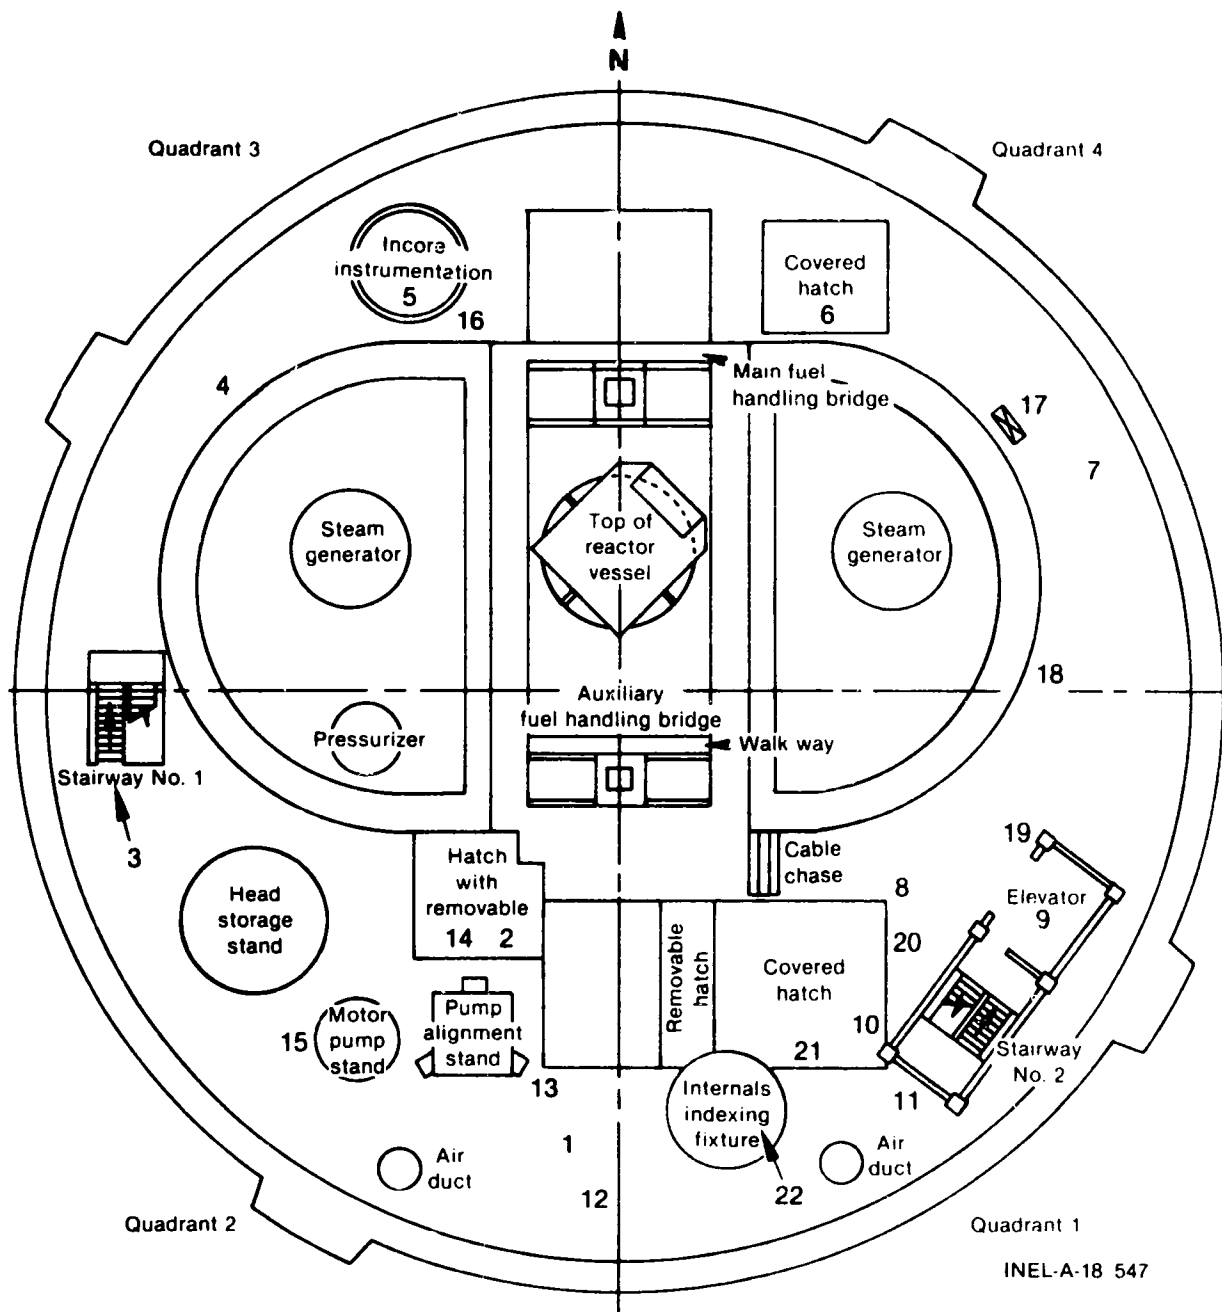
Figure 7. Elevation 347, Entry 3 radiation survey locations (see Table 3).

Data Acquisition Task Number	Location <sup>a</sup>	Instrument	Gamma Dose Rate (mrem/hr)	Beta Dose Rate (mrad/hr)	Neutron Reading (CPM)	Location
22A	(1)	RO-2A	150	--	--	South side
22A	(2)	RO-2A	150	--	--	At hatch with removable grating
22A	(3)	RO-2A	400	--	-	Stair No. 1
22A	(4)	RO-2A	100	--	--	Open area northwest corner
22H	(5)	RO-2A	2000	--	--	Incore instrument service area
22A	(6)	RO-2A	100	--	--	Covered hatch northeast corner
22A	(7)	RO-2A	100	--	--	Open area northeast corner
22A	(8)	RO-2A	125	--	--	Between elevator and CRD cable chase
22A	(9)	RO-2A	280	--	--	Top of elevator No. 2
22A	(10)	RO-2A	100	--	--	Covered hatch southeast corner
22H	(11)	RO-2A	200	--	--	5 feet from HP-R-214
22A	(12)	RO-2A	125	--	--	Open area, south side

Data Acquisition Task Number	Location <sup>a</sup>	Instrument	Gamma Dose Rate (mrem/hr)	Beta Dose Rate (mrad/hr)	Neutron Reading (CPM)	Location
22A	(13)	RO-2A	300	--	--	Southeast of pump alignment side
22A	(14)	RO-2A	300	--	--	Hatch with removable grating
22A	(15)	RO-2A	400	--	--	Open area southwest corner
22H	(16)	RO-2A	2000	23	--	Incore instrument hot spot
22A	(17)	RO-2A	200	--	--	Open area northeast corner
22A	(18)	RO-2A	120	--	--	Near D-ring west on center line
22A	(19)	RO-2A	150	--	--	Elevator--contact reading
22A	(20)	PNC-4	--	--	<50	East of closed stairwell
22A	(21)	RO-2A	400	--	--	West of closed stairwell
22A	(22)	RO-2A	250	--	--	Open area south side

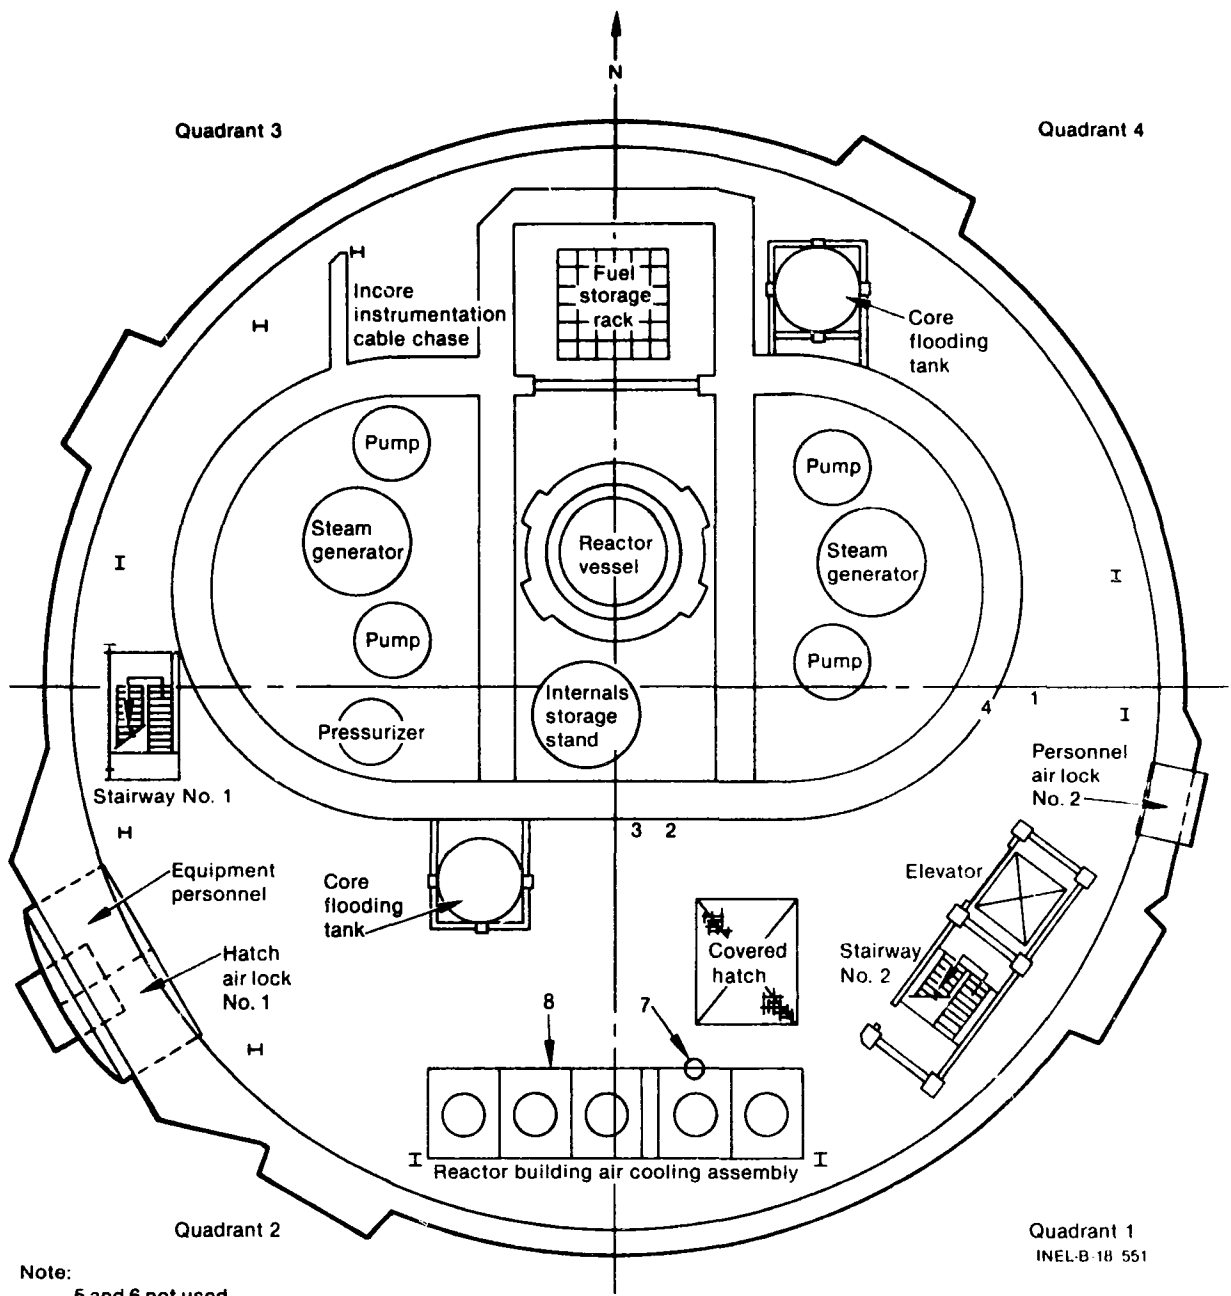
Figure 8. Elevation 305, Entry 3 surface contamination locations (see Table 4).

Data Acquisition Task Number	Specimen <sup>a</sup>	Sample Number	Location	Gross <sup>a b</sup> ( $\mu\text{Ci}$ )	Gross $\theta/\gamma$ ( $\mu\text{Ci}$ )	$\text{Sr}^{90}/\text{Y}^{90}$ ( $\mu\text{Ci}$ )	$\text{Cs}^{134}$ ( $\mu\text{Ci}$ )	$\text{Cs}^{137\text{C}}$ ( $\mu\text{Ci}$ )	$\text{Cs}^{137}/\text{Sr}^{90}$ Ratio <sup>c</sup>
7D	(1)	51068	Vibration detector	<7.4 <sup>-7</sup>	1.5 <sup>-2</sup>	1.8 <sup>-3</sup>	/1.9 <sup>-3</sup>	/1.5 <sup>-2</sup>	8.33
7D	(2)	51069	SR monitor	<7.4 <sup>-7</sup>	2.9 <sup>-2</sup>	5.2 <sup>-3</sup>	/3.8 <sup>-3</sup>	/2.8 <sup>-2</sup>	5.3
7D	(3)	51070	SR monitor	<7.4 <sup>-7</sup>	2.6 <sup>-3</sup>	4.5 <sup>-5</sup>	5.4 <sup>-4</sup> / 4.2 <sup>-4</sup>	3.2 <sup>-3</sup> / 3.5 <sup>-3</sup>	77.7
7D	(4)	51071	Vibration detector	--	--	7.0 <sup>-2</sup>	/2.5 <sup>-2</sup>	/1.8 <sup>-1</sup>	2.57

(5)	Not used		--	--	--	--	--	--
	(6)	Not used		--	--	--	--	--	--
7G	(7)	51072	Air cooler B	--	--	2.7 <sup>-1</sup>	/1.7 <sup>-1</sup>	/1.2	4.44
7G	(8)	51073	Air cooler D	--	--	5.9 <sup>-2</sup>	/2.8 <sup>-2</sup>	/2.1 <sup>-1</sup>	3.56
7C	(9)	51074	Core flood piping	--	--	5.8 <sup>-2</sup>	/9.3 <sup>-2</sup>	/6.9 <sup>-2</sup>	1.19
7C	(10)	51075	Core flood piping	<7.4 <sup>-7</sup>	2.0 <sup>-2</sup>	5.6 <sup>-4</sup>	3.7 <sup>-3</sup> / 3.4 <sup>-3</sup>	2.5 <sup>-2</sup> / 2.6 <sup>-2</sup>	46.4
7C	(11)	51076	Valve in CFT line	--	--	1.2 <sup>-1</sup>	/1.7 <sup>-1</sup>	/1.2	10.0
7C	(12)	51077	RC make-up line	<7.4 <sup>-7</sup>	5.9 <sup>-2</sup>	3.7 <sup>-3</sup>	9.7 <sup>-3</sup> / 1.1 <sup>-1</sup>	7.0 <sup>-2</sup> / 8.0 <sup>-1</sup>	21.35
7C	(13)	51078	RC make-up line	--	--	3.3 <sup>-2</sup>	/1.1 <sup>-1</sup>	/8.2 <sup>-1</sup>	7.45
7B	(14)	51079	Floor under CFT A	--	--	1.8 <sup>-1</sup>	/2.3 <sup>-1</sup>	/1.7	9.44

7B	(15)	51080	Stained area under CFT A	--	--	5.5 <sup>-2</sup>	1/6 <sup>-1</sup> / 1.1 <sup>-1</sup>	1.1/ 8.0 <sup>-1</sup>	14.55
7B	(16)	51081	Stained area under CFT A	--	--	1.0 <sup>-1</sup>	1.5 <sup>-1</sup> / 1.0 <sup>-1</sup>	9.3 <sup>-1</sup> / 7.5 <sup>-1</sup>	7.5
