Quick Look Report Entry 4 Three Mile Island Unit 2 November 13, 1980

GEND-INF-004 TIO-QLR

QUICK LOOK REPORT ENTRY 4 THREE MILE ISLAND UNIT 2. NOVEMBER 13, 1980

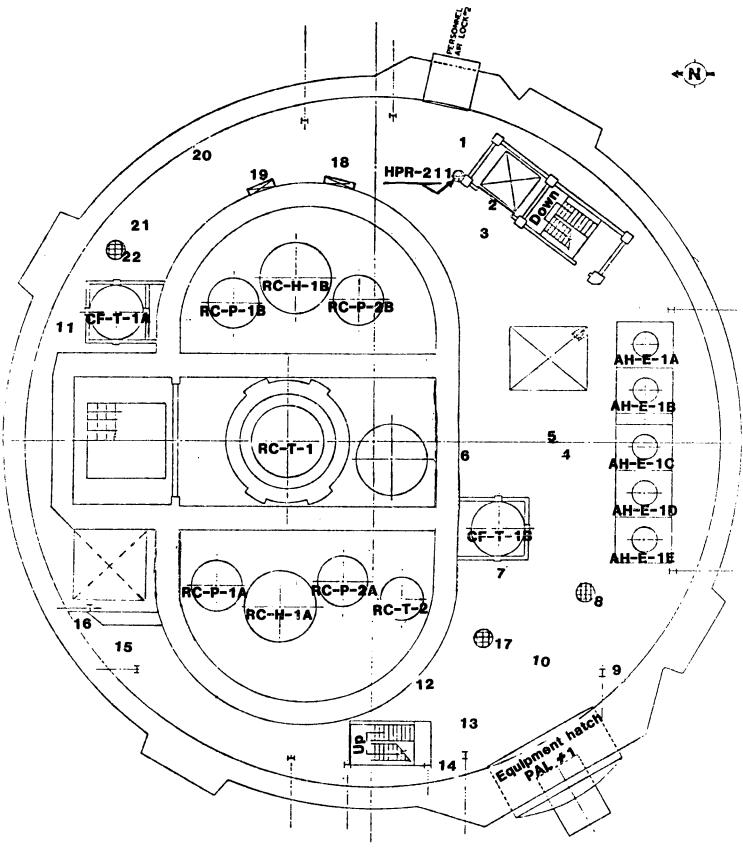
PLAN VIEW, ELEVATION 305

| Data Acquisition Task Number | Location Figure 1 ^a | Instrument | Gamma Dose Rate (mrem/hr) | Beta Dose Rate (rad/hr) | Location |
|---|---|---|---|---|---|
| 4 | 7 | RO-2A | 3800 | | B-core flood tank piping |
| I | 13 | RO-2A | 3000 | 16.5 | Chains on floor near open stairwell |
| 1 | 15 | RO-2A | 300* | | Northwest section of reactor building |

Figure 1. Radiation survey locations on Elevation 305 for Entry 4, November 13, 1980. (Refer to Table 2.)

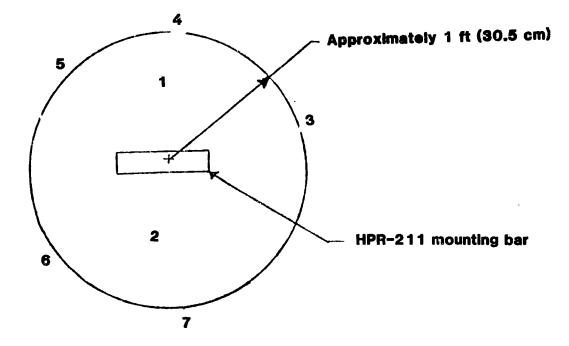
HPR-211 Area Survey

Figure 2. Radiation survey location on Elevation 305 for Entry 4, November 13, 1980. This is the HPR-211 area survey, located on the enclosed stairwell wall, as indicated in Figure 1. (Refer to Table 3.)

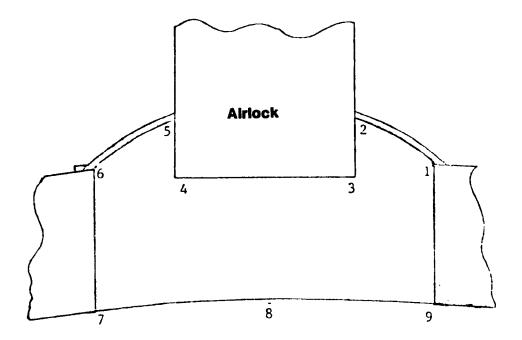
Reactor Building Equipment Hatch

Figure 3. Radiation survey locations on Elevation 305 for Entry 4, November 13, 1980. These survey locations are indicated on the plan view of the reactor building equipment hatch. (Refer to Table 4.)

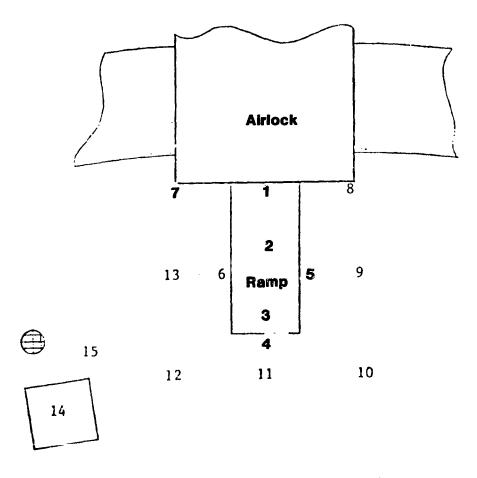
Reactor Building Personnel Airlock #2

Figure 4. Radiation survey locations on Elevation 305 for Entry 4, November 13,1980. These survey points are indicated on the plan view of the reactor building Personnel Airlock (PAL) #2. (Refer to Table 5.)

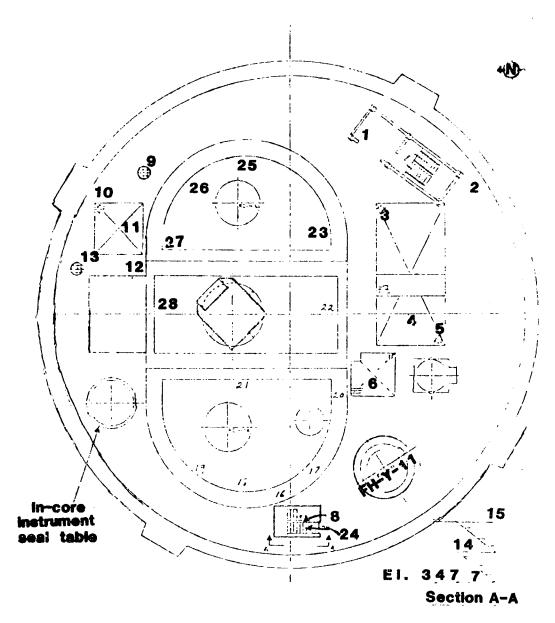
PLAN EL 347'-6"

Figure 5. Radiation survey location on Elevation 305 (data points 16-28 are at Elevation 367) for Entry 4, November 13, 1980. (Refer to Table 6.)

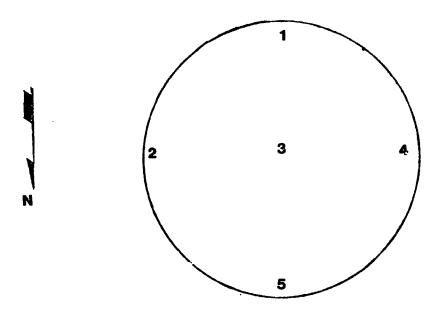
Incore Instrumentation Seal Table

Figure 6. Radiation survey locations at Elevation 347 for Entry 4, November 13,1980. These survey points are on the in-core instrumentation seal tabel. (Refer to Table 7.) Smear samples 1 through 8 were taken in the center of a two foot by two foot area. This area is located on Elevation 305' between the #2 PAL entry ramp and the D-ring as shown below. Sequence of the smears was as follows:

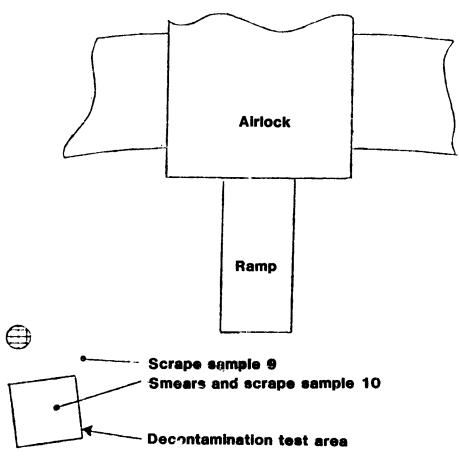
Reactor Building Personnel Airlock #2

Figure 7. Location of decontamination test area on Elevation 305 made during Entry 4, November 13,1980. The airlock in the figure is #2 PAL.

a. See Figure 7 for locations at which samples were taken.
