QUICK LOOK REPORT
ENTRY 5
THREE MILE ISLAND UNIT 2
December 11, 1980

GEND-INF-005
TIO-QLR

This report summarizes the raw data obtained during Entry 5 at Three Mile Island Unit 2. During the entry into containment, which was made on December 11, 1980, beta/gamma surveys were performed on Elevation 305 and 347, and on the reactor head-fuel pool area and the polar crane access ladder and platform.

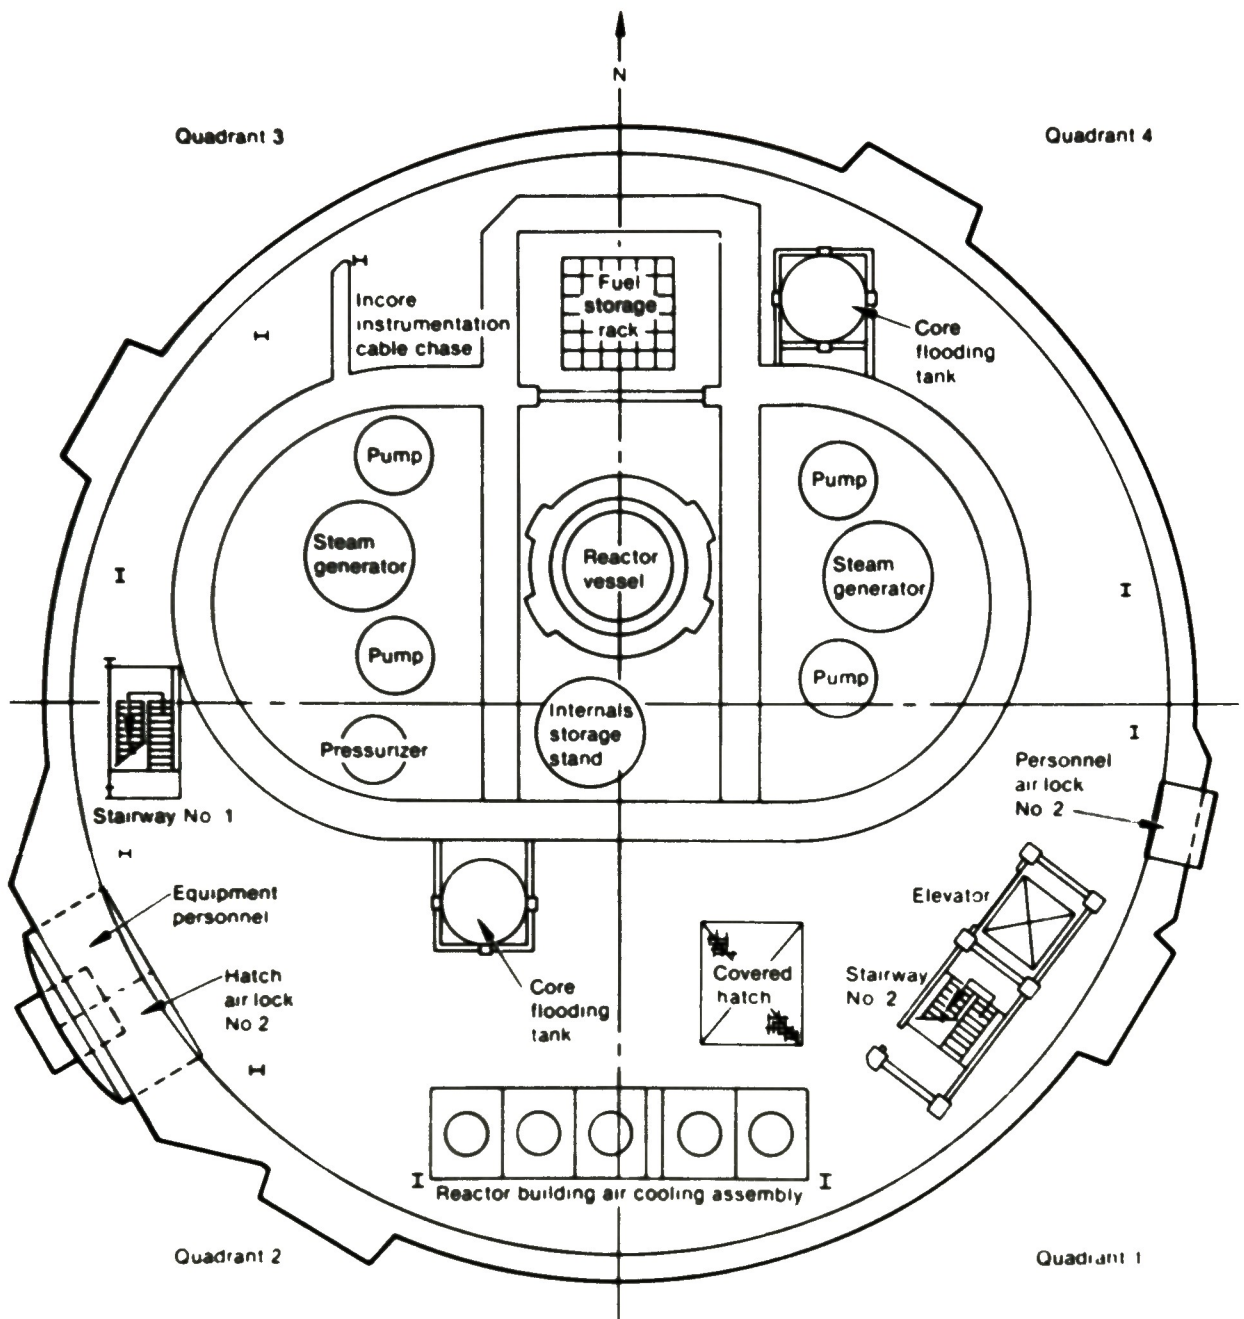
Figure 1. Elevation 305 diagram.

- high readings around floor penetrations and opening to Elevation 282; also around Core Flood Tank B
- readings dropped off considerably away from openings.

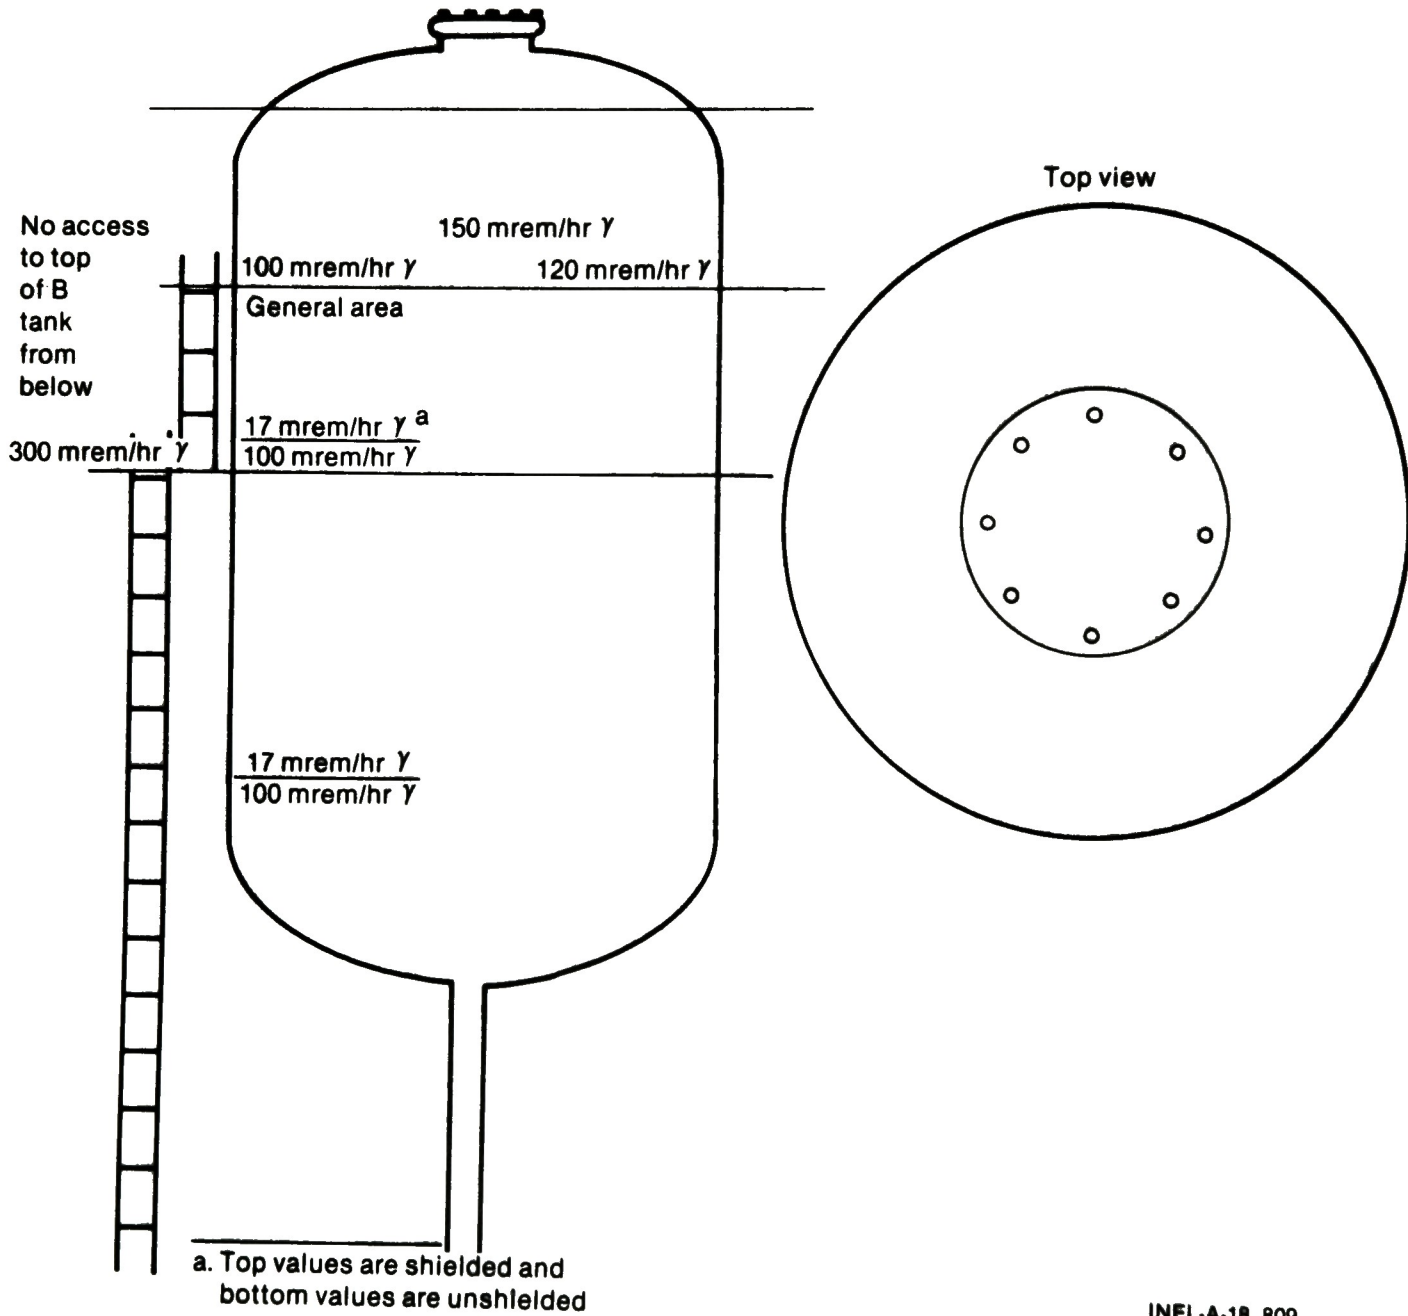
Figure 4. Core Flood Tank B radiation survey looking south.

Piping upstream of check valve under Core Flood Tank B is hot (high radiation).

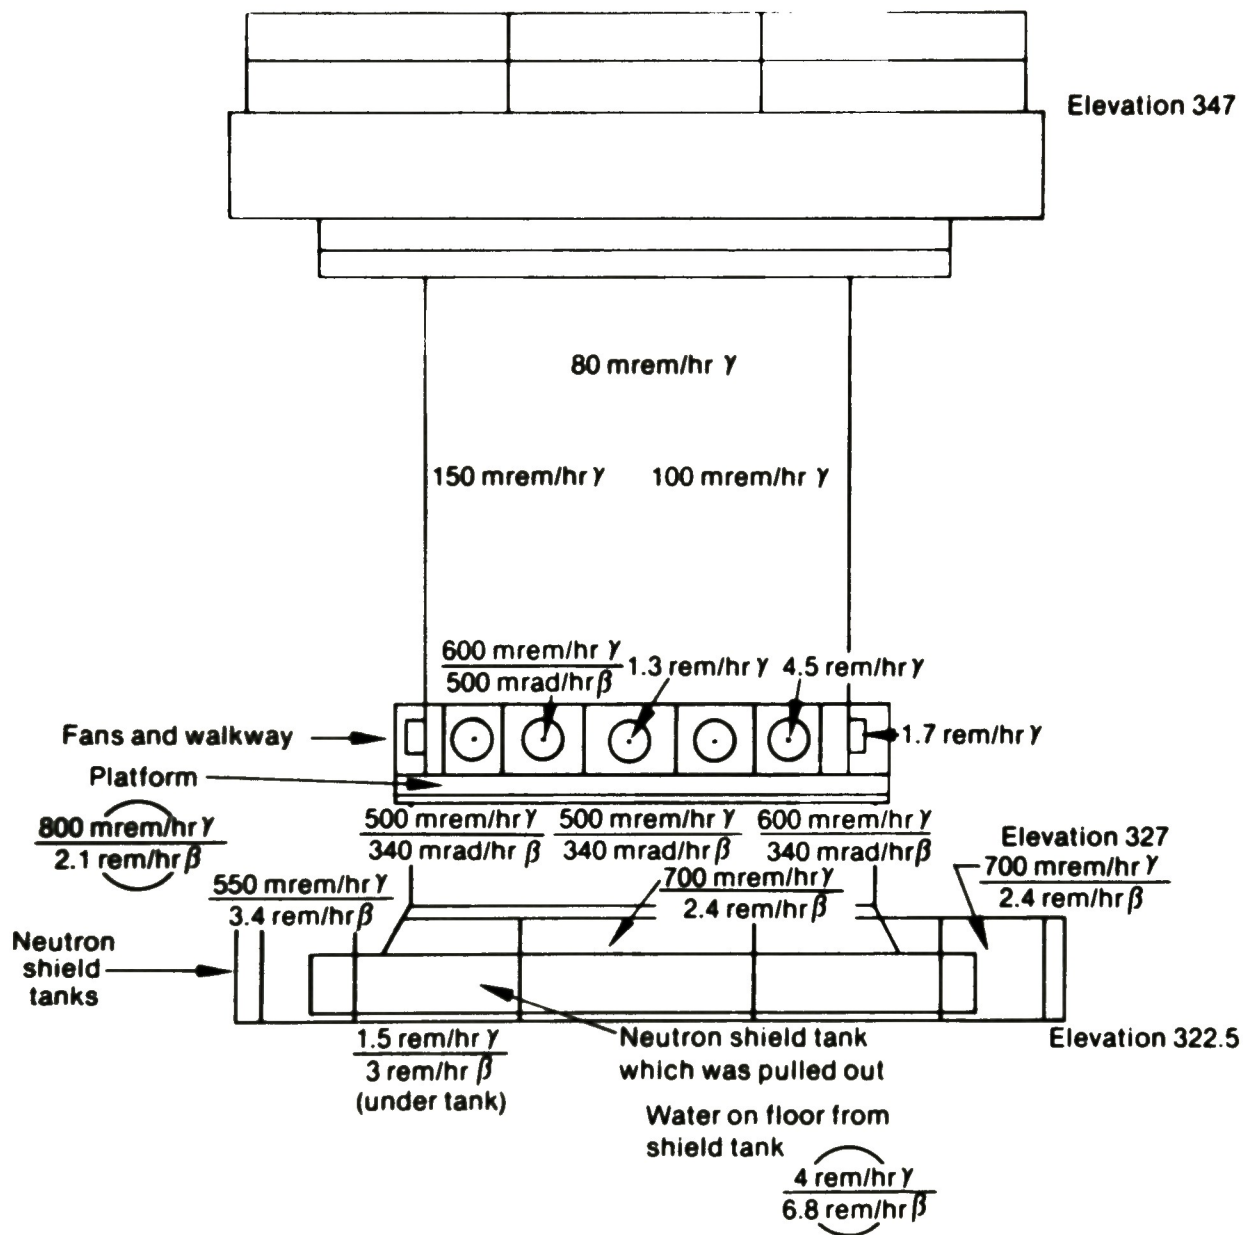
Figure 6. Reactor head radiator survey looking north.

Note: Circled readings are contact readings; others are general area.

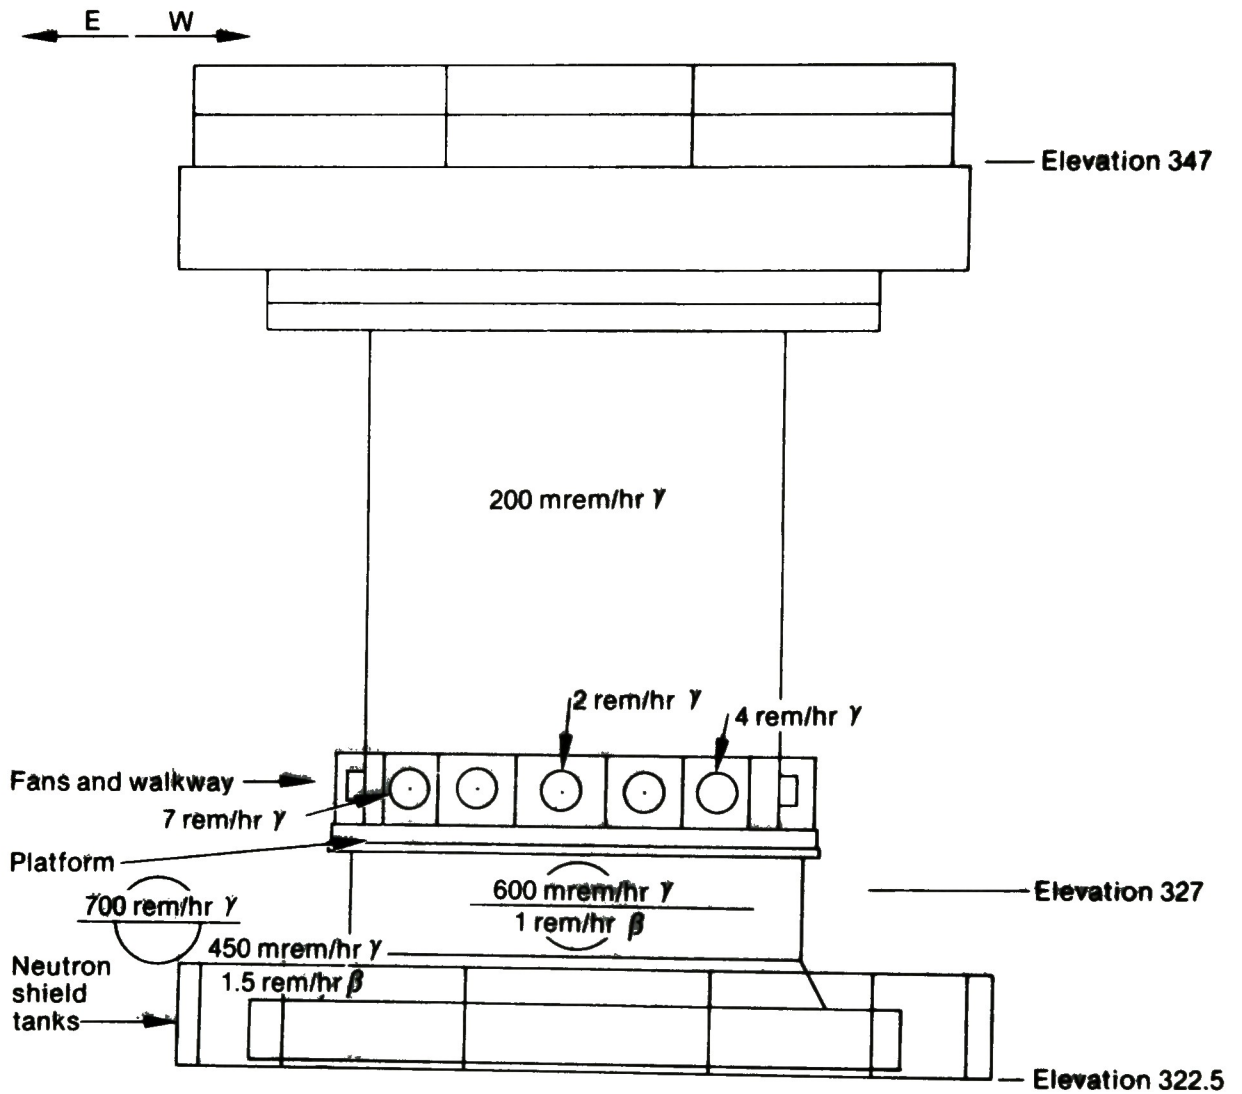
Figure 7. Reactor head radiator survey looking south.

Note: Circled readings are contact readings; others are general area.

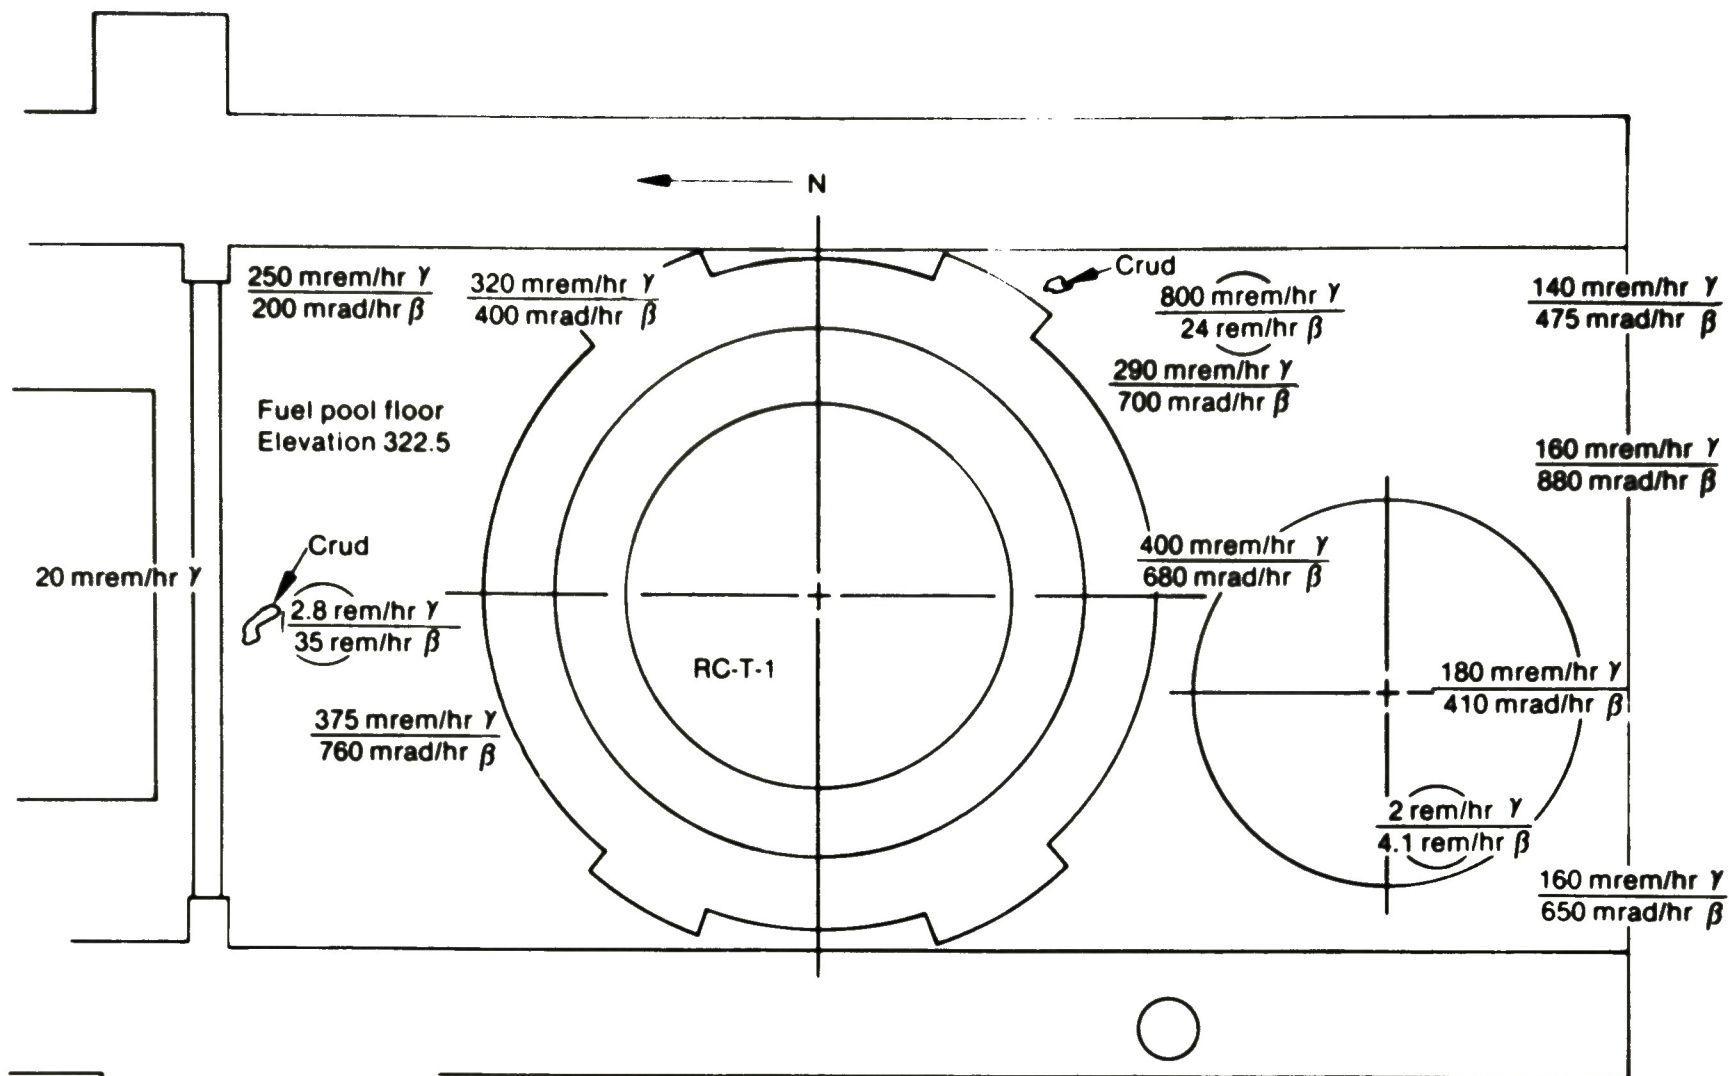
Figure 8. Fuel pool radiation survey.

Note: Circled readings are contact readings; others are general area.

- 250 mrem/hr at top of fuel pool ladder
- 100 mrem/hr below Elevation 347 to bottom of pool
- 150 mrem/hr pool floor with RO-2A.

Large pile of crud on north side of pool

- 2.5 rem/hr γ , 40 rad/hr β on contact.

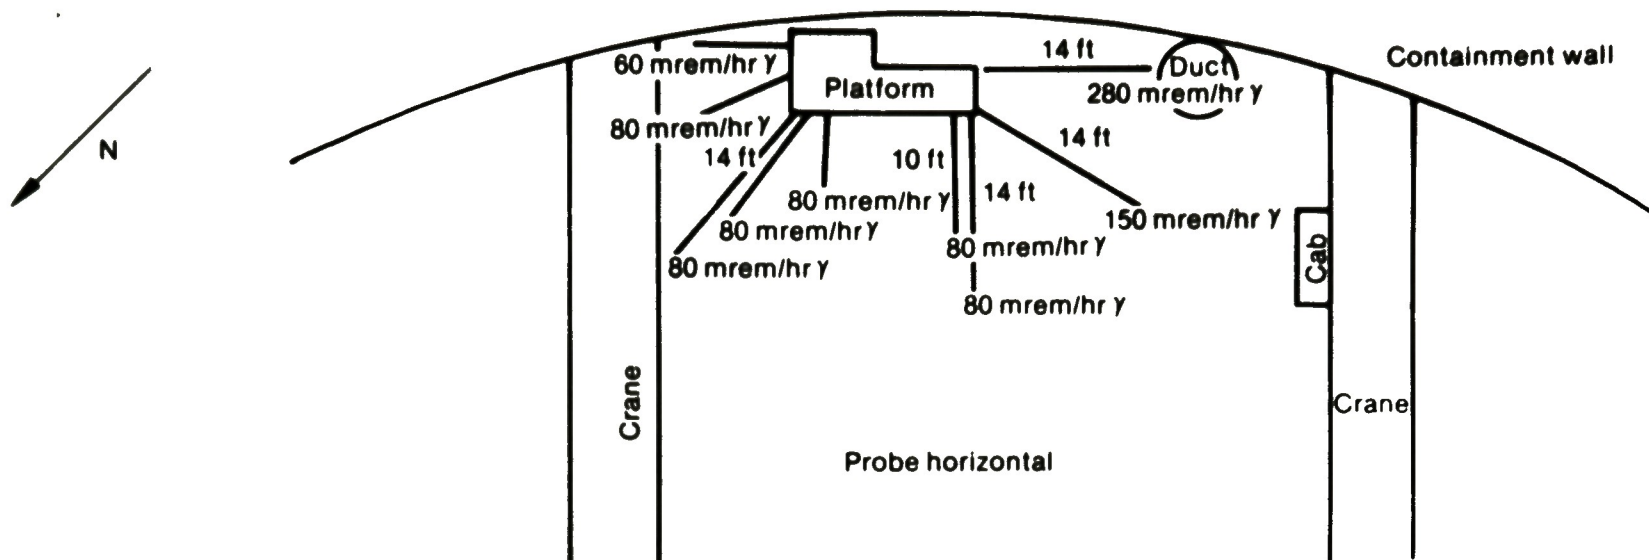
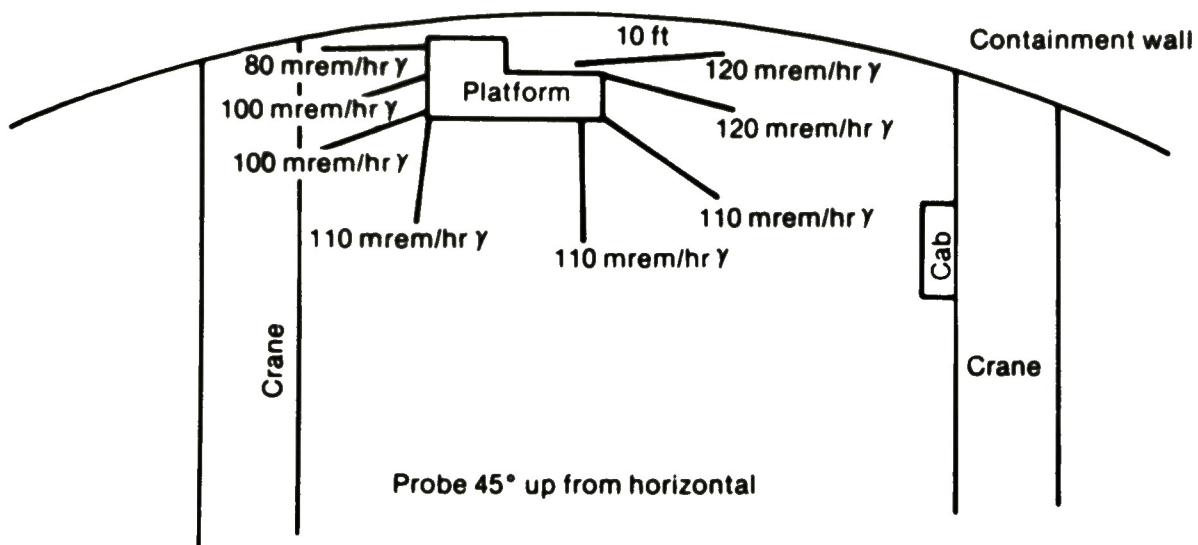
Figure 10. Polar crane access platform radiation survey.

~ 8 ft straight up - close to wall - 50 mrem/hr γ
 ~ 8 ft straight up - 3 ft from wall - 100 mrem/hr γ
