GEND-INF- 007
TIO-QLR
August 1981

QUICK LOOK REPORT
ENTRY 7
THREE MILE ISLAND UNIT 2

Bechtel Northern Corporation/
General Public Utilities Nuclear Corporation

QUICK LOOK REPORT
ENTRY 7
THREE MILE ISLAND UNIT 2
MARCH 17, 19, AND 20, 1981

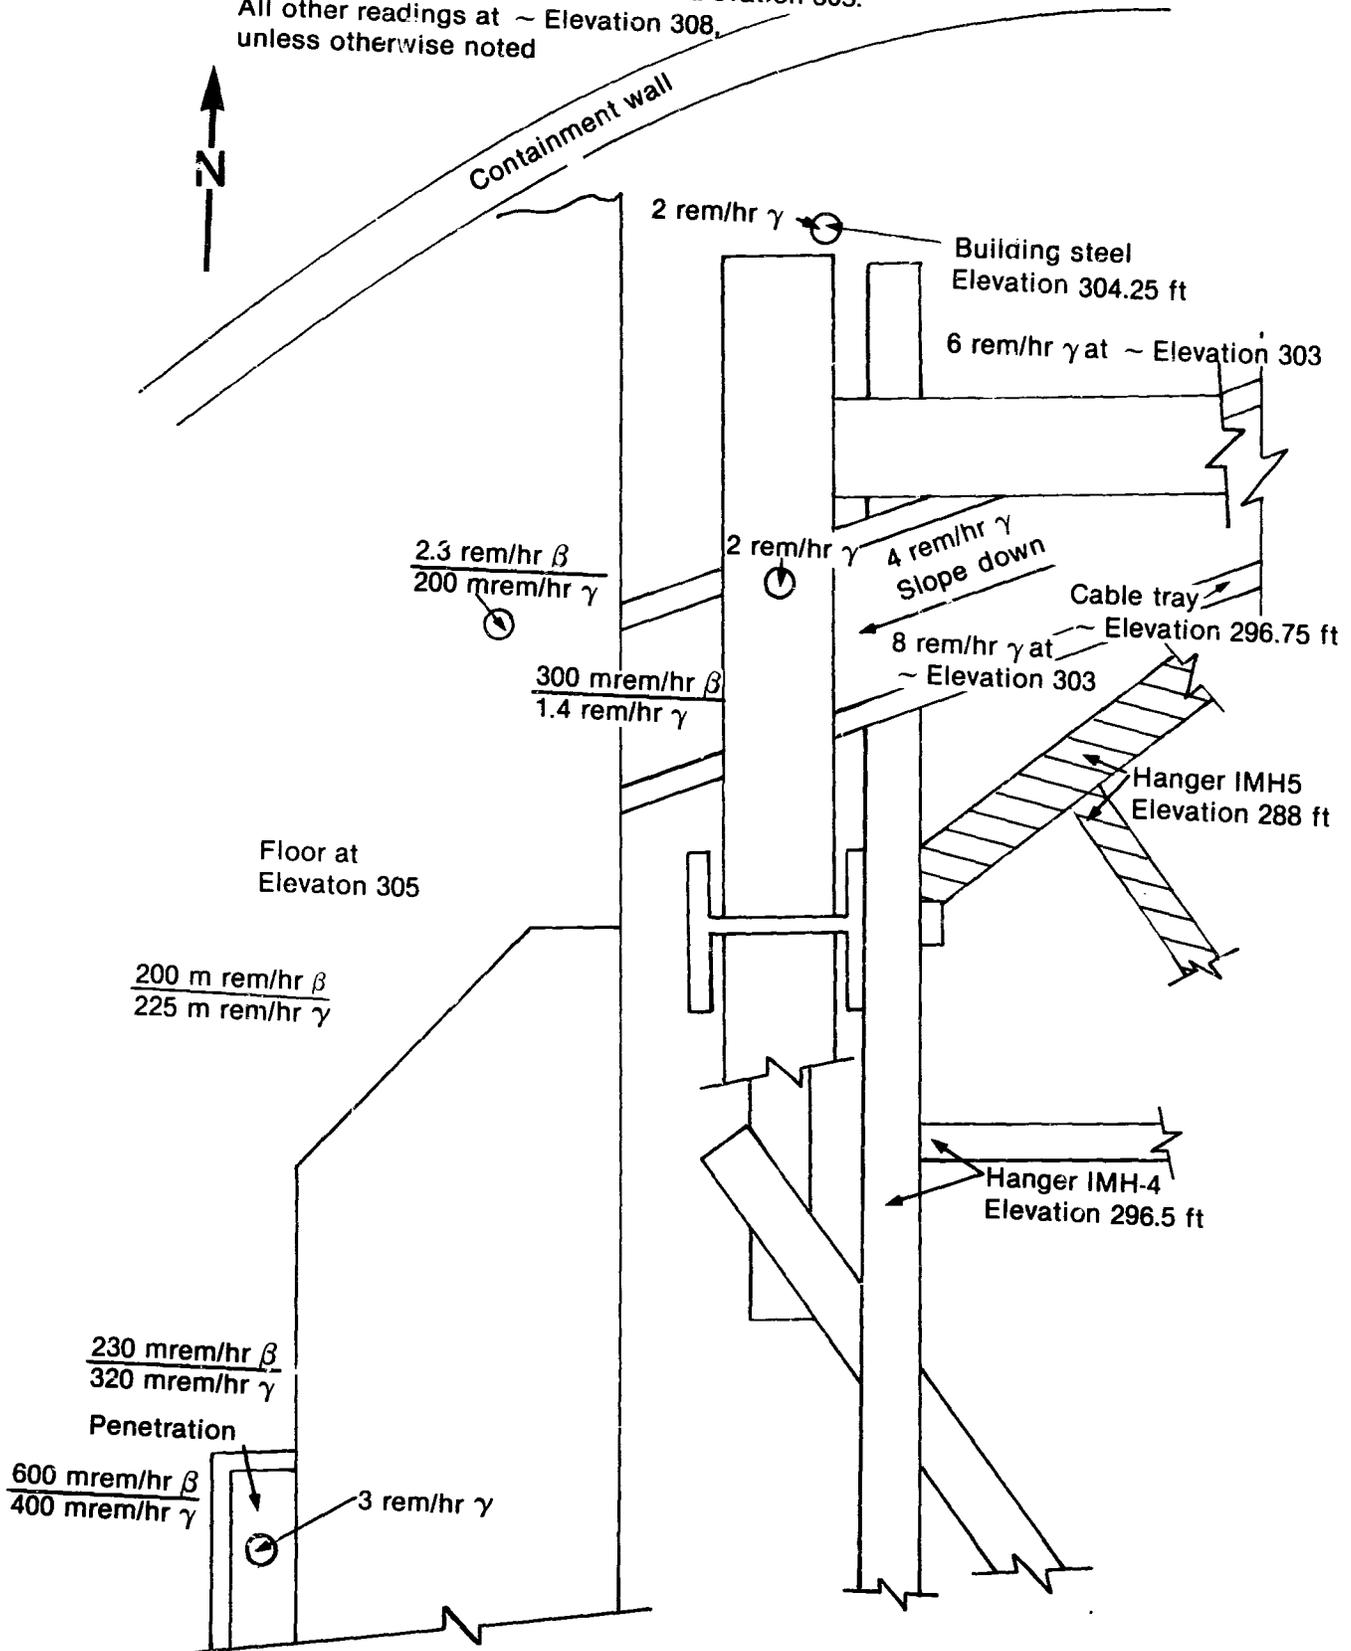
Figure 1. Elevation 305, reactor building in-core instrumentation cable chase--structural design.

<u>Data Acquisition</u> <u>Task Number</u>	<u>Location</u> <u>Figure 1</u>	<u>Instrument</u>	<u>Gamma</u> <u>Dose Rate</u>	<u>Beta</u> <u>Dose Rate</u>	<u>Location</u>
45	As Noted on Figure 1		As Noted on Figure 1		
20	As Noted on Figure 2		As Noted on Figure 2

a. Readings with circles were taken on Elevation 305.
 All other readings at ~ Elevation 308,
 unless otherwise noted

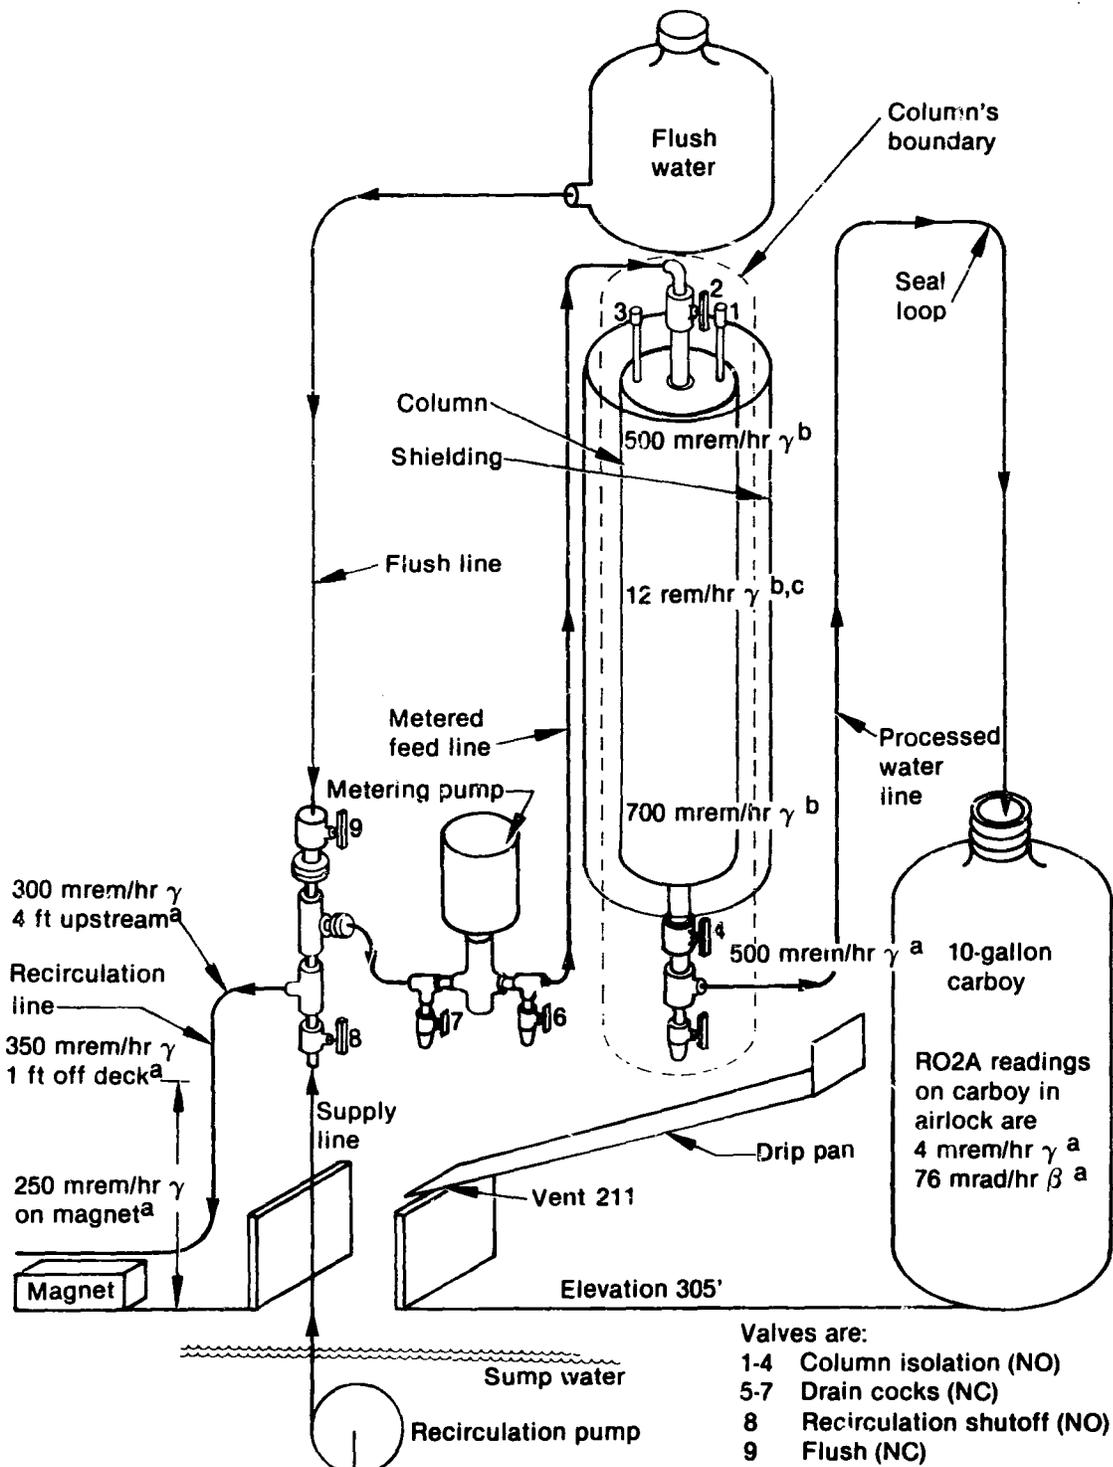
Figure 2. Reactor building sumpwater resin column experiment--system flow diagram.

a. No change in readings after processing.
 b. Readings after processing.
 c. From a distance of 6 to 8 in., reading decreased to <1 rem/hr γ .
 Note: Camera side reading was 300 mrem/hr γ , not shown on drawing.

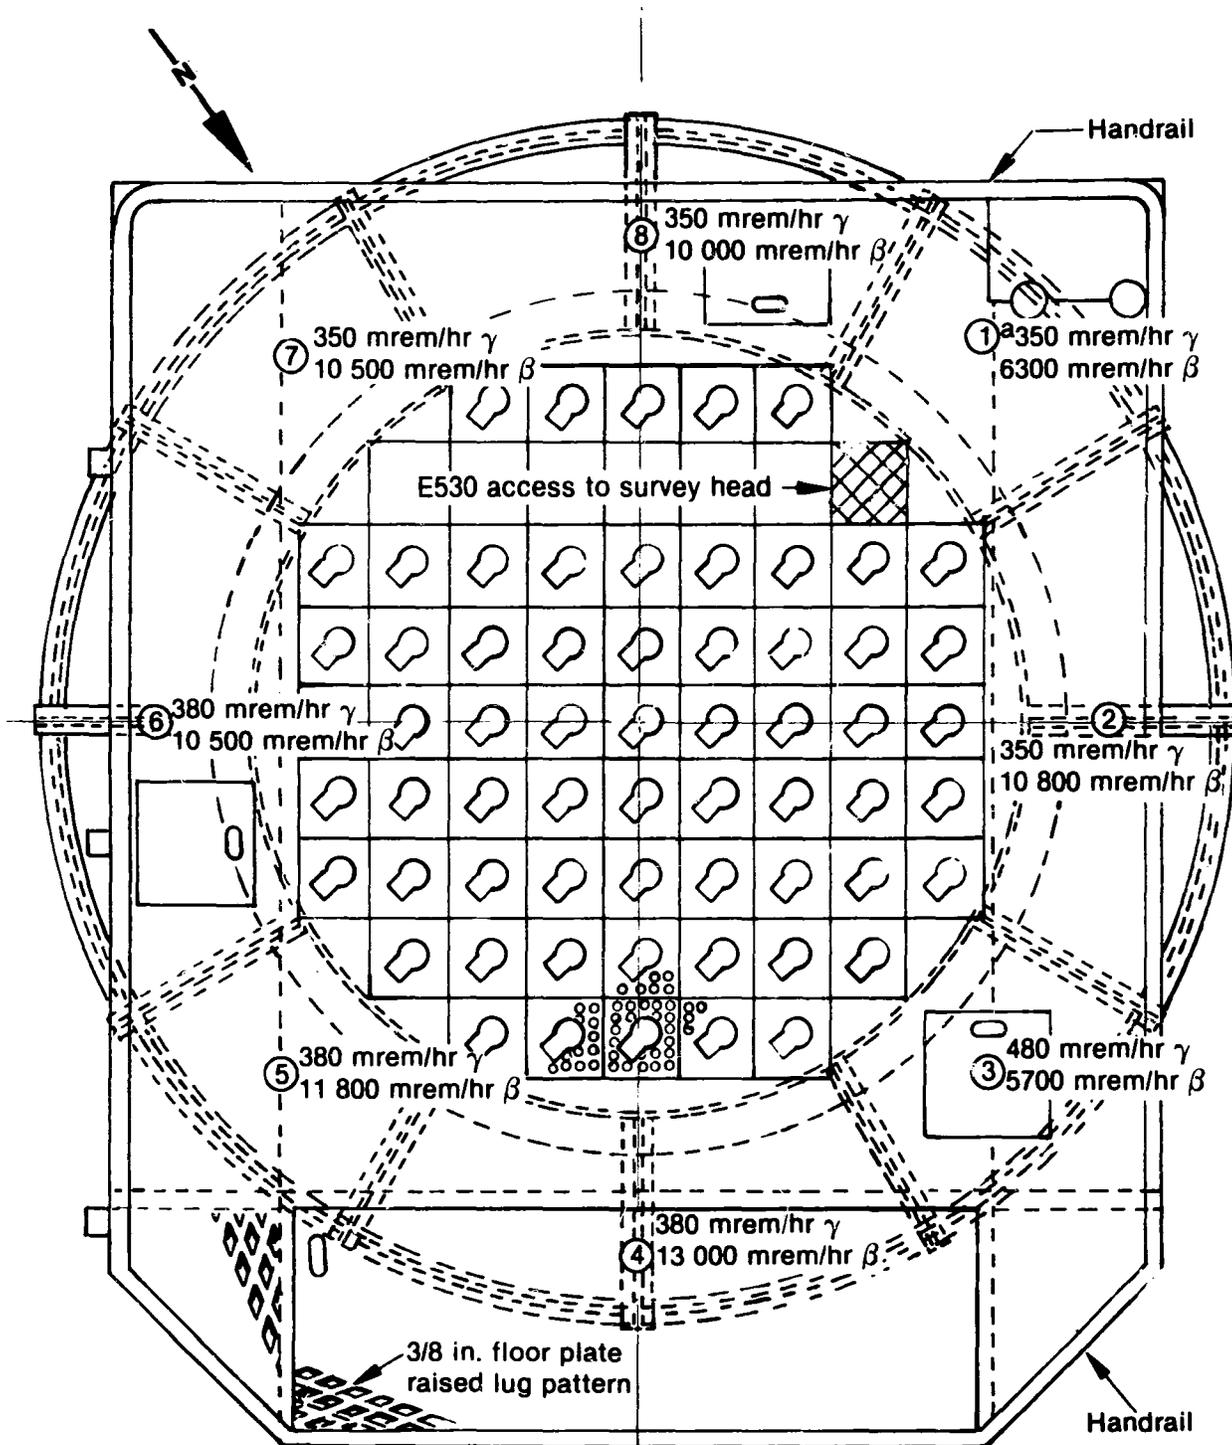
Figure 3. Reactor vessel service structure control rod drive mechanism.

a. Numbers correspond to those shown in Table 4. All readings were taken with an RO2A on contact.

Data Acquisition Task Number	Specimen	Sample Number	Location ^b	Cs-134 (μCi)	Cs-137 (μCi)
27	smear ^a	58731	1	2.3 ⁻¹	1.8 ⁰
27	smear	58732	2	3.8 ⁻¹	3.0 ⁰
27	smear	58733	3	6.1 ⁻¹	4.9 ⁰
27	smear	58734	4	5.8 ⁻¹	4.3 ⁰
27	smear	58735	5	7.7 ⁻¹	5.9 ⁰
27	smear	58736	6	6.1 ⁻¹	4.7 ⁰
27	smear	58737	7	2.7 ⁻¹	2.2 ⁰
27	smear	58738	8	5.5 ⁻¹	4.2 ⁰
27	smear	58739	Position indicating cables on access bridge to service structure	4.9 ⁻¹	3.7 ⁰

b. Numbers correspond to those shown in Figure 3.

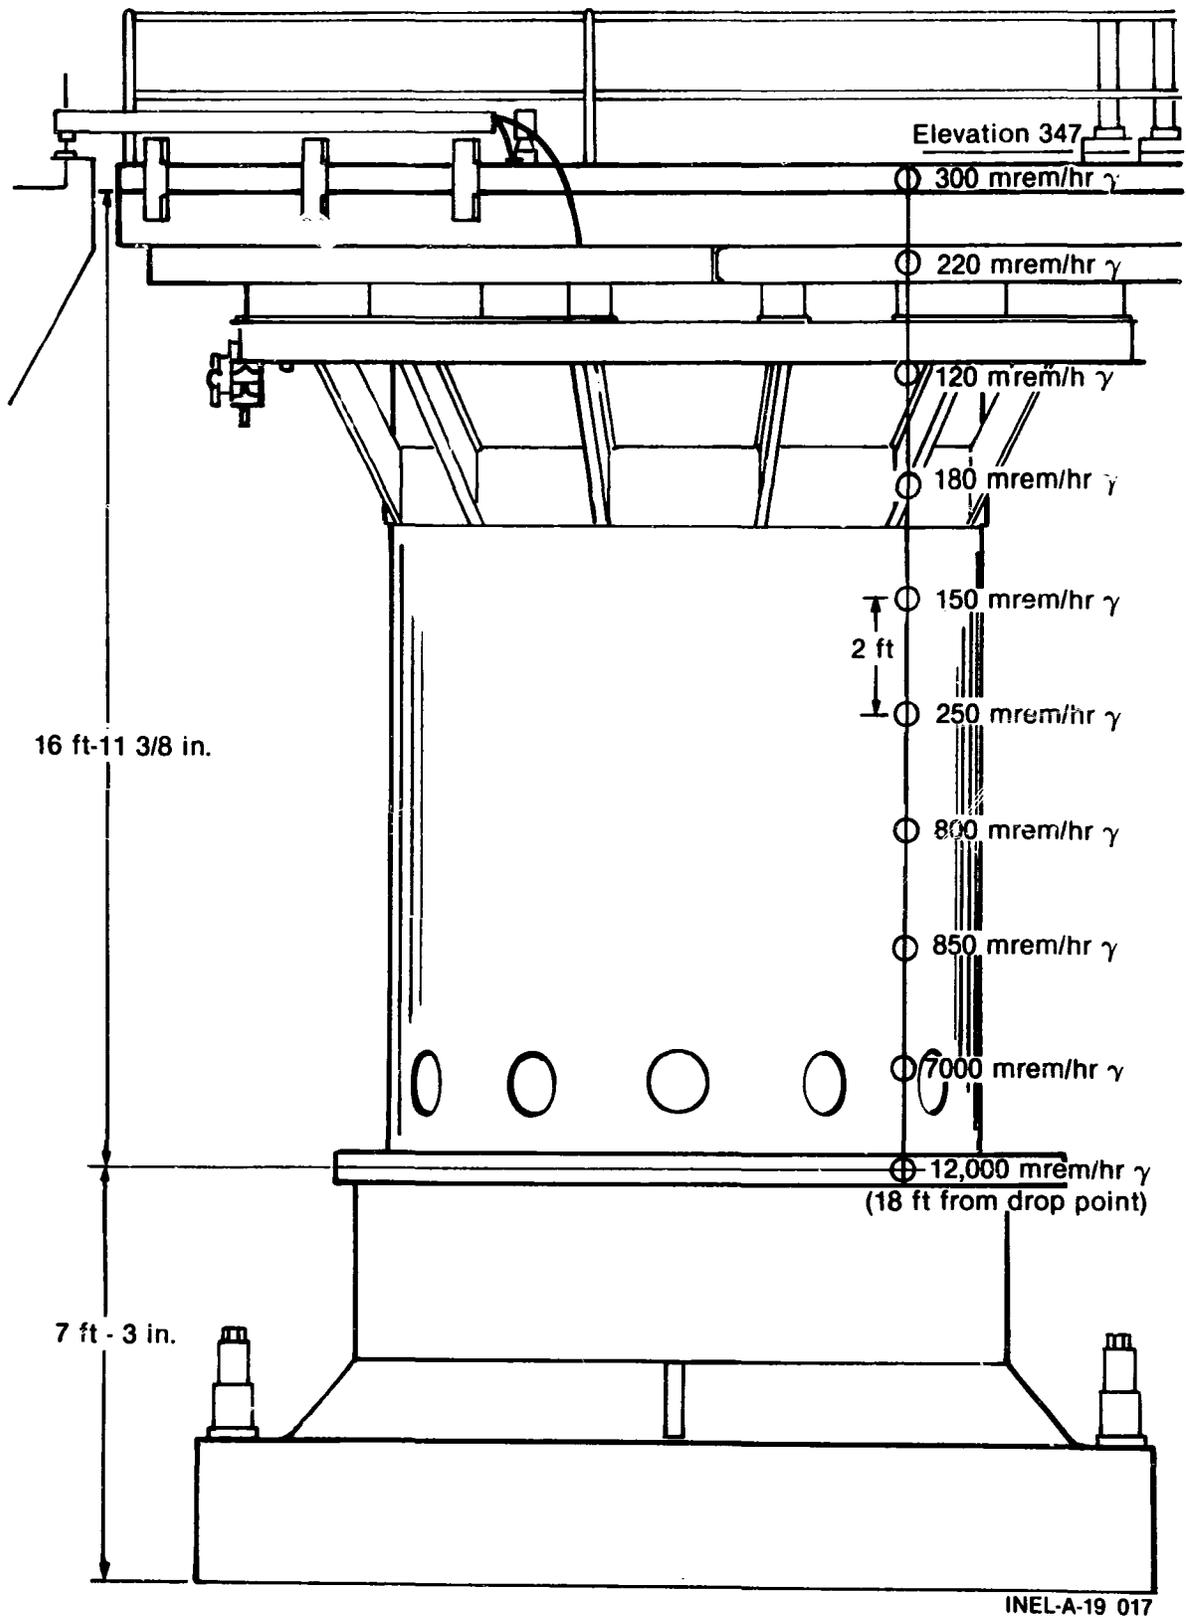
Figure 4. Reactor vessel service structure inside of barrel.

<u>Data Acquisition Task Number</u>	<u>Location Figure 2</u>	<u>Instrument</u>	<u>Gamma Dose Rate</u>	<u>Beta Dose Rate</u>	<u>Neutron Reading</u>	<u>Location</u>
23, 27	As noted on Figure 3 and Figure 4			As Noted on Figure 3 and Figure 4
