## TMI-2 PRESSURE TRANSMITTER EXAMINATION AND EVALUATION OF CF-1-PT1, CF-2-LT1, AND CF-2-LT2

GEND-INF-029  
Vol. II

Published April 1984

EG&G Idaho, Inc.  
Idaho Falls, Idaho 83415

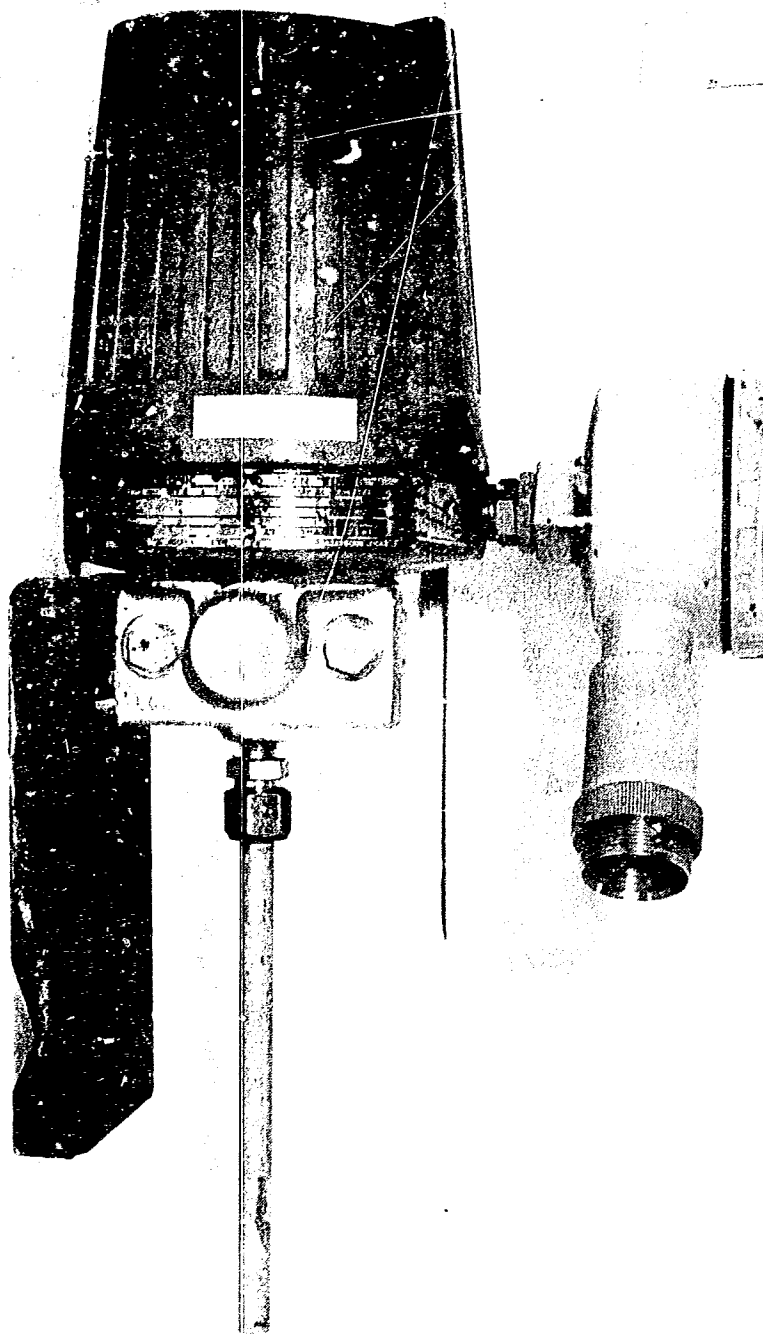
From initial visual examination at the INEL, it appeared that the transmitter was in good condition, except for a heavy coating of corrosion and some rust on the bolts holding the pressure port assembly together (see Figures 1 and 2). The interior of the transmitter, including the sensor/electronic module assembly, was free from corrosion and radioactive contamination. The circular junction box showed no signs of corrosion and was relatively free of radioactive contamination. The minor amount of contamination found in the junction box during the examination was probably a result of the removal process, since there was no corrosion present. It appears that the conduit installation associated with this transmitter did not permit water to enter the junction box, as was the case with the earlier Foxboro unit removed from TMI-2.

Figure 1. Foxboro Transmitter CF-1-PT1.

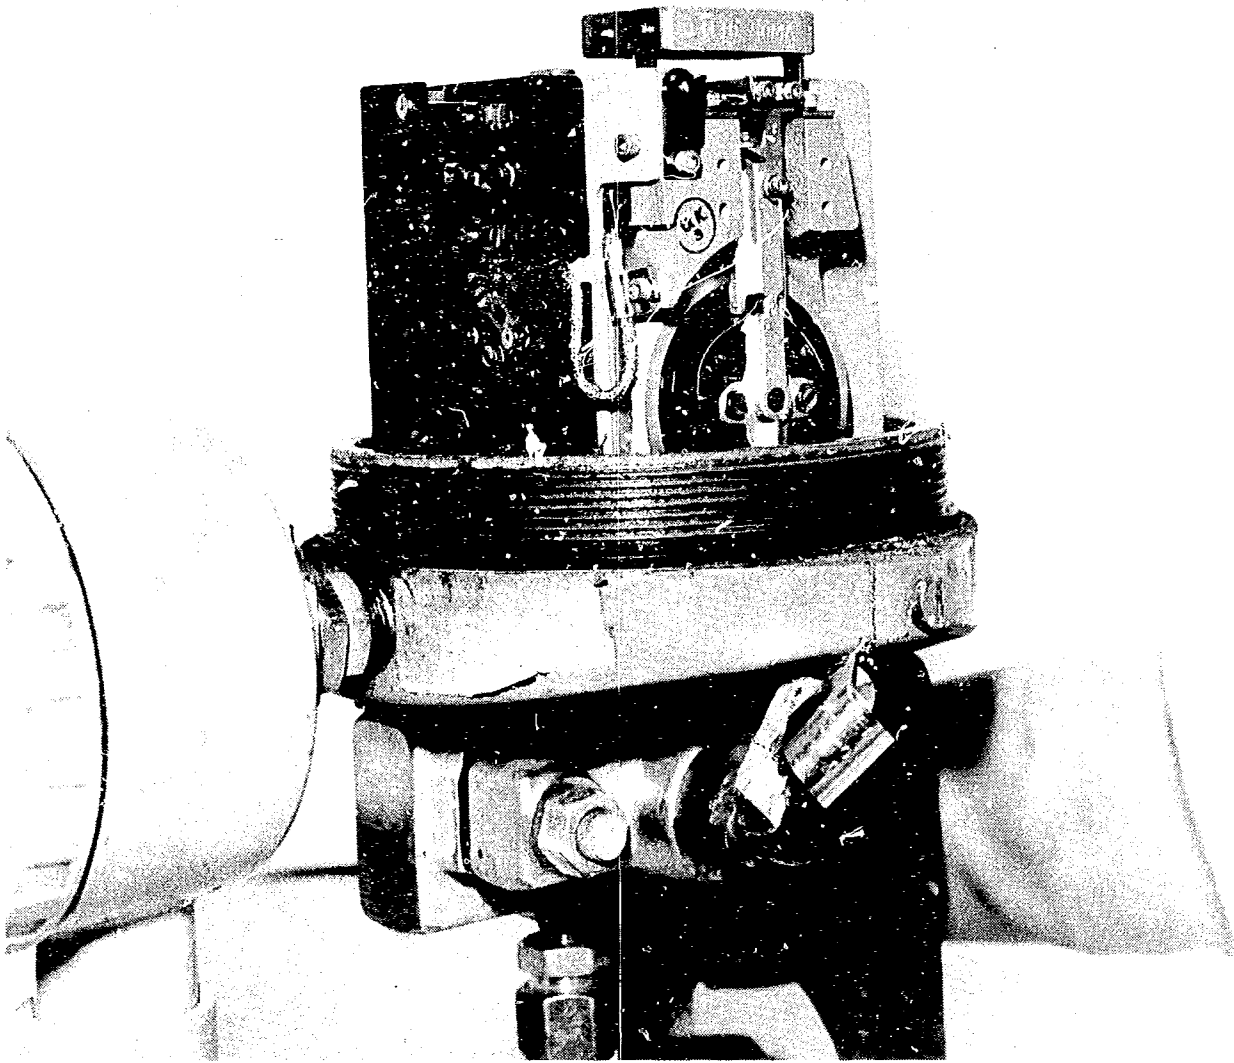
Figure 2. Foxboro Transmitter CF-1-PT1 - internal view.

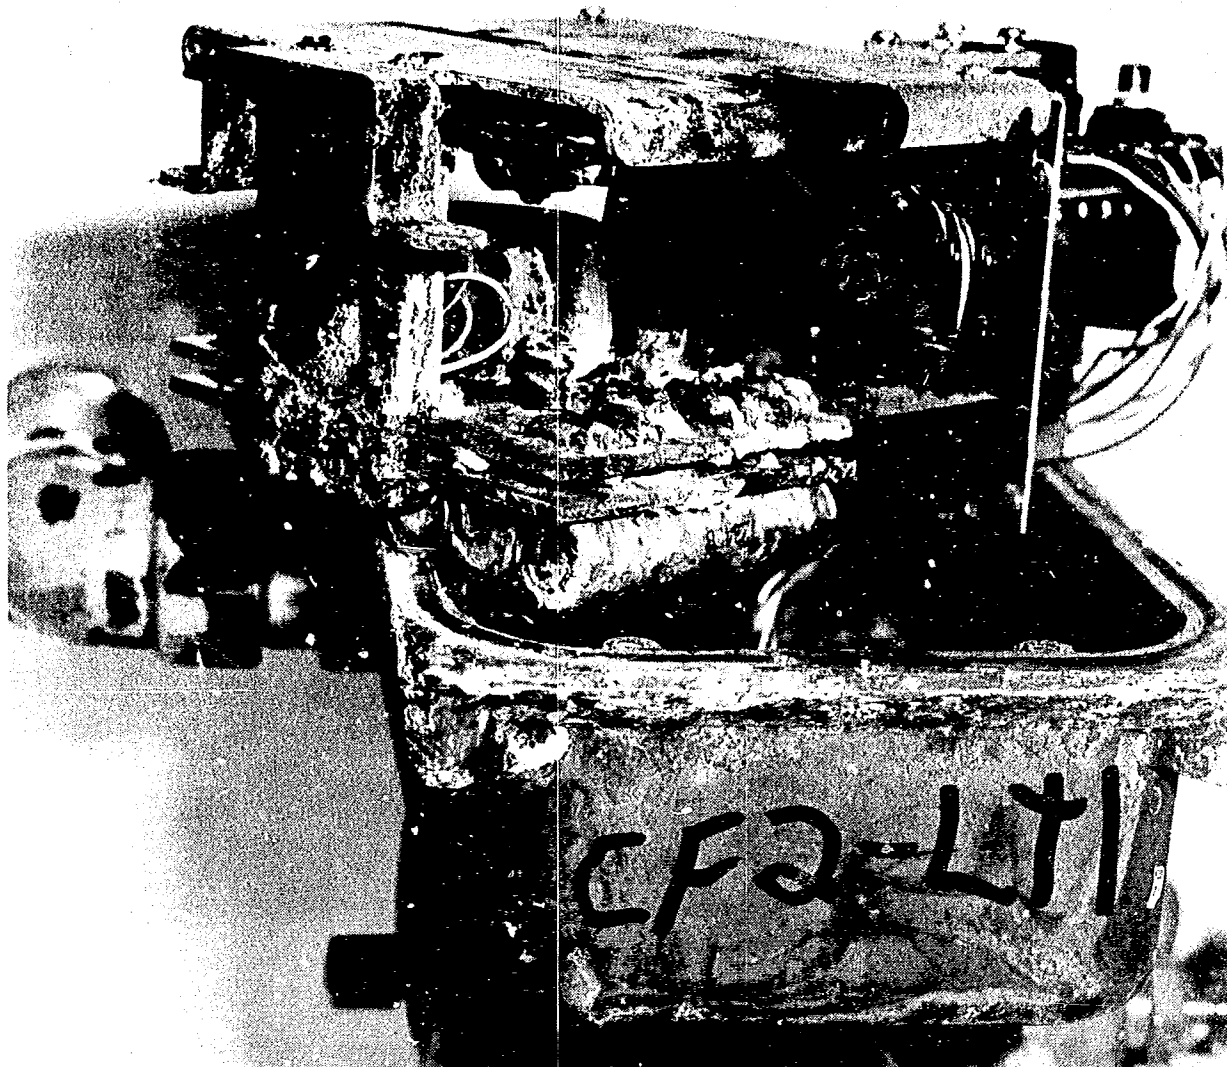
- o There was a heavy layer of rust on assembly nuts and conduit fittings.
- o There was severe corrosion and degradation of internal components rendering the units inoperable (see Figures 3 and 4).
- o The units had a high level of internal radioactive contamination, indicating leakage into the units subsequent to the accident.

- o Portions of the cover plate seal appeared to be in poor condition (see Figures 6 and 7). This may have permitted additional moisture to enter the housing.
- o The water level in the transmitter appeared to reach a depth of approximately 3-1/3 in. (see Figures 6 and 7).
- o The water inside the transmitter apparently leaked out of the housing through the seal. This is evident from the corrosion and hard water deposits around the lower exterior portion of the transmitter (see Figure 3).

Figure 3. CF-2-LT1 showing condition of the electronic module and base of housing.

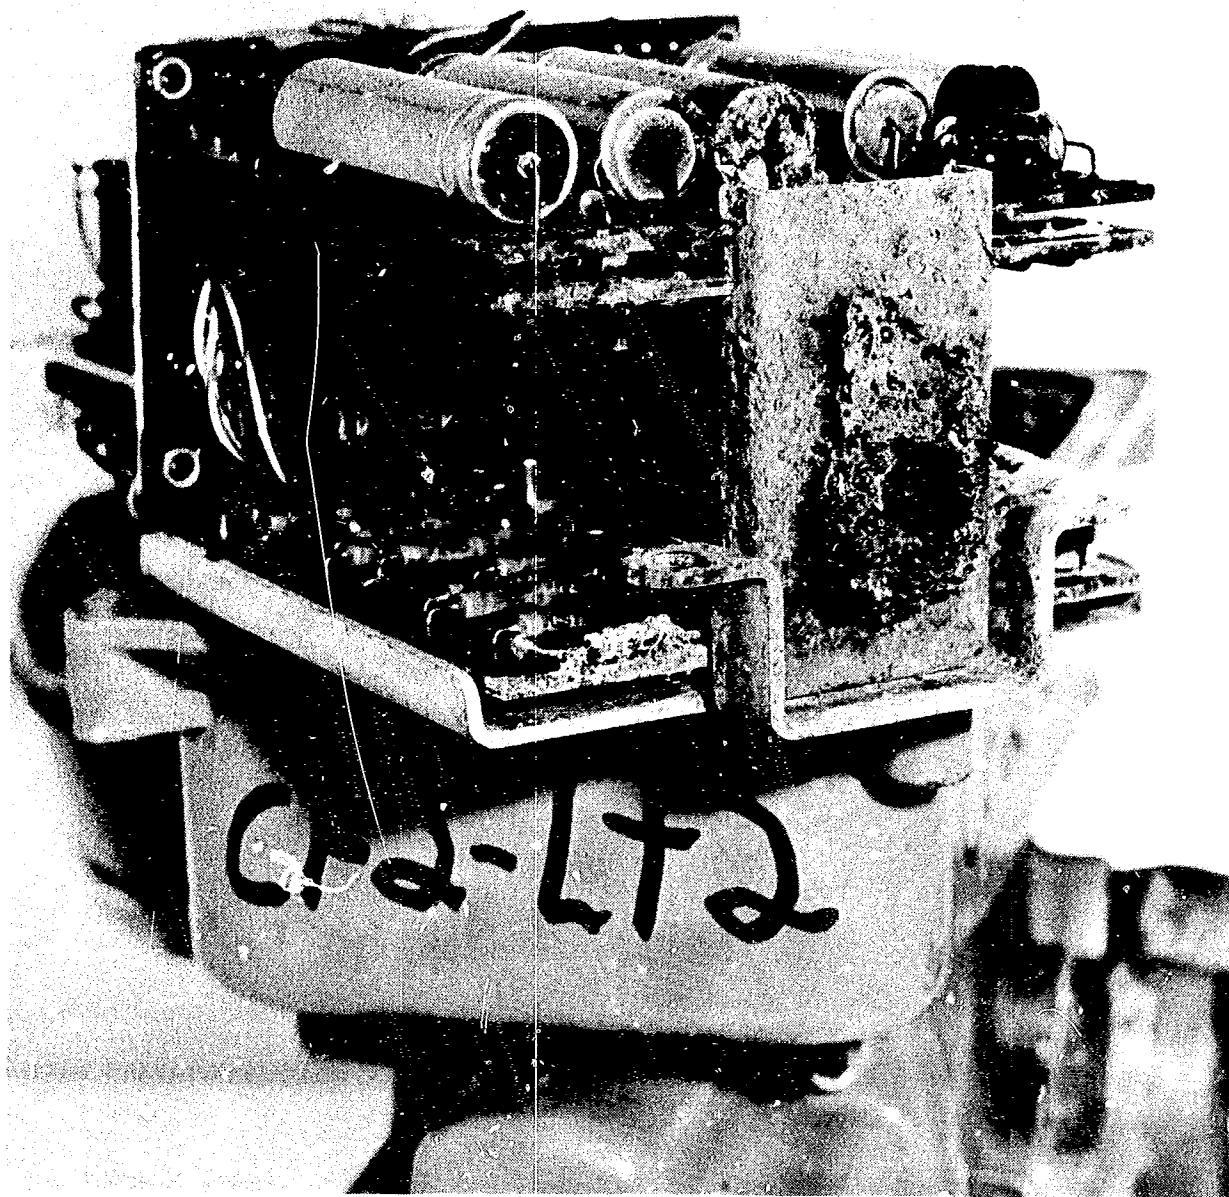
Figure 4. CF-2-LT2 showing the condition of the electronic module.

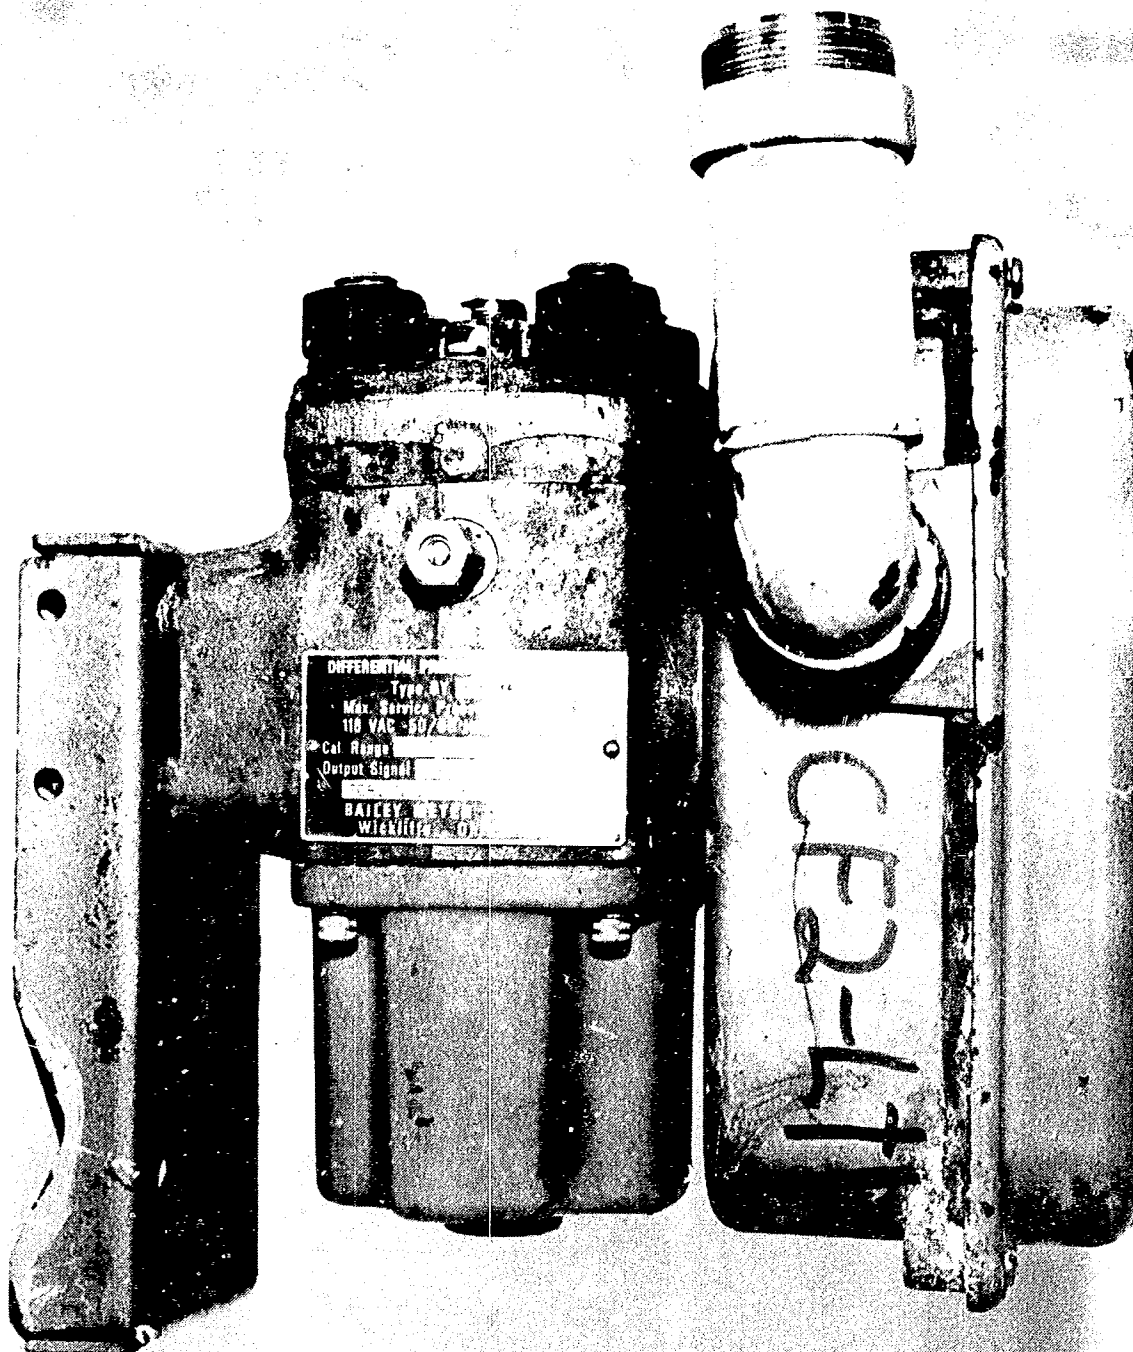
Figure 5. Bailey Transmitter CF-2-LT1.

CF-2-LT1 (Figure 5)

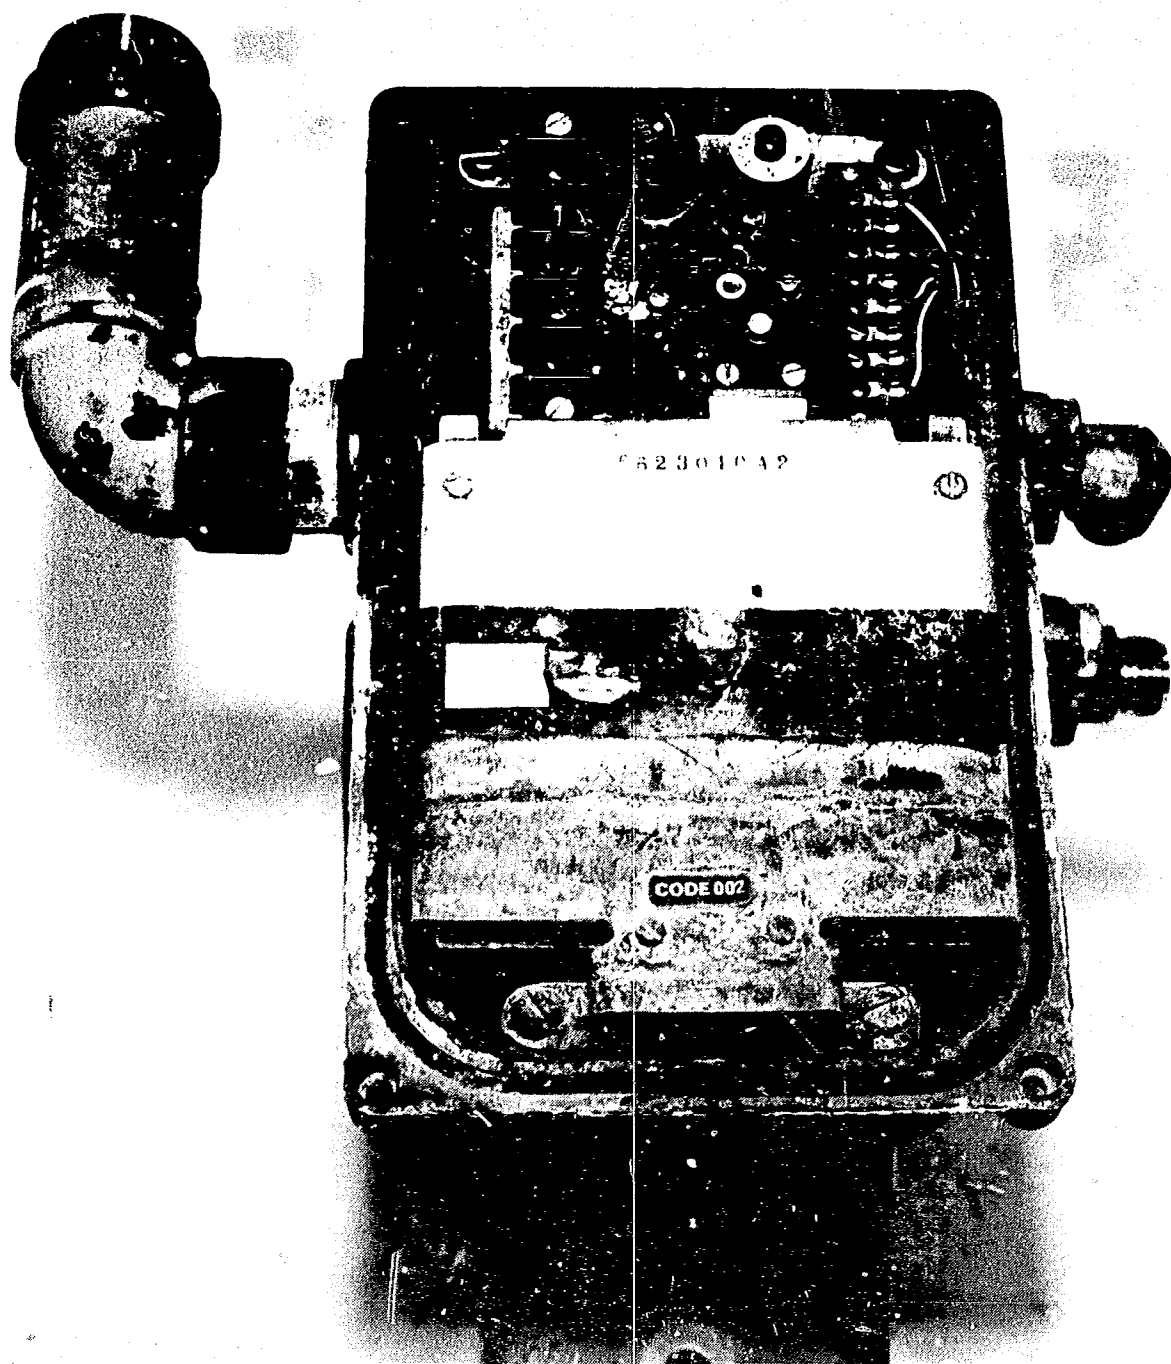
Figure 6. CF-2-LT1 with cover plate removed.

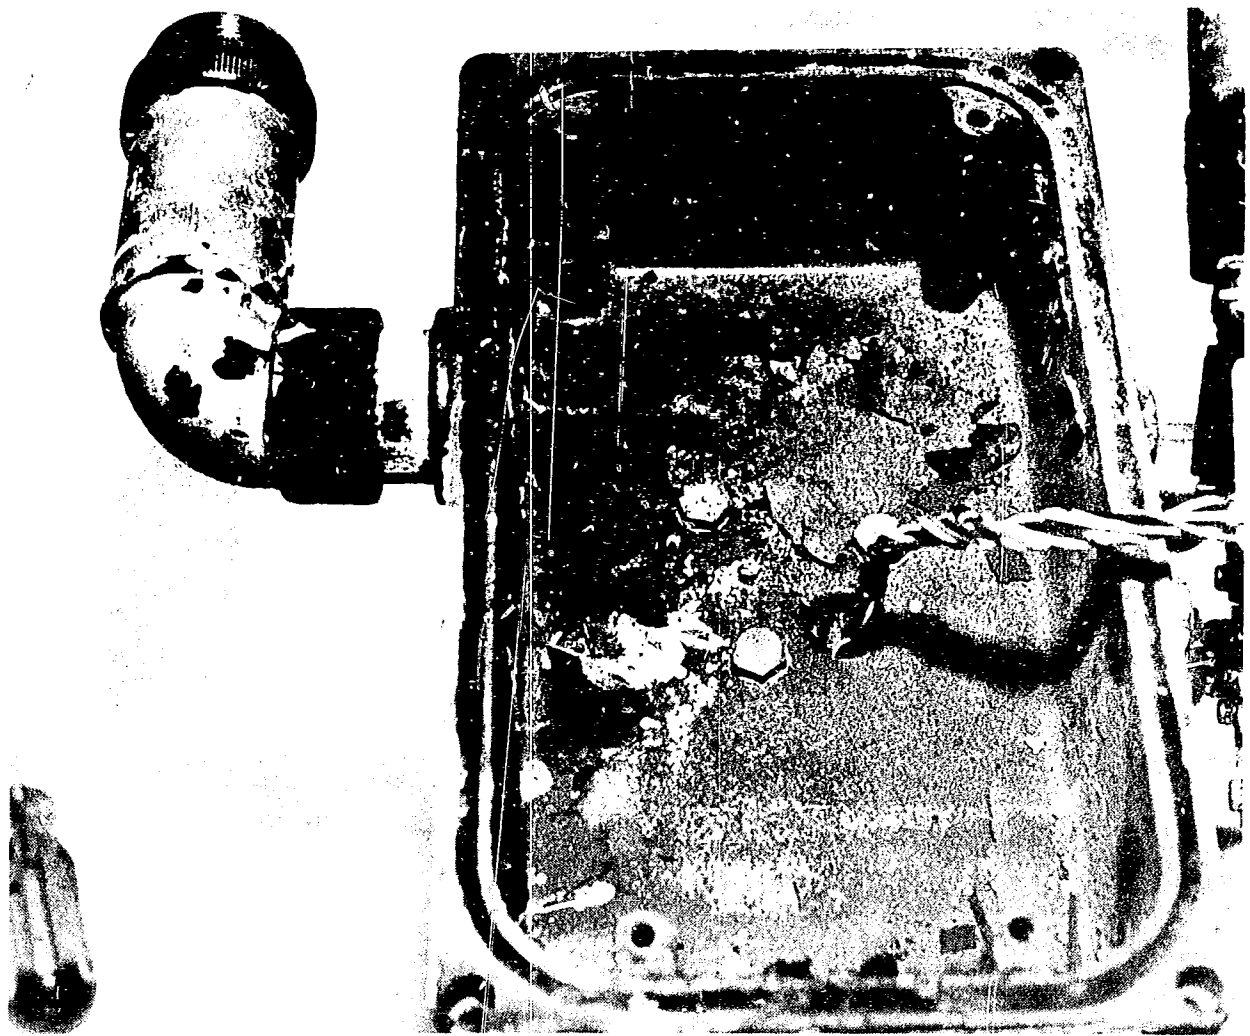
Figure 7. CF-2-LT1 with electronic module removed.

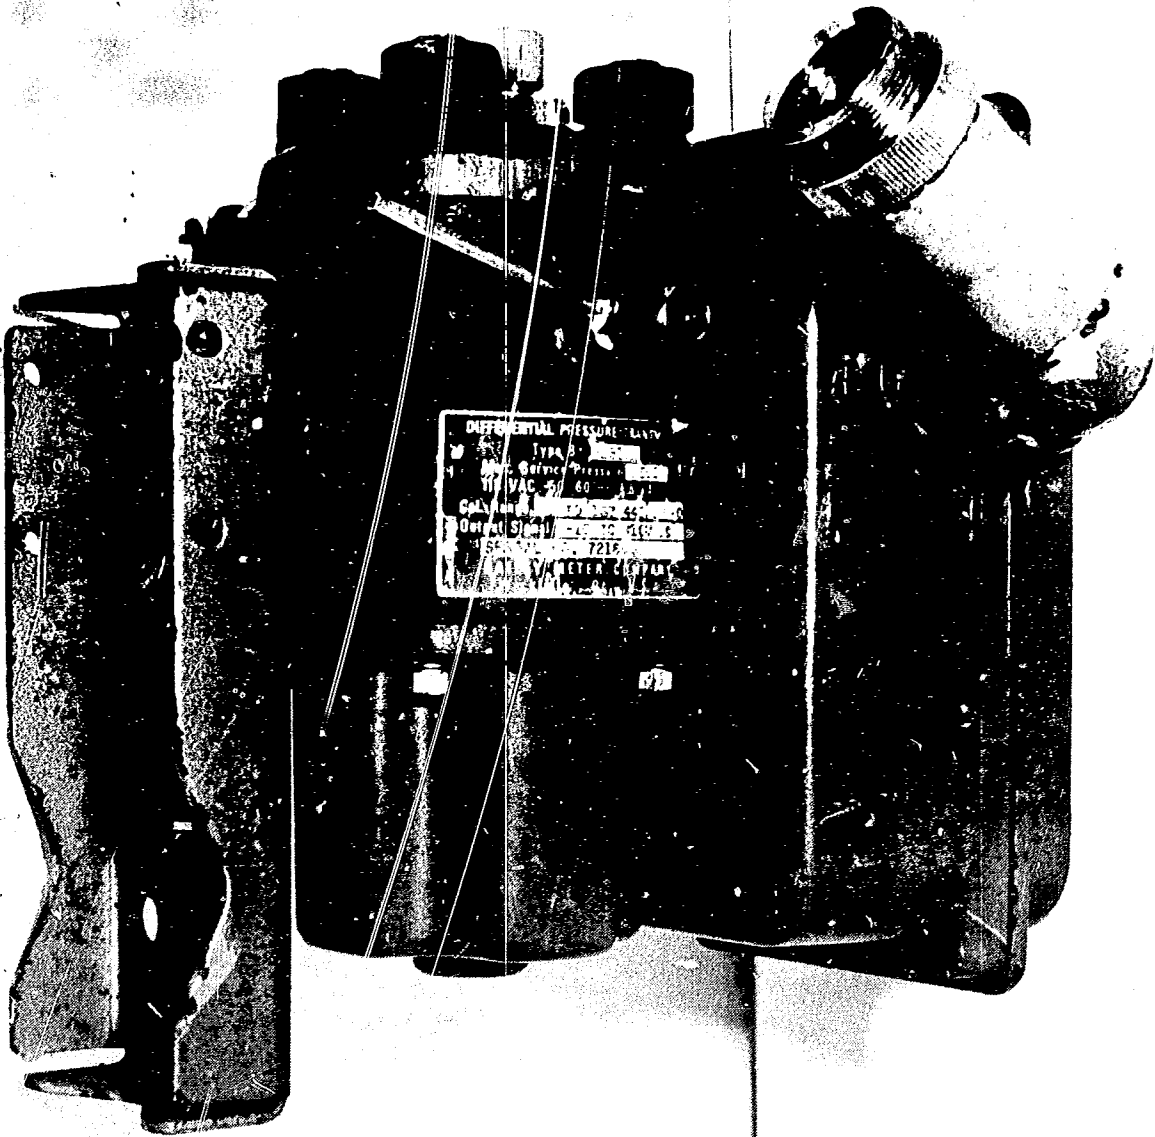
Figure 8. Bailey Transmitter CF-2-LT2.

CF-2-LT2 (Figure 8)

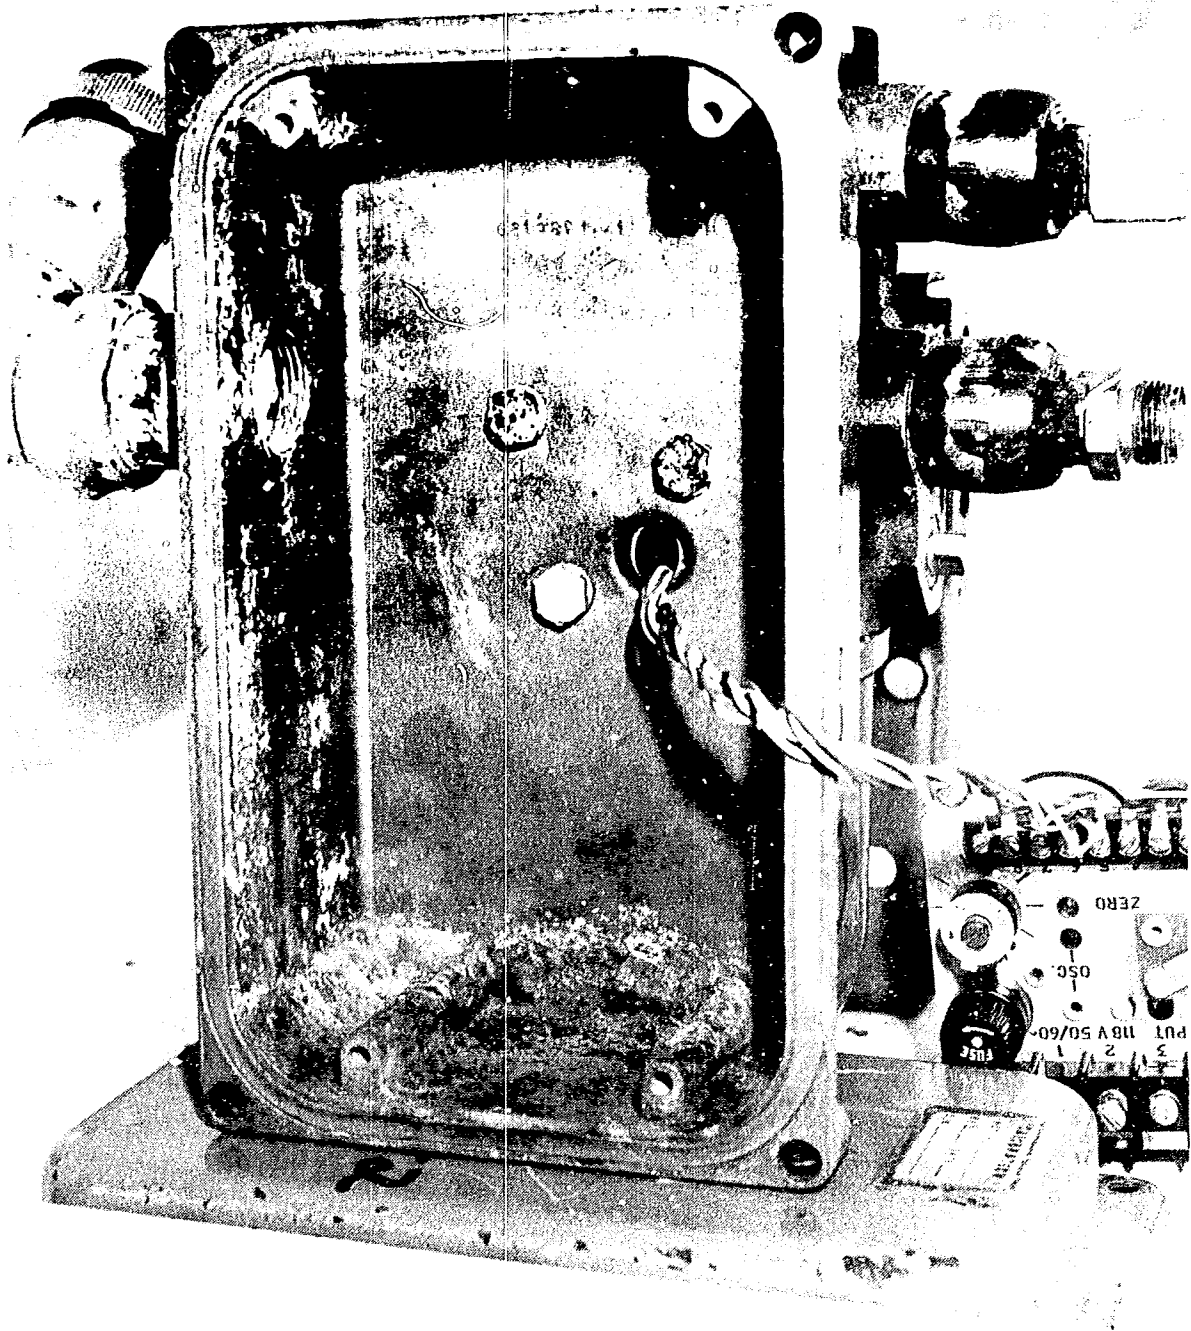
- o The cover plate seal appeared to be in good condition and there was minimum corrosion around the seal (see Figure 9).

Figure 9. CF-2-LT2 with electronic module removed.

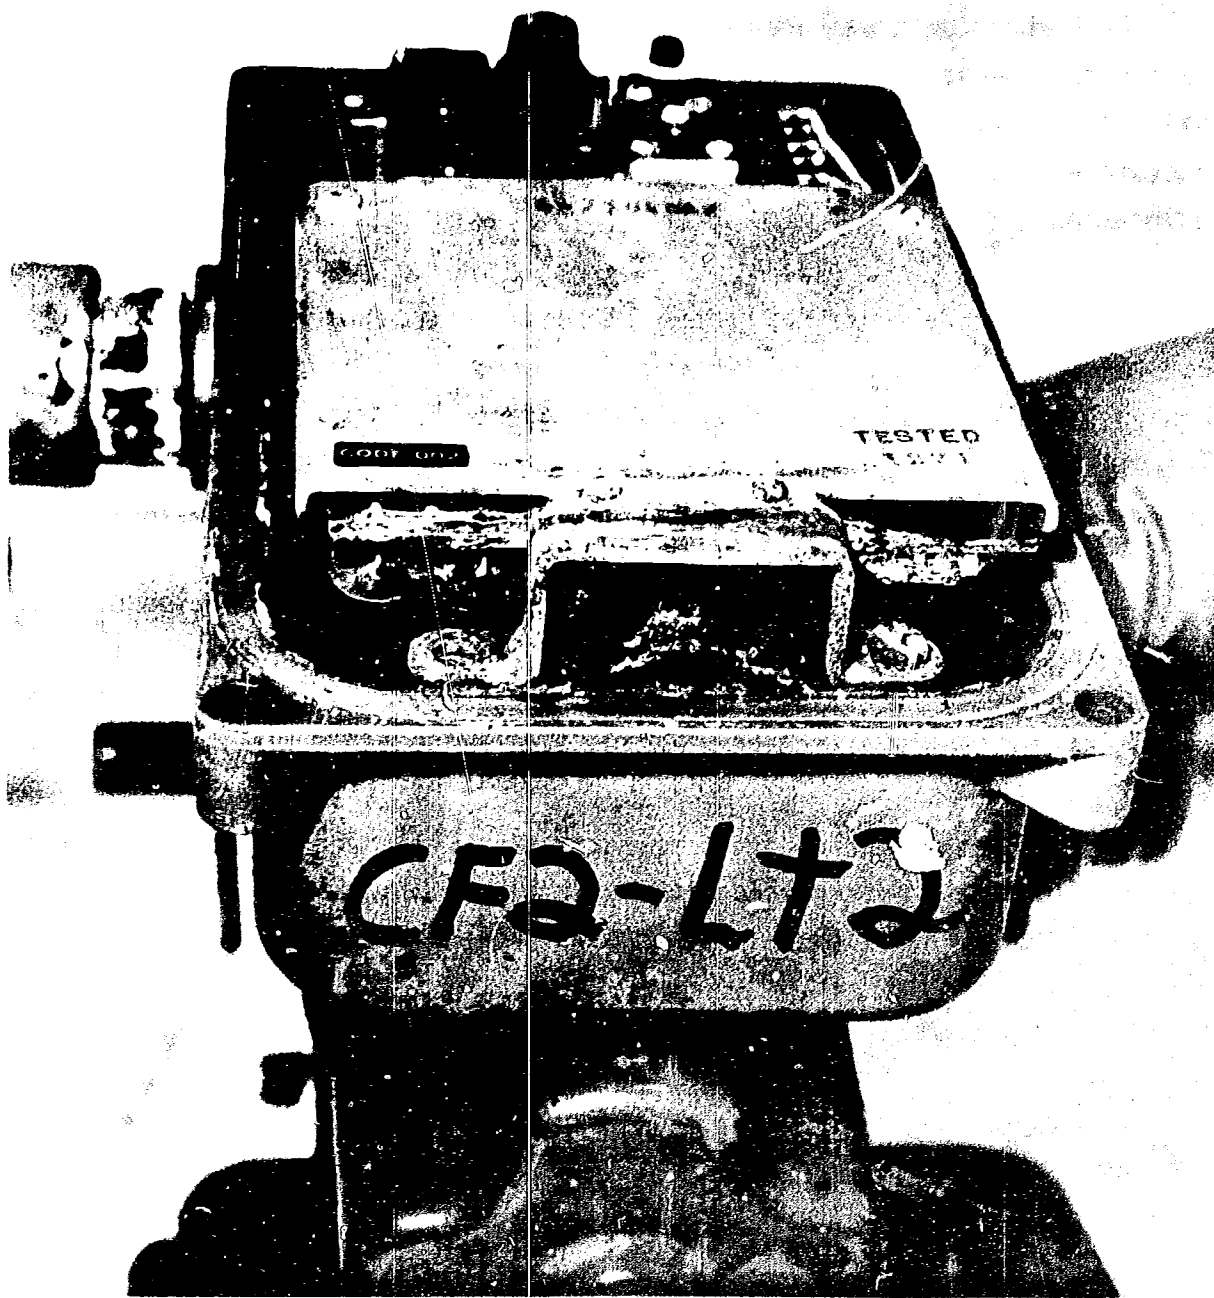
- o The water level in the transmitter appeared to have reached a depth of approximately 2/3 in. (see Figure 10).
- o It appears that the water entered through the conduit and ran down the inside of the transmitter. Internal corrosion was mainly along the side where the conduit entered the housing and the bottom area (see Figure 9).
- o The water that got inside the transmitter did not appear to leak out of the transmitter through the seal area. This is evident from the lack of corrosion on the exterior surface of the housing around the cover plate seal (see Figure 10).

Figure 10. CF-2-LT2 with cover plate removed.

These results indicate the importance of a well defined installation procedure that ensures adequate sealing of the housing and the following of approved conduit installation practices to prevent moisture leaks in the systems.
