TMI-2 PRESSURE TRANSMITTER EXAMINATION PROGRAM
YEAR-END REPORT: EXAMINATION AND EVALUATION OF PRESSURE
TRANSMITTERS CF-1-PT3 AND CF-2-LT3

Rolf C. Strahm
Merlin E. Yancey

February 1983

Published on Behalf of the GEND Group
by
EG&G Idaho, Inc.
Idaho Falls, Idaho 83415

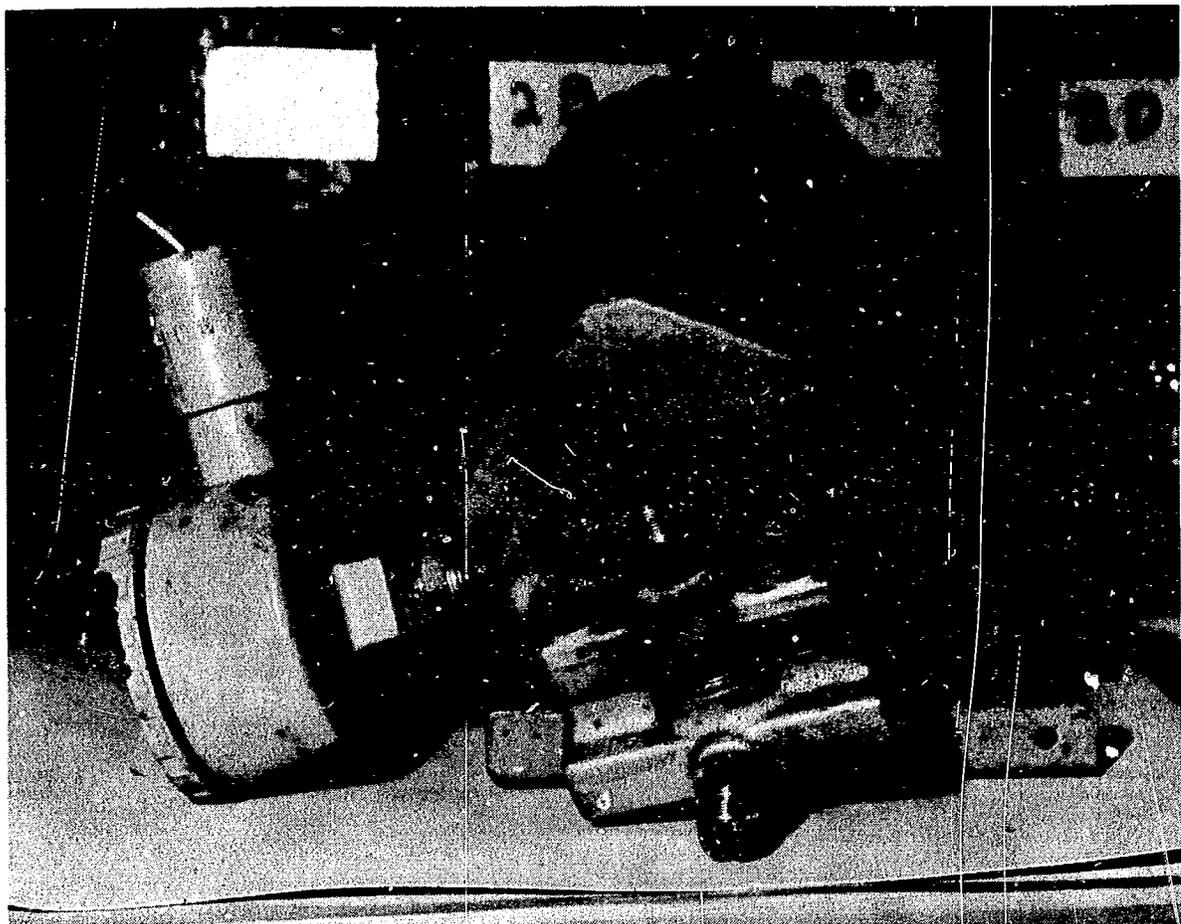
Figure 2. Photograph, Foxboro pressure transmitter.

- o The nuts and bolts holding together the flanged pressure port assembly had a heavy coating of rust; all other surfaces, painted and stainless steel, appeared fairly clean (see Figure 2).

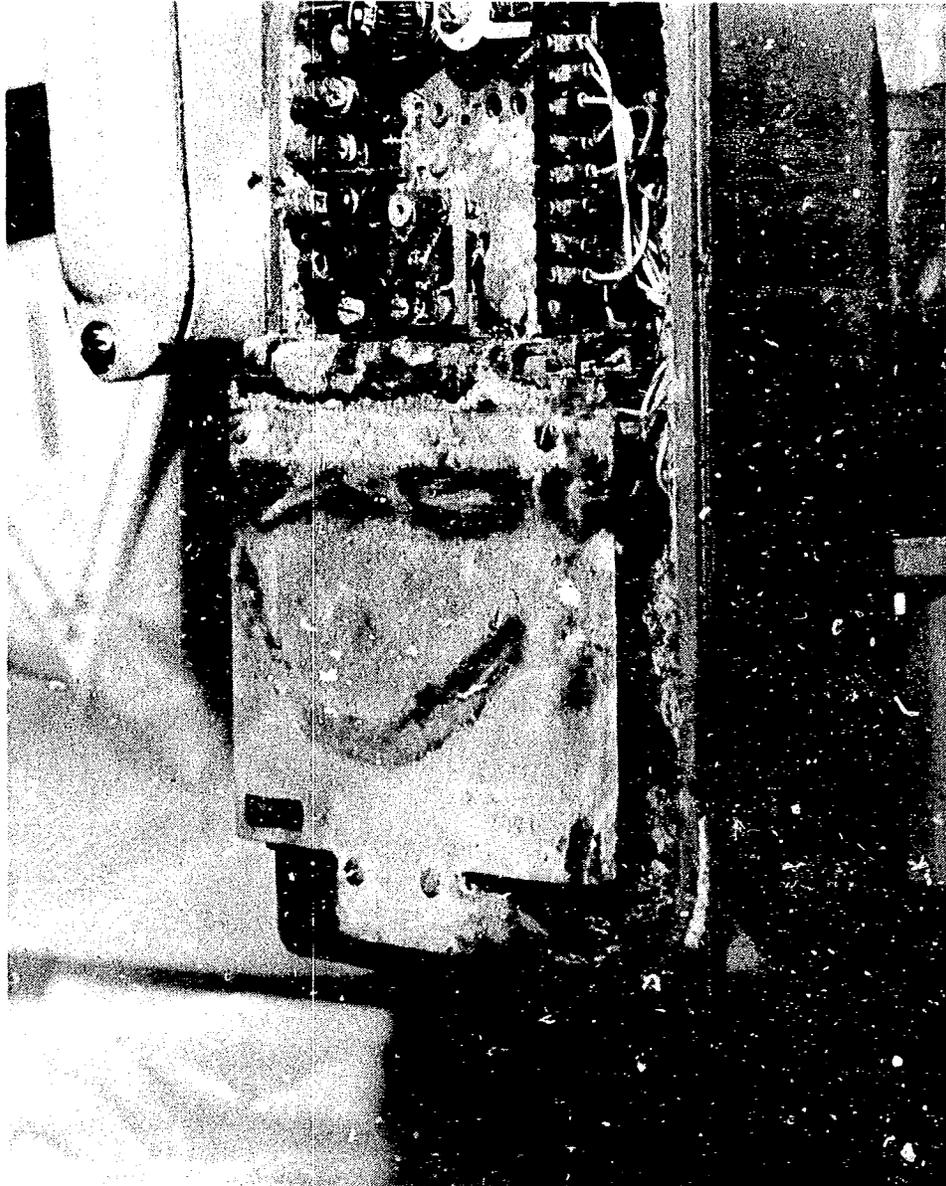
Figure 7. Photograph, Bailey pressure transmitter, internal view.

- o The interior of the housing and certain components were heavily corroded, and there was an accumulation of grit-like material at the bottom (see Figure 7).
- o The interior was radioactively contaminated. A smear count indicated about 300,000 dpm.

The transmitter case gasket and the conduit junction box cover gasket were examined and found to be in good condition. It is believed that water entered the transmitter assembly through the flexible conduit or its fittings.

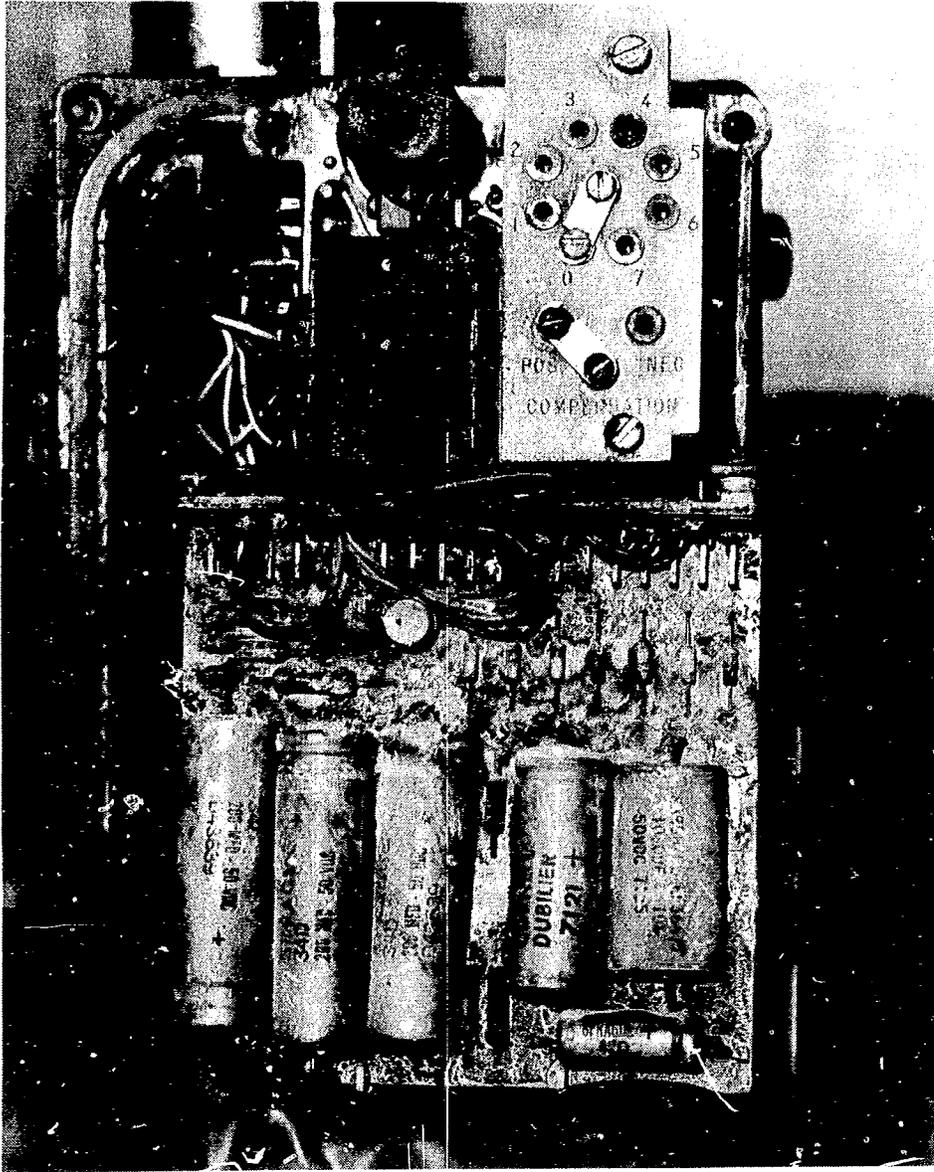
Figure 8. Photograph, Bailey pressure transmitter, circuit board, front view.

- o Some electronic components were badly corroded; some leads were completely corroded away. (See capacitors in Figure 8.)
- o A transformer, T-2 (oscillator circuit), appeared to have been badly burned (see Figure 9).
- o Regulator Power Transistor Q-2 was rusted so badly it crumbled when contacted (see Figure 10).
