GEND-INF--041

## EVALUATION OF TMI-2 PRESSURE SWITCHES NM-PS-1454 AND NM-PS-4174

EG&G Idaho, Inc.  
Idaho Falls, Idaho 83415

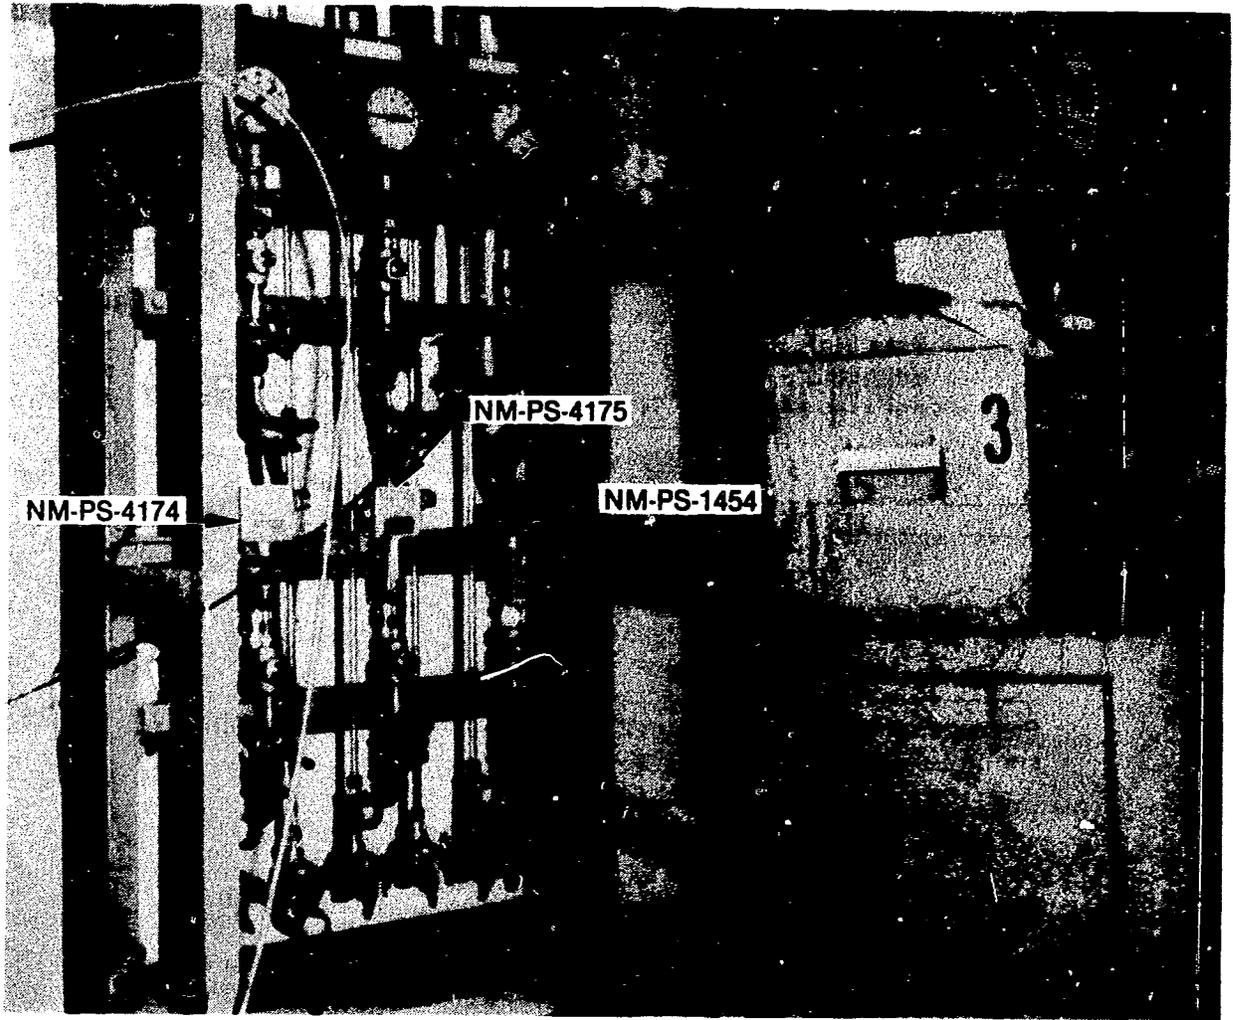
Figure 1. Instrument Rack 432 at the 347-ft elevation, showing pressure switches NM-PS-1454, NM-PS-4174 and NM-PS-4175.

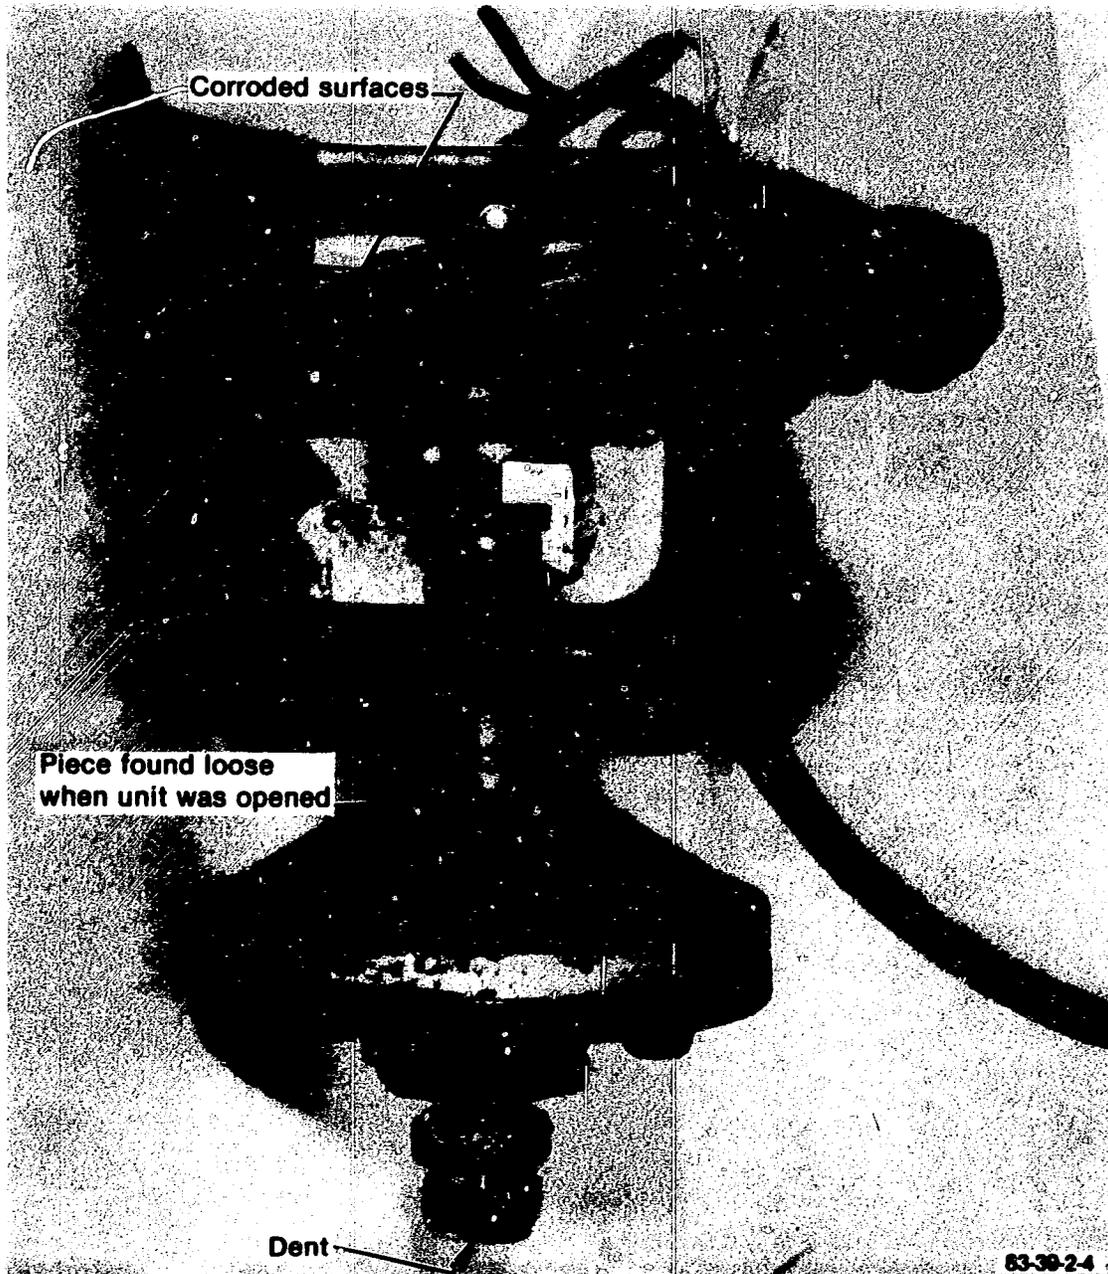
Figure 3. Pressure switch NM-PS-4174 interior.

The interior of the switch enclosure portion of NM-PS-4174 was clean but appeared to have had moisture in it at one time, as evidenced by the corrosion of ferrous metal parts (see Figure 3). The water that caused this corrosion may have been from the hot-water spraying of the Reactor Building during the gross decontamination experiment. The cover gasket appeared to be in good condition, so it is likely that water entered the enclosure through the conduit or its associated fittings.

Therefore, it is recommended that instruments such as these pressure switches be carefully sealed when installed to prevent the incursion of moisture.

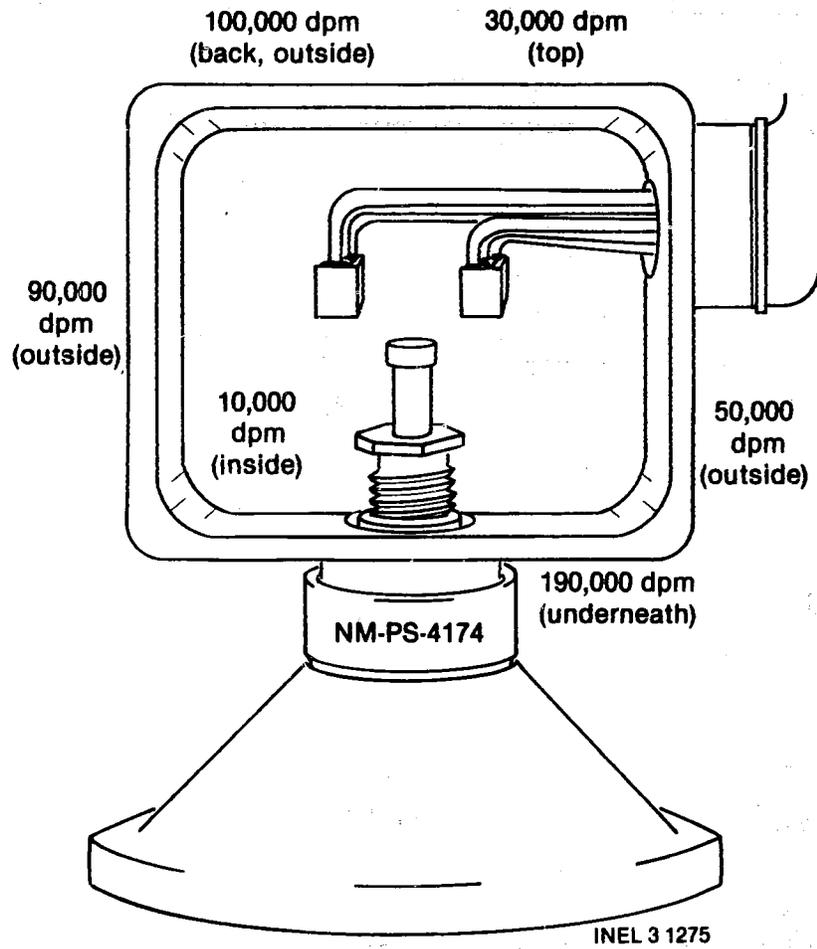
Radiological Observations. The exterior smear survey shows 30,000 to 190,000 disintegrations per minute (dpm) gross beta and gamma radiation (see Figure 6). The interior of the switch enclosure shows 10,000 dpm, indicating contaminated water or air had entered the enclosure. Cover plate gamma spectrum analysis and full smear count results are presented in Table 2.

Figure 6. Contamination smear sites for NM-PS-4174.

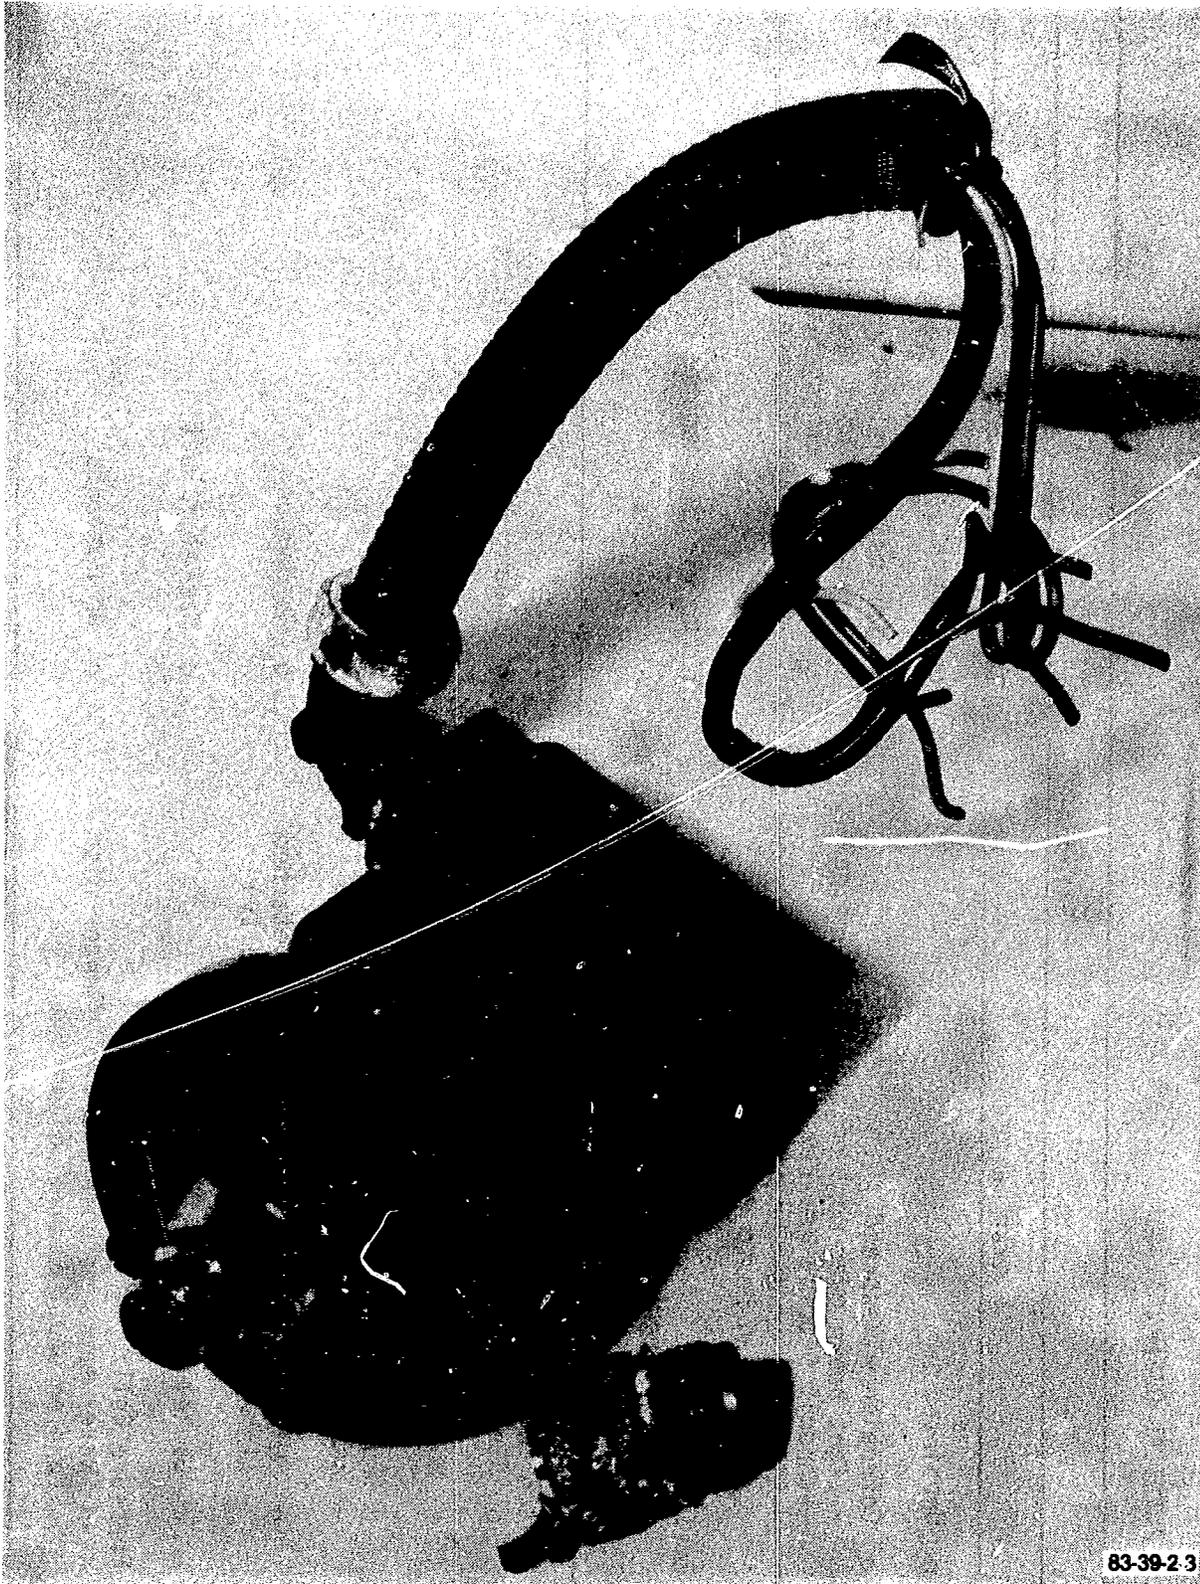
83-39-23

Visual Observations. The bolts holding the flanged pressure port assembly together had a heavy coating of rust; all other surfaces were lightly corroded. Table 3 provides a detailed comparison of visual observations of both switches externally and internally. (See also Figure 7.)

The unit appears to have been damaged in handling. There is a dent in the pressure fitting, and the switch actuation plate was adrift in the switch enclosure. The actuation plate was reinstalled prior to mechanical characterization.

Figure 7. Pressure switch NM-PS-4174 exterior.

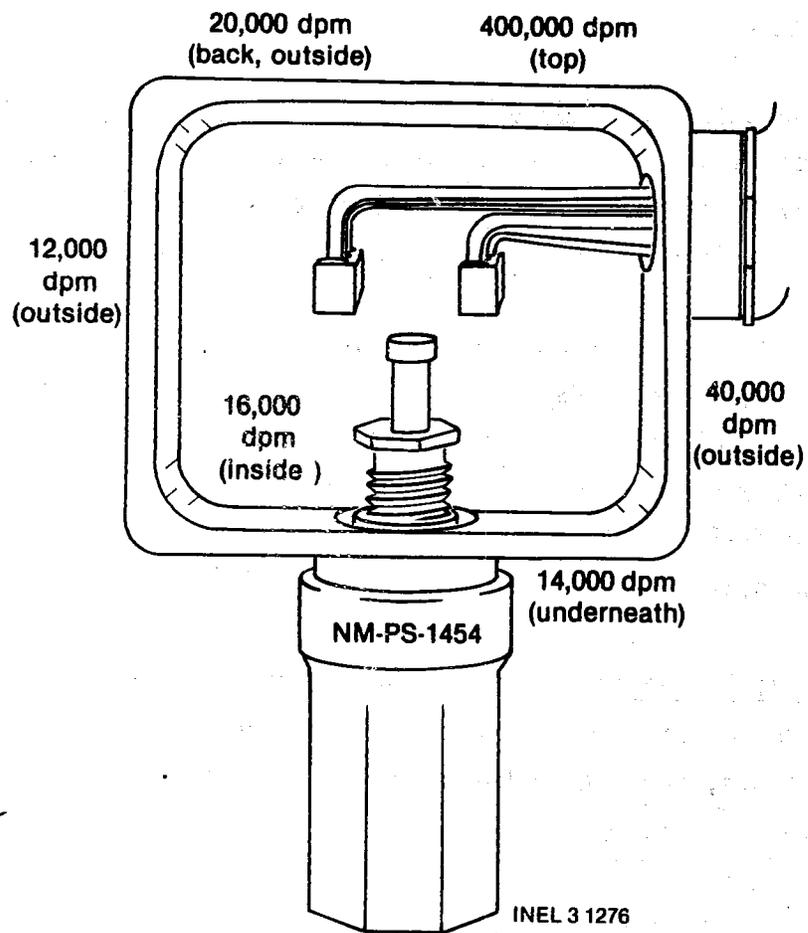
Radiological Observations. A smear survey of the switch exterior shows 12,000 to 400,000 dpm gross beta and gamma radiation (see Figure 9). The interior of the switch enclosure shows 16,000 dpm, indicating contaminated air had entered the enclosure. Cover plate gamma spectrum analysis and full smear count results appear in Table 2.

Figure 9. Contamination smear sites for NM-PS-1454.

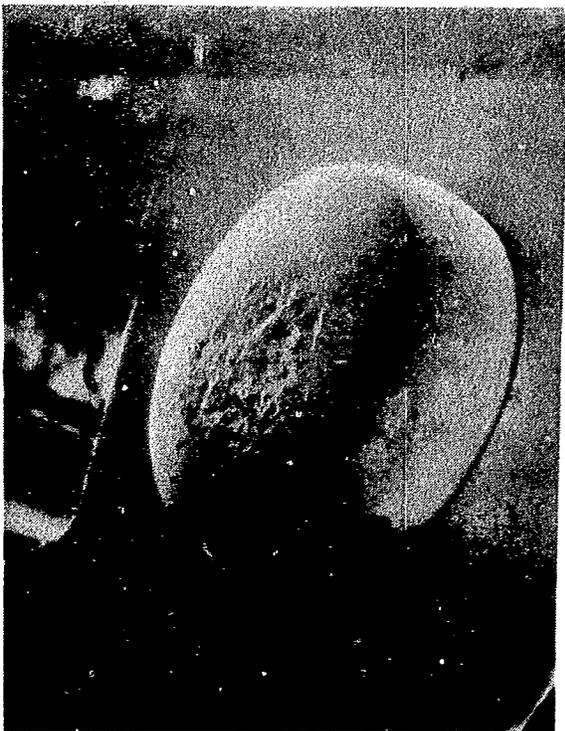
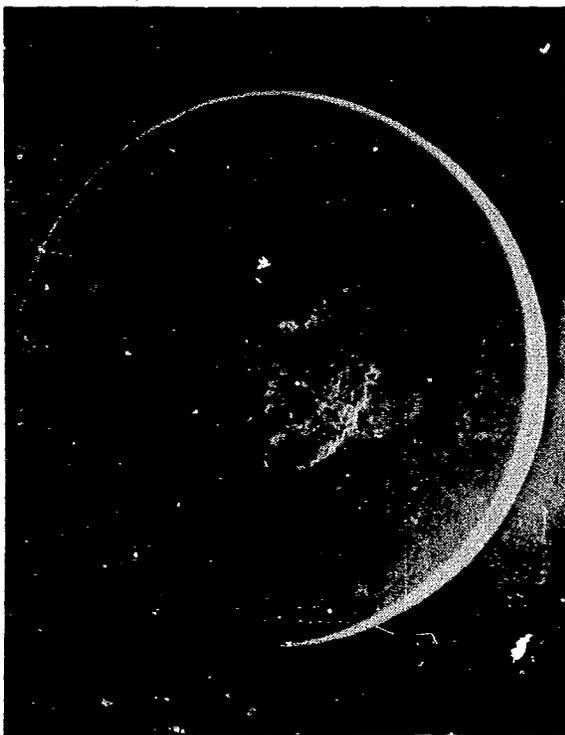
AC/DC Overload. Scanning electron microscope photographs of the right switch (ac overload) of NM-PS-4174 showed evidence of marked contact pitting (see Figures 10 and 11). Consequently, this right switch is considered unacceptable for further use. The left switch (dc overload) of both NM-PS-4174 and NM-PS-1454 showed evidence of contact arcing, but pitting appeared to be minimal (see Figures 10, 12, and 13).

Figure 11. Scanning electron microscope photographs of NM-PS-4174 right switch taken at the angles shown in Figure 10, post ac overload. (None of these contacts saw plant service.)

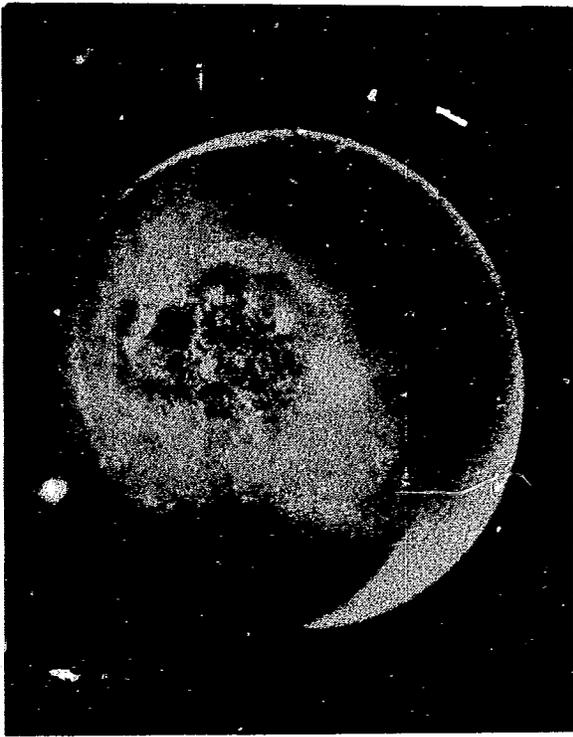
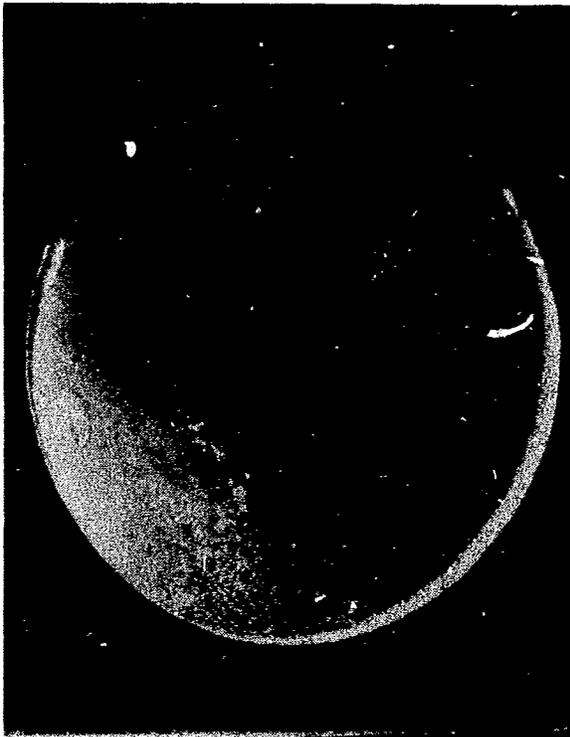
Figure 12. Scanning electron microscope photographs of MM-PS-4174 left switch taken at the angles shown in Figure 10, post dc overload.

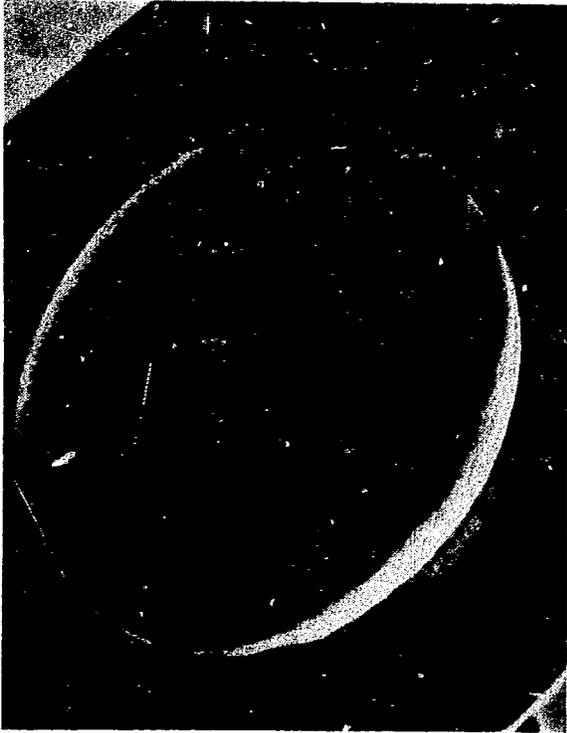
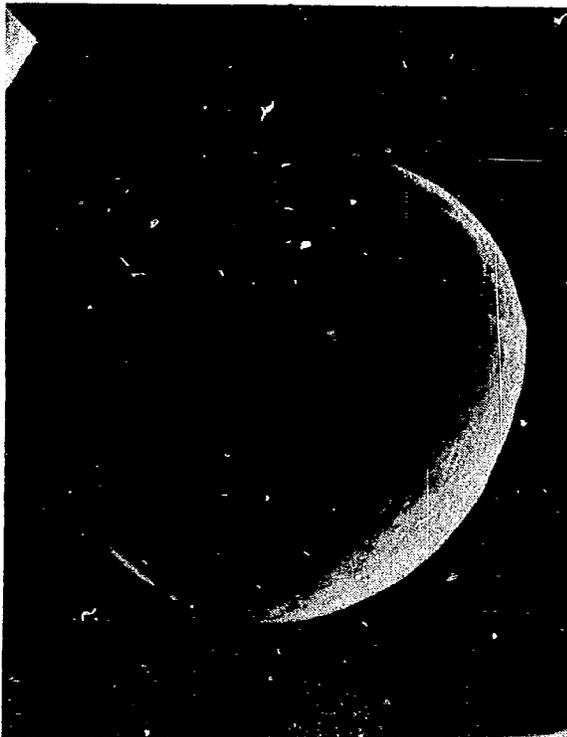
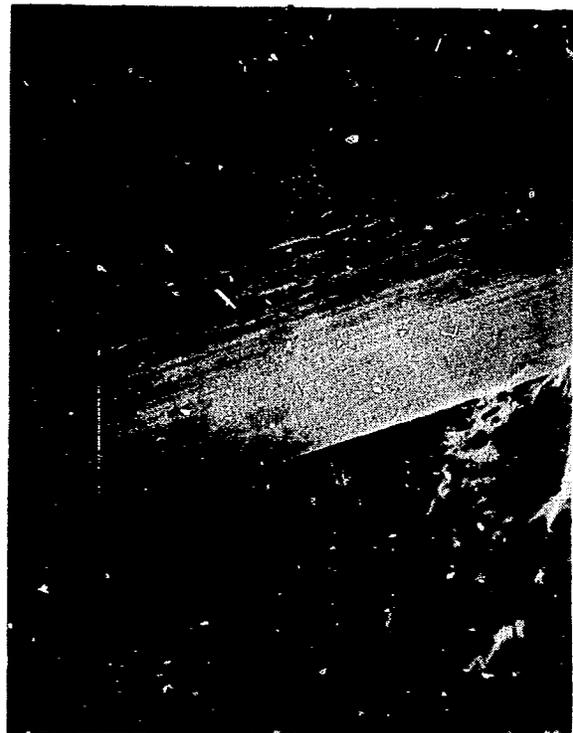
Figure 13. Scanning electron microscope photographs of MM-PS-1454 left switch taken at the angles shown in Figure 10, post dc overload.
