Dry Cask Storage Characterization Project- Phase I: CASTOR V/21 Cask Opening And Examination

*W. C. Bare
L. D. Torgerson*

August 2001

*Idaho National Engineering and Environmental Laboratory
Bechtel BWXT Idaho, LLC*

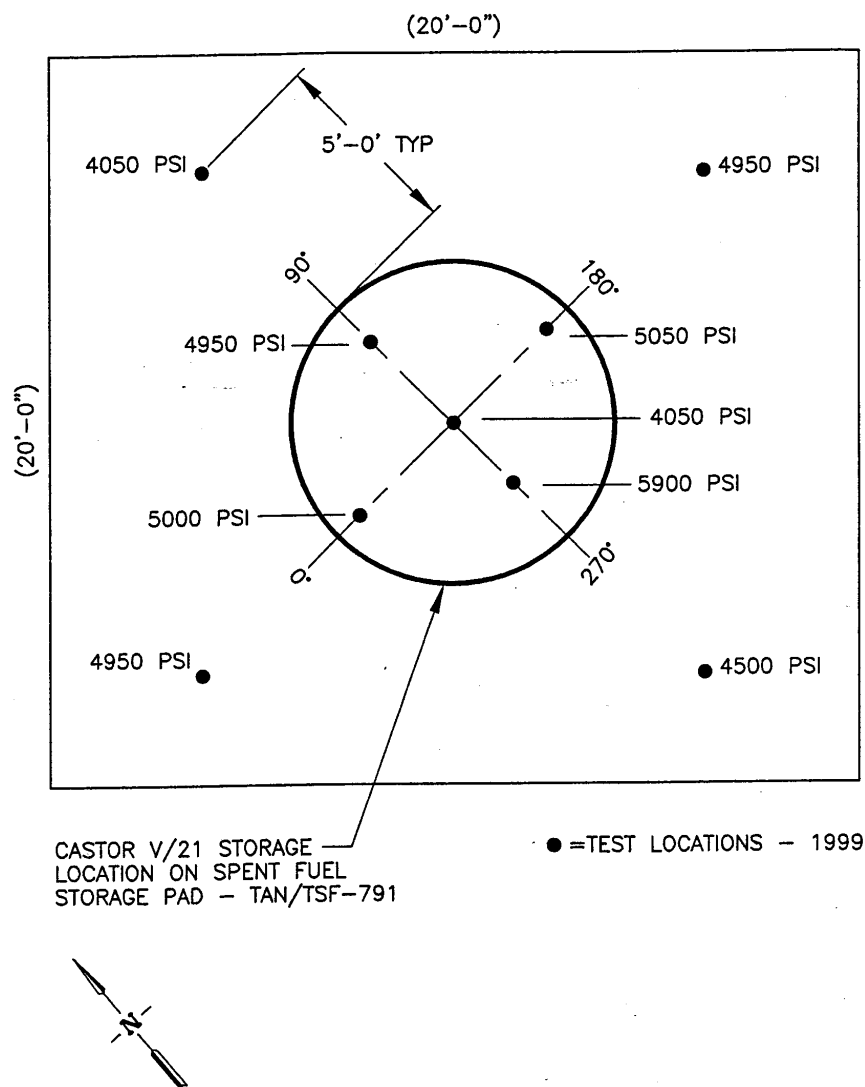
Figure 2-2. Rebound hammer test locations at CASTOR V/21 storage pad location.

The structural soundness of the concrete was determined by ASTM test standard C805-94 (Test Method for Rebound Number of Hardened Concrete, also known as the Swiss hammer test). The Swiss hammer test was performed on the concrete surface in 9 places in a 37.2 m (122 ft) area centered on the placement of the CASTOR V/21 cask, of which 5 places were selected in the area under the cask. The nine test results (Figure 2-2), which ranged from 28 MPa (4050 psi) to 41 MPa (5900 psi), averaged at 33 MPa (4800 psi) and demonstrated that the structural integrity of the concrete pad still meets or exceeds the 28 MPa (4050 psi) design strength of the concrete.

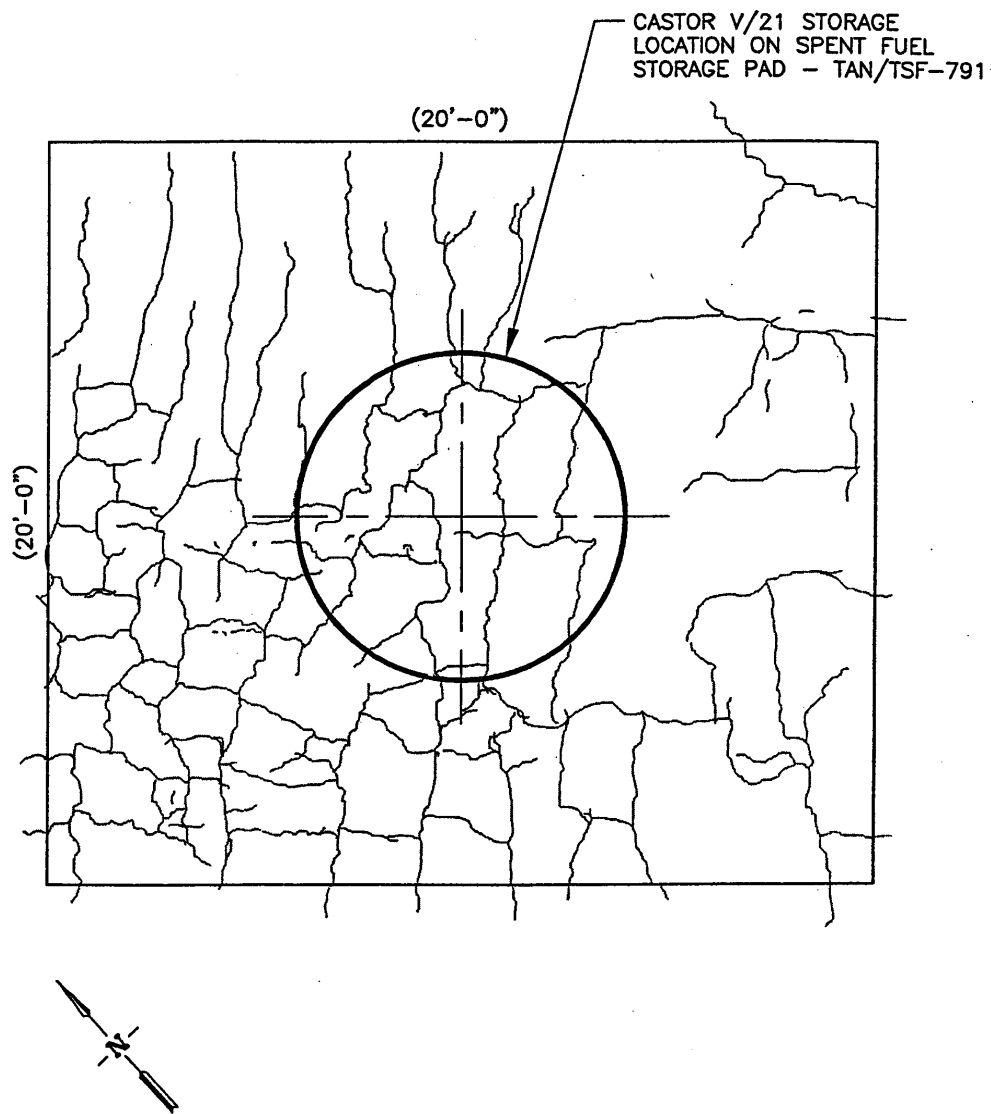
The pad was also visually inspected for evidence of degradation and structural failure. The surface of the whole pad did not exhibit any evidence of structural failure of the concrete, such as open cracks or cracks with displacements in elevation of the surface. The surface of the concrete did not exhibit any evidence of spallation of the surface, exposed aggregate, or aggregate pop-out from the surface. The surface was solid and exhibited only minor wear and environmental weathering, well within the extent of weathering expected for the cold and windy climate of Idaho. The broom-finished unpainted surface exhibited only a network of faint, fine surface shrinkage cracks (Figure 2-3), less than 0.8 mm (1/32 in.) wide and of superficial depth, and a few rust stains under the cask from lightly rusted bolts on the cask. Similar cracks were prevalent across the entire surface of the pad, and were not associated with the cask locations. Tests with a straight taught line across the 6.1 m \times 6.1 m (20 \times 20 ft) grid indicated that there was no sag or vertical displacement in the concrete associated with the crack network; measurements with a straight edge and the taught line indicated only localized variations in the elevation of the concrete that were less than 3.2 mm (1/8 in.). The localized variations in elevation were not associated with the location of the cask and were most likely an artifact of the screeding and finishing when the concrete was originally poured.

Figure 2-3. Shrink crack indication of CASTOR V/21 concrete pad storage area.

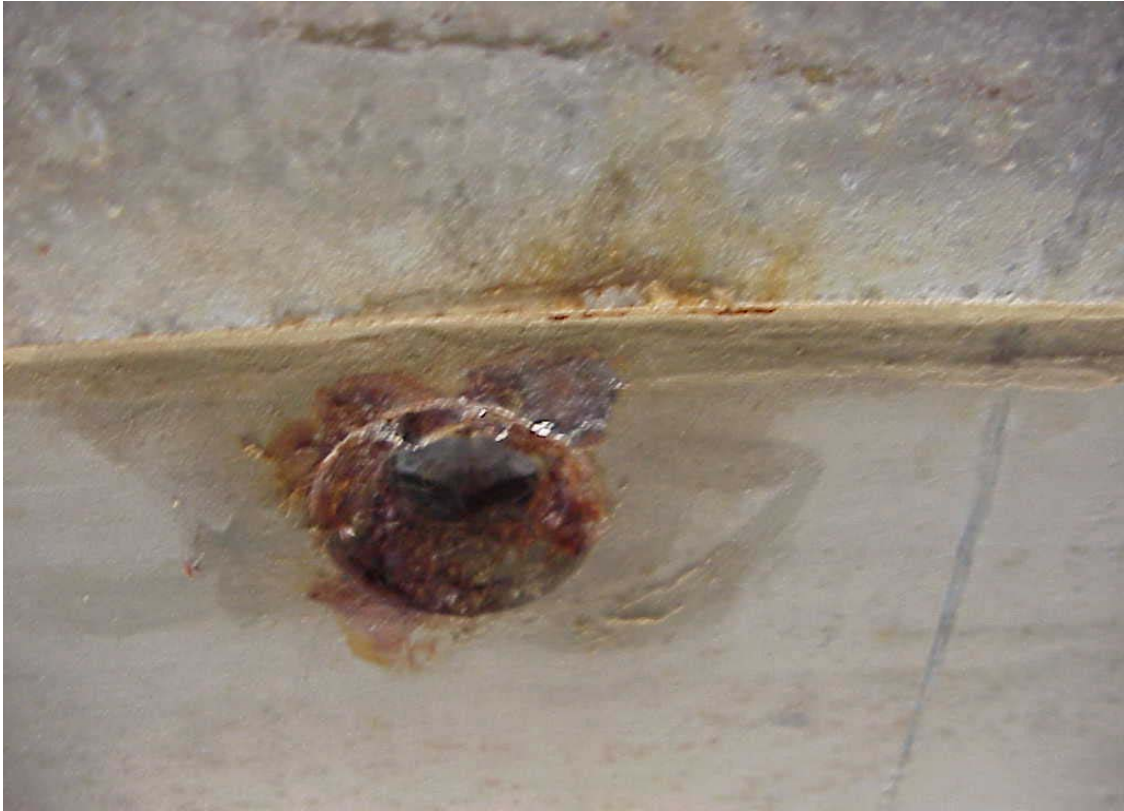
Figure 2-4. Cask bottom cover plate bolt corrosion.

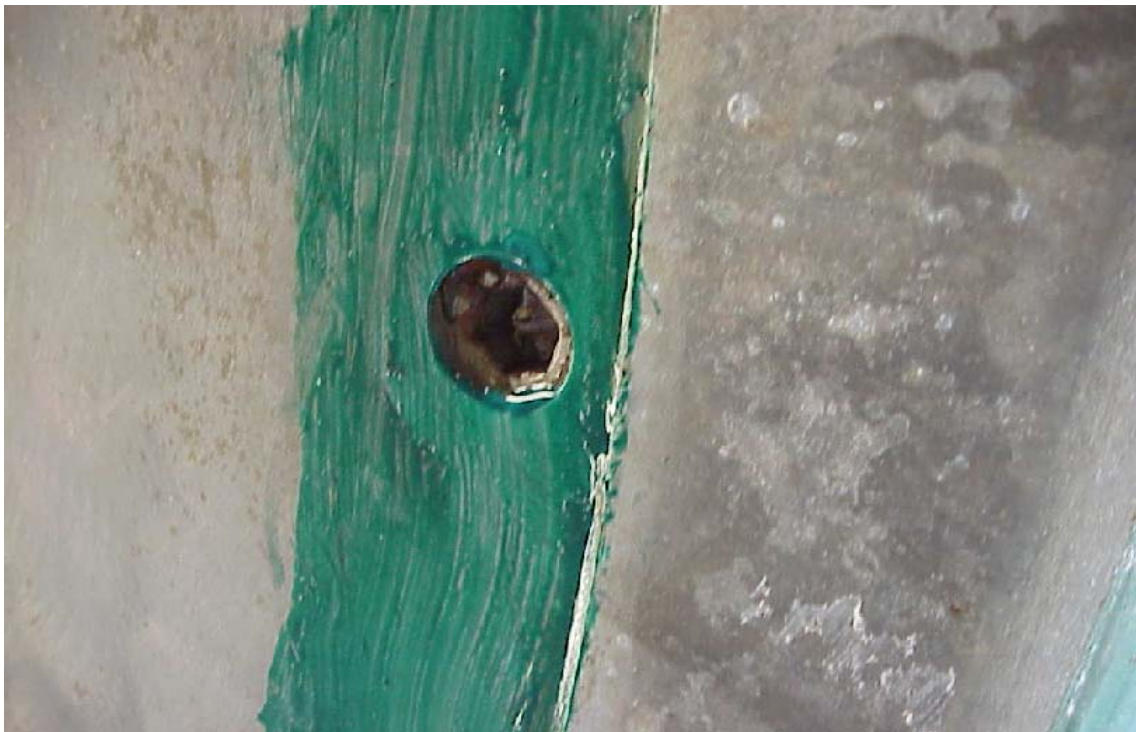
Figure 2-5. Cask bottom cover plate bolt after corrosion removal.

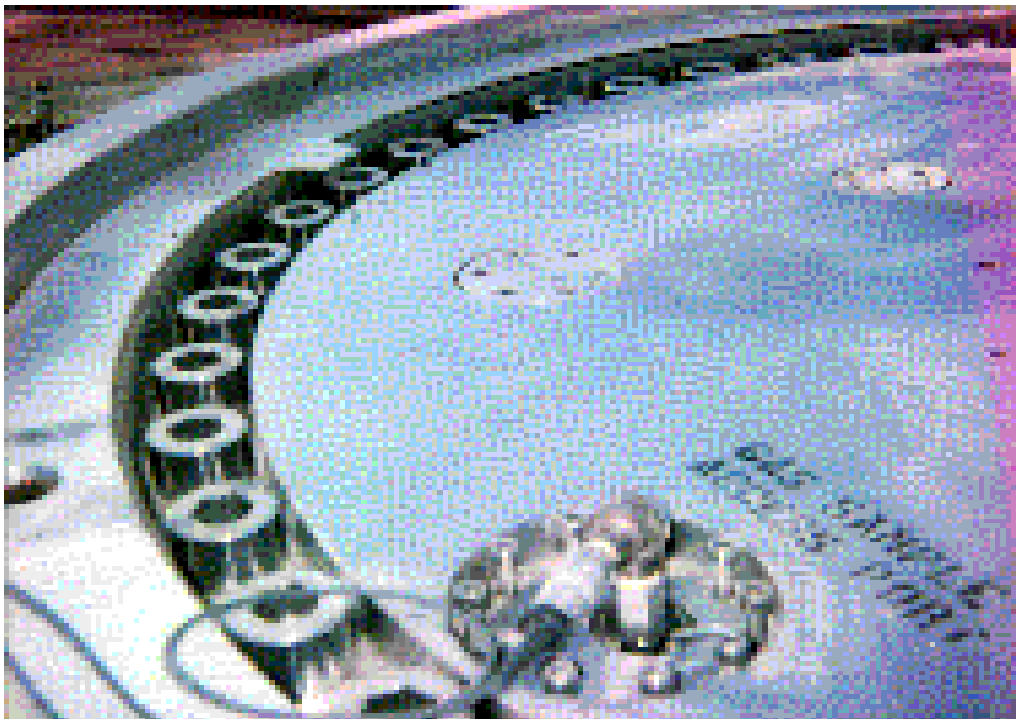
All bolts were in satisfactory condition. The exposed portion of all bolt heads were found to be in very good condition. None of the primary lid bolts as shown in Figures 2-6 and 2-7 had any indications of

Figure 2-7. Cask primary lid bolts prior to removal.

pitting or general corrosion, cracks, thread damage, discoloration, or any defects or indications of potential failure. All bolts had a deposit of graphitic thread lubrication over the threaded area of the shaft. Nine of the bolts also had a residue of a light gray/white material on the threads that resembled tape residue, and a residue of a red compound, probably a thread compound.

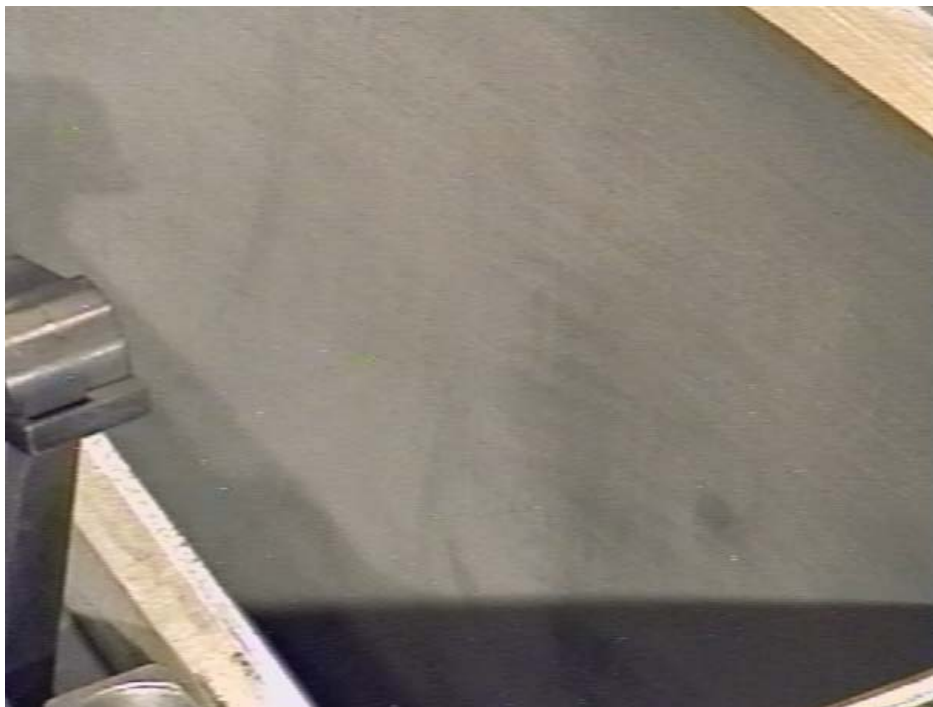
Figure 2-13. Cask wall at top—typical surface condition.

Considering the tight fit of the basket within the cask body, the nickel coating on the upper sidewall shows little evidence of damage due to insertion of the basket. The only discernible feature that might constitute significant coating damage was a black mark on the sidewall at the level of and coincident with the corner of fuel tube D3. However, the black surface mark appeared to be superficial, and did not have any burrs or dimensional relief indicative of substantial abrasion damage, corrosion product formation, or cracks. While the feature is coincident in location with the corner of fuel tube D3, it cannot be the result of abrasion by the corner of the fuel tube (by vibration from cask handling), for the fuel tube is separated from the wall by the thickness of the steel barrel plate comprising the outer rim of the basket. Instead, this feature may be the result of abrasion during insertion of the tightly fitting basket into the cask or from vertical thermal expansion of the tightly fitting basket barrel wall during the 1985 thermal tests. The upper sidewall has several similar, less distinct blemishes that could be construed as light scuffing or abrasion of the nickel coating from contact during the insertion of the basket into the cask body. These features consist of black ‘scuffs’ and spots on the nickel surface, as if the nickel plating was lightly abraded from the high points of the rough as-machined surface of the cask body. These features have no discernible relief, implying negligible superficial damage at worst, and have no evidence of more than possibly superficial surface corrosion as might have occurred prior to sealing the cask in 1985. Furthermore, there was no evidence of delamination and peeling of the nickel layer around these features or of subsurface corrosion or blistering in the areas surrounding the features, which could be the expected effect from a corrosive, oxidizing environment.

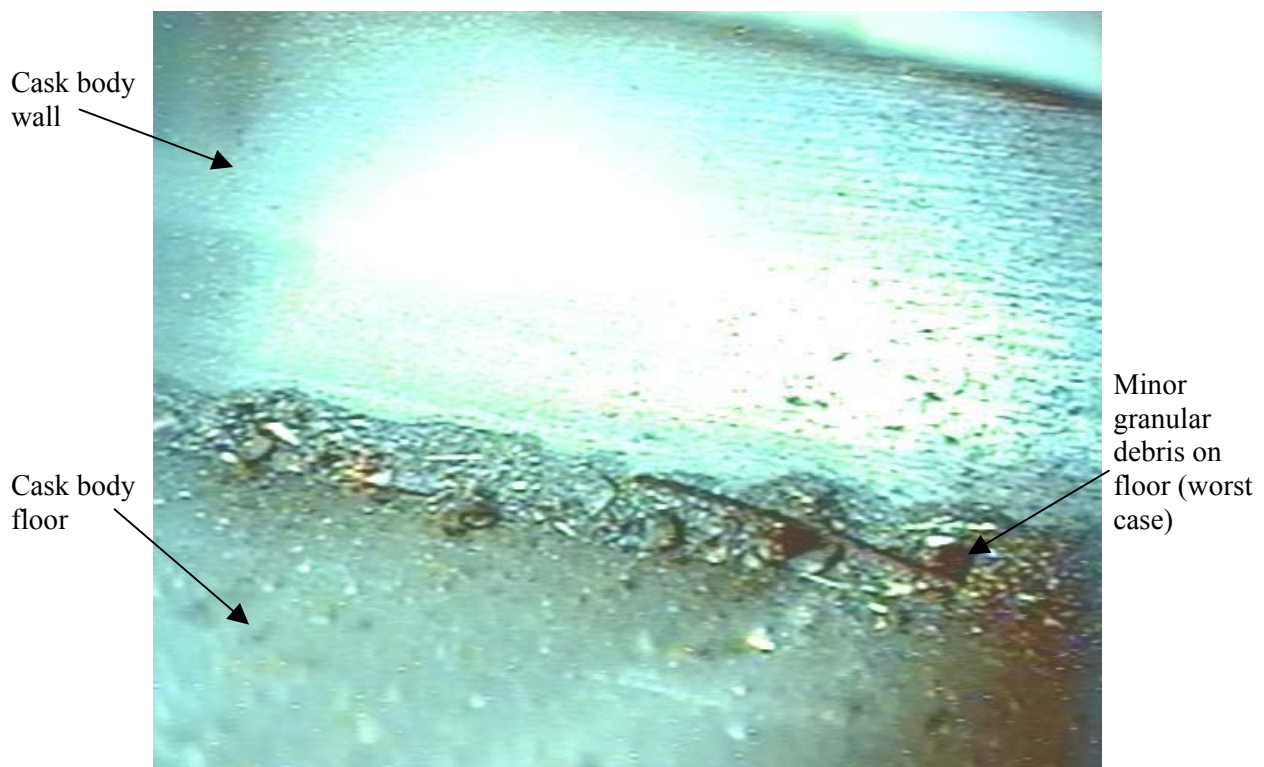
Small grains of debris were thinly scattered over most of the cask floor as shown in Figure 2-14 and Appendix F. The debris ranged from sandlike particles of submillimeter to several millimeter size to long slivers of material several millimeters in length. These generally appeared to have been deposited after the nickel plating of the surface, because the larger particles were dark in color and not reflective. Similar material had accumulated on the horizontal bars at the bottom of each fuel tube on which the fuel assemblies rested. Much of the sand-like debris probably consists of welding slag or grinding swarf from the basket. However, some of the debris appeared to consist of slivers of metal. The slivers may be slivers of stainless steel gouged from the fuel tube walls by insertion and extraction of the fuel assemblies, because the fuel tube walls exhibited much evidence of scraping by the fuel assemblies.

Figure 2-14. Cask floor and wall below fuel tube C8—reflective surfaces free of corrosion.

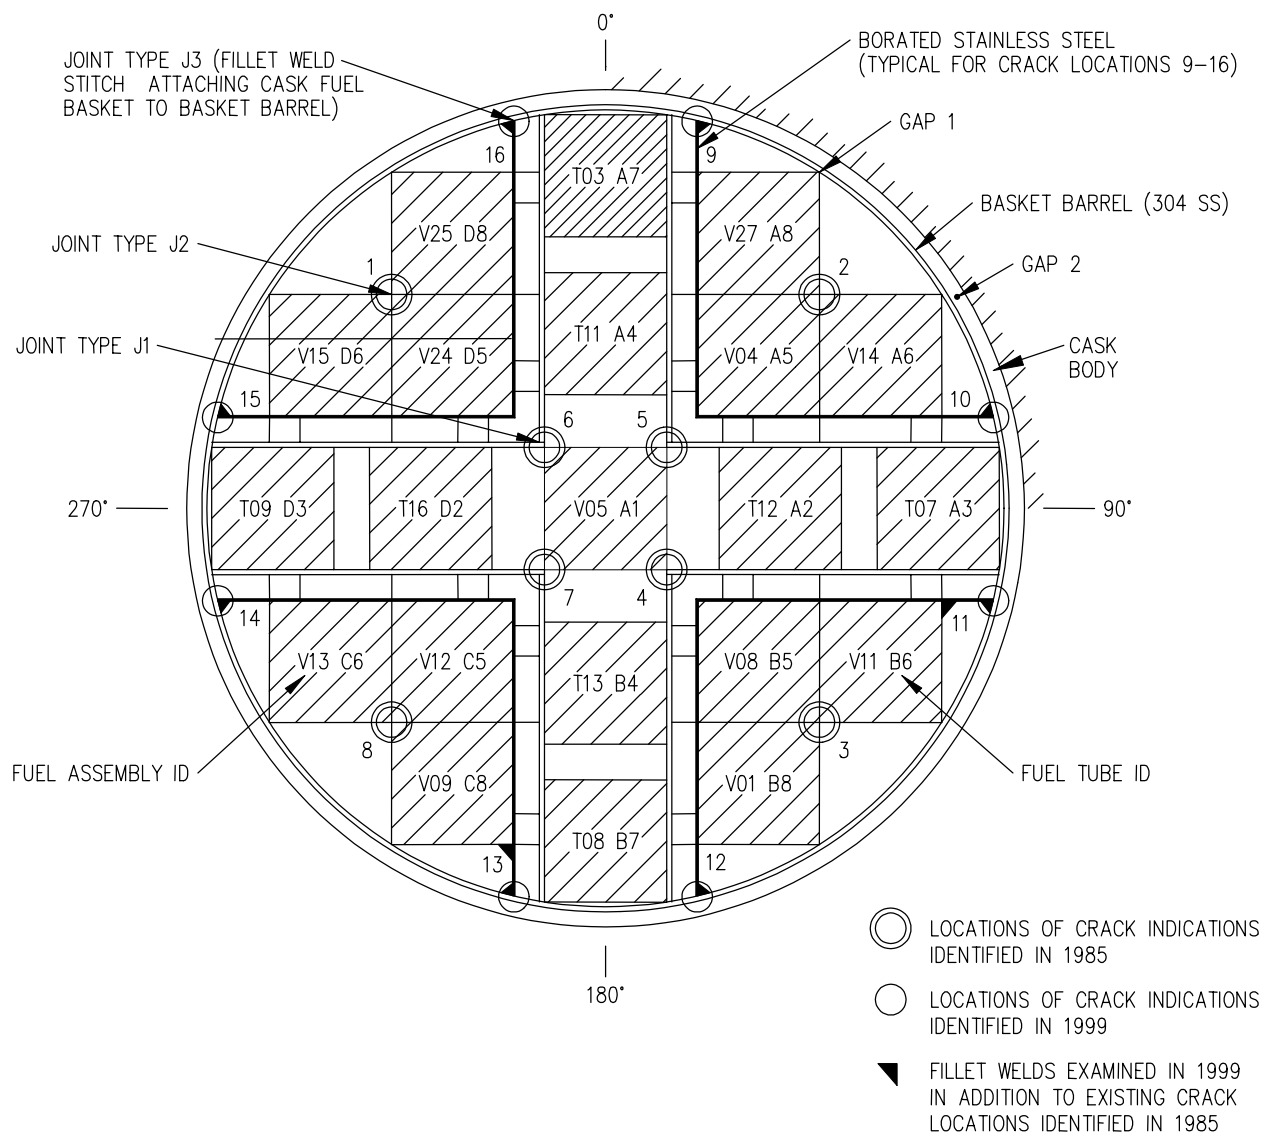
Figure 2-16. CASTOR-V/21 basket crack indication locations and fuel tube arrangement.

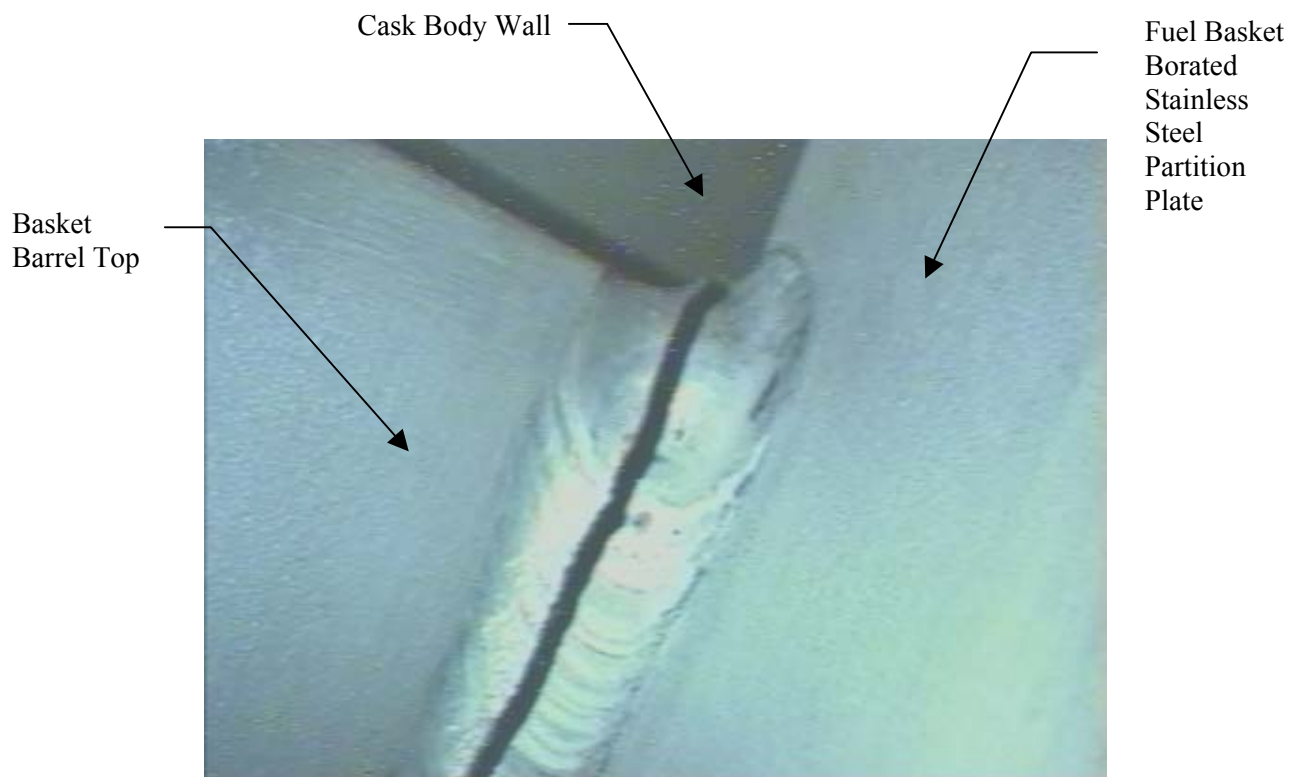
Figure 2-17. Typical top stitch weld crack at location 14 identified in Figure 2-16.

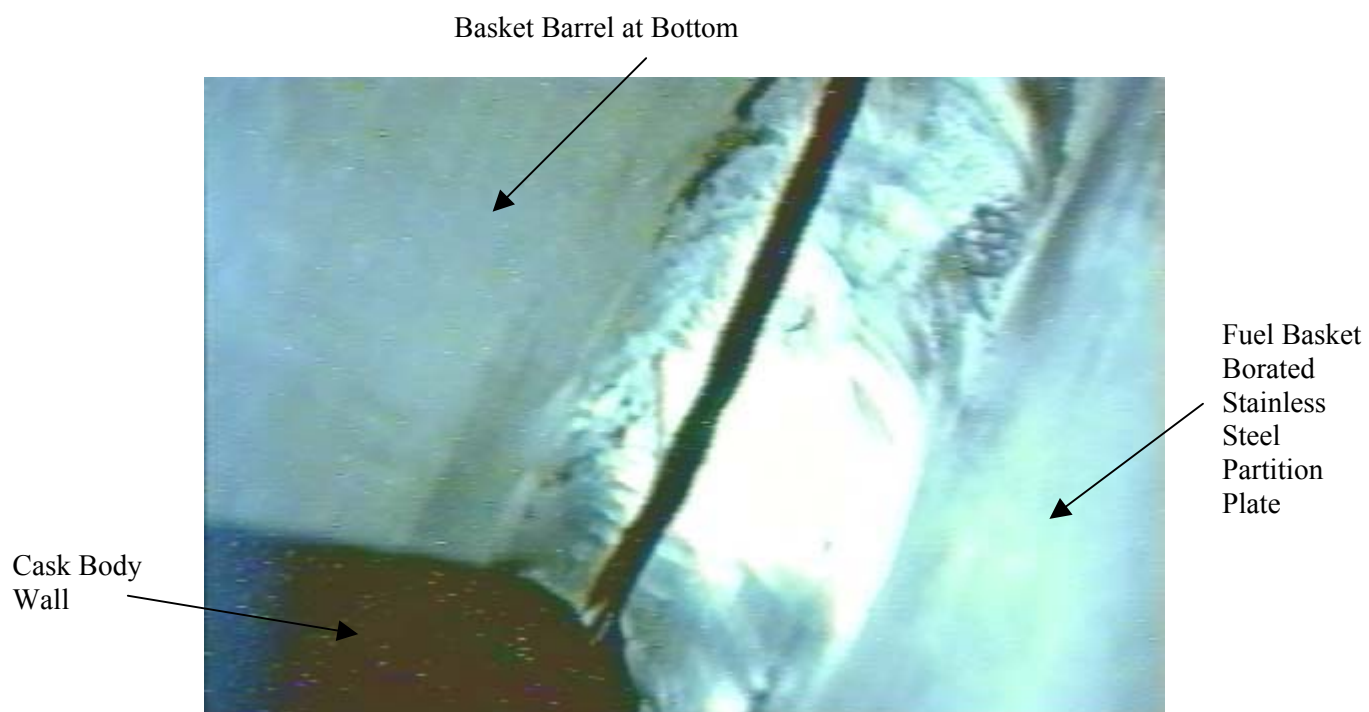
Figure 2-18. Typical bottom stitch weld crack at location 14 identified in Figure 2-16.

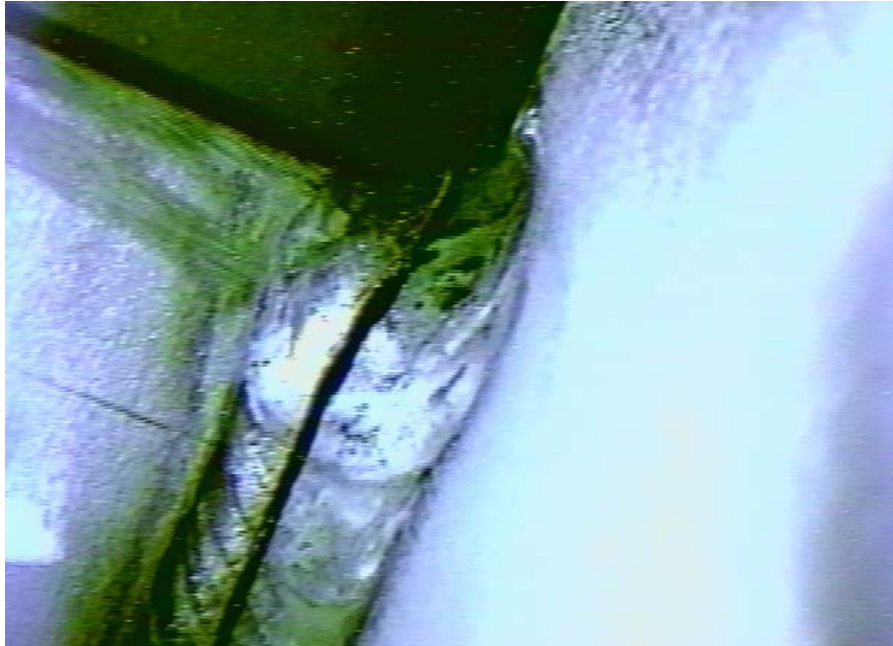
Figure B-3. Top weld crack at location 10 identified in Figure B-19.
(Triangular air channel between fuel tube A3 & A6)

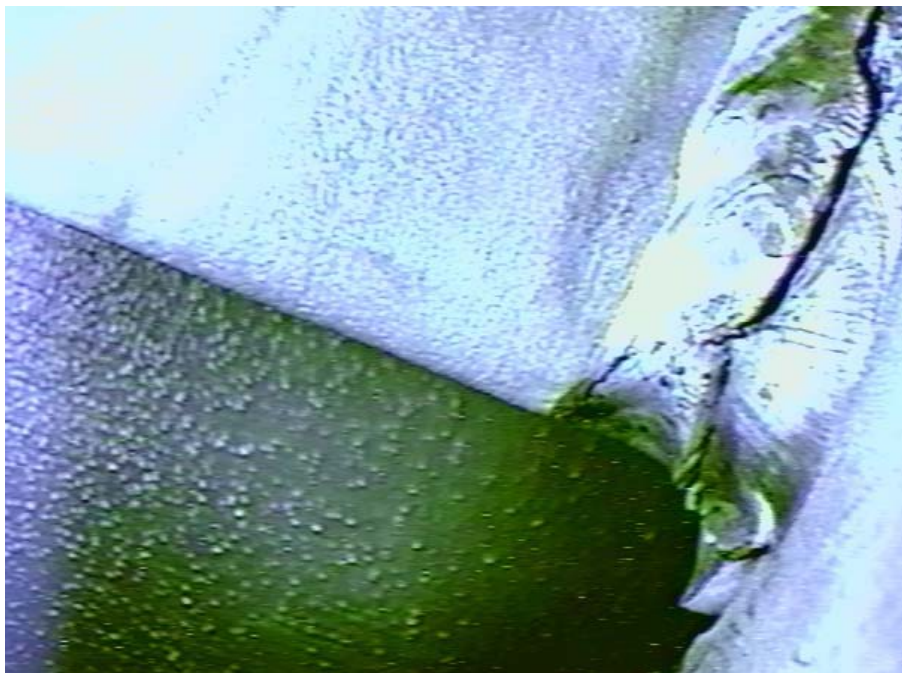
Figure B-4. Bottom weld crack at location 10 identified in Figure B-19.
(Triangular air channel between fuel tube A3 & A6)

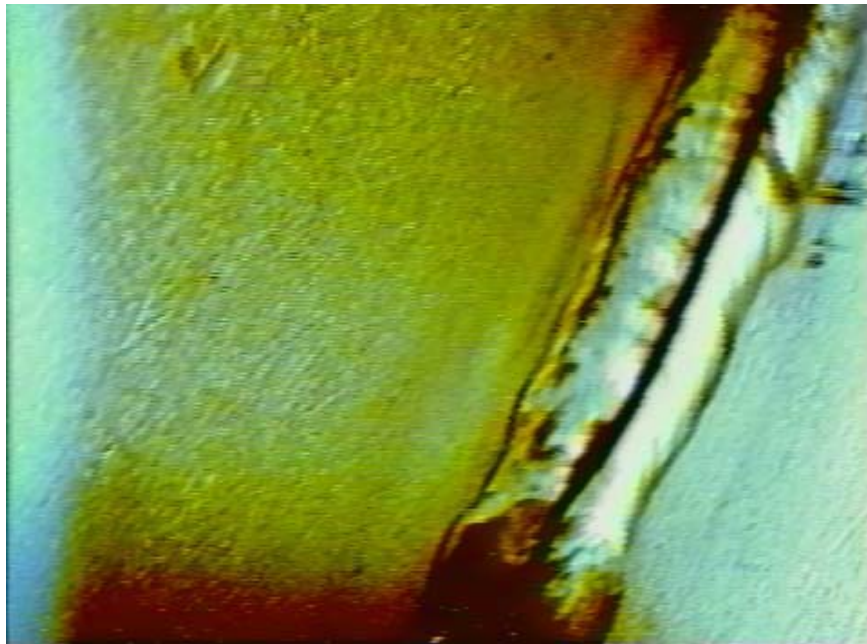
Figure B-6. Bottom weld crack at location 11 identified in Figure B-19.
(Triangular air channel between fuel tube A3 & B6)

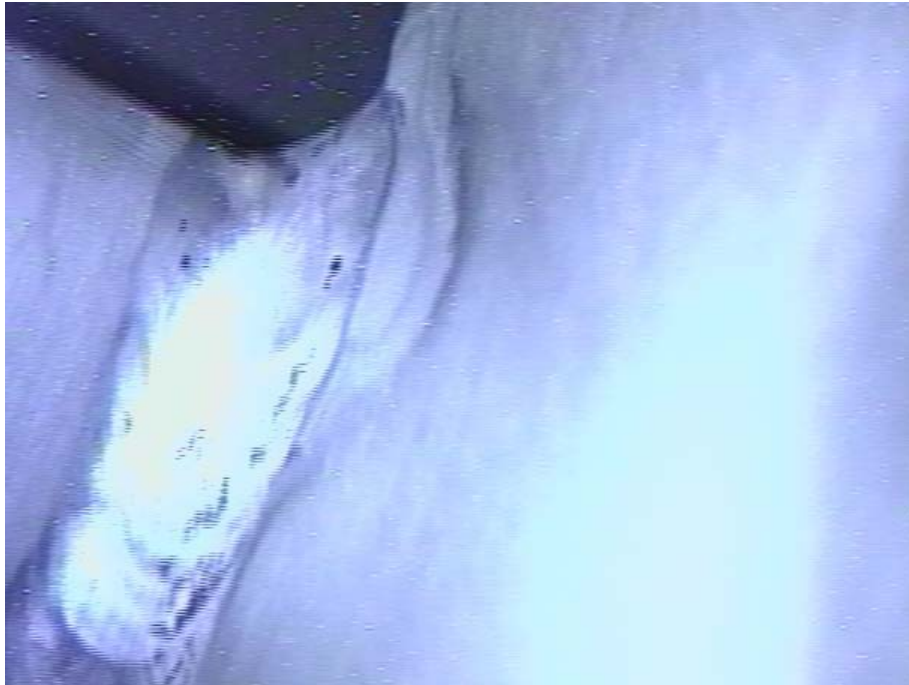
Figure B-7. Top weld no crack. Location number 12 identified in Figure B-19.
(Triangular air channel between fuel tube B7 & B8)

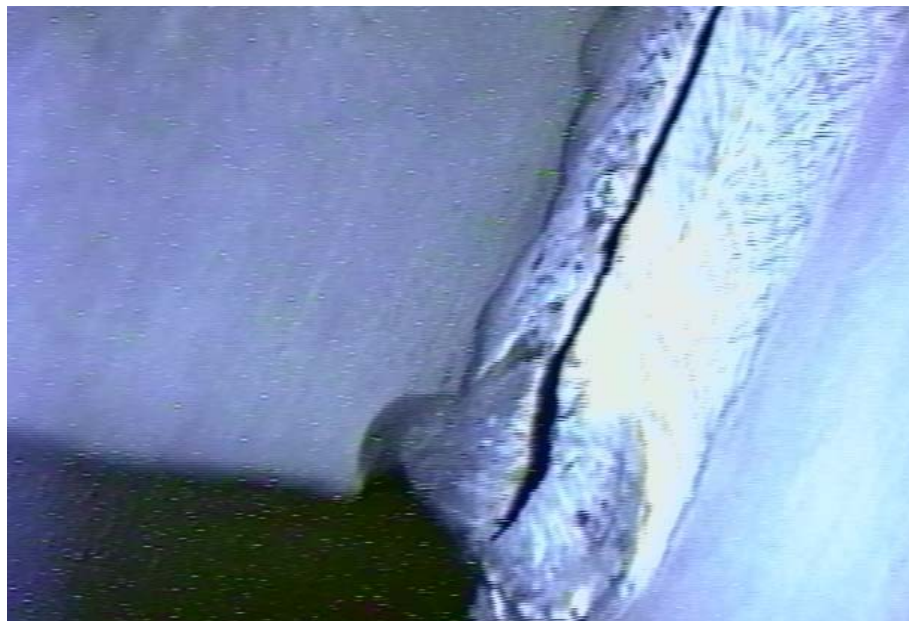
Figure B-8. Bottom weld crack at location 12 identified in Figure B-19.
(Triangular air channel between fuel tube B7 & B8)

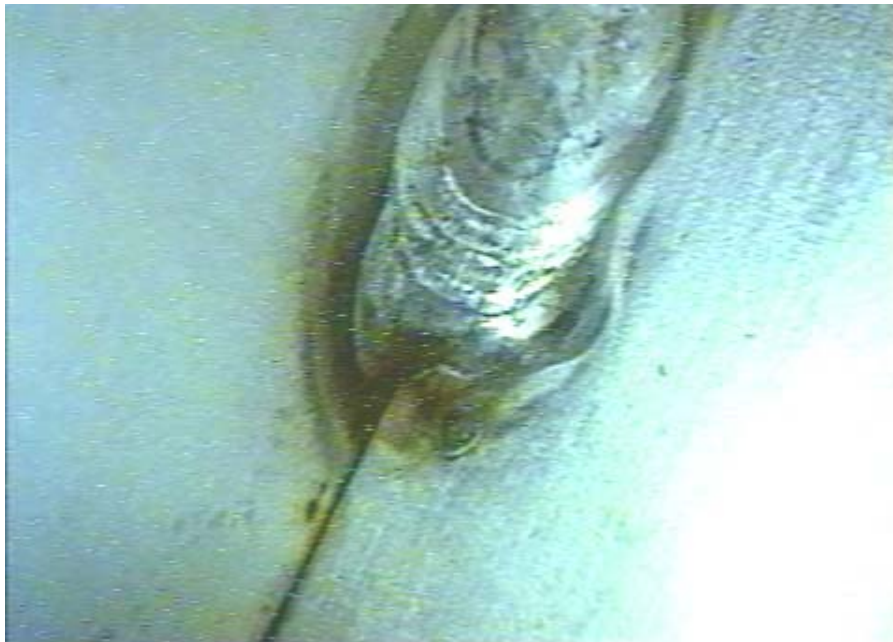
Figure B-9. Top weld crack (minor) at location 13 identified in Figure B-19.
(Triangular air channel between fuel tube B7 & C8)

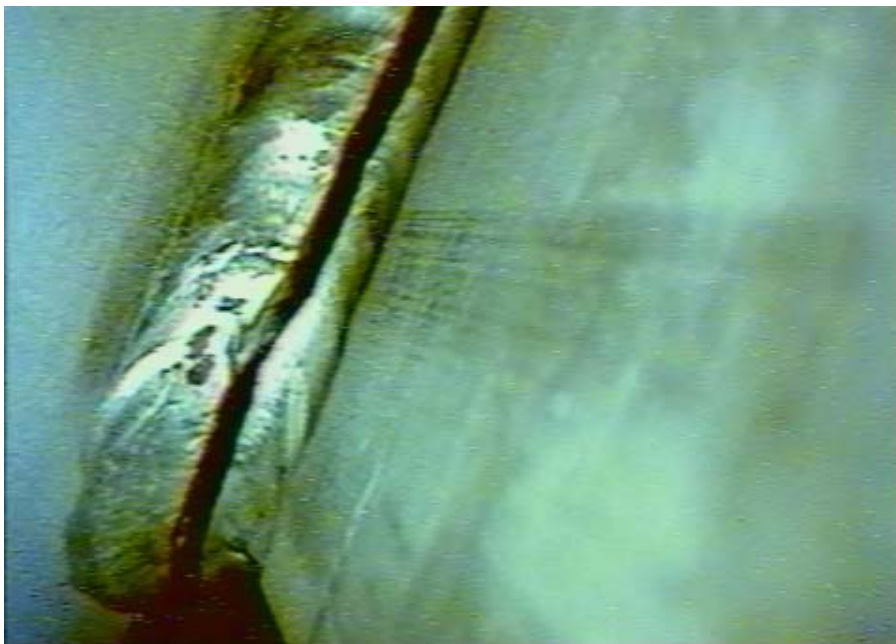
Figure B10. Bottom weld crack at location 13 identified in Figure B-19.
(Triangular air channel between fuel tube B7 & C8)

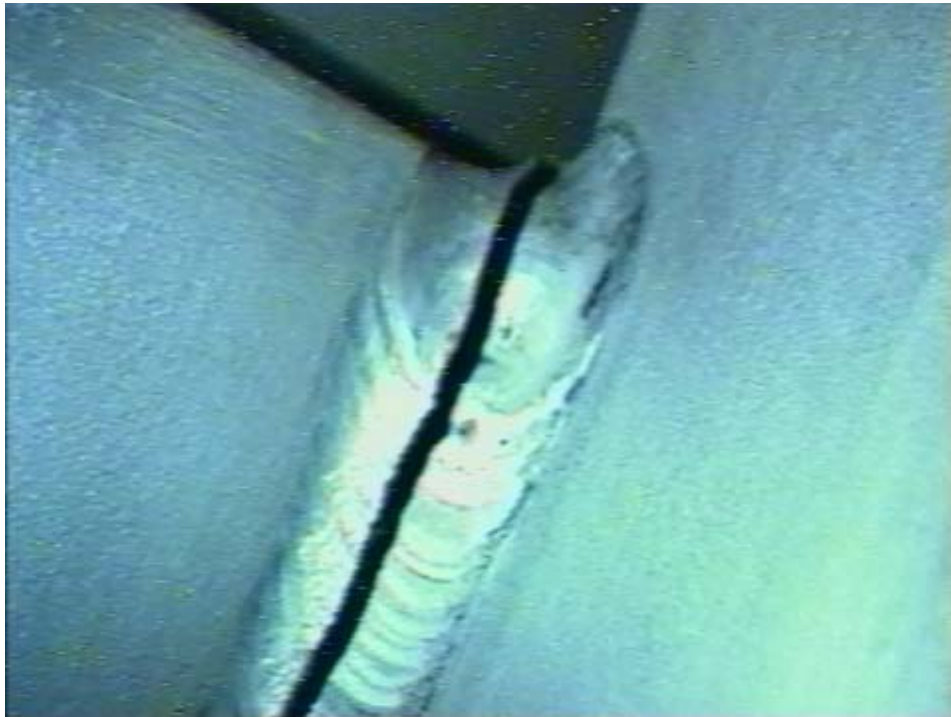
Figure B-11. Top weld crack at location 14 identified in Figure B-19.
(Triangular air channel between fuel tube C6 & D3)

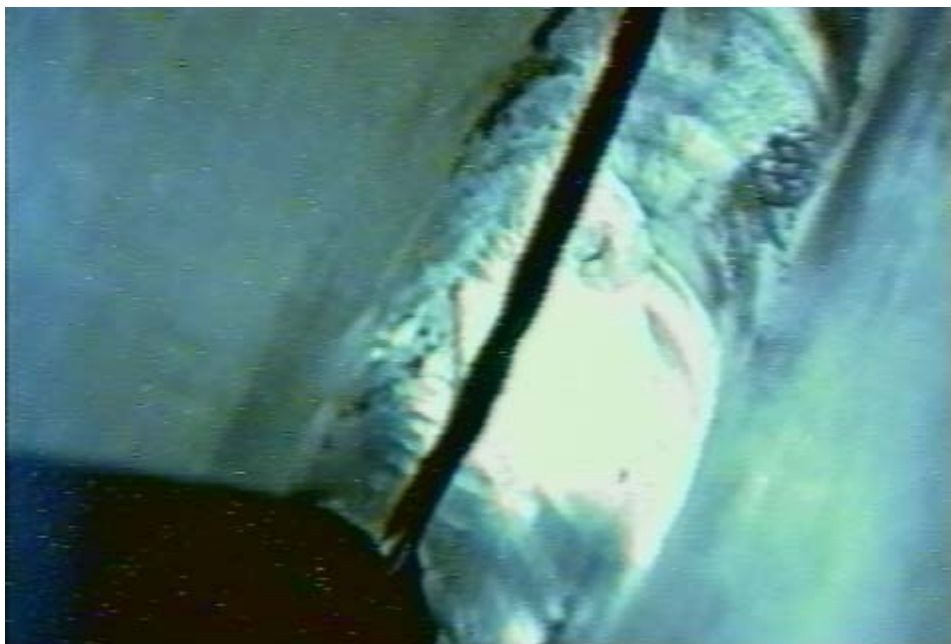
Figure B-12. Bottom weld crack at location 14 identified in Figure B-19.
(Triangular air channel between fuel tube C6 & D3)

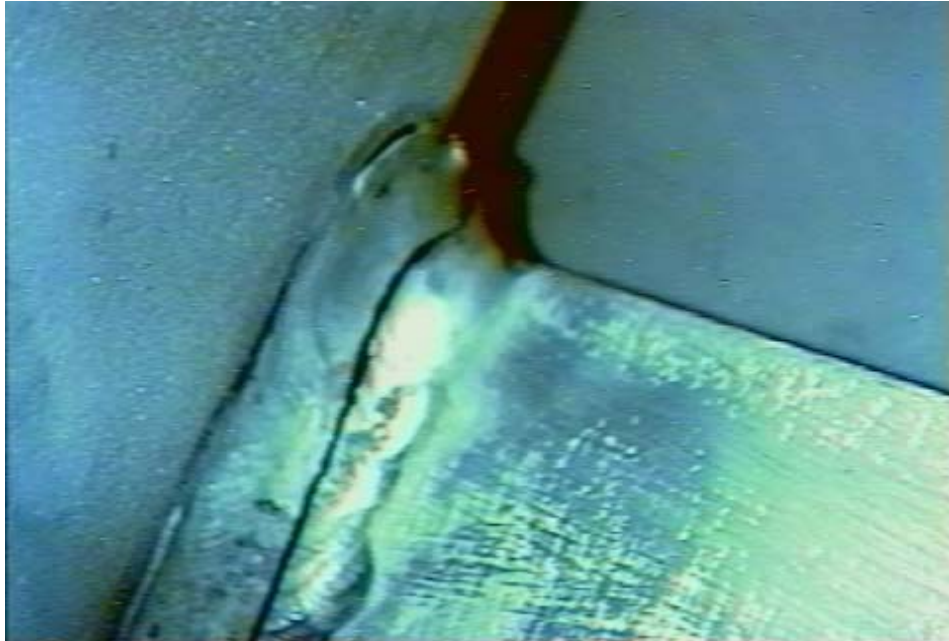
Figure B-13. Top weld crack at location 15 identified in Figure B-1.
(Triangular air channel between fuel tube D3 & D6)

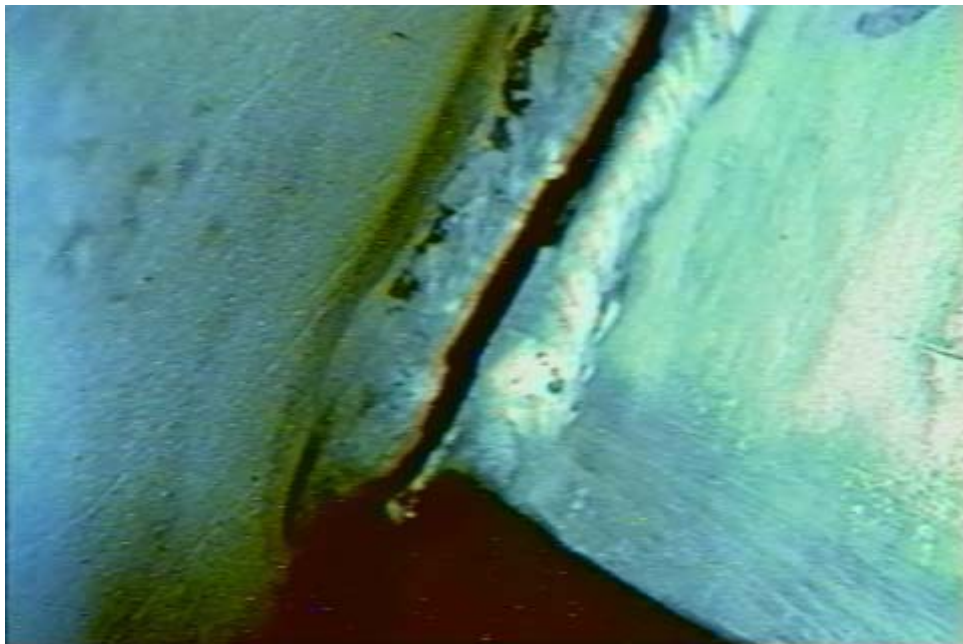
Figure B-14. Bottom weld crack at location 15 identified in Figure B-19.
(Triangular air channel between fuel tube D3 & D6)

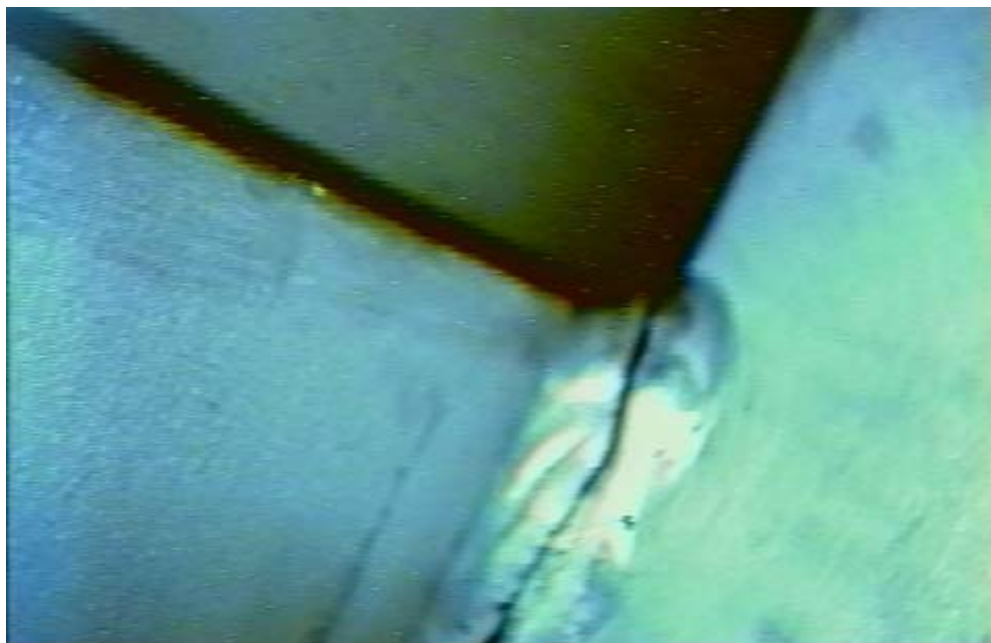
Figure B-15. Top weld crack at location 16 identified in Figure B-19.
(Triangular air channel between fuel tube A7 & D8)

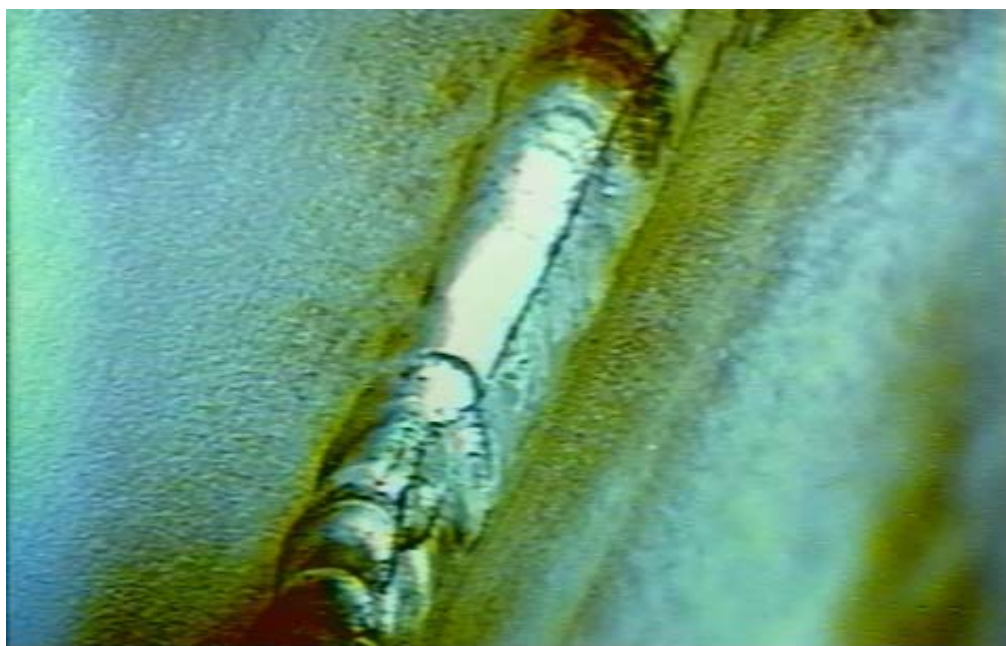
Figure B-16. Bottom weld crack at location 16 identified in Figure B-19.
(Triangular air channel between fuel tube A7 & D8)

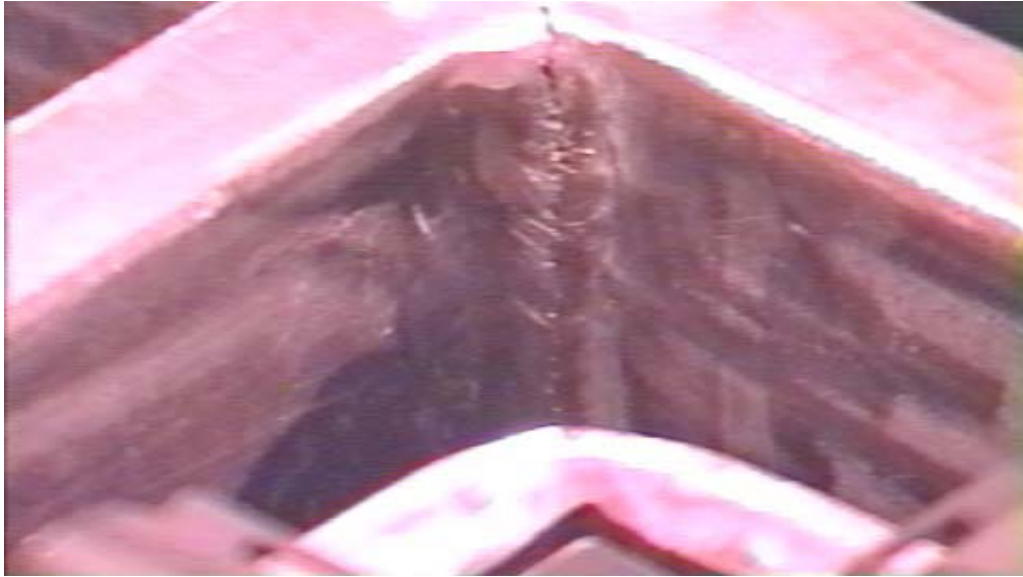
Figure B-17. Crack in basket weld below weld crack 4 (120°) identified in Figure B-19.

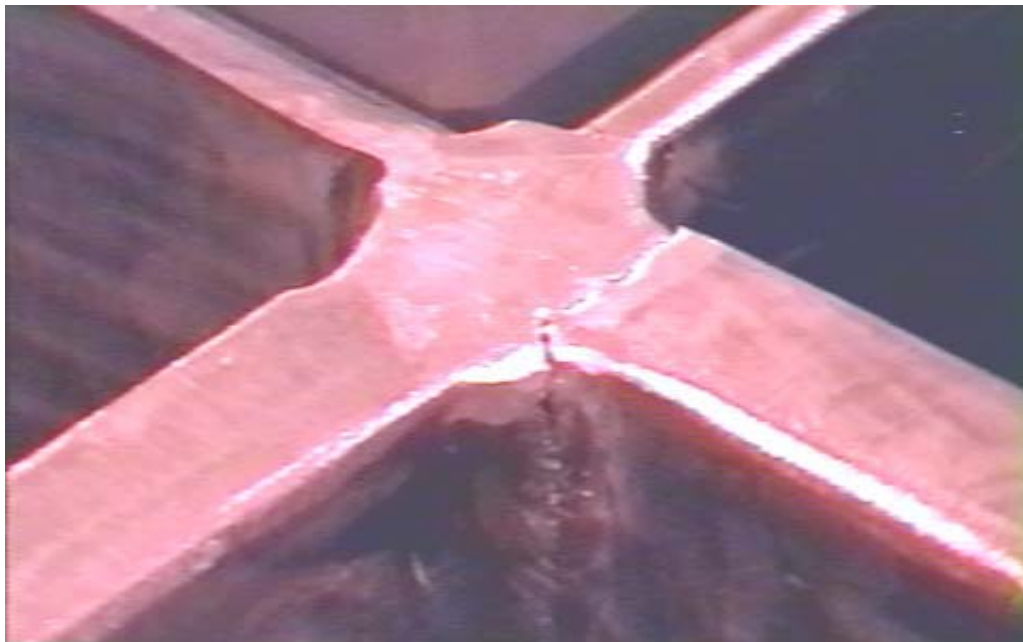
Figure B-18. Same as Figure B-17 with complete view of existing weld crack 4 identified in Figure B-19.

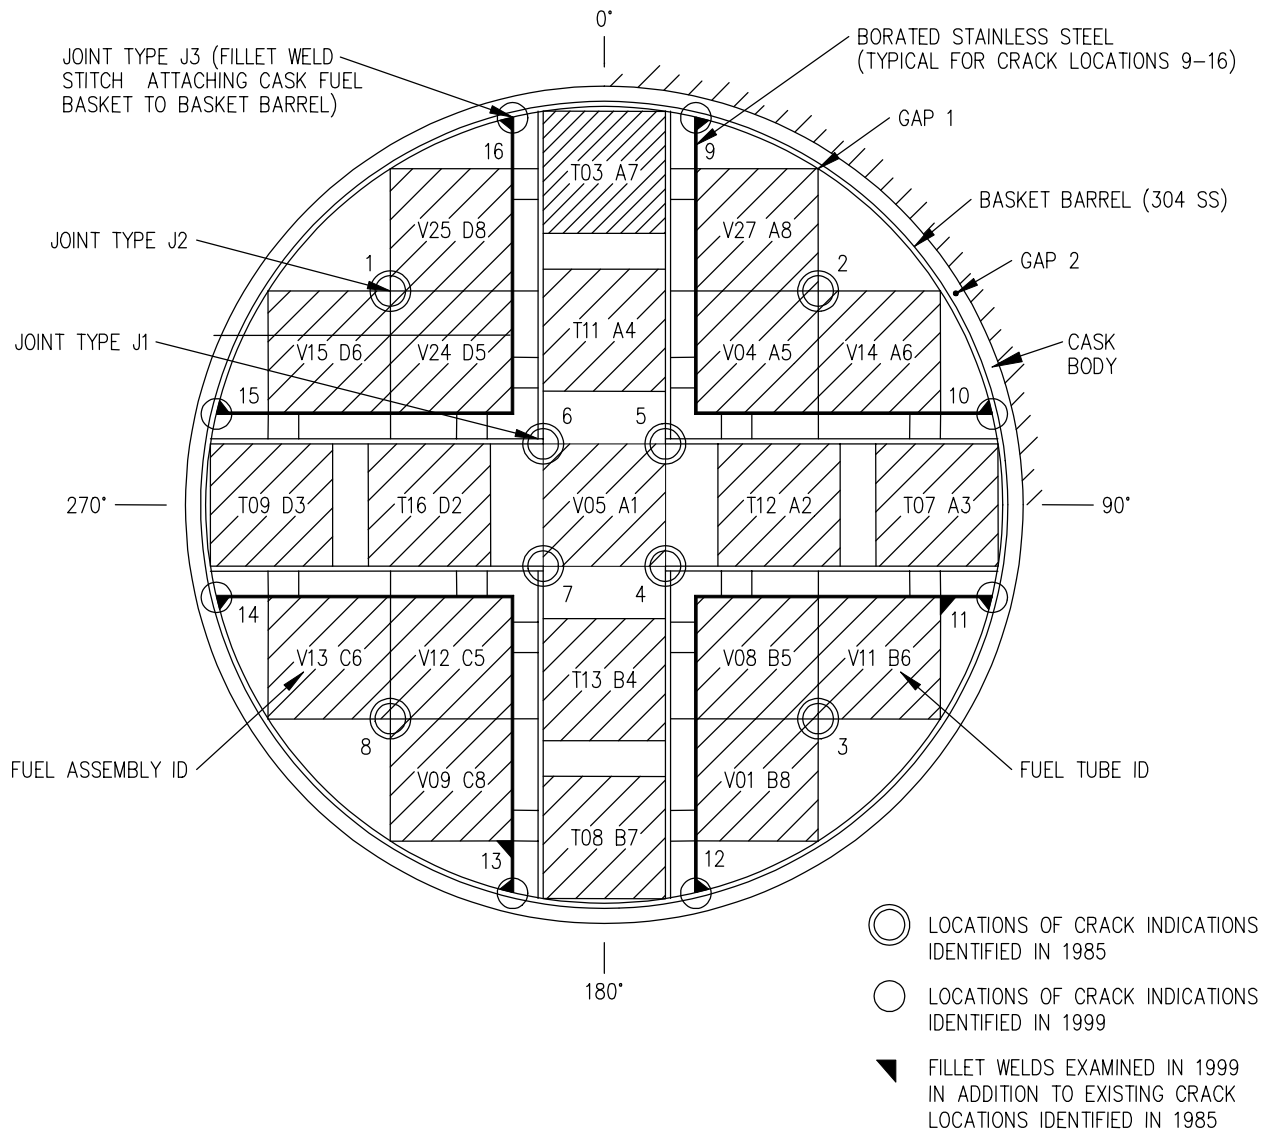
Figure B-19. CASTOR V/21 Basket Crack Indication Locations.

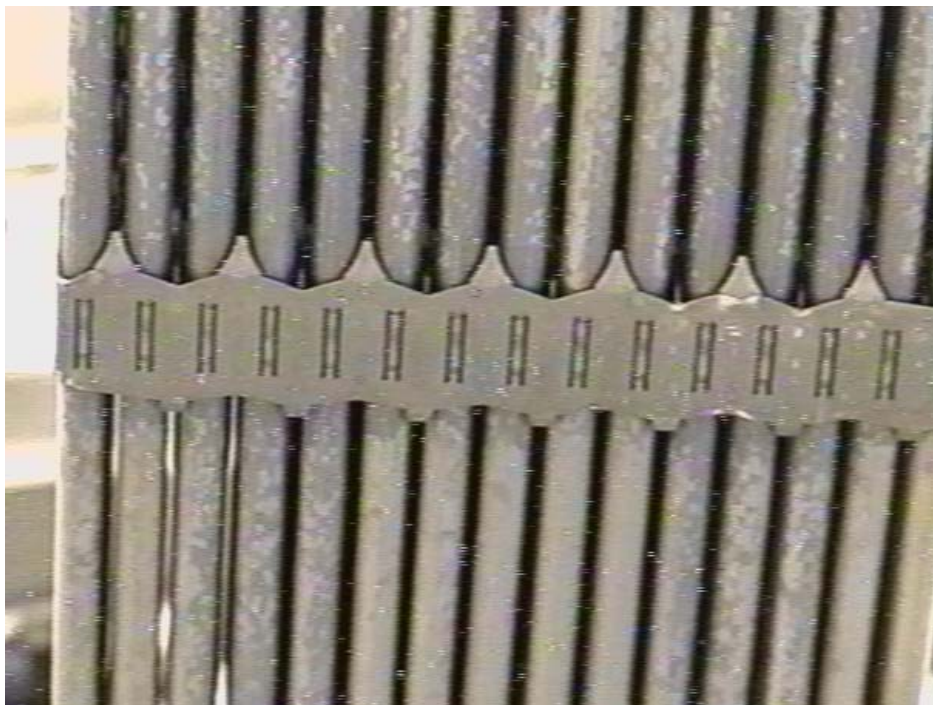
Figure C-3. Oxide mottling noted around spacer #5 on fuel assembly V-05.
