Dry Cask Storage Characterization Project- Phase I: CASTOR V/21 Cask Opening And Examination

*W. C. Bare
L. D. Torgerson*

August 2001

*Idaho National Engineering and Environmental Laboratory
Bechtel BWXT Idaho, LLC*

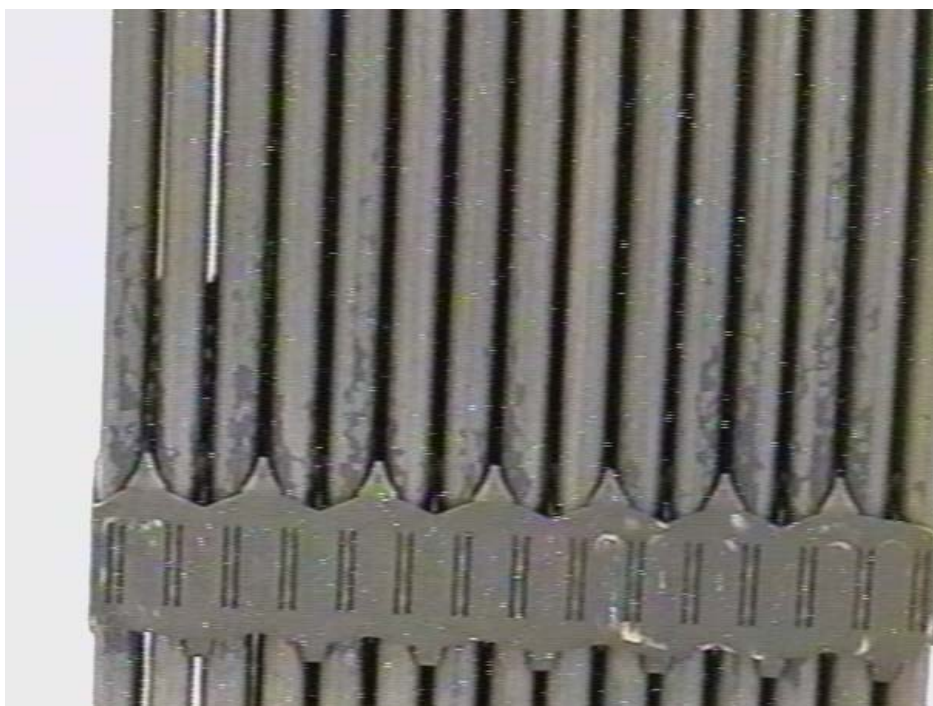
Figure C-4. Oxide mottling noted around grid spacer #6 on V-05.

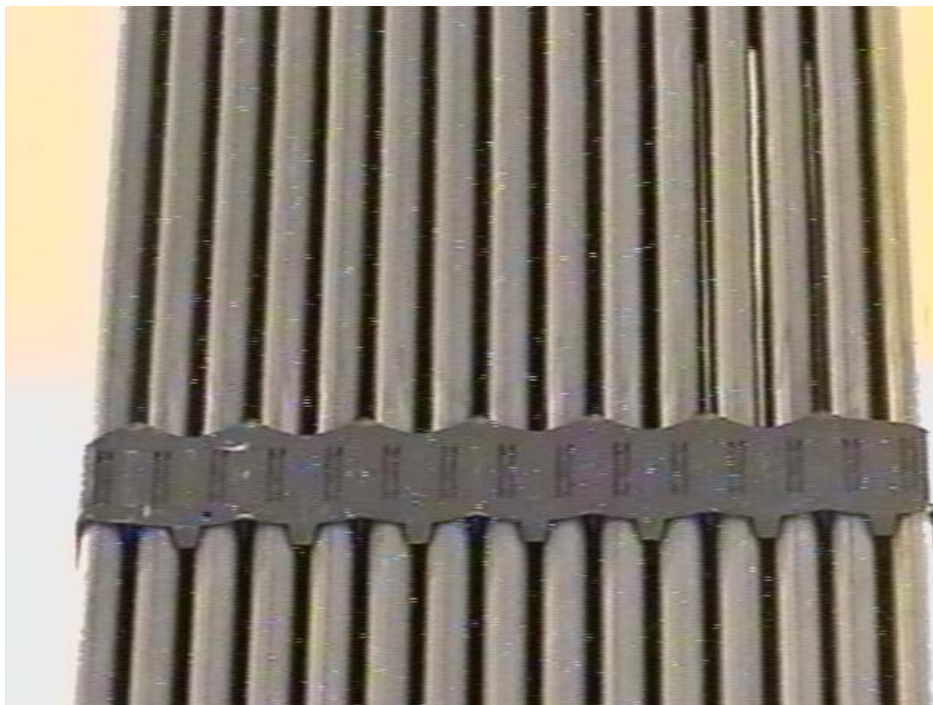
Figure C-5. Fuel assembly V-05—area around upper grid spacer—rods clean and minimal bowing noted.

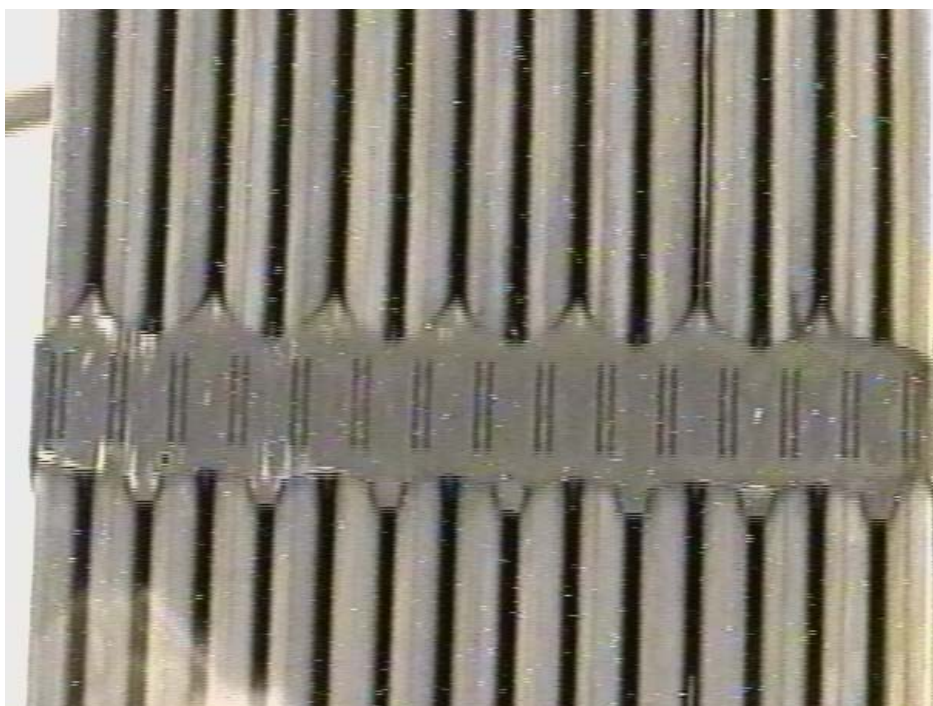
Figure C-6. Fuel assembly V-05 area around third grid spacer—noted light abrasion marking on spacer.

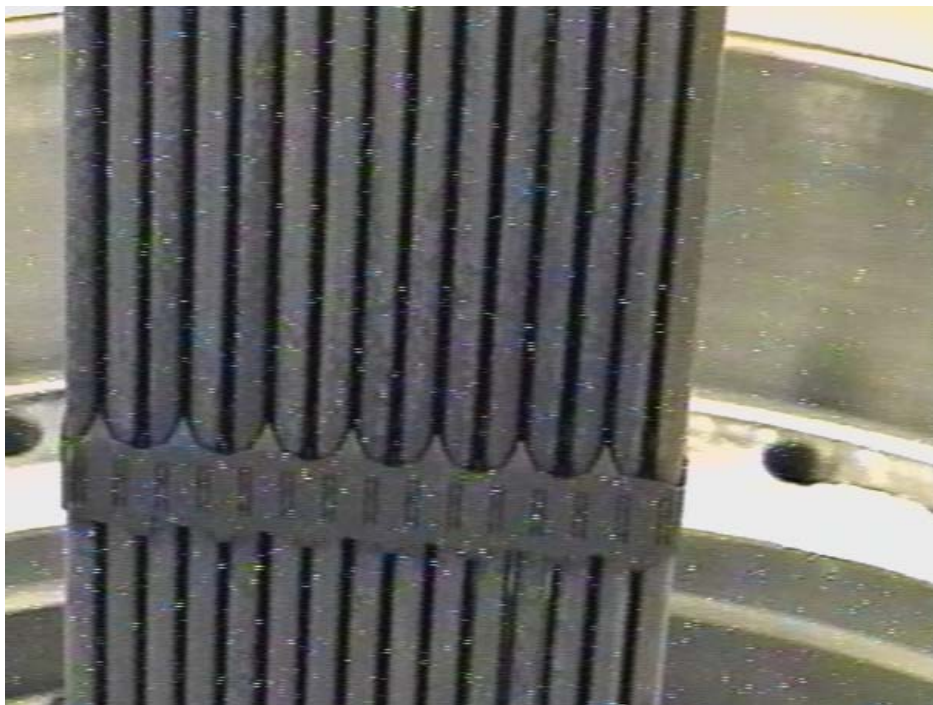
Figure C-7. Fuel assembly V-05 oxide mottling noted around fifth grid spacer.

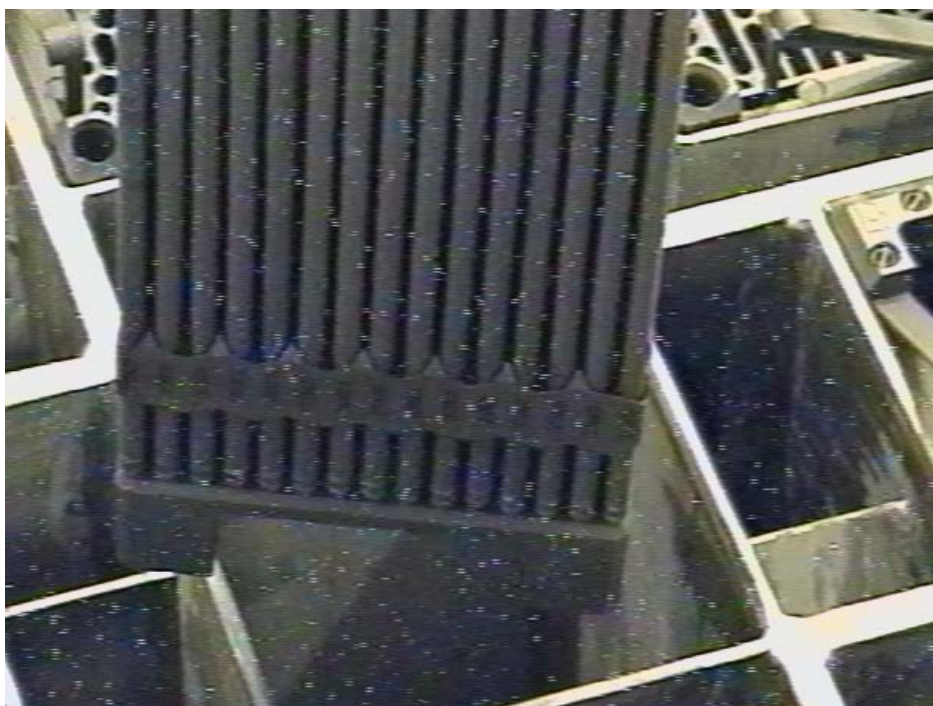
Figure C-8. Fuel assembly V-05 bottom of fuel element V-05—light oxide mottling noted—no loose material seen on rods or top of bottom nozzle.

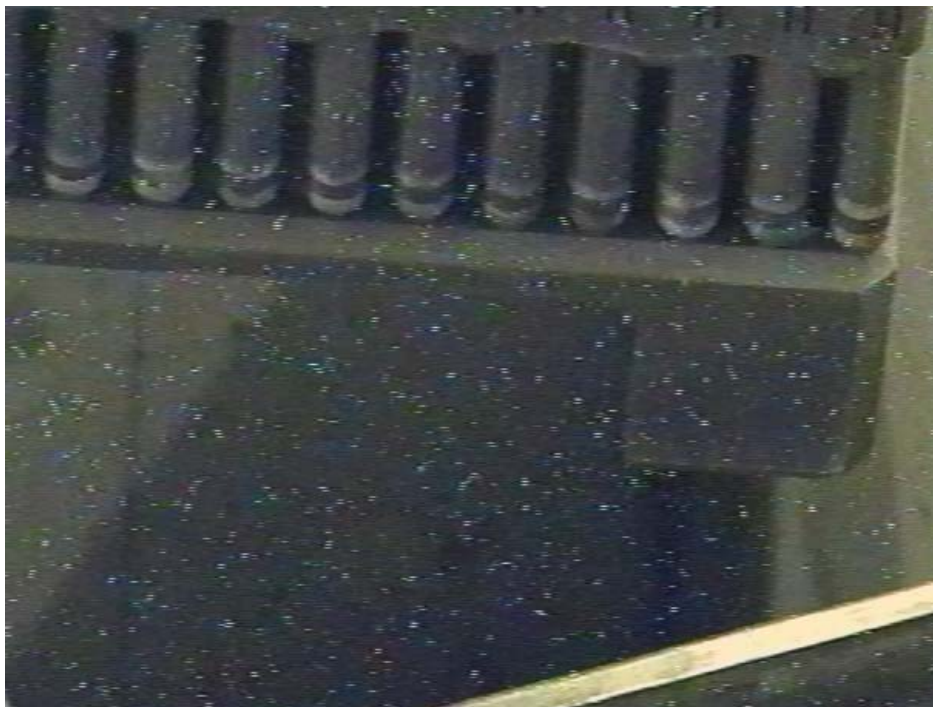
Figure C-9. Fuel assembly V-05 detail of bottom of element—note oxide rings adjacent to rod end weld.

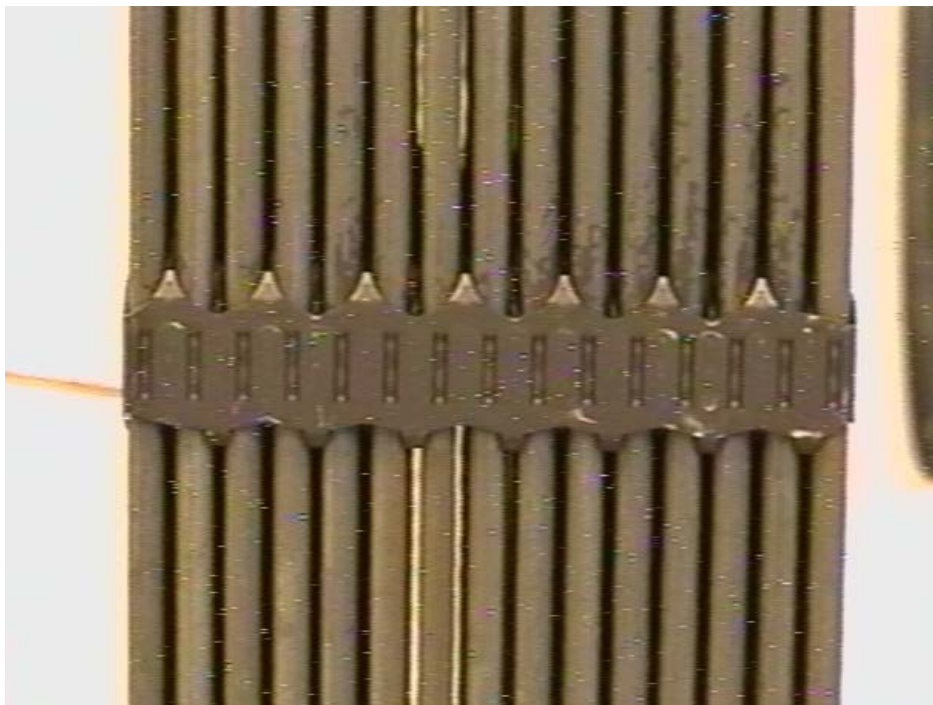
Figure C-11. Fuel assembly V-05 oxide mottling noted around grid spacer 5.

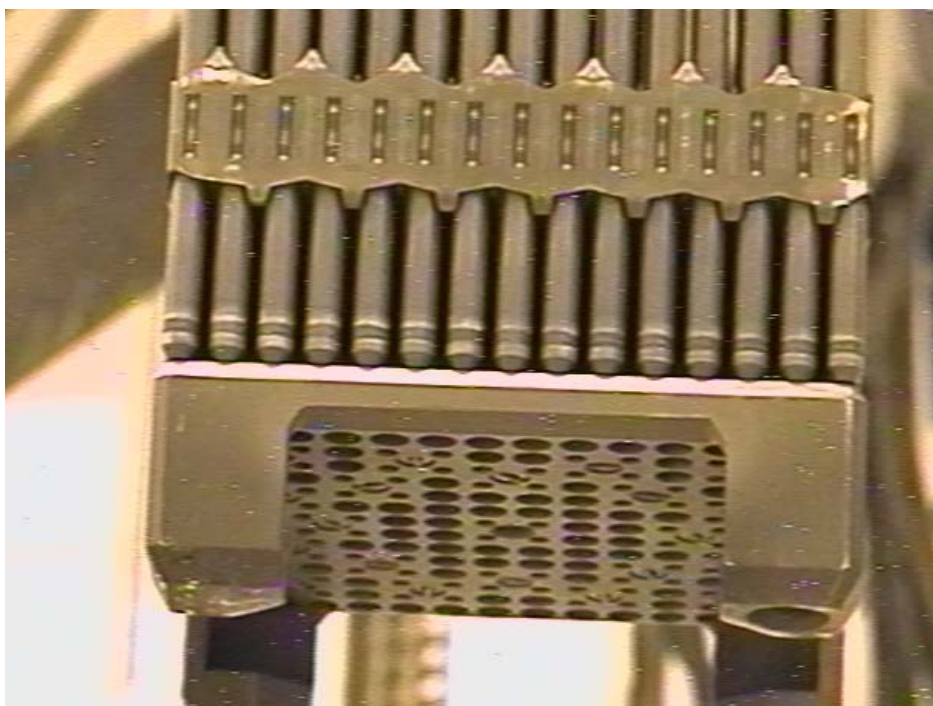
Figure C-12. Fuel assembly V-05—bottom left nozzle—noted mechanical fasteners searing guide tubes.

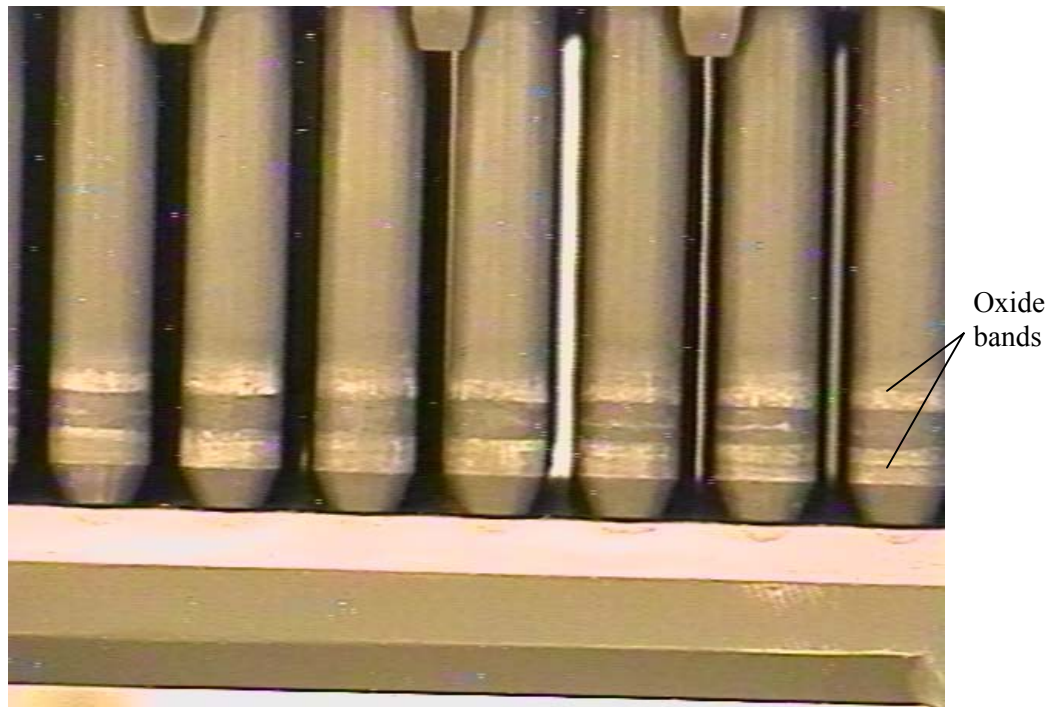
Figure C-13. Fuel assembly V-05 looking for loose “crud”—non was evident.

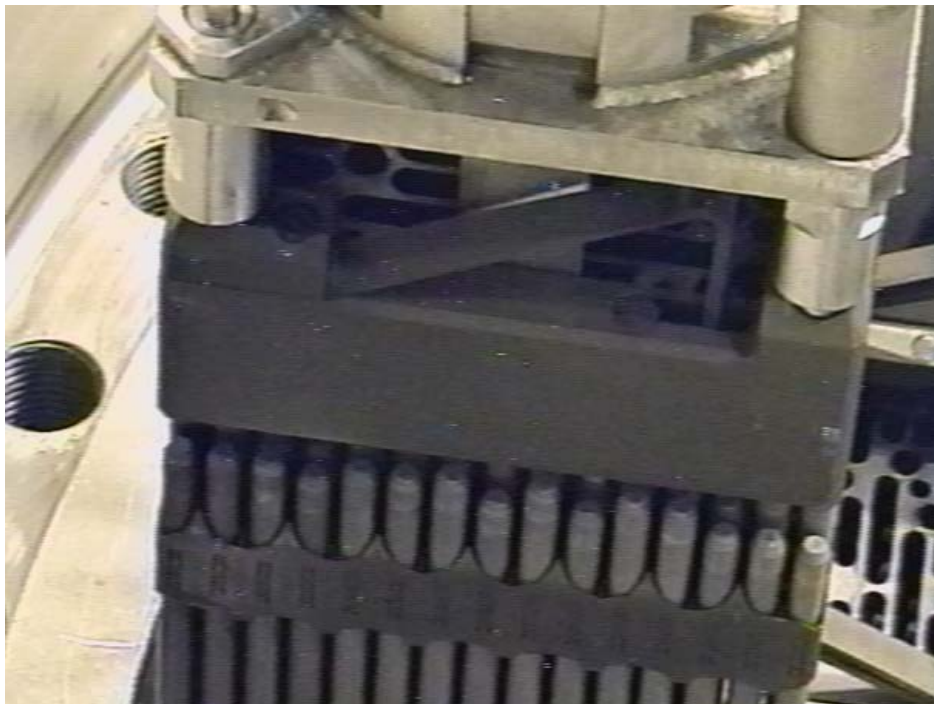
Figure C-14. Element T-03 being withdrawn—note fuel rod growth.

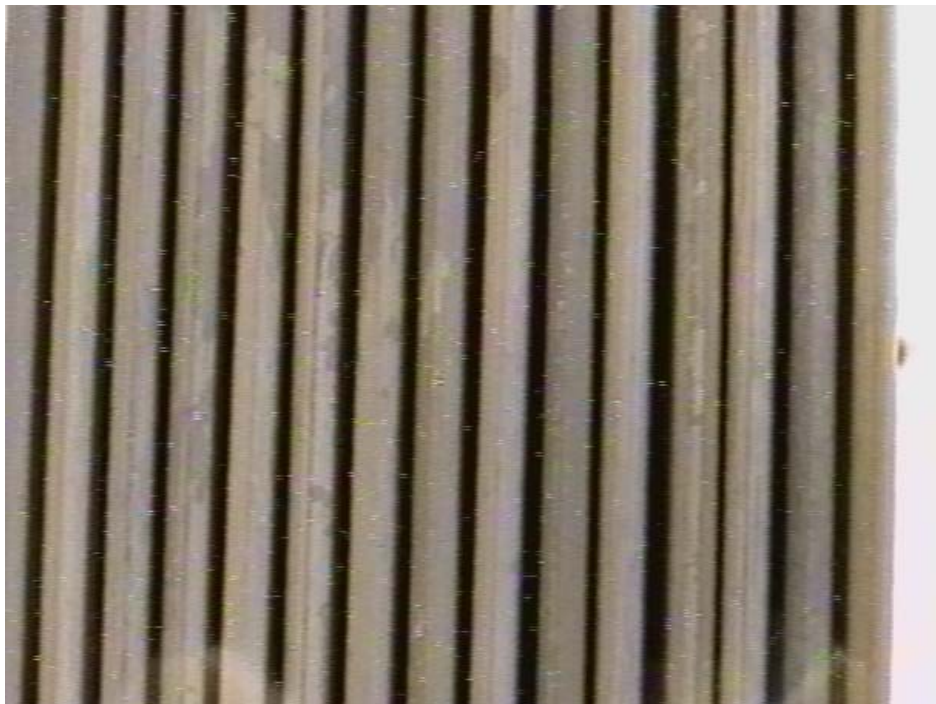
Figure C-16. Element T-03 midpoint of assembly noted oxide density increases as we go lower on the element.

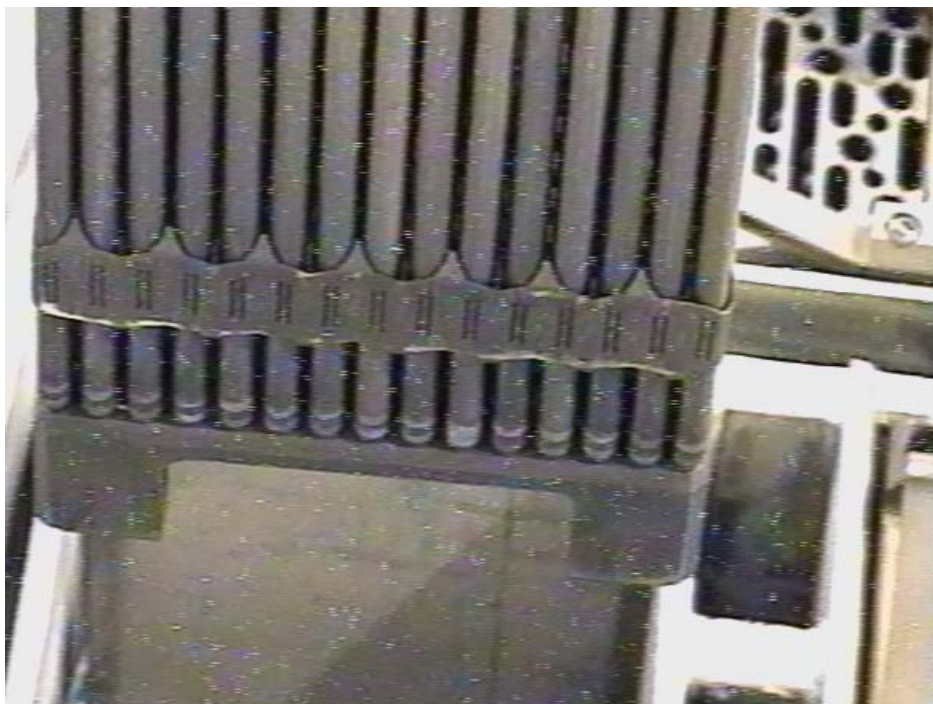
Figure C-18. Element T-03 bottom of fuel element—light oxide—no loose material obvious on surfaces.

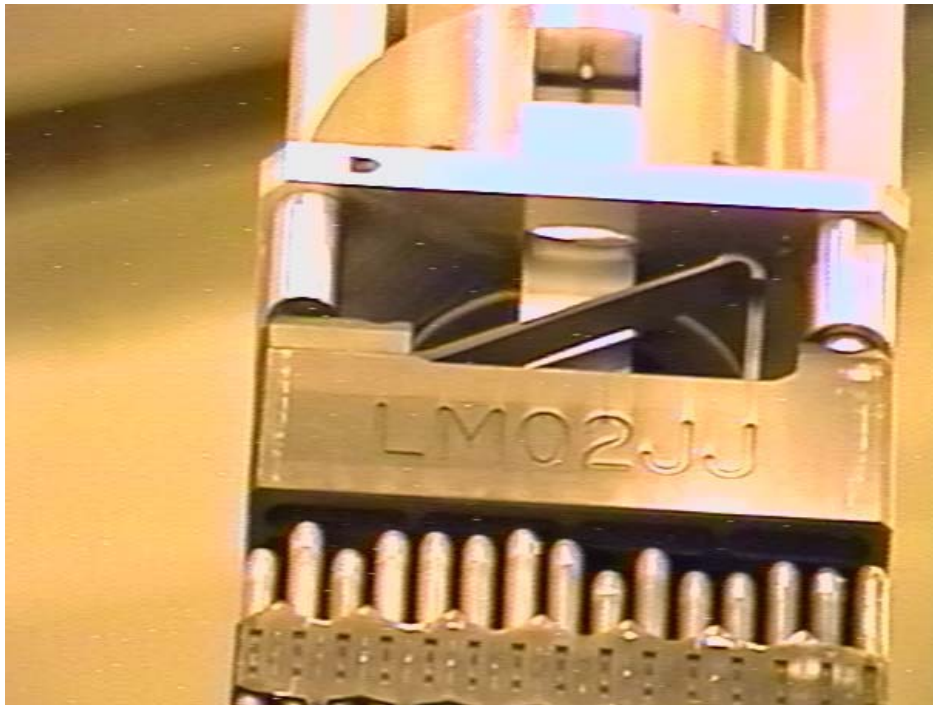
Figure C-19. Fuel element T-03—notes serial number—fuel rod growth evident.

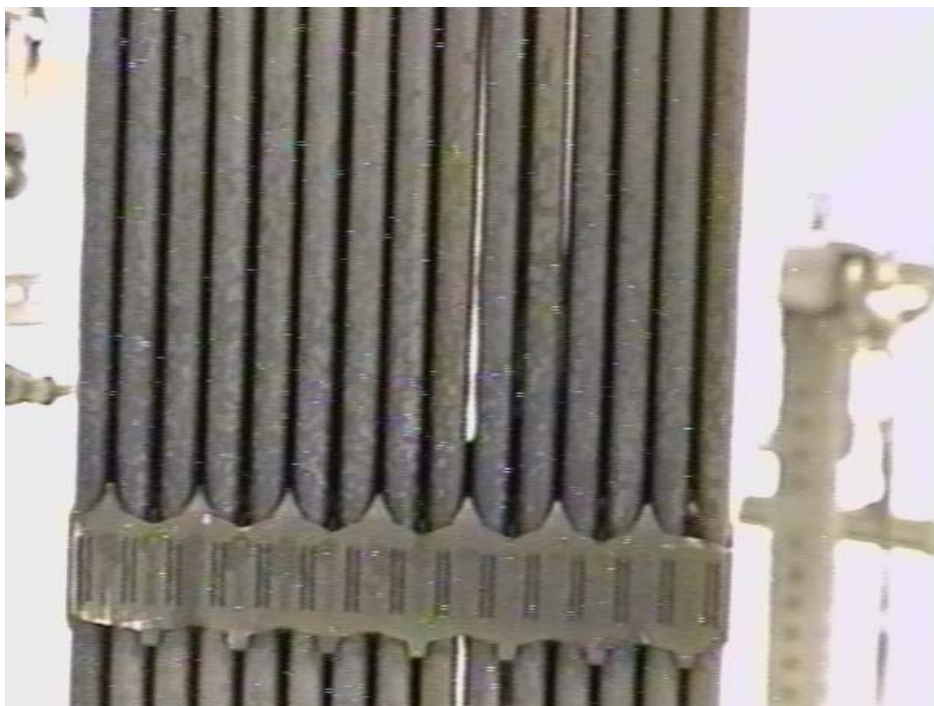
Figure C-22. Fuel assembly V-27 oxide mottling noted.

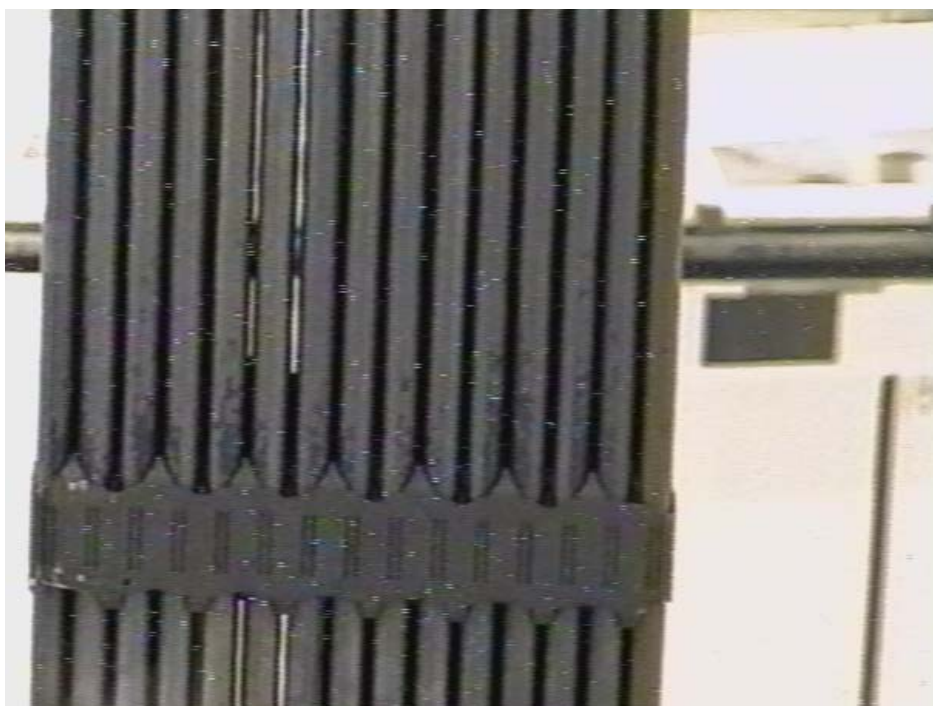
Figure C-34. Fuel assembly V-08 at fifth spacer—noted oxide mottling.

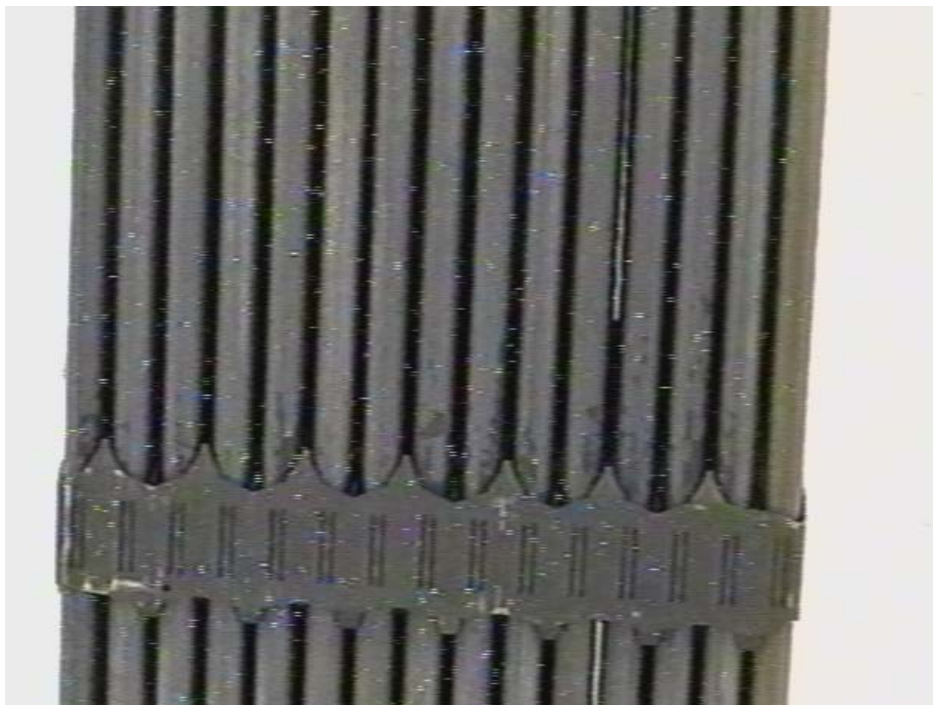
Figure C-65. Fuel assembly V-05 fourth grid spacer oxide mottling noted.

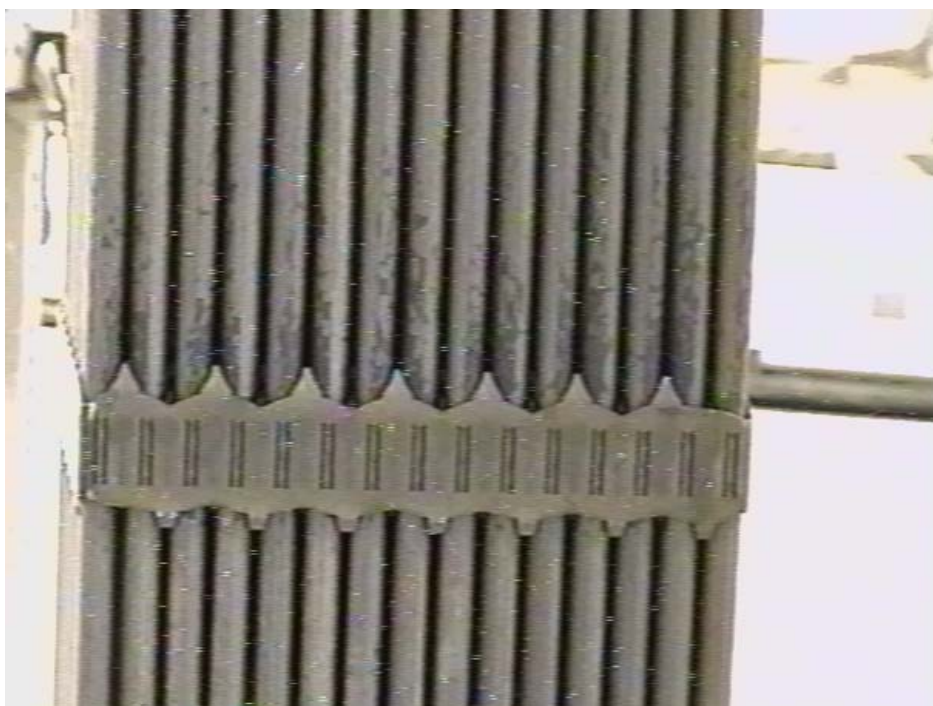
Figure C-66. Fuel assembly V-04 mottling at fifth grid spacer.

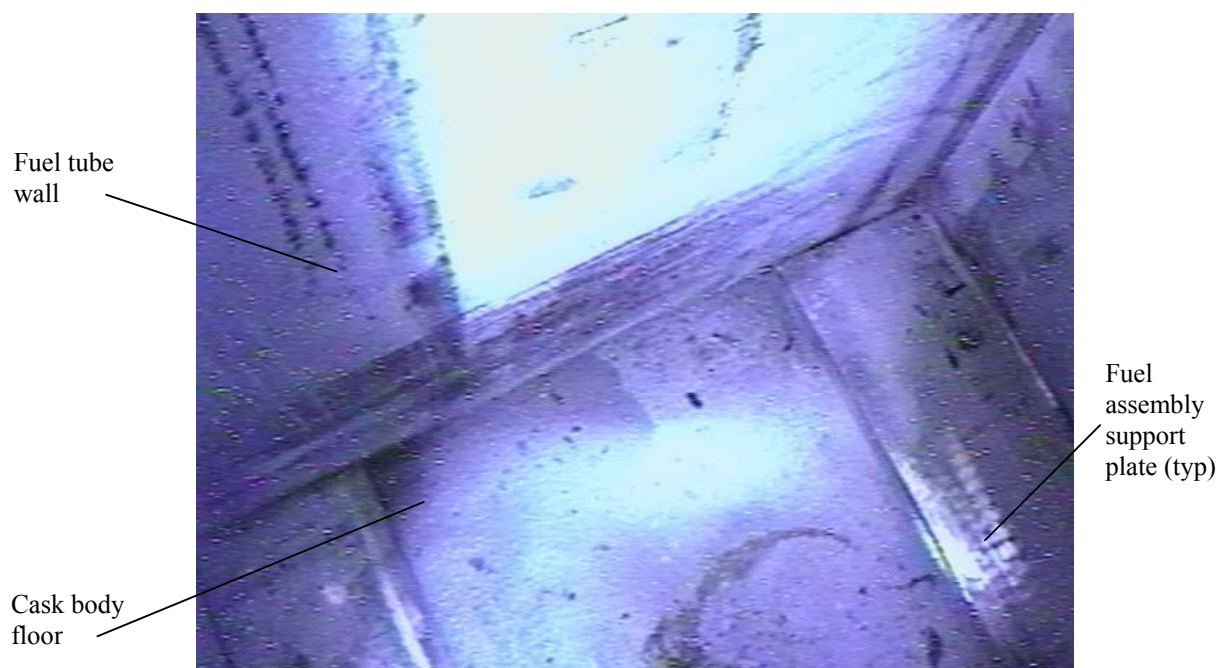
Figure D-2. Fuel Tube A-1 – Close up of bottom – minor debris noted.

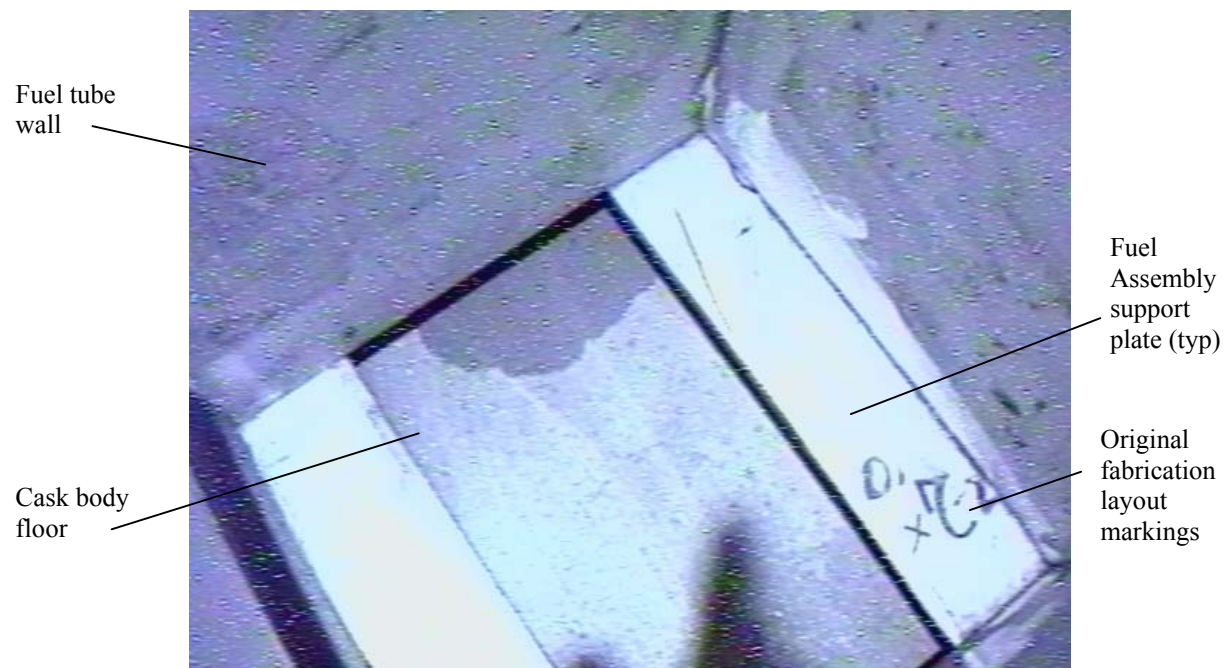
Figure D-3. Fuel tube A-7 – closeup of bottom – noted stain – no conclusion – surfaces are clean and bright. This view approximates condition viewed at the bottom of all fuel tubes.

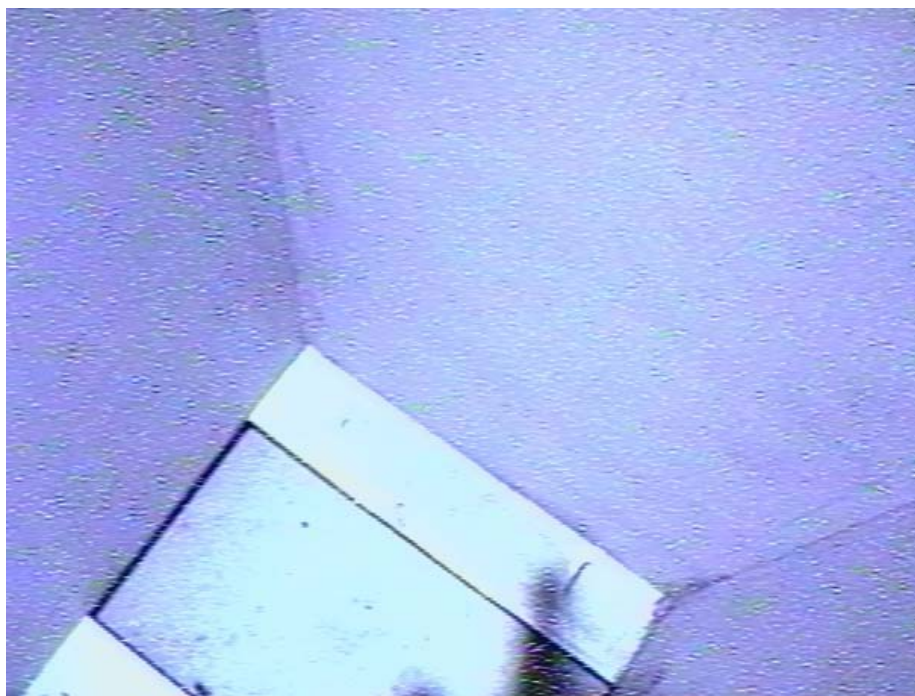
Figure D-4. Fuel tube A-5 bottom – Noted typical absence of quantities of loose material.

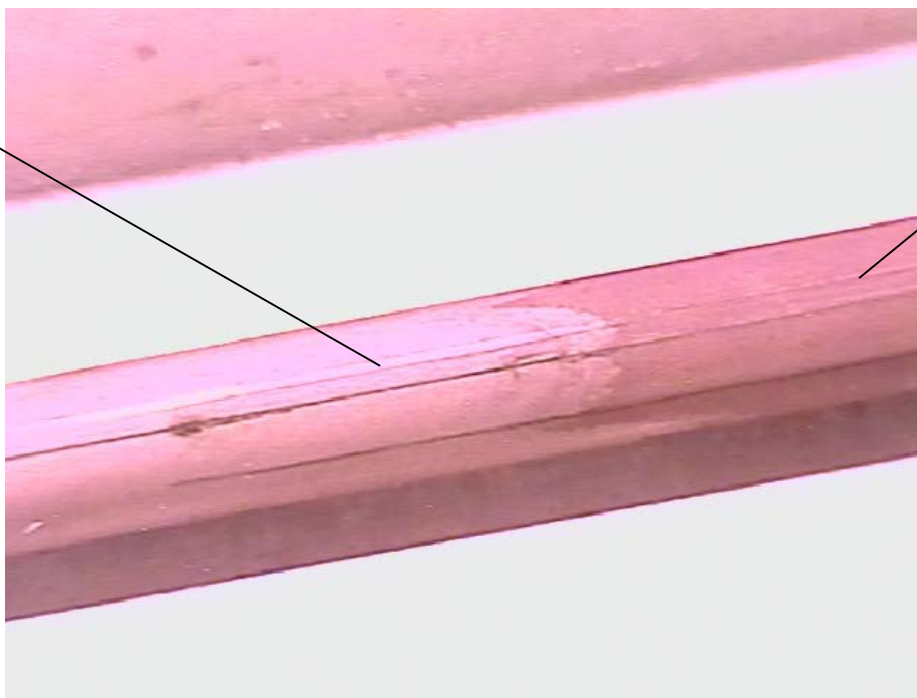
Figure E-7. Condition of fuel rod—light oxide coating minor—scratches believed from moving rod through spacer grids.

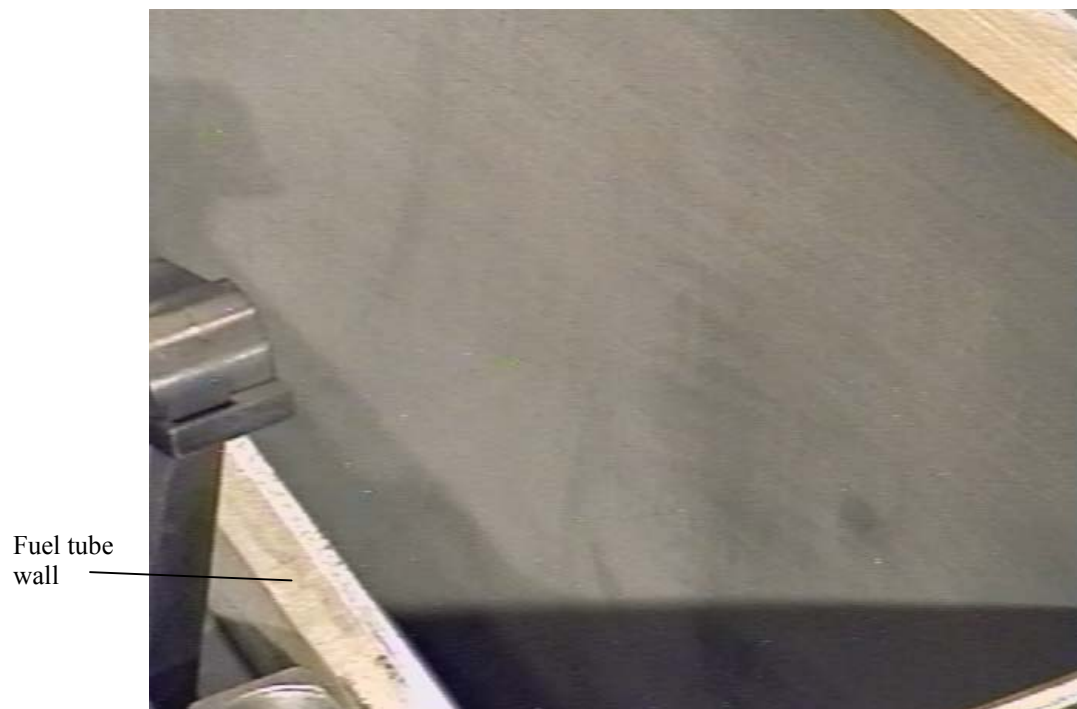
Figure F-2. Cask inner wall at top—typical surface condition.

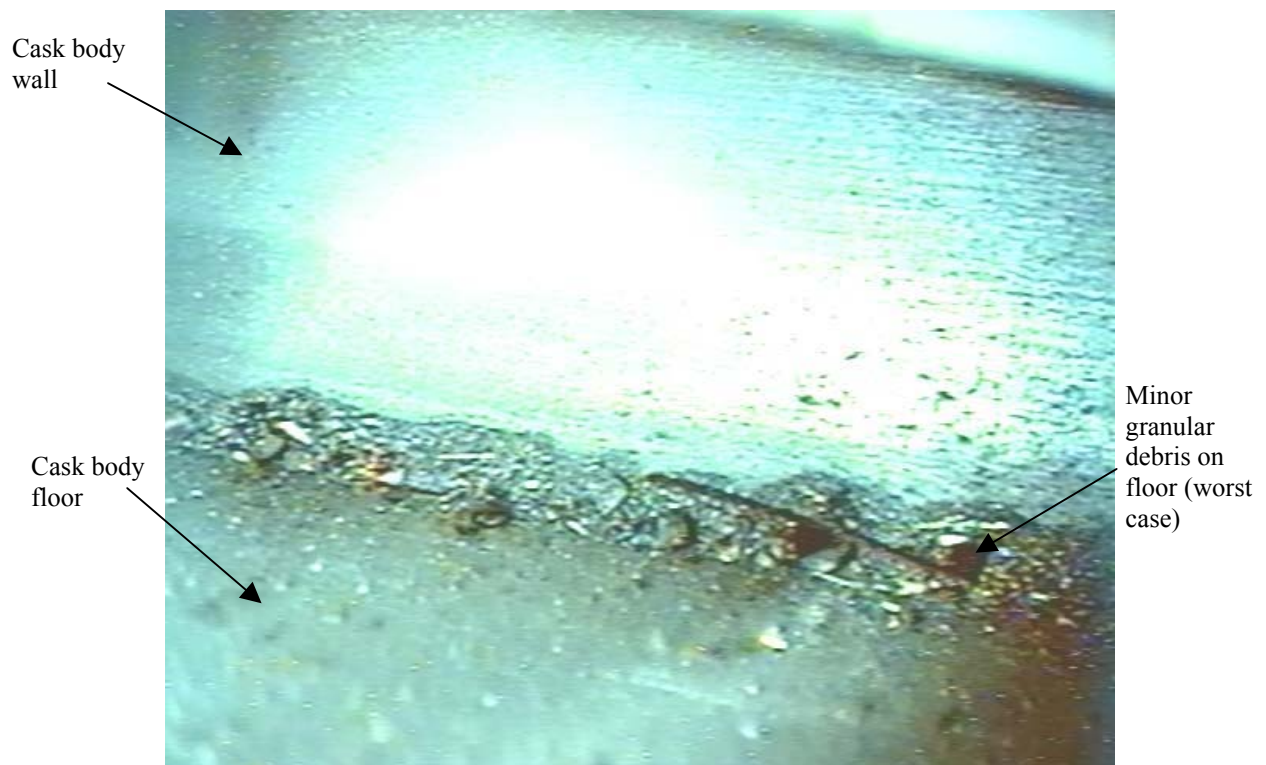
Figure F-4. Cask floor and wall below fuel tube C8—reflective surfaces free of corrosion.

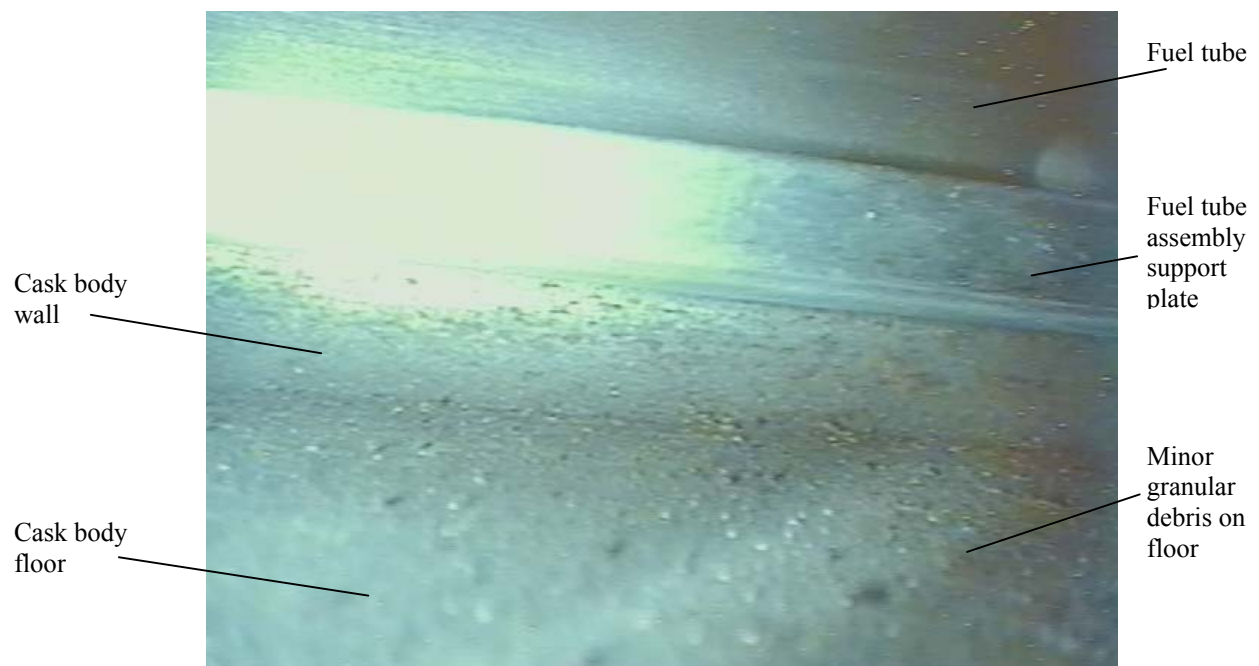
Figure F-5. Cask floor and wall below fuel tube D3—reflective surfaces free of corrosion.

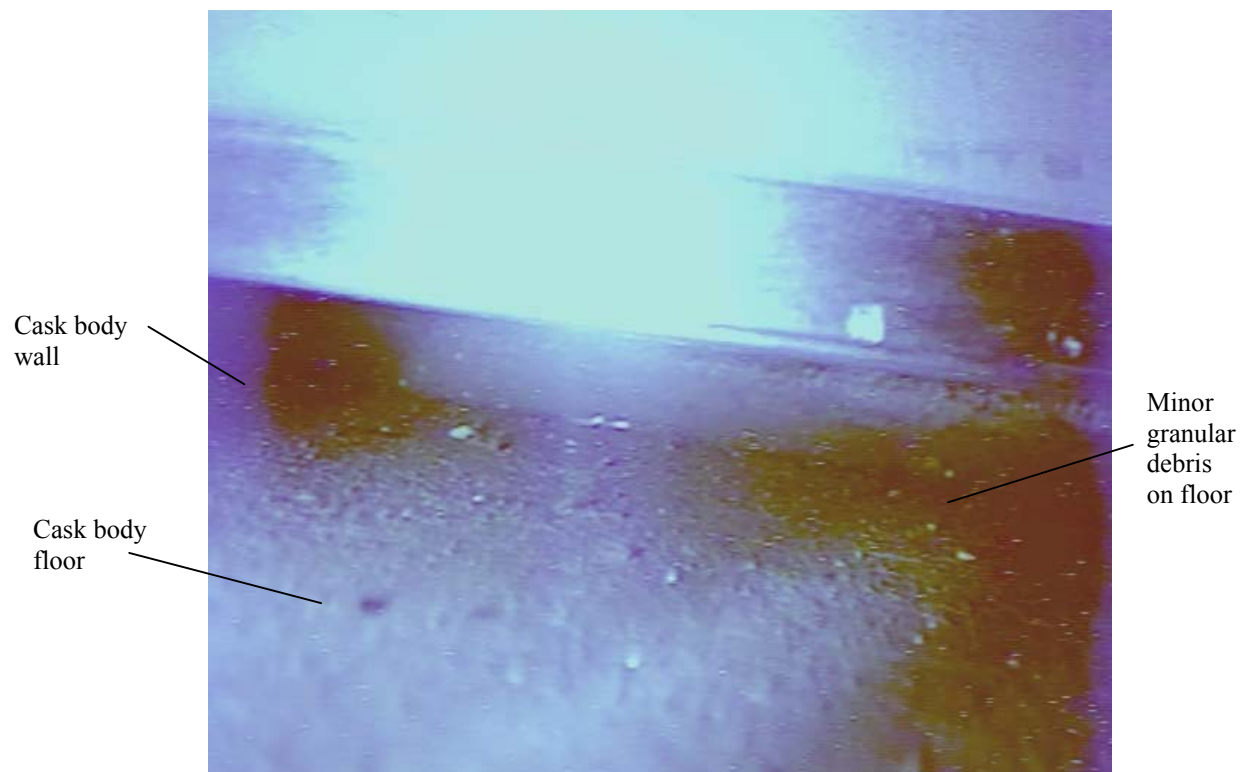
Figure F-6. Cask floor and wall below fuel tube D6—reflective surfaces free of corrosion.

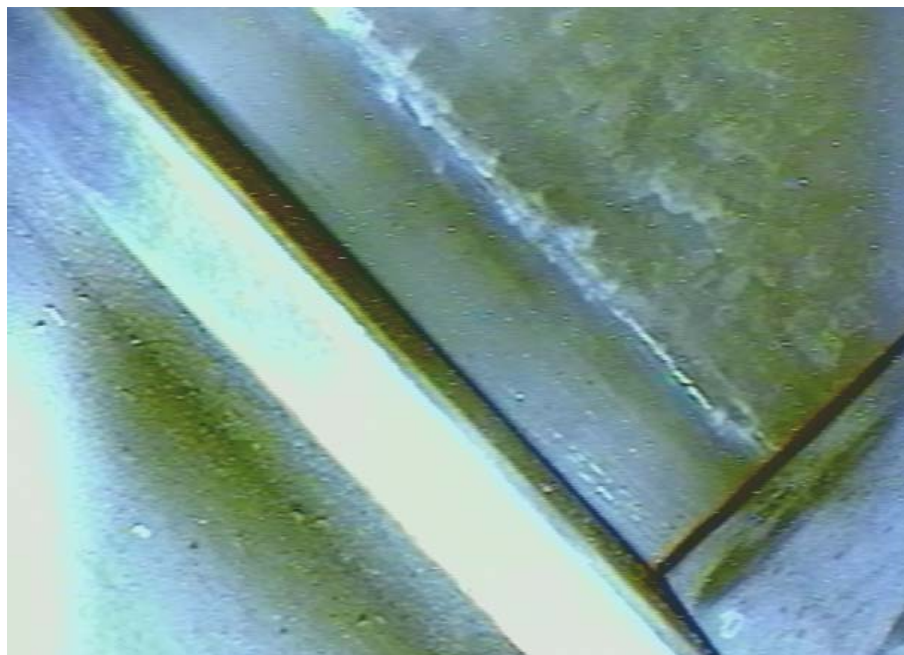
Figure F-7. Cask floor and wall below fuel tube A7—reflective surfaces free of corrosion—minor granular debris on floor.

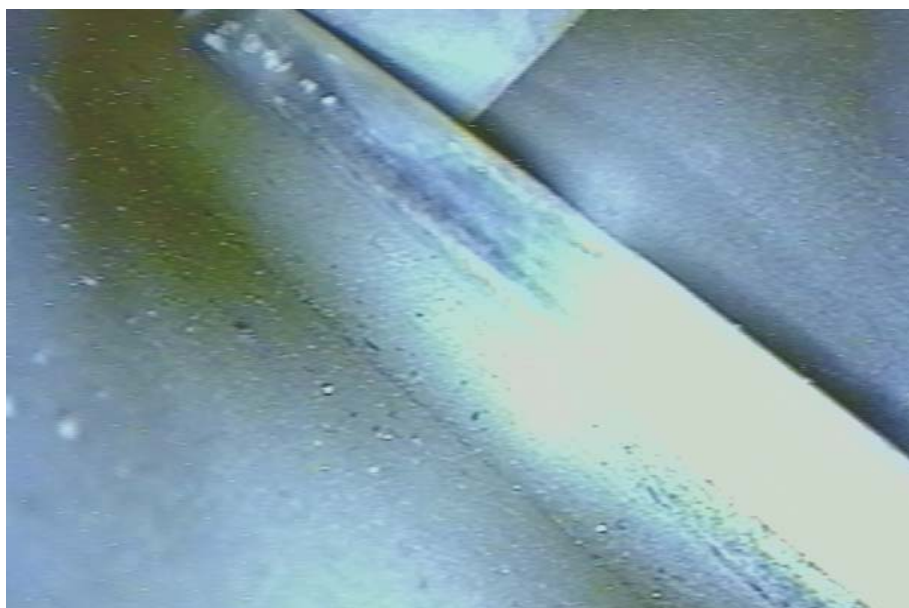
Figure F-8. Cask floor below fuel tube A3—reflective surfaces free of corrosion—minor granular debris on floor.

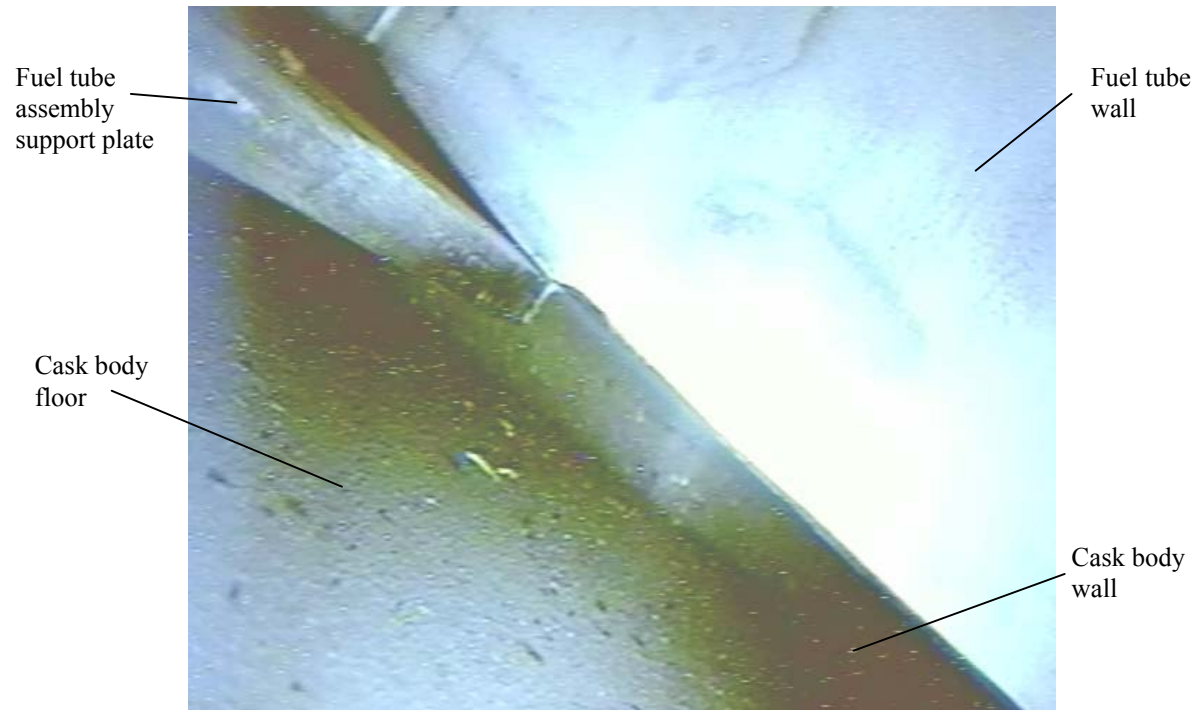
Figure F-9. Cask floor below fuel tube B6—reflective surfaces free of corrosion—minor granular debris on floor.

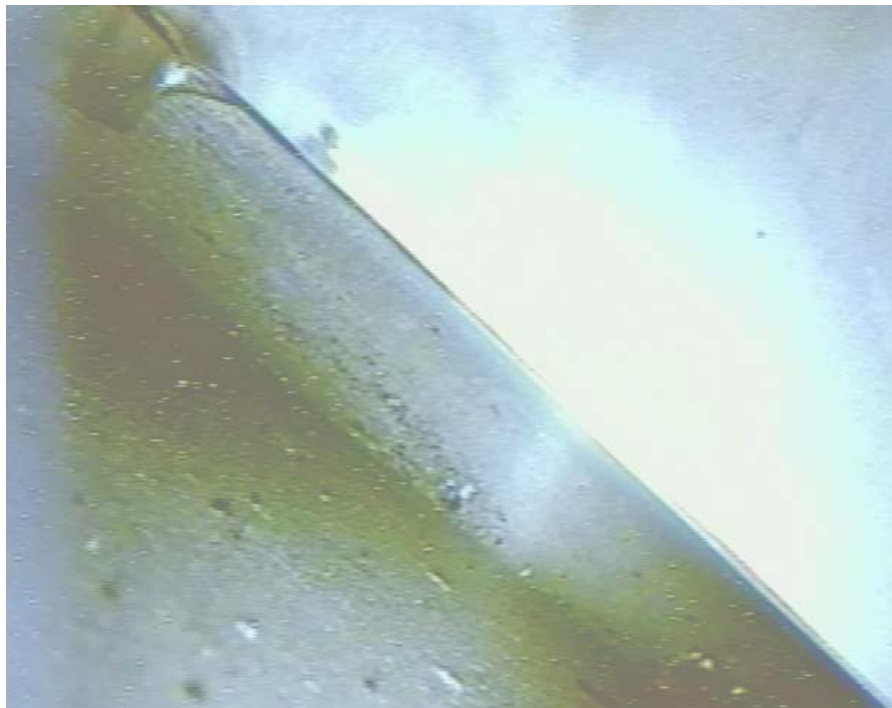
Figure F-10. Cask floor below fuel tube B8—reflective surfaces free of corrosion—minor granular debris on floor.

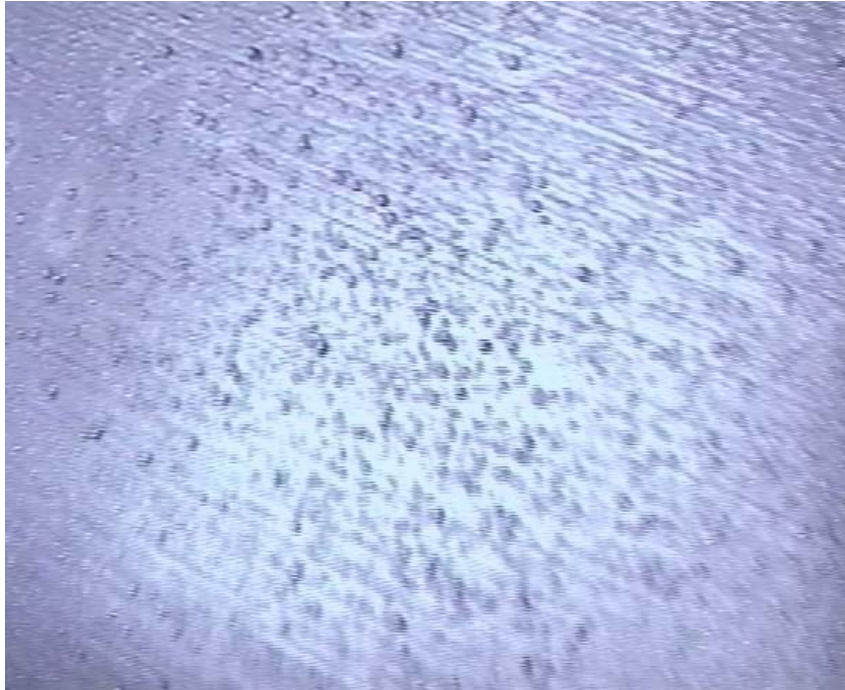
Figure F-11. Cask wall below and between fuel tubeA7 and A8—reflective surface free of corrosion—typical of cask wall condition without mineral stains- nodular ductile cast iron nickel plated.

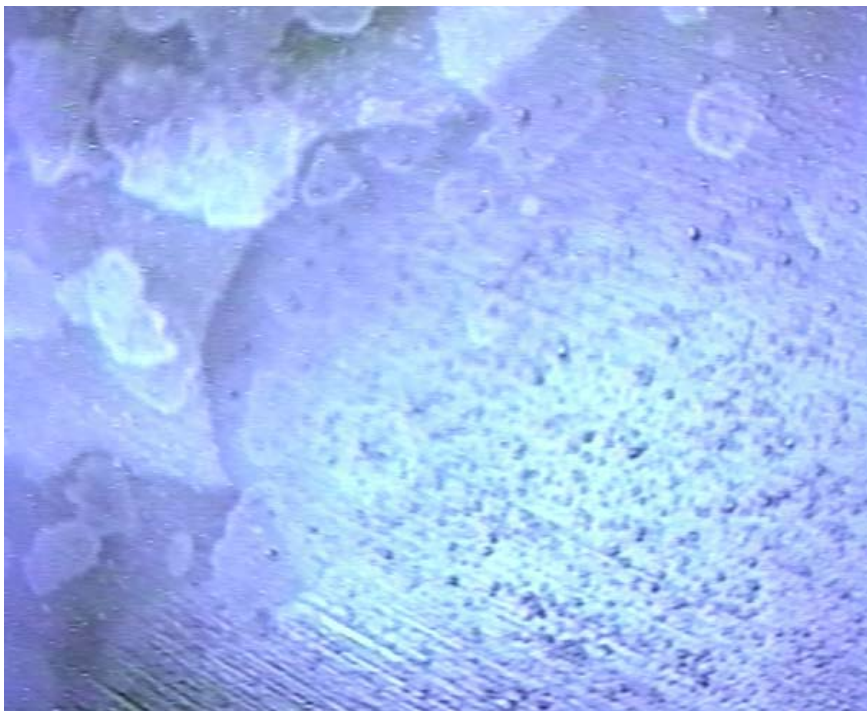
Figure F-12. Cask wall below and between fuel tubeD3 and D6—reflective surface free of corrosion—typical of cask wall condition with mineral stains—nodular ductile cast iron nickel plated.
