# Control Rod Malfunction at the NRAD Reactor

**PHYSOR 2010**

Thomas L. Maddock  
Ronald C. Johansen

May 2010

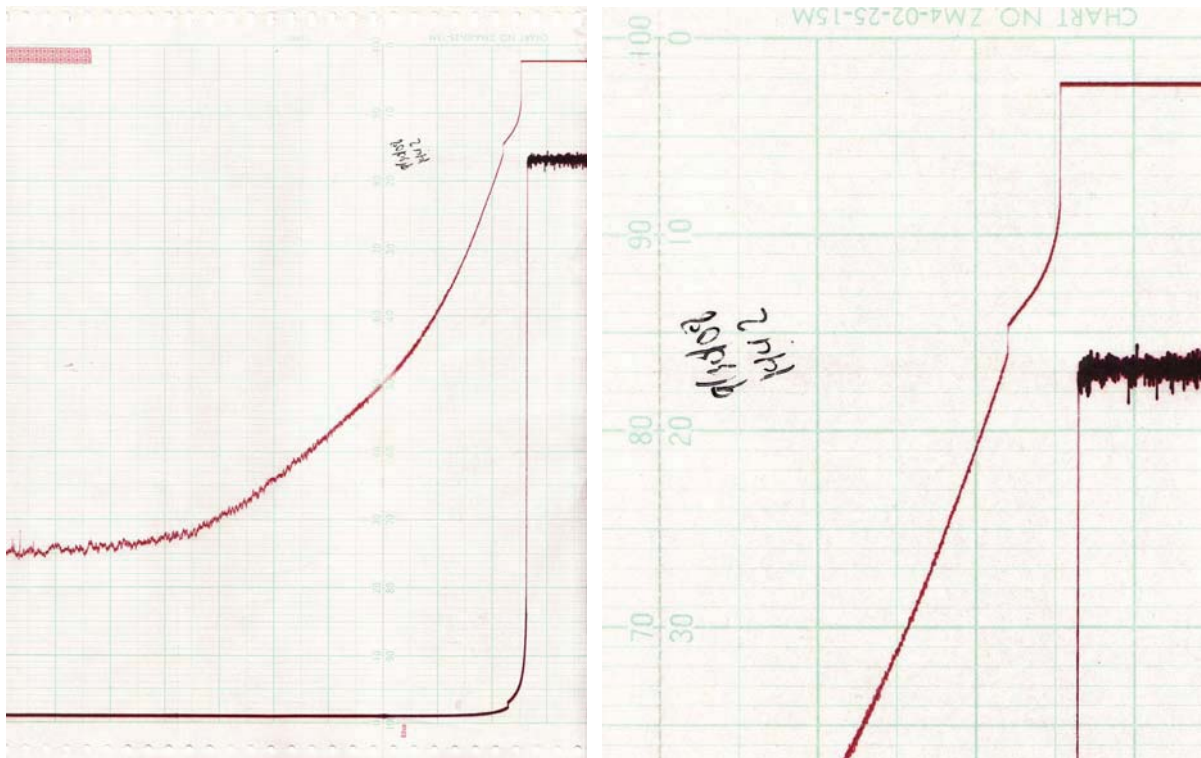
**Figure 1. 9-30-08 Power Trace.**

On 30 September 2008, the NRAD reactor was performing a routine run at 250 kW when an anomaly occurred during shutdown. To terminate the run, the reactor operator pressed the Manual Scram switch. The Regulating Rod and the Shim Rod No. 1 indicator lights showed that the connecting rods had dropped, and the corresponding rod drive position indicators began to count down. None of these typical indicators of proper rod function occurred for Shim Rod No. 2. The indicator lights did not show the rod was down, and the rod drive position indicator did not count down. The reactor operator pushed the Manual Scram switch two more times, but the indications did not change. After some discussion with the reactor supervisor, the reactor operator pushed the Manual Scram switch and held it in. A moment later, the appropriate indications for Shim Rod No. 2 were observed. The indicator lights showed that the rod was down, and the rod drive position indicator began to count down.

In addition to the indications described above, the log and linear channel power traces for the shutdown have a sharp drop or step that coincides with the timing of the final push of the Manual Scram switch. The step appears at the same time in both channels, but is easier to identify on the log trace. The power traces also show that the reactor was safely shutdown and the traces appeared to have the same negative 80-second period that is typically observed at shutdown. At no time was there any concern about the safety of the shutdown. While the reactor tank water was still warm, and with the reactor shutdown Shim Rod No. 2 was raised and scrambled several times in an effort to repeat the problem. The rod functioned normally during all of the tests.

traces shown in Figure 1 is the linear power channel trace from the anomalous shutdown. The small drop in power can be seen in the linear power trace although it is not as pronounced as in the log power trace.

The sharp vertical drop that appears in the log power trace occurs about 40 seconds into the shutdown. If Shim Rod No. 2 dropped when it was supposed to, another explanation was needed for the vertical drop on the power trace. It was thought that the drop might be caused by an alignment issue with the pulse-log counting and campbelling circuits. A Realignment was performed according the General Atomics instructions for this nuclear instrument. Without operating the reactor, the results of the realignment were not immediately obvious, but the alignment did not require significant adjustment. Additionally the drop in the curve occurred between the 8<sup>th</sup> and 9<sup>th</sup> decade. The crossover region is between the 5<sup>th</sup> and 6<sup>th</sup> decade making it unlikely that the drop was the result of an alignment problem. A small drop in reactor power can also be seen at the same time on the linear power trace. An issue with log channel alignment would not explain why the linear channel showed a similar drop in power.

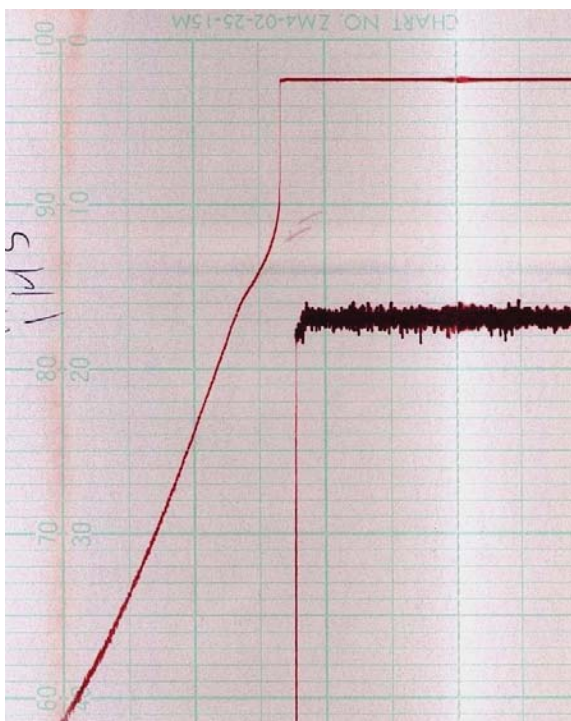
**Figure 2. 9-10-08 Power Trace.**

The drop in power observed in the shutdown traces prompted an investigation into what a normal shutdown trace looks like. All of the NRAD chart recordings for the last several years were examined. An odd bump or discontinuity was found in almost all of the shutdown traces in approximately the same location as the drop that that occurred on the 30 September power trace. The discontinuity is more severe in some traces than others. Figure 2 and Figure 3 show two of the extremes, although it is hard to compare them because a different chart speed was used for Figure 3.

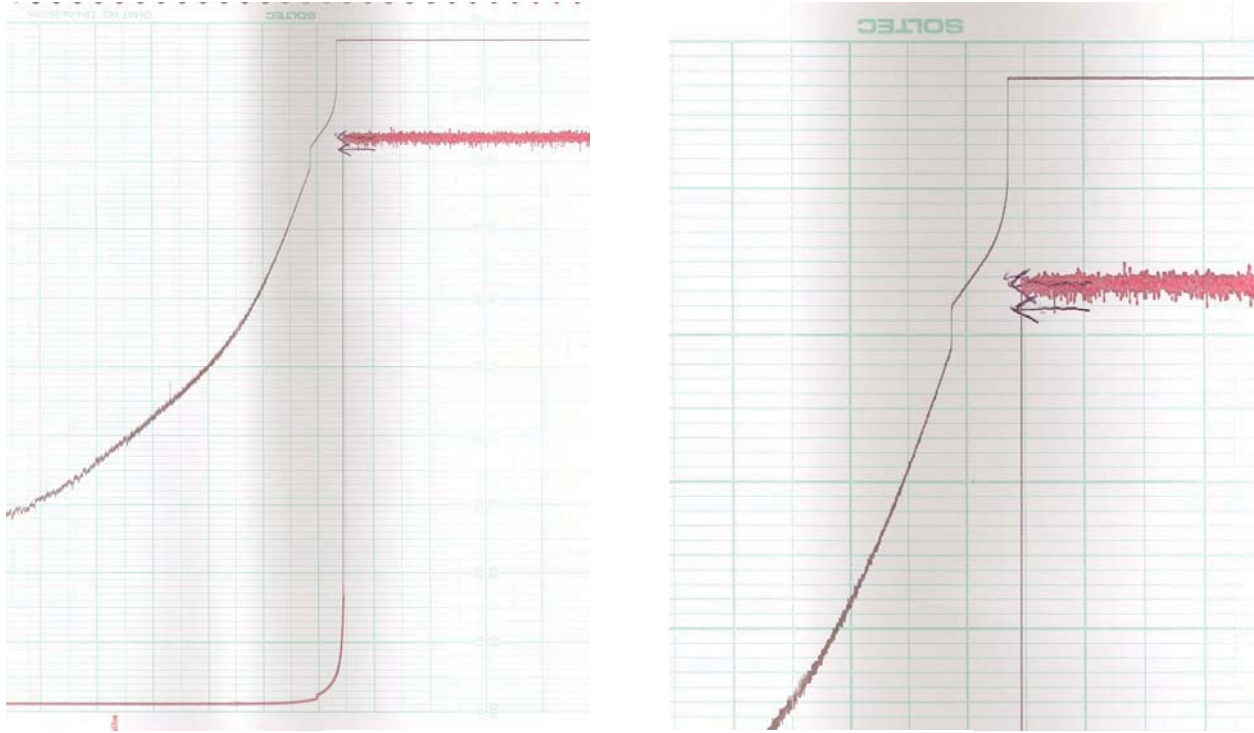
**Figure 4. Delayed Rod Insertion Test 2-5-09**

After all of the troubleshooting and repairs were complete, the proposed test to delay the insertion of Shim Rod No. 2 intentionally during a shutdown was performed. The reactor was operated at 250 kW. The Regulating Rod and Shim Rod No. 1 were both scrammed. After 40 seconds, Shim Rod No. 2 was then scrammed. The power trace from this test can be seen in Figure 4. The obvious similarity between this power trace and the one from the anomalous shutdown on 30 September 2009 indicated that Shim Rod No. 2 did not drop immediately during the 30 September shutdown. It was now clear that the problem was actually a stuck control rod, not a limit switch or nuclear instrument problem.

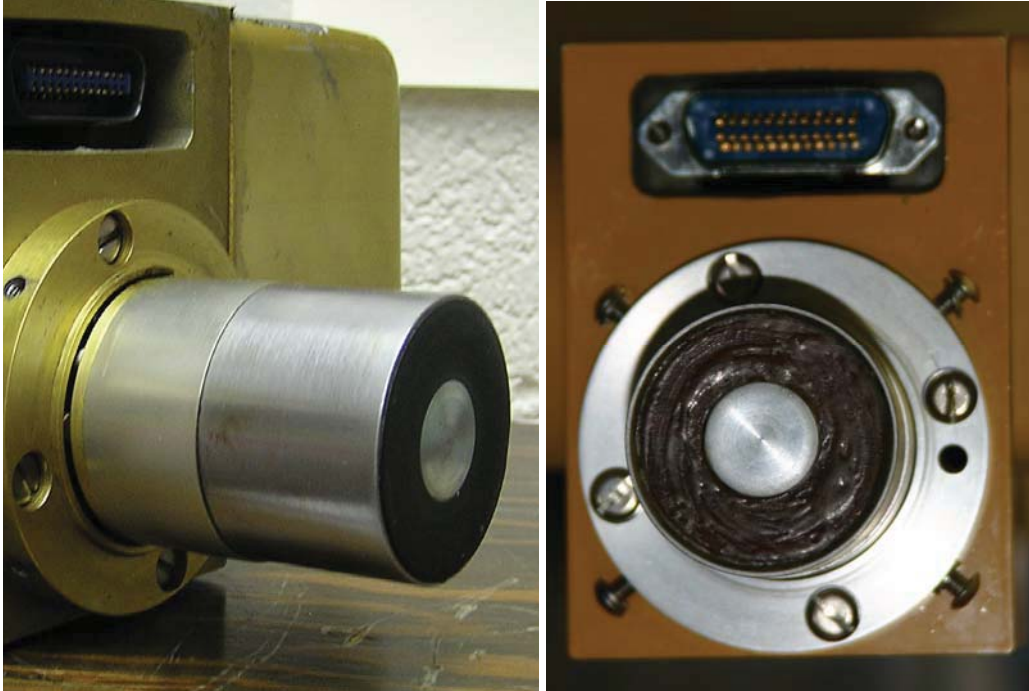
**Figure 5. Old Electromagnet (left) New Electromagnet (right)**

While the troubleshooting activities were being performed, new control rod drive mechanisms were found in storage at MFC. It was determined that the drives had not been used. General Atomics, the manufacturer of the control rod drive mechanisms, informed us that the drives had a newer electromagnet with a slightly recessed magnet face. The magnet potting was also intentionally left rough instead of being polished smooth as on older drives. General Atomics stated these changes were to prevent a buildup of film or moisture on the magnet that could prevent the release of the armature when the magnet is deenergized. General Atomics also mentioned that a buildup of film or moisture has not been a problem for facilities where the typical shutdown method is to scram the reactor verses driving the rods in. One of the new style control rod drive mechanisms and electromagnets was installed in the Shim No. 2 position. Pictures of the two magnet faces are shown in Figure 5.

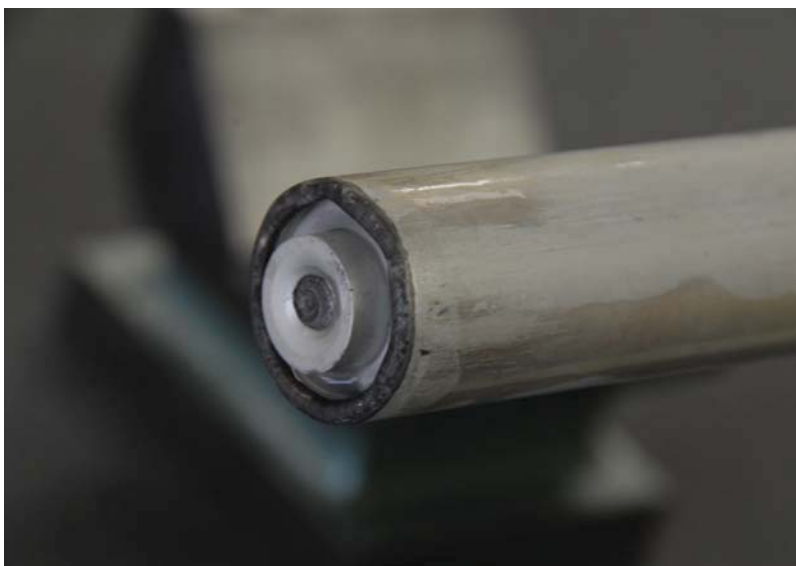
**Figure 6. Shim Rod #2 Bottom End**

The upper portion of the connecting rod has a piston assembly that travels inside of a barrel. The piston was only visible through small holes in the barrel. To inspect the piston and barrel thoroughly, a complete disassembly was necessary. The barrel and control rod were lifted from the reactor tank. The radiation levels were low enough to permit moving everything to an inspection lab. The control rod was dimensionally inspected and found to be within tolerance. Light rub marks were observed at the upper and lower end of the control rod, see Figure 6. The marks were evenly distributed around the circumference, indicating the rod was not sticking or binding at a certain location. The upper and lower weld beads were uniform and smooth with no protrusion that might catch in the holes of the guide tube. No excessive wear, burrs, corrosion, foreign material, or algae were observed on the control rod.

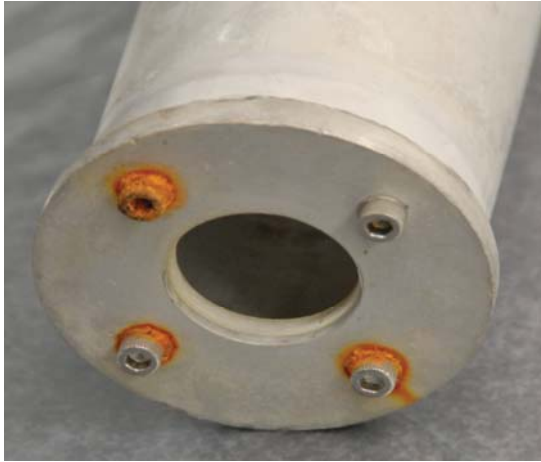
**Figure 7. Corroded Fasteners on Shim Rod #2 Barrel**

The barrel and connecting rod assembly were removed from the guide tube in the inspection lab. The corroded fasteners at the bottom of the barrel are shown in Figure 7. One of the fasteners and three of the washers were found to be carbon steel instead of stainless steel. Discoloration from the corroded fasteners was also found on the piston area of the connecting rod (see Figure 8). The connecting rod had small gritty particles on it along with grease or oil residue. The connecting rod was removed from the barrel and checked for straightness. The total indicated runout of the rod was 0.15 in. The piston to barrel wall clearance varied from 0.003 in. to 0.043 in. Figure 9 shows the side of the piston with the smallest clearance to the barrel ID. The piston connection used two fasteners that go through holes in the piston assembly. The piston/connecting rod assembly was moved back and forth in the barrel by hand, to feel for friction, sticking, or binding. The piston did not catch on any edges, but there was a noticeable amount of resistance. For comparison, the resistance was also checked in a new barrel. The new barrel required less force to move the piston and had a smoother feel. With the connecting rod removed, a ring of grease was observed in the barrel where the armature normally stops in the down position (see Figure 10). The

Besides a thorough cleaning of all of the components a number of modifications were made to prevent future failures of the scram system. First, the design of the upper connecting rod was changed to increase the weight. The total buoyant weight of the new control rod and connecting rod assembly was approximately 9 pounds. Second, the design of the piston flange was changed to use four bolts that more securely maintained the proper geometry. Third, maintenance procedures for the control rod drive mechanism were changed to stop unnecessary lubrication. Fourth, the Manual Scram switch was changed to a latching or push-pull type switch to prevent the electromagnets from being reenergized when the switch is released. After making the changes, 100 consecutive rod drops of Shim Rod No. 2 were performed. The average rod drop time decreased approximately 0.15 seconds. The NRAD reactor operated successfully for a 2-month period before being shutdown to undergo a conversion from highly enriched uranium (HEU) to LEU fuel. At the time of writing, this conversion is still underway.

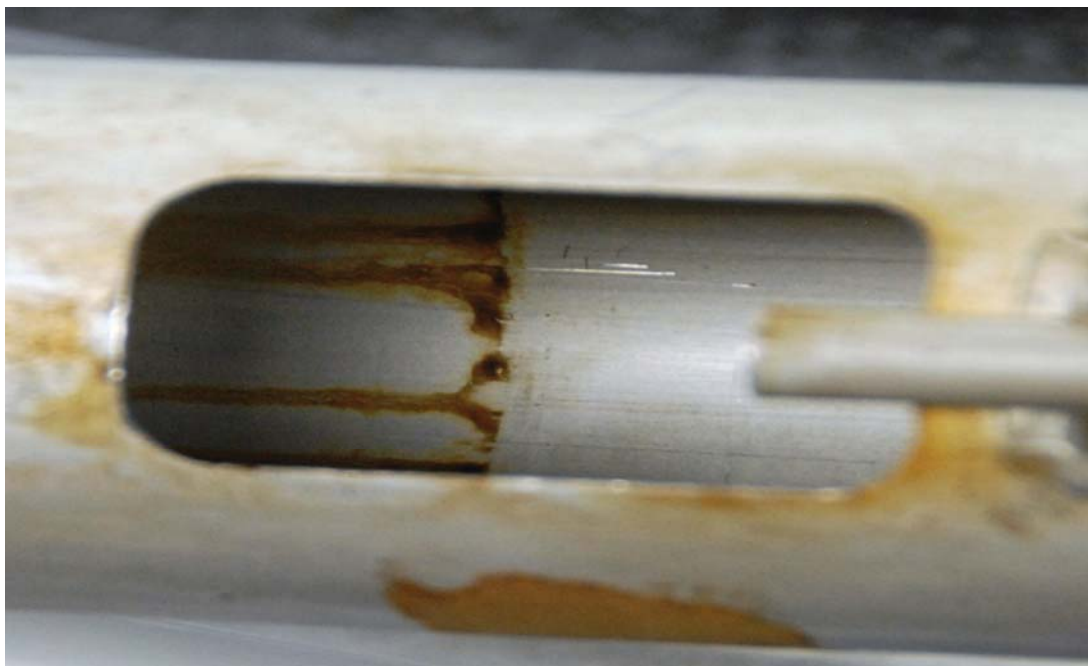
**Figure 6. Grease in Shim #2 Barrel**

grease likely came from the lubrication of the control rod drive mechanism. The grease had run down to the armature and barrel where it collected over many years of service.

The failing of Shim Rod No. 2 to drop during a scram was ultimately attributed to a combination of factors. The buildup of grease and corrosion products in the barrel combined with the unusually light weight of the controls rod assembly caused the control to stick in the barrel. Because a momentary switch was used to scram the reactor, power to the electromagnets was restored when the switch was released. A delay in the movement of the control rod during a scram resulted in the control rod being recaptured. The possibility of a control rod being recaptured was eventually confirmed when an operator was able to intentionally press the scram switch fast enough to demonstrate a recapture. An evaluation of rod recapture that was part of an internal INL report is included in appendix A.
