# **Fiscal Year 2010 Revegetation Assessment**

November 2010

**INL/EXT-10-20331**

**Idaho National Laboratory  
Idaho Falls, Idaho 83415**

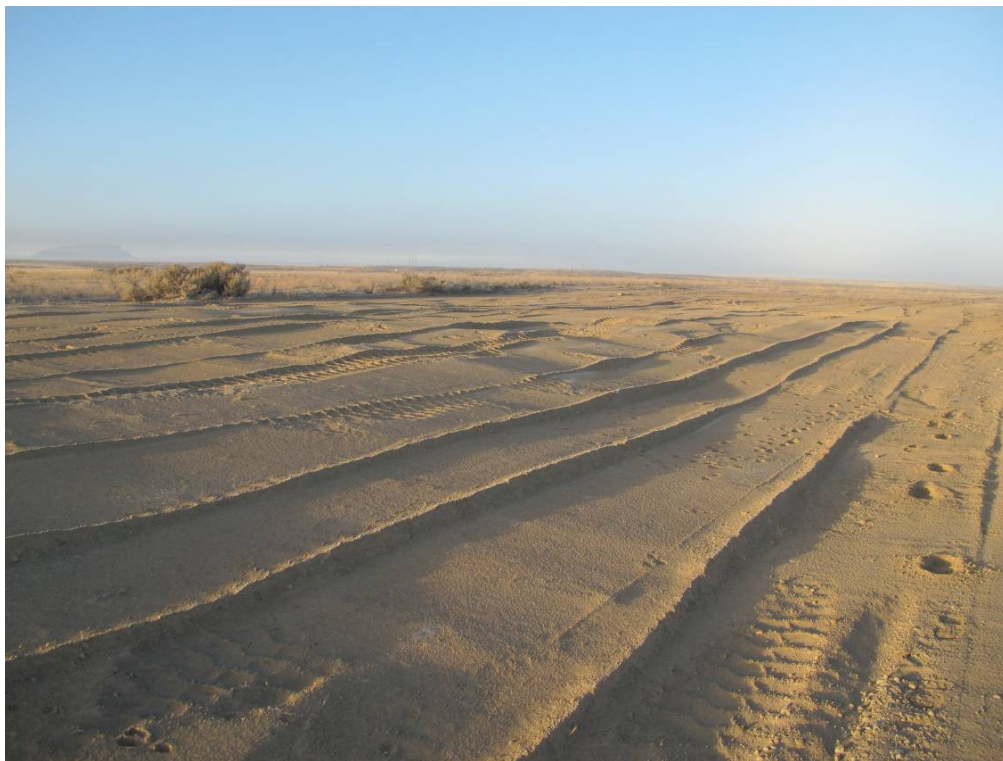
Figure 5. Disturbed area resulting from the removal of the soil pile previously located south of the MFC facility.

A soil pile was located on the south side of the road that runs east and west along the southern barriers. The soil pile had not been seeded. In late October 2010, the soil pile was removed to grade (Figure 5).

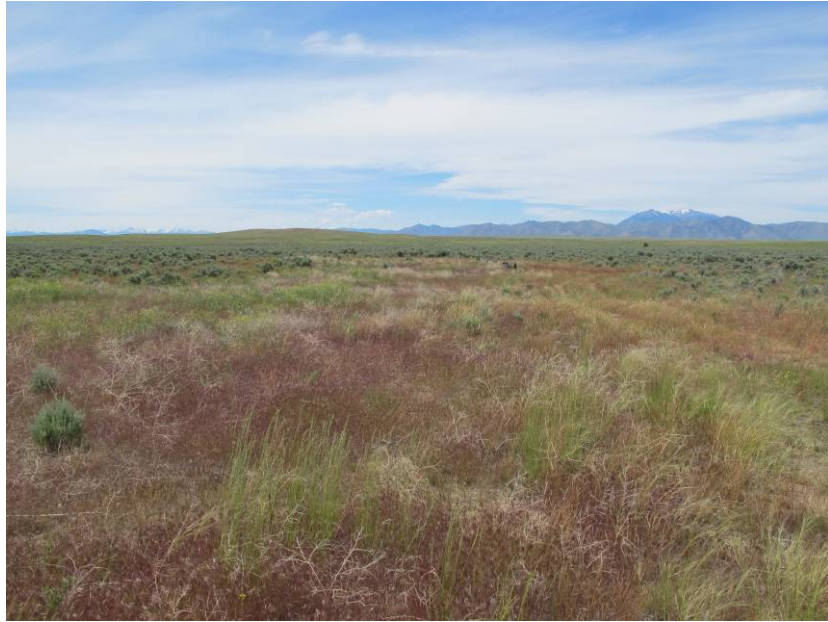
Figure B-1. Southwest Big Loop Trench at the GI.

The southwest Big Loop Trench vegetation is composed primarily of cheatgrass, Jim Hill tumbledustard (*Sysimbrium altissimum*), and western tansymustard (*Descurainia pinnata*) (Figure B-1). Density of Jim Hill tumbledustard and western tansymustard appear to be lower this year than it was in 2009. Perennial grasses observed included: bottlebrush squirreltail, needle and thread grass, Sandberg bluegrass (*Poa secunda*), and thickspiked wheatgrass. Sandberg bluegrass appeared to be the most common perennial grass observed. Wyoming big sagebrush plants were located within the disturbed area of the trenches. These sagebrush plants appeared healthy based on the vigorous annual growth.

As described in the above sections, the disturbed areas within the GI Project are recovering as expected for this type of ecosystem, and shrubs are beginning to establish within the disturbed area. Due to the lack of perennial cover, however, these sites have still not achieved final stabilization. Most of the trenches show good establishment of shrub seedlings, so allowing succession to progress may be the best course of action. The GI project will continue to be visually observed to monitor progress toward meeting final stabilization.

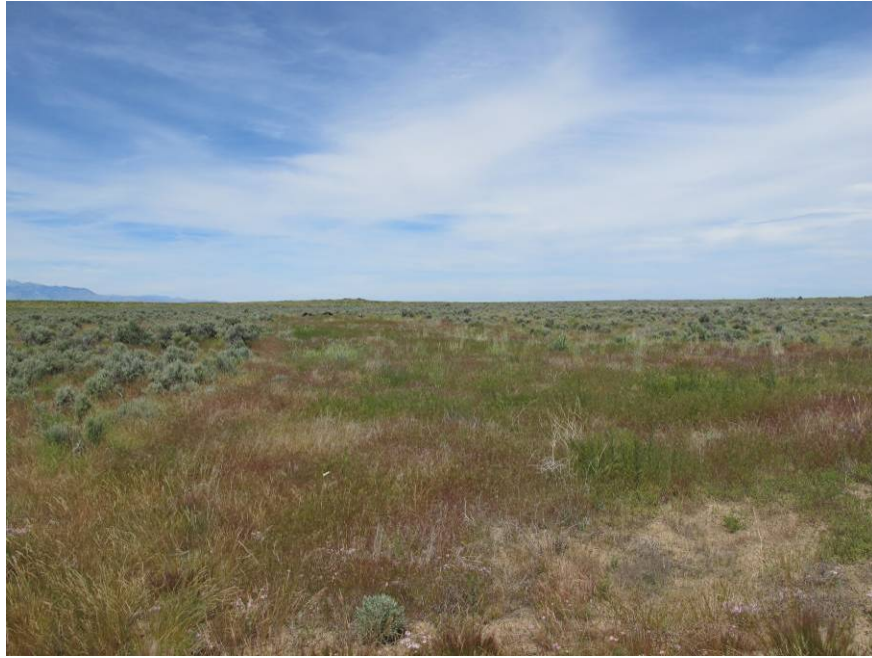
Figure B-3. Northeast Big Loop Trench at the GI.

Similar to the other two Big Loop Trenches, the northeast Big Loop Trench (Figure B-3) is dominated by cheatgrass. Jim Hill tumbledustard and western tansymustard don't appear to be as numerous at this trench as they are at the other two trenches. Other forbs observed included: silvery lupine and shaggy fleabane. Perennial grasses included bottlebrush squirreltail, Sandberg bluegrass, and thickspiked wheatgrass. Fewer Wyoming big sagebrush plants were found on this site, but those that were observed showed vigorous annual growth.

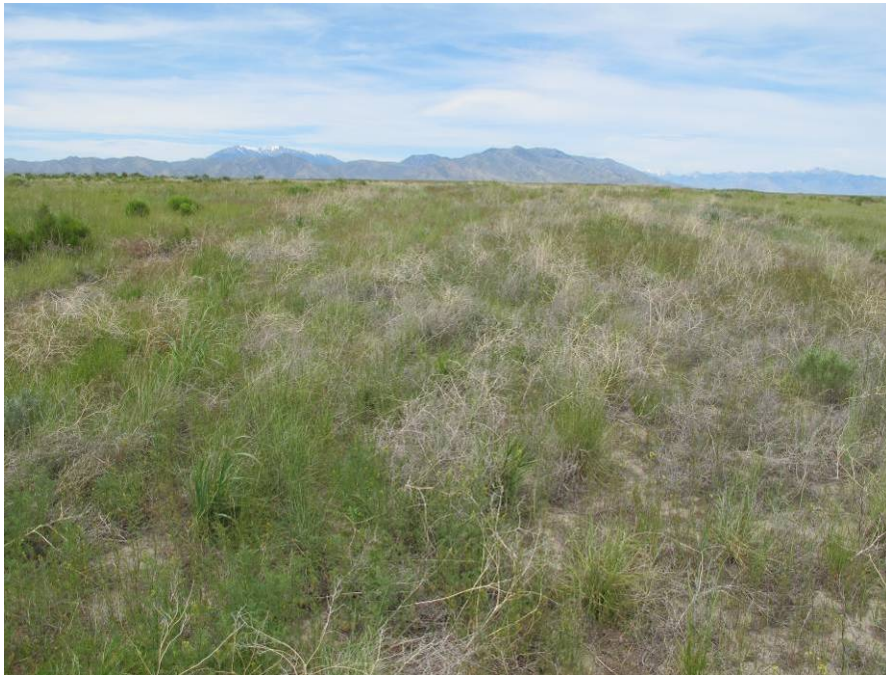
Figure B-4. Long Saddle Trench at the GI.

There are some areas in the Long Trench comprised almost solely of cheatgrass and Jim Hill tumbledustard (Figure B-4). In other areas, the native perennial grasses appear to be doing well. Perennial grasses observed included needle and thread grass, Indian ricegrass, and western wheatgrass. Russian thistle production was significantly lower than in 2009. Wyoming big sagebrush and green rabbitbrush plants were showing vigorous growth.

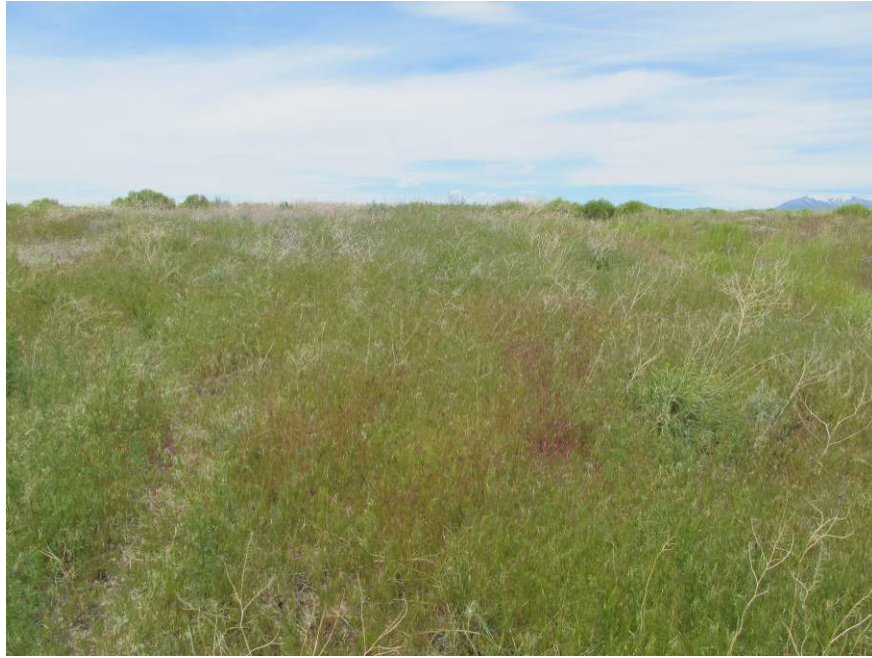
Figure B-5. West Saddle Trench at the GI.

Cheatgrass is the dominant species in the West Trench (Figure B-5). A few needle and thread grass, bottlebrush squirreltail, and Indian ricegrass plants were observed. Other species identified were Wyoming big sagebrush, orange globemallow (*Sphaeralcea munroana*), and western tansymustard.

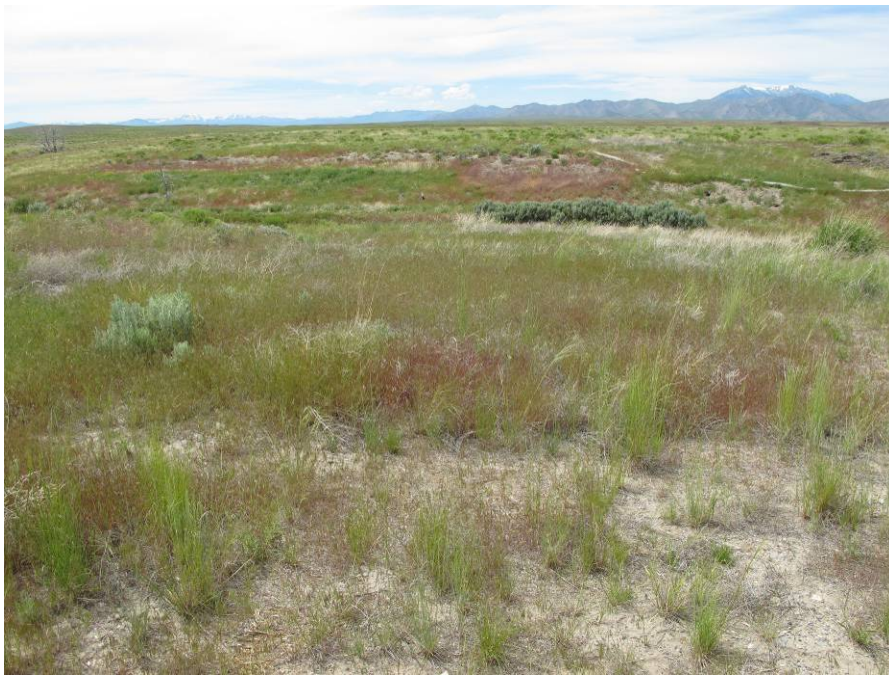
Figure B-6. East Saddle Trench at the GI.

Similar to the other two Saddle Trenches, cheatgrass was the dominant grass species in the East Trench. Perennial grasses included western wheatgrass, needle and thread grass, bottlebrush squirreltail, and Indian ricegrass (Figure B-6). The perennial grasses appeared vigorous as did the few Wyoming big sagebrush plants. Orange globemallow and silvery lupine (*Lupinus argenteus*) were also observed.

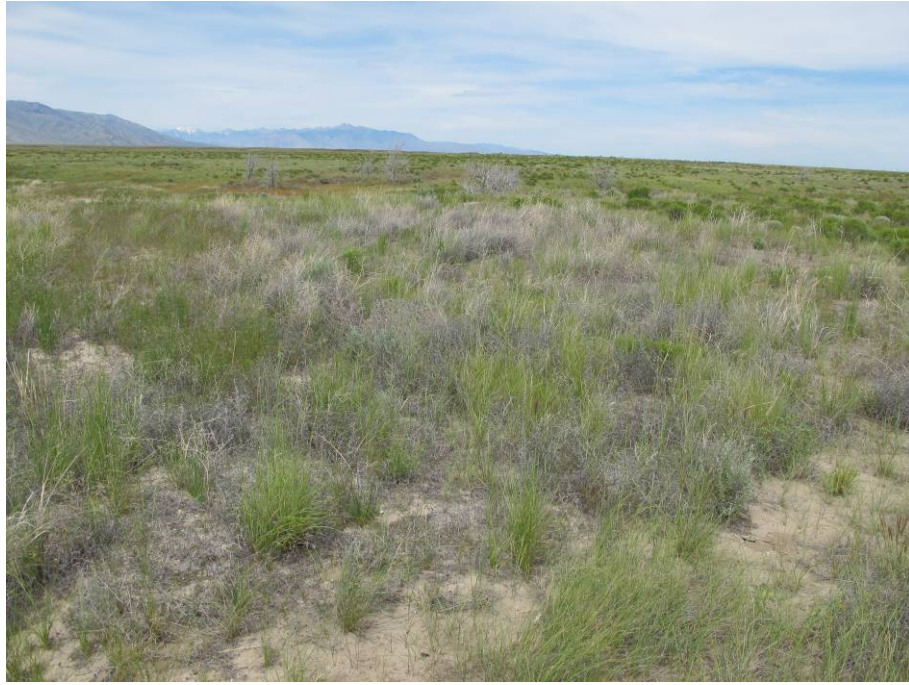
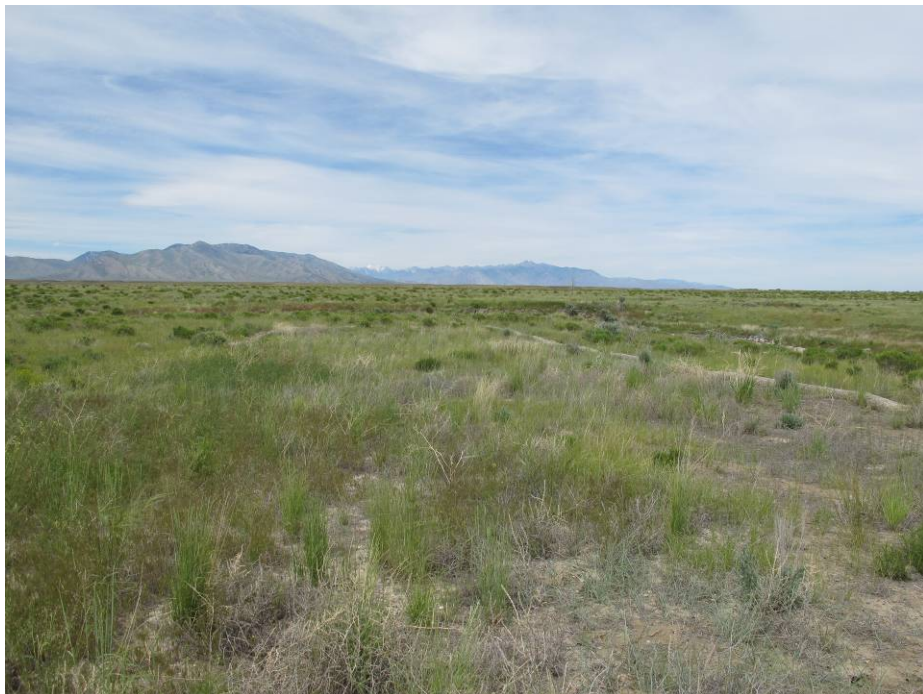
Perennial needle and thread grass and Indian rice grass are dominant grass species at the East and West Trenches (Figures B-7 and B-8). Growth appears to be vigorous. Other perennial grasses observed were bottlebrush squirreltail and Sandberg bluegrass. Cheatgrass is present but not nearly as abundant as it is at the Big Loop Trenches or the Saddle Trenches. Wyoming big sagebrush and green rabbitbrush are showing vigorous growth.

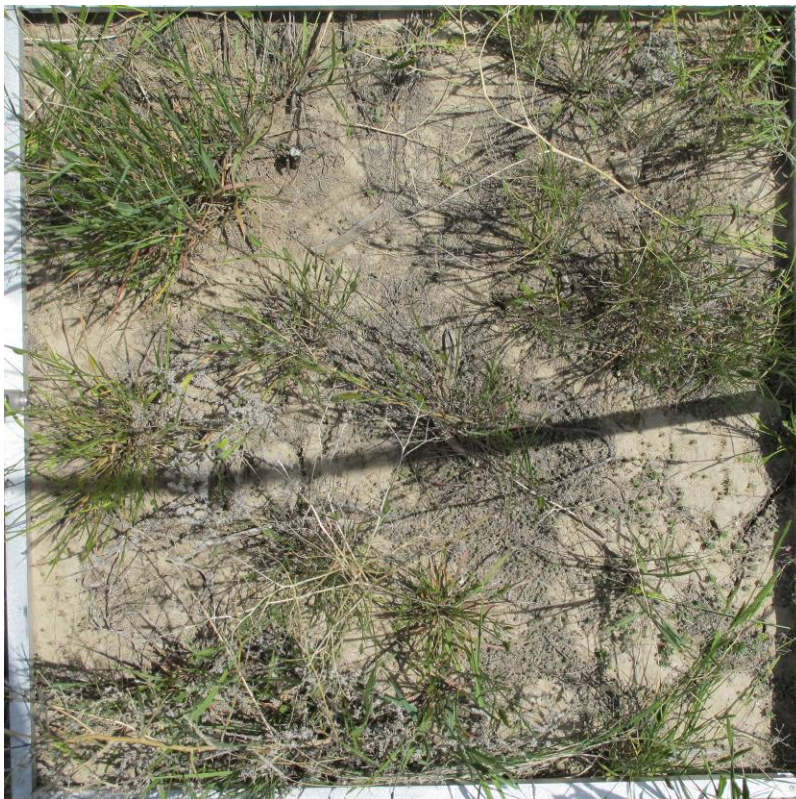
Figure B-12 Disturbed area vegetation plot for the Septic Tank Drain Field.

The septic tank drain field is approximately 58 ft x 105 ft. Perennial vegetation has reached 79.2% of background (Table A-3, Figure B-12) and consists almost entirely of crested wheatgrass. There is not a statistical difference between mean cover percentages for background and disturbed area transects ( $p = 0.093$ ). The mean percentage of grass in the background is significantly higher than that of the disturbed area ( $p = 0.044$ ). Annuals including kochia, pinnate tansymustard, halogeton, cheatgrass, and clasping peppergrass were also observed, but mean cover percentage of annual species is not significantly different between the background and disturbed areas ( $p = 0.305$ ). There is still a small strip of bare ground running down the middle of the disturbed area. Transects were located as shown in Figure 4.

Because the area surrounding the project is dominated by crested wheatgrass, it is expected that crested wheatgrass will eventually become the dominant species on the disturbed sites. The Septic Tank Drain Field and fenced area east of MFC-736 have achieved final stabilization and will not be evaluated in future assessments. The Power Cable Corridor and fenced area between MFC-735 and MFC-736 will be evaluated again in 2011 to determine whether or not final stabilization has been achieved.

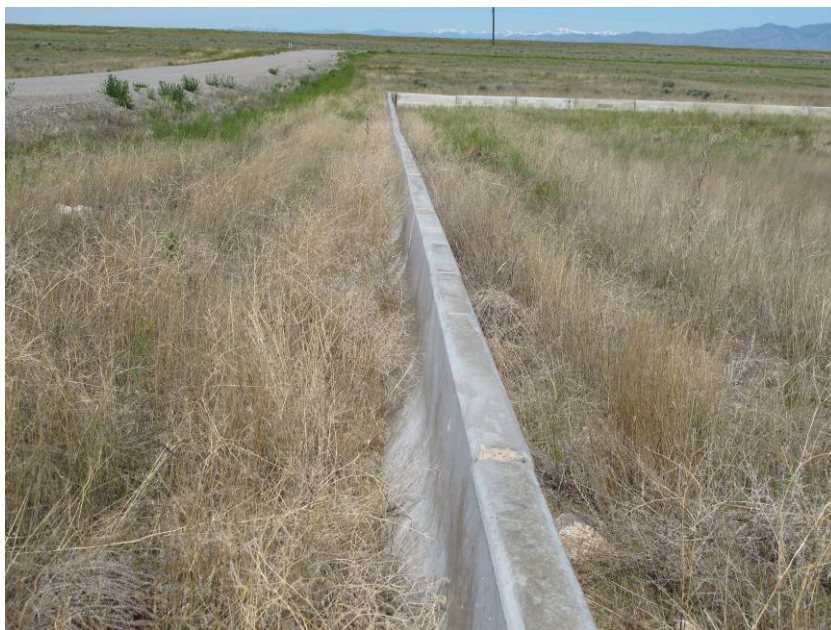
Figure B-13. Overview of the MFC Vehicle Barrier Project.

The relatively cool, moist spring appeared to favor the grasses. Overall, the disturbed sites appear to be recovering well. However, there were a couple of locations (Figure B-13) with very little new growth in 2010. In 2009, these areas had a dense cover of forbs and grasses.

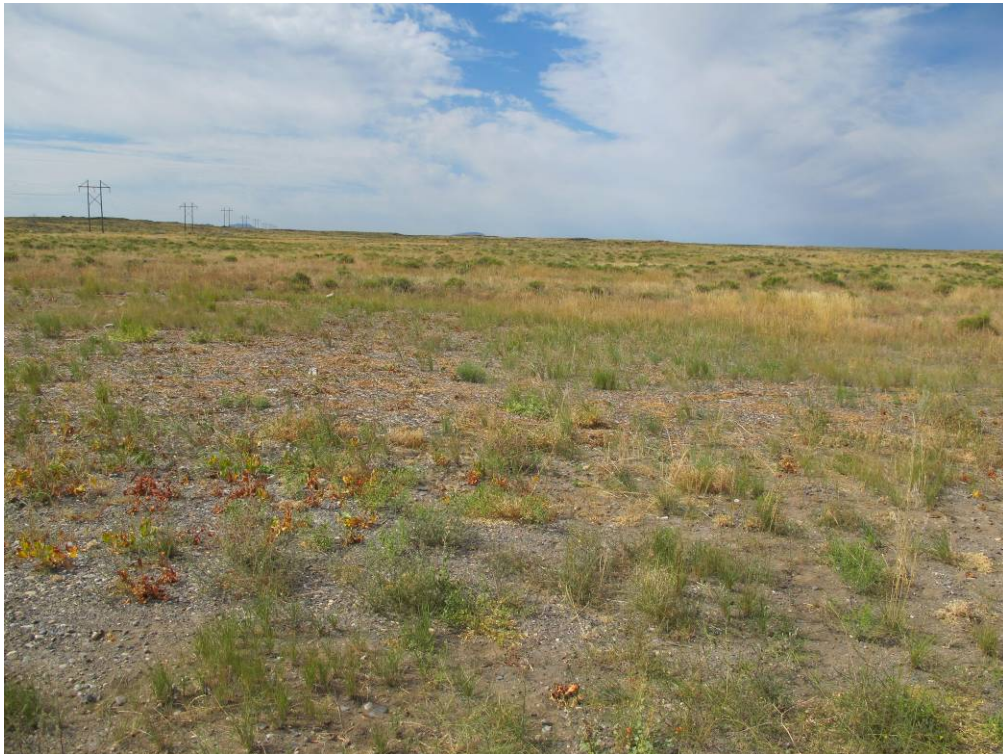
Figure B-16. Disturbed area at the east end of the NSTR access road.

Wood chips in some locations at the turn-off on the east end of the range access road are very heavy in some cases 2-3" thick (Figure B-16). Lanceleaf scurfpea (*Psoralea lanceolata*), globemallow, silvery lupine, and textile onion (*Allium textile*) are forbs that are reestablishing the disturbed area. Bottlebrush squirreltail and needle and thread grass are also present. Cheatgrass was also noted.

Areas that did not burn and that have not reached the requirements for final stabilization, i.e. the area near Power Pole 179 and the disturbed area on the east end of the range access road will continue to be monitored for their progress towards reaching 70% of background cover.

It was recommended in the 2009 Revegetation Assessment that the wood chips in areas of heavy accumulation at the power pole 176 site and the turn-off at the east end of the range access road should be redistributed because of the potential to inhibit plant growth. On June 10, 2010, the digital camera sampling and analysis method was performed at the power pole 176 site. It was determined from this evaluation that the power pole 176 site had reached 98.8% of background, even though no wood chips had been redistributed at either site. Therefore, the digital camera sampling and analysis method will be

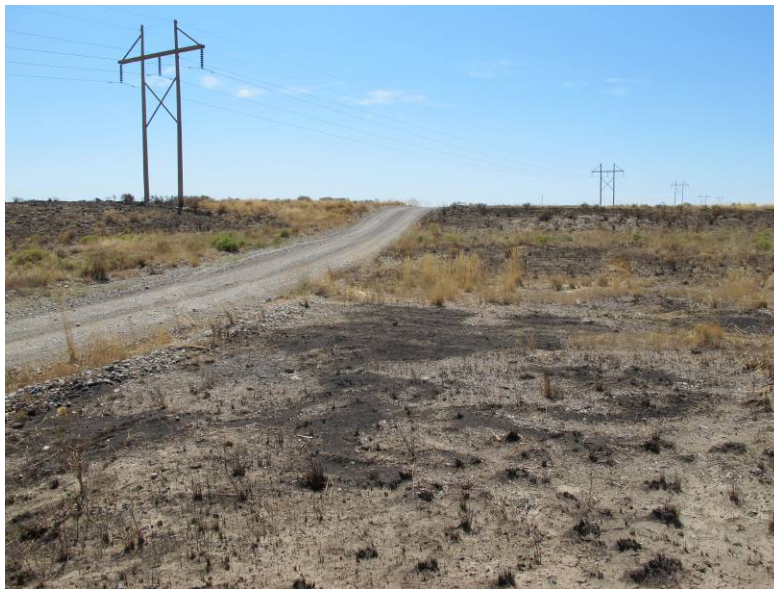
Figure B-18. Burned area near Power Pole 170.

This location was burned during the Jefferson Fire in mid July (Figure B-18).

On July 13, 2010 a wildland fire started near the Critical Infrastructure Test Range Complex and burned approximately 109,000 acres on the INL and adjacent lands, including the areas (near power poles 170 and 176) along the T-25 road discussed in earlier sections of this report. Where the fire occurred, vegetation composition in both disturbed and background areas is now at the same seral stage. Typical succession after the fire should begin with a grass/forb dominance, and eventually lead to sagebrush recovery in 30 or more years (Brown and Smith 2000). These burned sites will not be included in future versions of this revegetation assessment report.

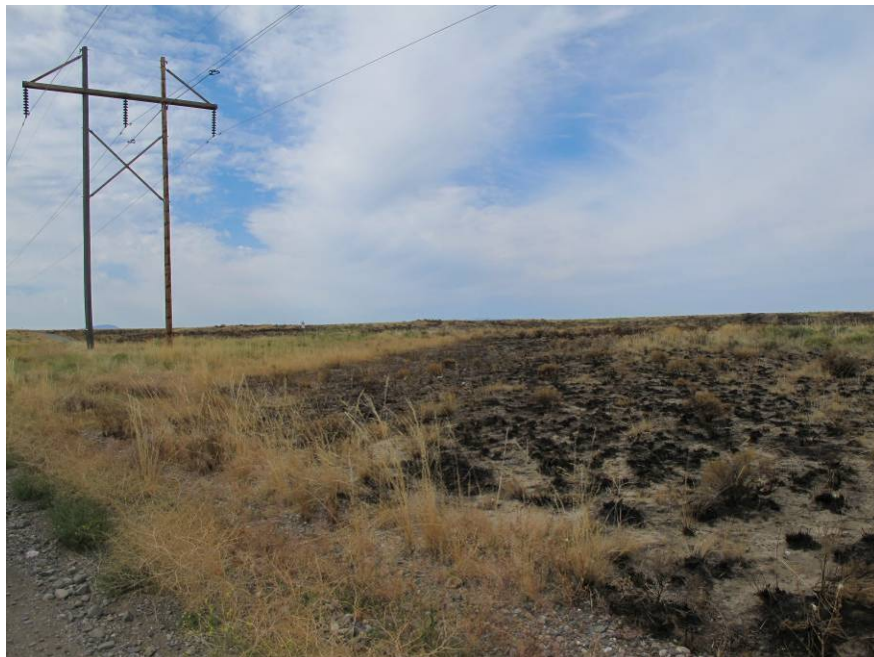
Figure B-20. Burned area near Power Pole 176.

As of June 10<sup>th</sup>, 2010 perennial cover at this location had reached 98.8% of background (Table A-5) and was composed mostly of grasses including Indian ricegrass, bottlebrush squirreltail, thickspiked wheatgrass, and needle and thread grass (Figure B-19). Green rabbitbrush seedlings were reestablishing within the disturbed site. There was not a significant difference between the mean percentage of cover between the background and disturbed areas ( $p = 0.948$ ). Additionally, the mean percentages for rock and soil cover were significantly higher in the background area than in the disturbed area ( $p = < 0.001$  for both). Part of the disturbed area and the background area was burned by the Jefferson Fire in mid July (Figure B-20).

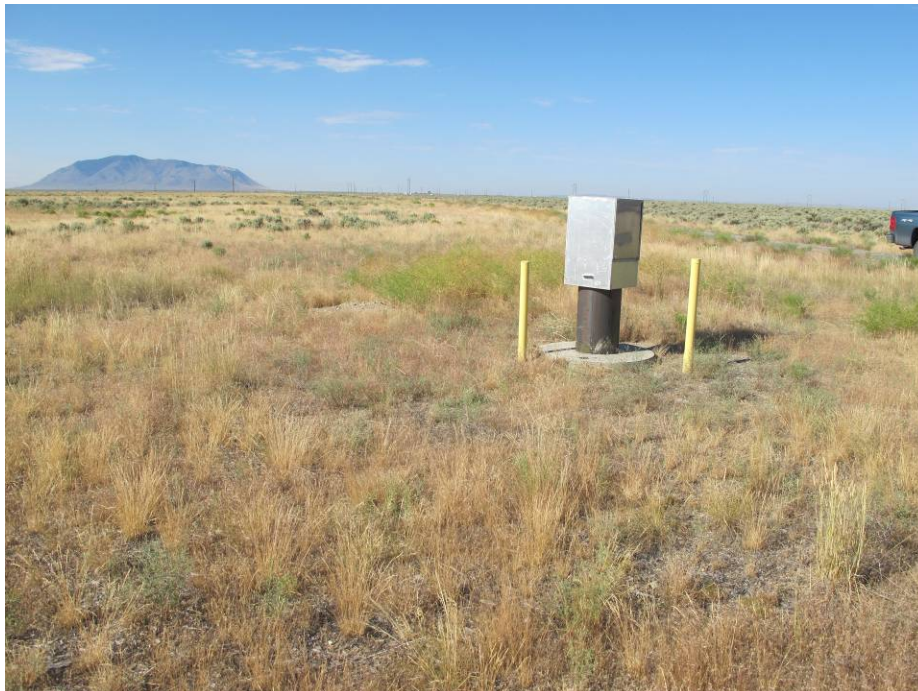
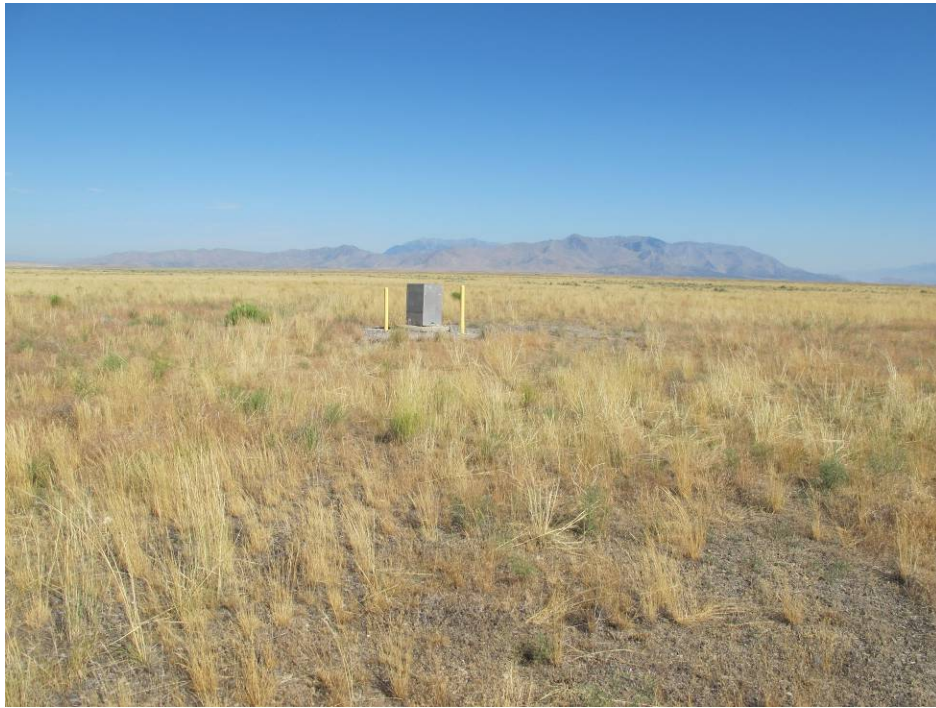
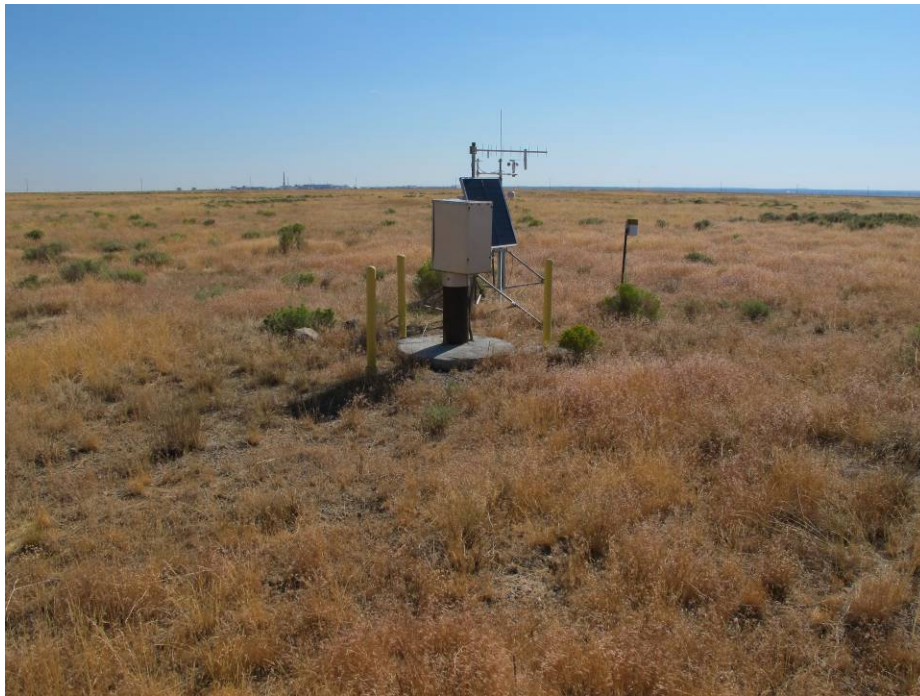
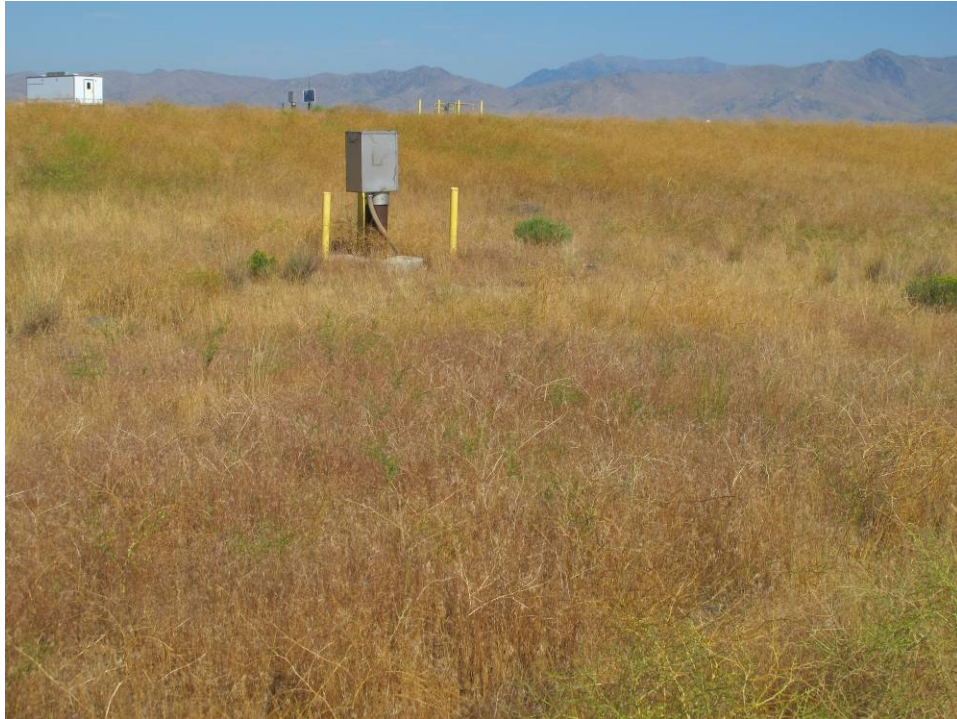
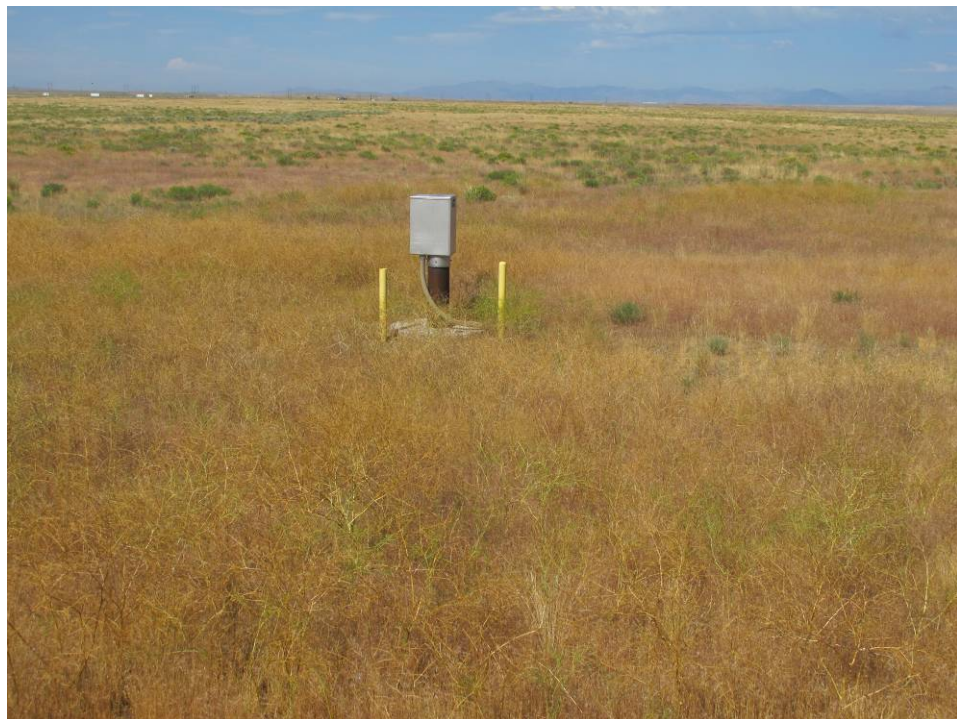
Wells 165, 166, 215, 201A, and 209 were also visually observed on August 5, 2010. Cheatgrass and tumble mustard can be found at all locations. Rabbitbrush appears to be establishing well. Indian ricegrass, bottlebrush squirreltail, needle and thread grass, and thickspiked wheatgrass are the most abundant native grasses. Native forbs include phlox, globemallow, and shaggy fleabane.
