# **Light Water Reactor Sustainability Constellation Pilot Project FY11 Summary Report**

R. Johansen

September 2011

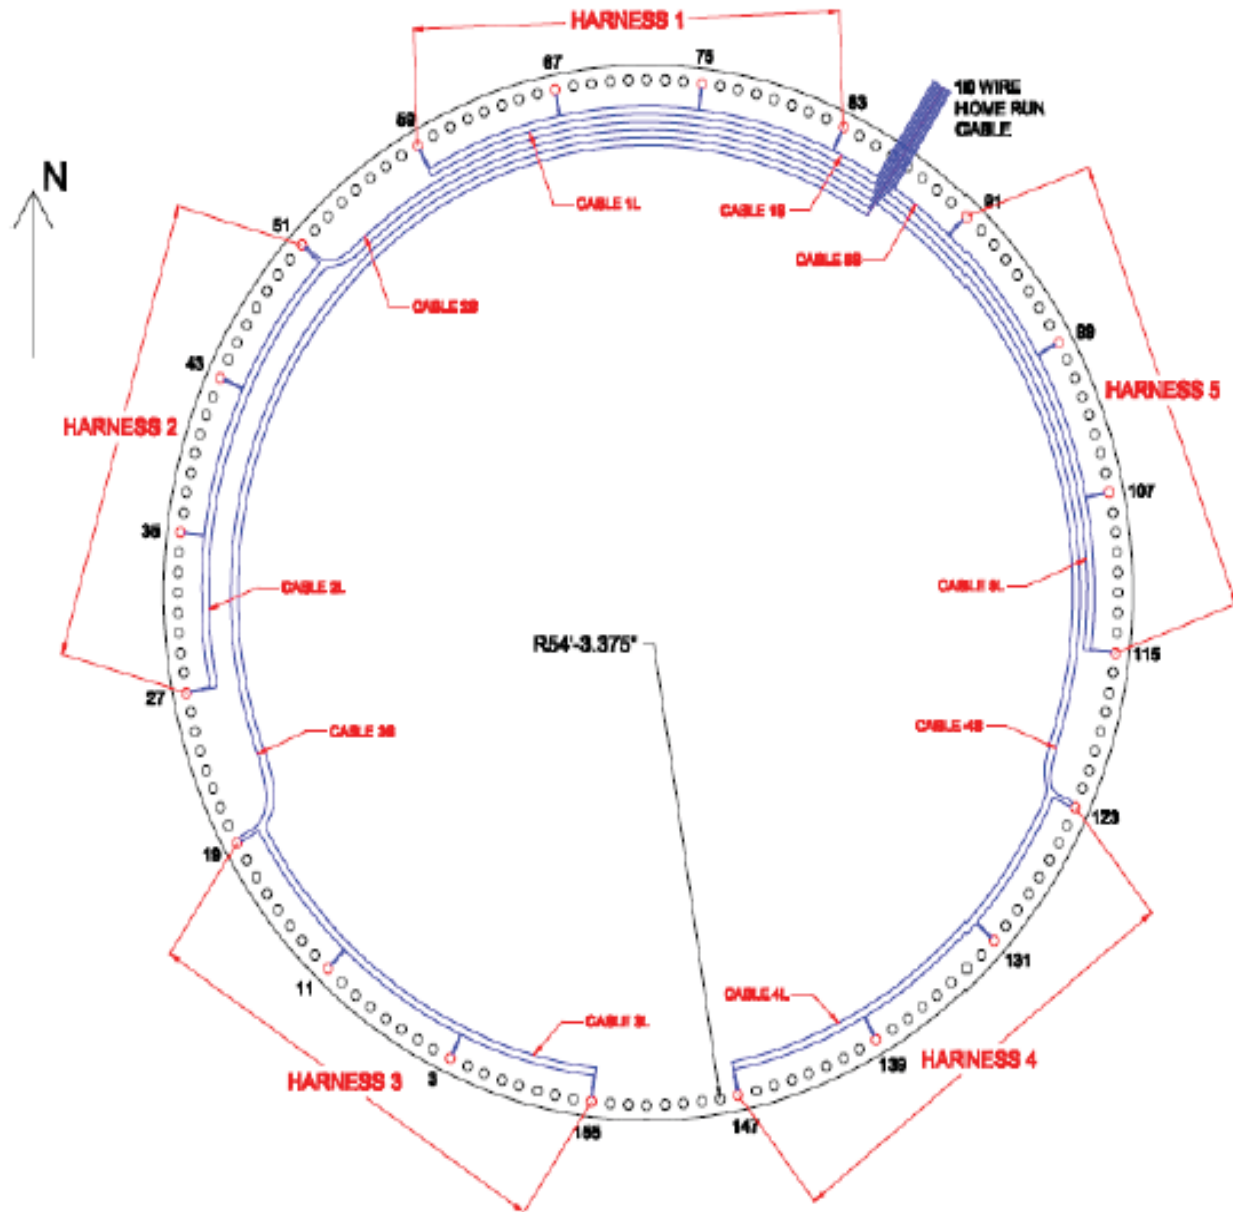
Figure 1. Tendon monitoring locations.

Twenty of the vertical tendons and one exposed circumferential rebar were outfitted with a fiber optic strain gauges (Figures 1 and 2) connected to a Data Acquisition System (DAS) to monitor temperature and strain of the containment wall and tendons. The system was operational for approximately one month prior to the Integrated Leak Rate Test (ILRT) and remains operational. The tendon monitoring system provides an active method to monitor and trend containment health. Testing of the tendon monitoring system showed proper responses to the containment pressurization. See Figure 3. Continuation of monitoring and evaluation of this system is recommended for FY12.

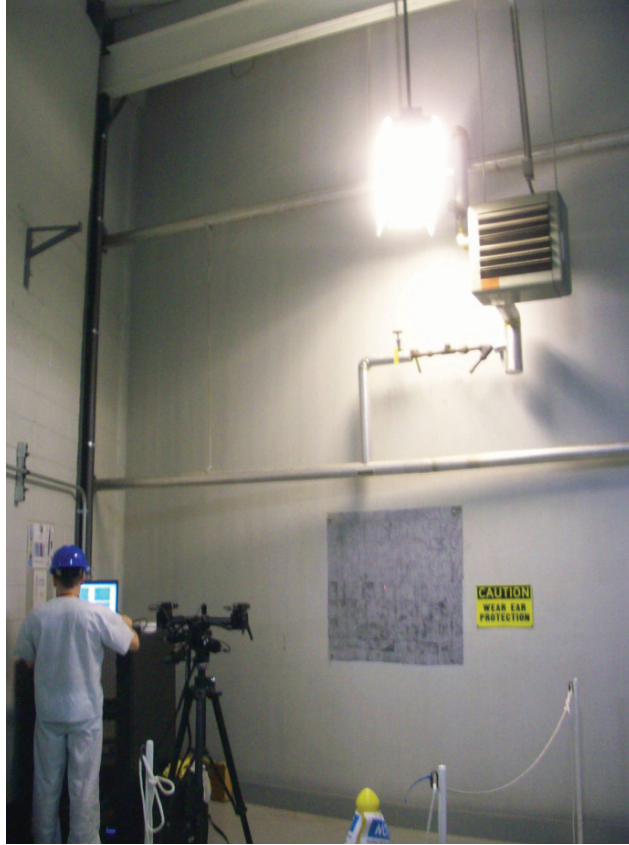
Figure 4. Digital image correlation camera setup at the 315 level.

Digital Image Correlation (DIC) utilizes two cameras separated on a bar at a known distance. The cameras capture a pattern on the surface and the software defines the shape of the surface. Utilizing multiple images, the software analyses shape changes and defines strain and displacements occurring on the surface. These images can be utilized for definition of shape changes for detection and monitoring of degradation mechanisms. See Figures 4 and 5 for the test set up.

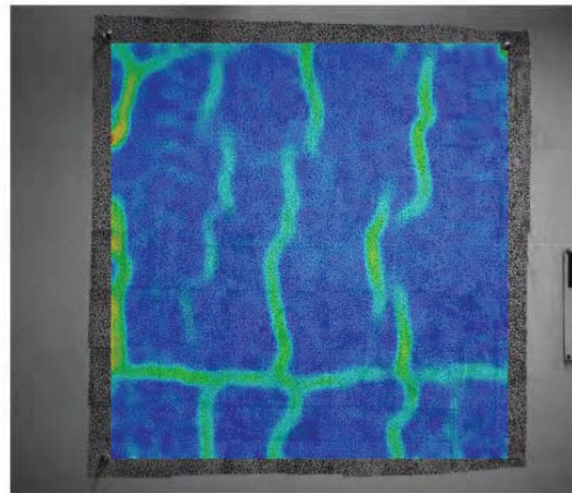
Figure 6. Major strain map (35 psi hold) at 315 level.

Two 3D digital image correlation systems were utilized during the Ginna ILRT. The most comprehensive data was obtained at the personnel hatch location, where a system continuously acquired data throughout the complete pressurization and depressurization cycles. Displacements and strains were also recorded periodically at a location at the 315 level and near the equipment hatch. These three locations were permanently marked as monitoring locations. Measurements included radial and in-plane displacements, principal strains, and crack opening displacements. See Figures 6, 7, and 8 for typical DIC results. Data was also obtained near the equipment hatch; the sensor was brought there for each of the three pressure holds.
