Summary of Post Irradiation Examination Results of the AFIP-6 Failure

RERTR 2011

**RERTR 2011 — 33rd INTERNATIONAL MEETING ON
REDUCED ENRICHMENT FOR RESEARCH AND TEST REACTORS**

A.B. Robinson¹, D.M. Wachs¹, F.J. Rice², D.M. Perez³

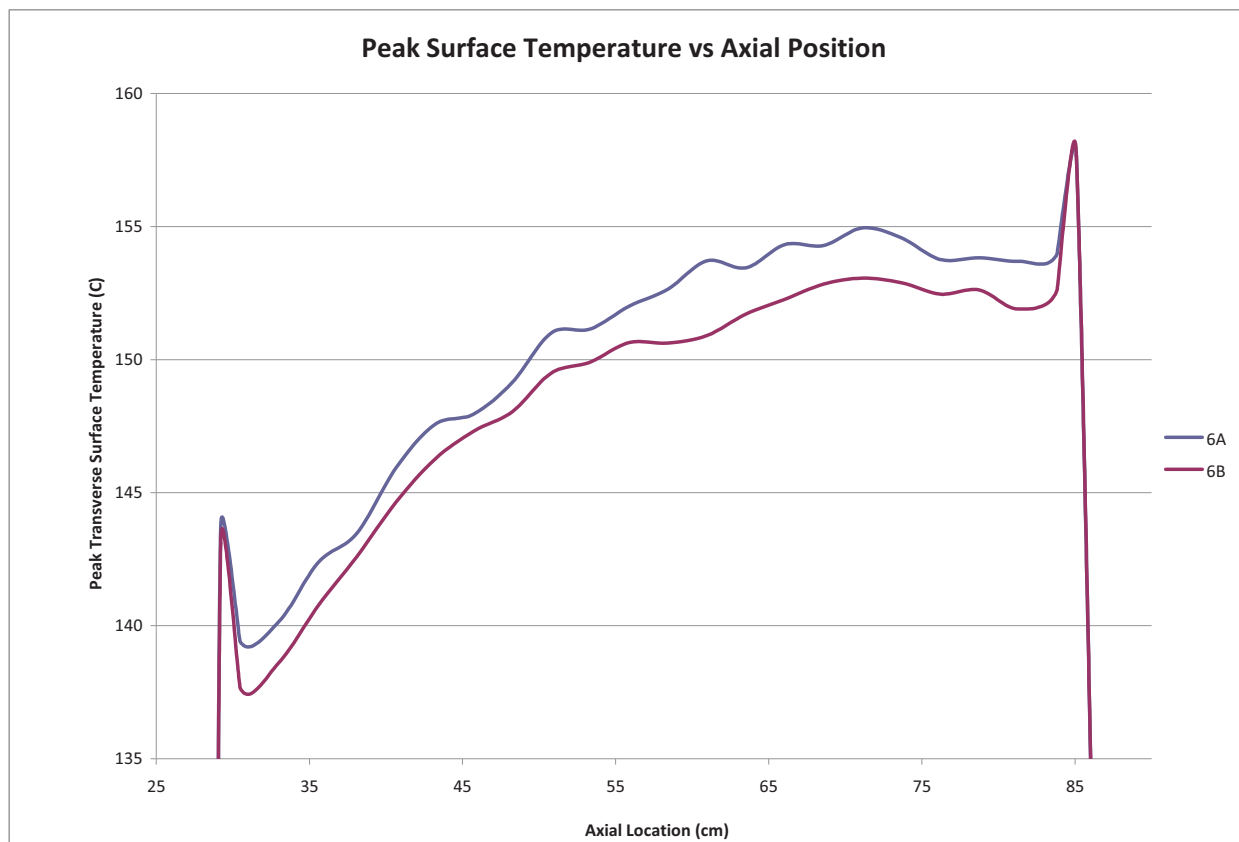
Subsequent detailed thermal hydraulic analysis of the experiment indicated that the combination of the high operating power and test vehicle configuration led to high nominal operating temperatures for the fuel plates. This elevated temperature accelerated surface corrosion and eventually led to spallation of the fuel plate cladding. The thermal insulating nature of this corrosion layer led to significantly elevated fuel meat temperatures that are assumed to have induced blistering. Figure 1 shows the calculated surface temperature of the oxide layer as a function of axial location down the plates². Calculations also indicate BOL peak heat fluxes were 525 W/cm².

Figure 1 Peak surface temperature of the oxide layer as a function of axial location

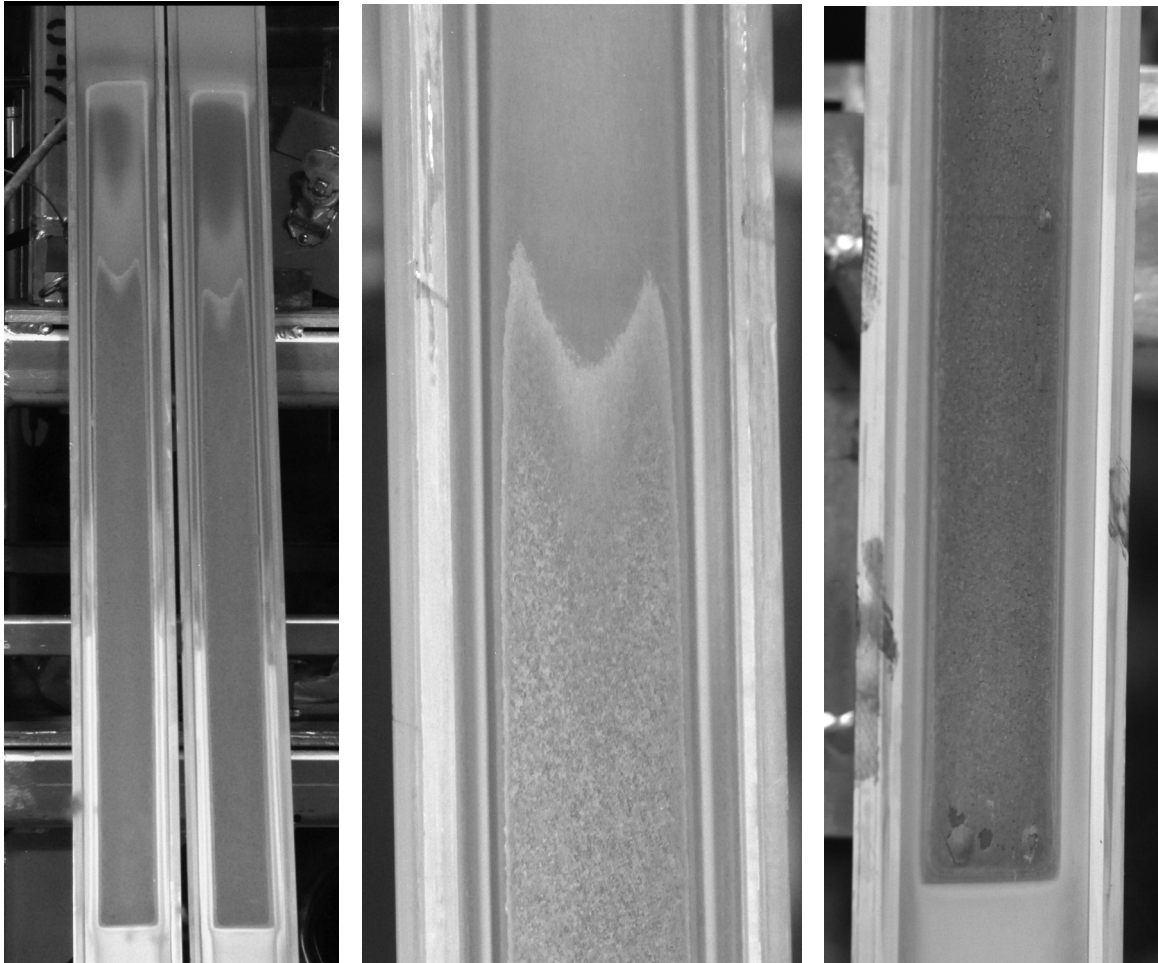
Visual examinations of the plates showed abnormal oxide formation, regions with pronounced blisters, and locations where spallation of the oxide had clearly occurred. Figure 2 and Figure 3 show samples of the images collected of the surface of the plates and the neutron radiograph images.

Figure 2 Visual examination photographs of AFIP-6 plates

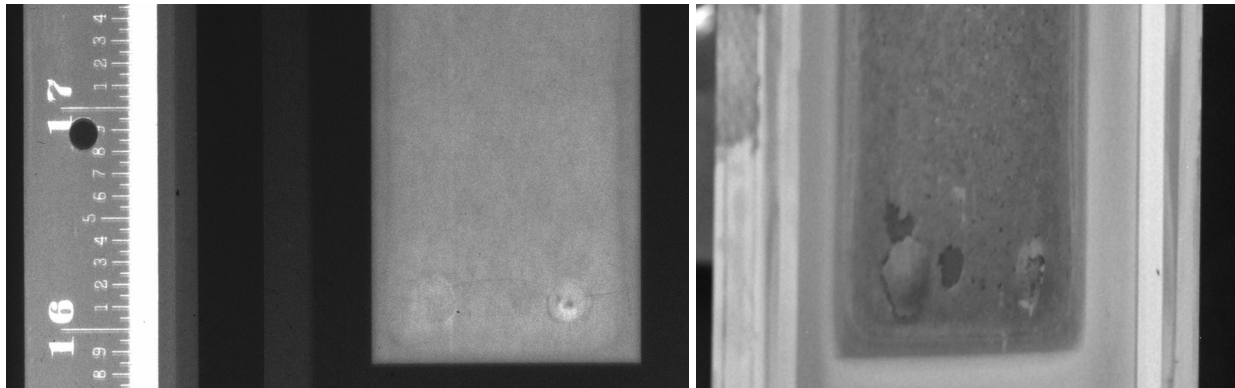
Figure 3 Comparison of neutron radiograph (left) and visual exam (right)

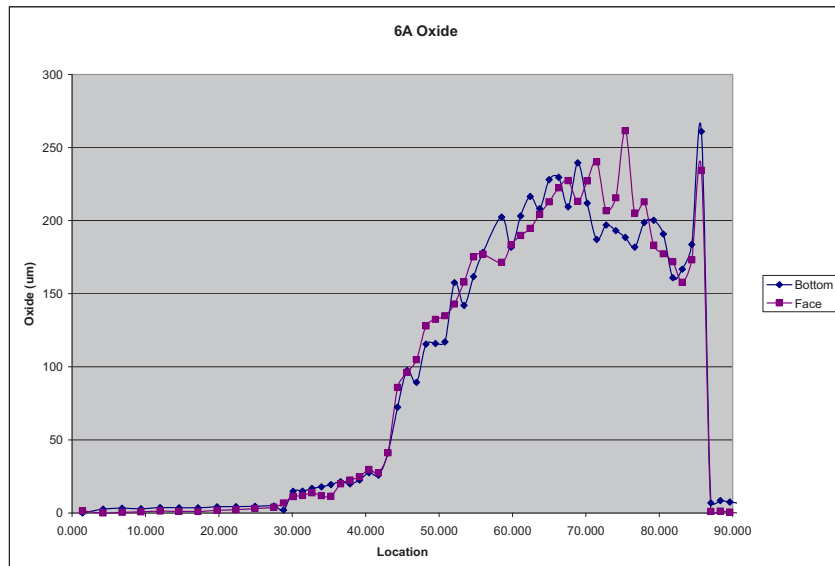
The results show a small increase at 30 cm’s where the fuel zone begins, and then a drastic increase at approximately 42 cm’s where the oxide begins to grow to an unstable value. Variations can be seen down the length of the 6A plate with peaks occurring at approximately 75 cm’s and 86 cm’s where visually observable blisters had occurred.

Figure 4 Eddy current results from plate 6A

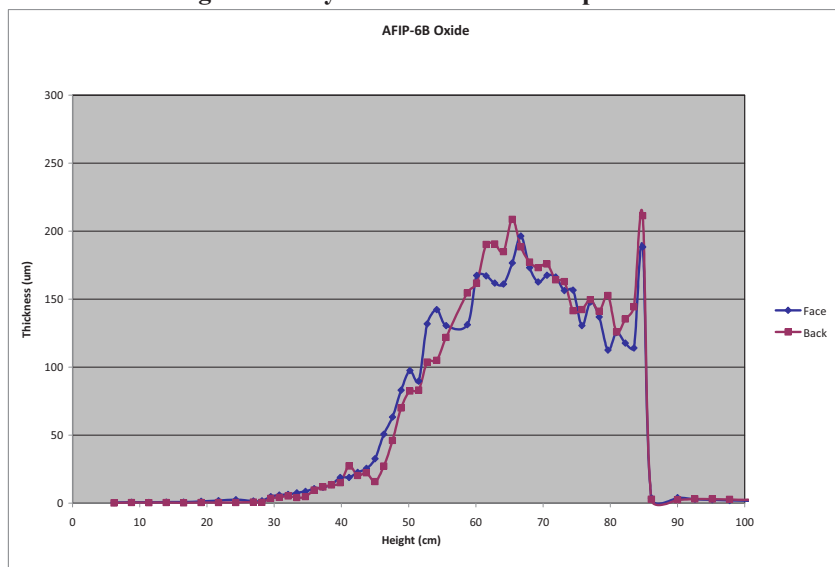
Figure 5 Eddy current results from plate 6B

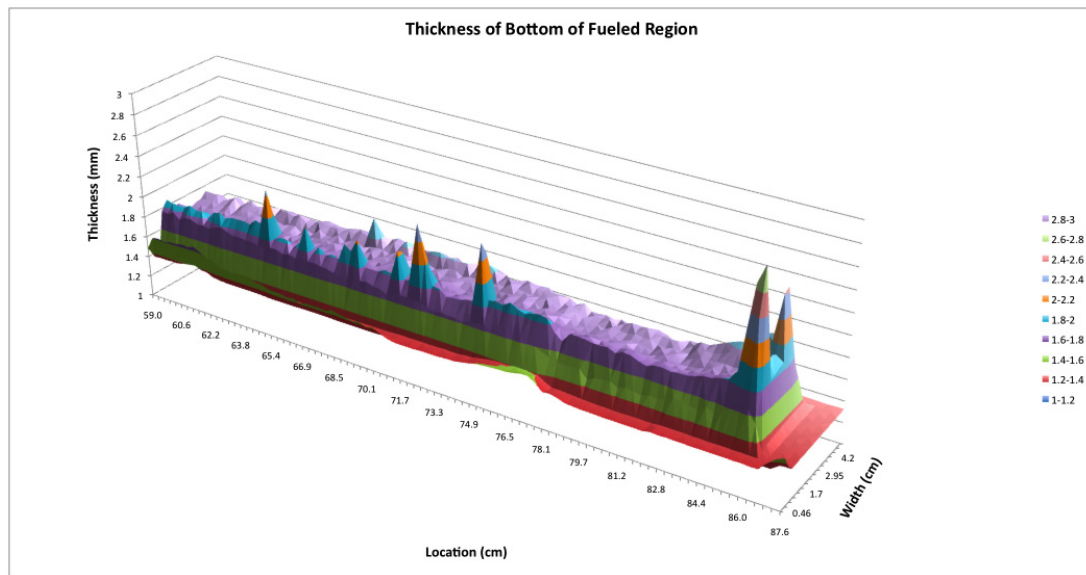
Because large blisters exaggerate the thickness data, swelling values will need to be determined using optical metallography. However, the thickness data gives an idea of the location of failures and defects over the surface of the plate. Plate 6A suffered two large blisters at the bottom region of the plate as well as smaller defects predominantly down one edge of the plate with an additional large blister towards the top of the fuel zone. Plate 6B had significantly fewer large defects as can be seen from the profiles in Figure 6 and Figure 7.

Figure 6 Thickness profile of fueled region of AFIP-6A plate

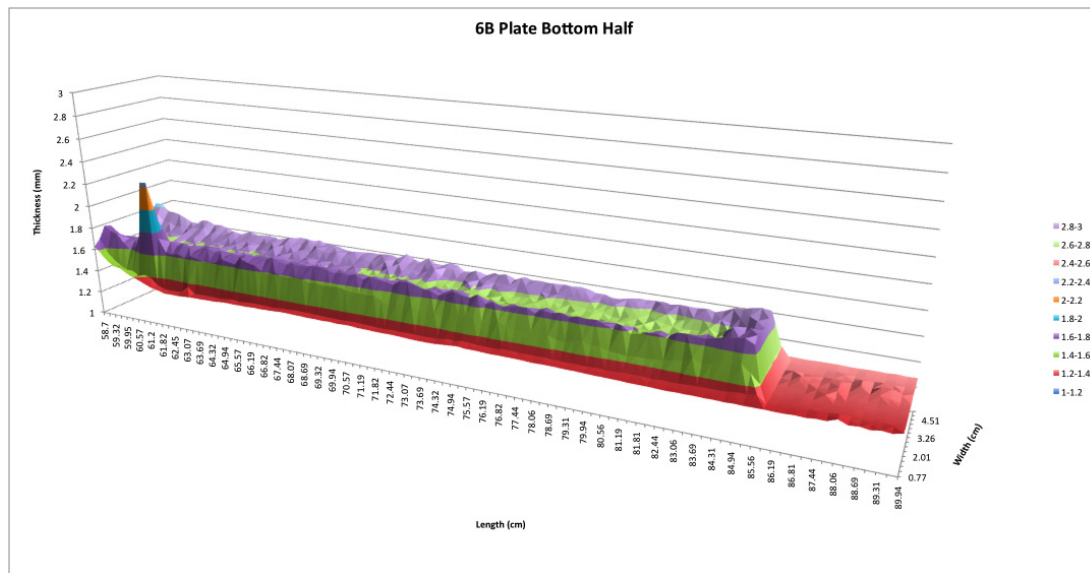
Figure 7 Thickness profile of fueled region of AFIP-6B plate

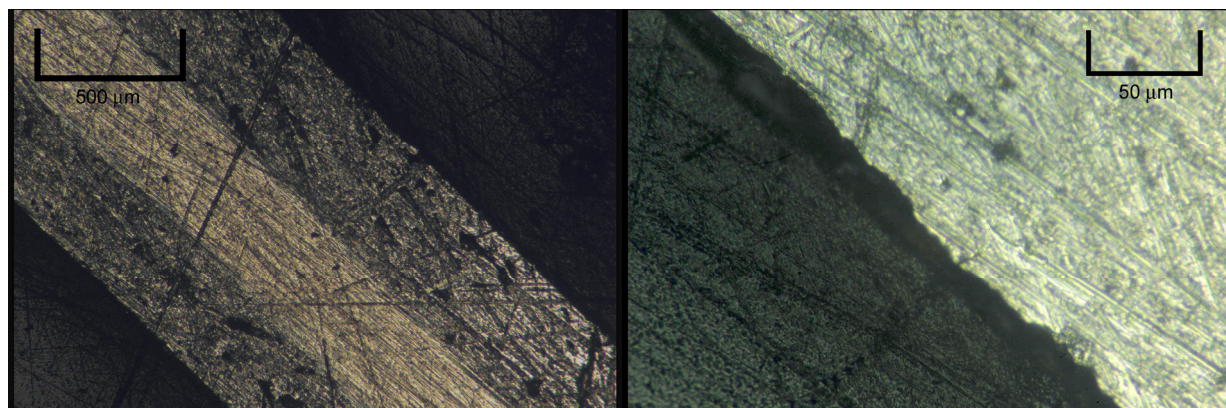
Samples taken from the top regions of the fuel plates indicate typical behavior of the fuel, cladding, and diffusion barrier. Examination showed behavior that has been seen in previous experiments. The oxide layer is thin (5-10 μm) Figure 8 (right), the cladding is uniform, there is little to no reaction between the fuel/zirconium/cladding, Figure 8 (left), and at this burnup no visible porosity can be seen.

Figure 8 Optical images from the top of plate 6A including

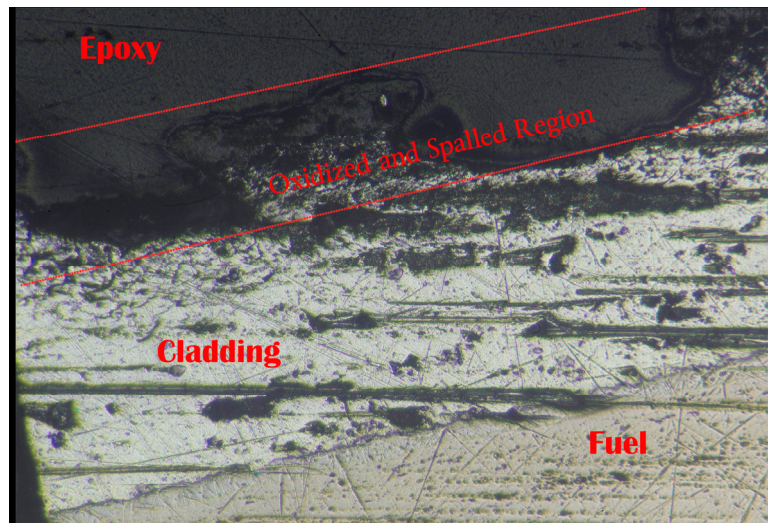
As the temperature increased down the length of the fuel plates, abnormal behavior was seen. Dramatic increases in plate surface oxide thickness were observed, which further increase the temperature of the fuel. Figure 11 shows one side of the cladding from plate 6A. Approximately half of the cladding thickness has been degraded by corrosion. The traditional oxide layer has spalled off and grain boundary attack of the aluminum has occurred resulting in compromised cladding properties, both thermal and mechanical. Similar results were seen in tests performed on aluminum at Oak Ridge National Laboratory by Selby et al.³ Figure 9 shows a region where spallation has occurred.

Figure 9: Image showing oxidation/spallation region

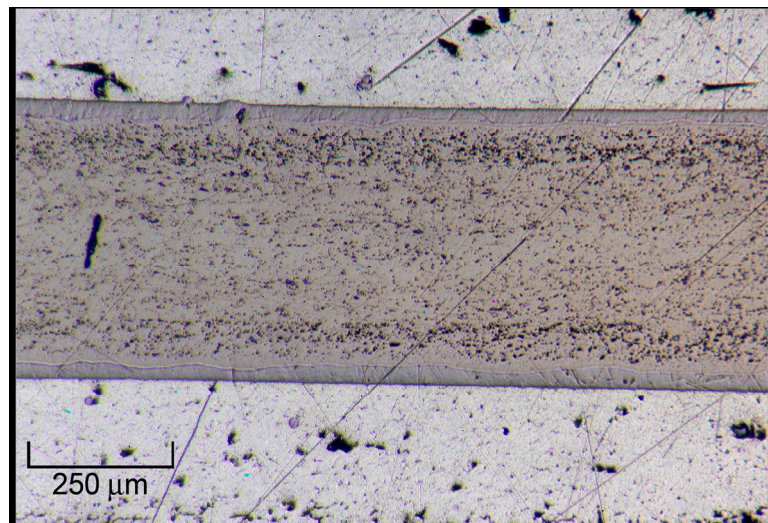
Figure 10 shows this large amount of porosity that was beginning to form within the fuel with emphasis given to the periphery regions of the fuel zone. Porosity did not appear to preferentially form along the fuel to zirconium bond line but rather 5-10 micrometers into the fuel. This indicates good stability of the fuel/zirconium/clad bond.

Figure 10: Porosity beginning to form in the fuel foil

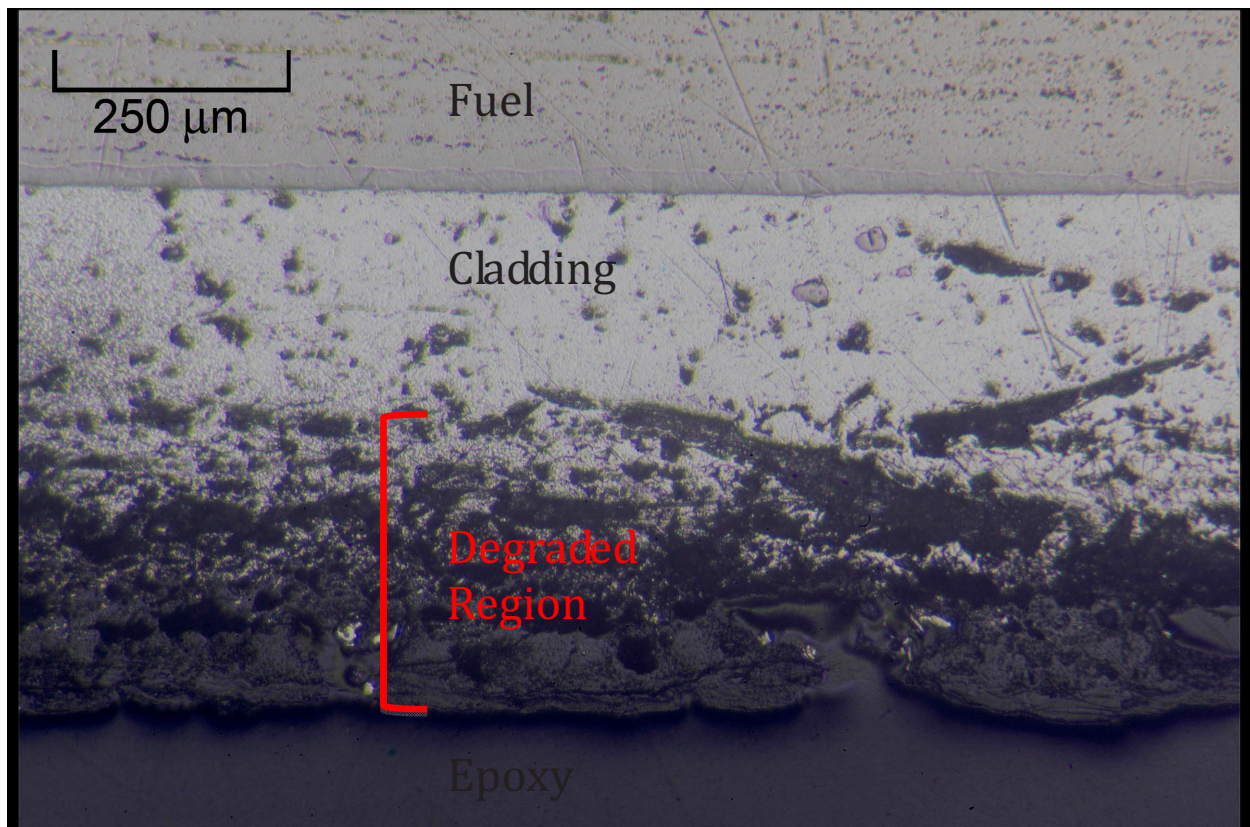
Figure 11: Image of plate surface at the mid plate of the AFIP-6A plate

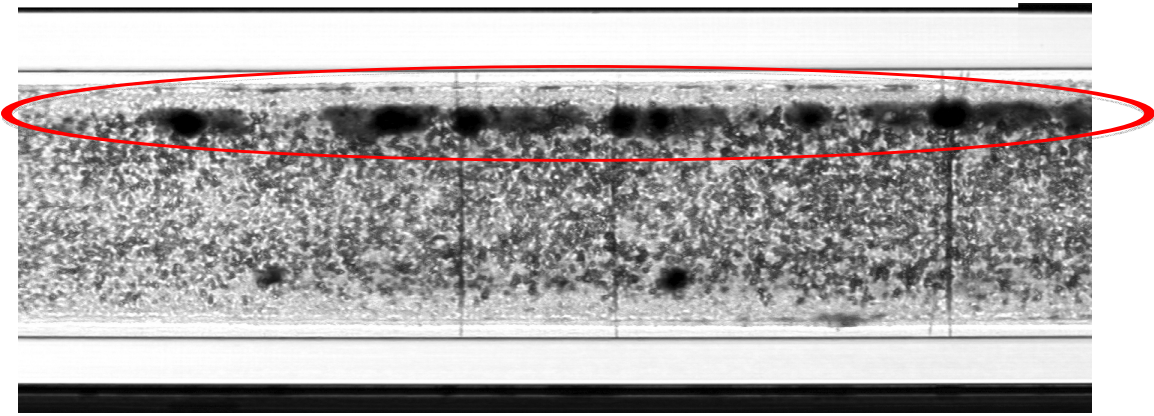
Moving axially down the fuel plates, the resulting decrease in the thermal conductivity of the cladding has further increased the fuel temperature and again changed the fission gas retention properties of the U-Mo fuel foil. The small, dispersed fission gas bubbles seen in cooler locations of the experiment are no longer visible within the fuel. Large voids have now formed in locations where fission gas bubbles were seen previously in cooler parts of the plate, i.e. Figure 10. Figure 12, an axial section, shows examples of two void regions that have formed within the fuel meat very near the rail region. Again, these voids have formed a small distance into the fuel and away from the interface. It is anticipated that these defects have become ‘sinks’ for fission gases and will ultimately become large enough to cause blisters like those observed in hotter regions of the plate. UT images indicate that these voids continue to appear down the length of the fuel plate as shown in Figure 13.

Figure 13: UT scan indicating the location of large porosity in the fuel along the rail

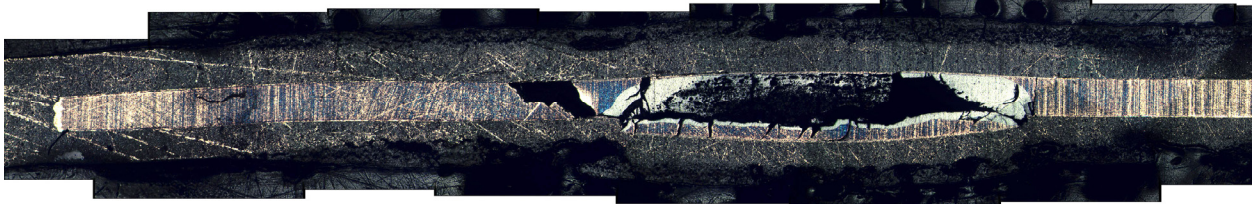
A cross section was taken through the blistered region at the bottom of plate 6A, which corresponded to the highest temperature region during the test. Figure 14 shows the fuel through the blister and as expected, significant damage to the fuel has occurred. A large void has formed near the centerline of the fuel foil and cracking is evident in the fuel around the void. It is anticipated that cracks in the cladding over this blister resulted in the release of fission gases to the primary coolant.

Figure 14: Cross section through blistered region of 6A plate
