CNEA Fresh Fuel Plate Characterization Summary Report

INL/EXT-12-24722

February 2012

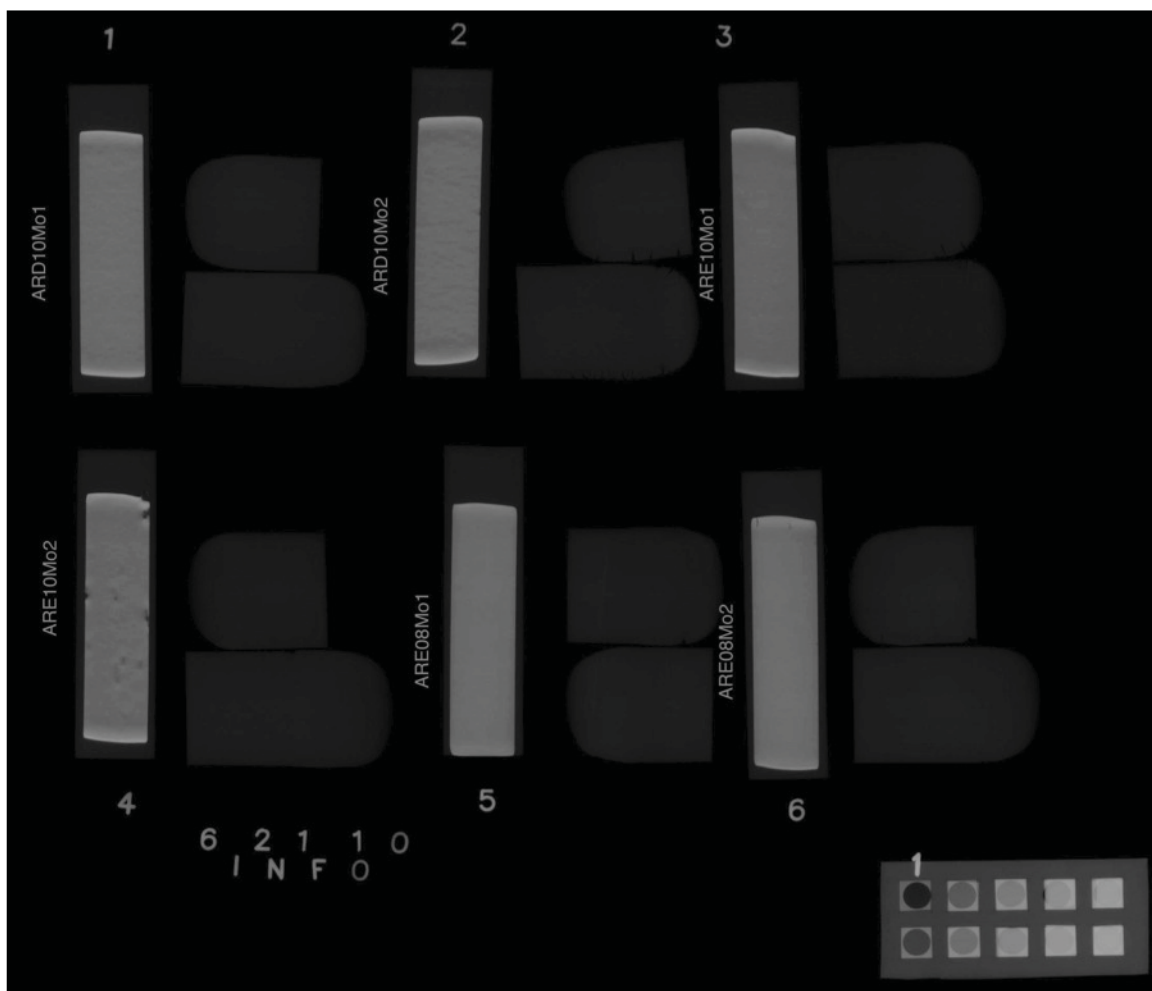
Figure 3: Radiography of CNEA plates for density.

The plates as listed in Table 3 show the density images in Figure 3 and are labeled accordingly. All plates based on the end region thickness exceeded the maximum fuel foil thickness specification requirements.

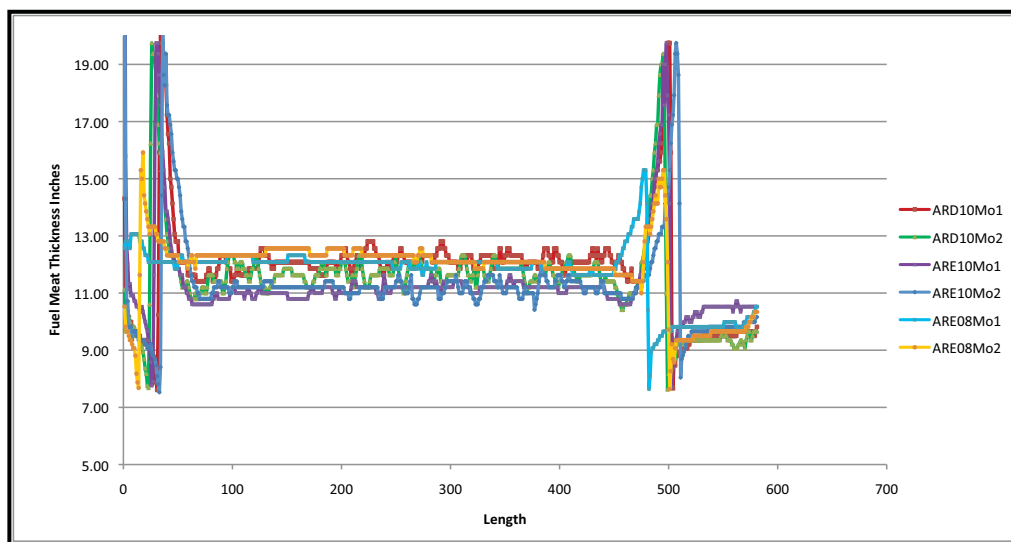
Figure 4: Estimated foil thickness CNEA plates using 0.030'' zirconium plate.

While the radiography density analysis method has not been applied to Zircaloy clad plates by the INL for previous experiments a method was established in this experiment that indicated non-uniform foil thicknesses. The foil thickness are indicated in the plots shown in Figure 4 and Figure 5 using a 0.030 (0.76 mm)-thick zirconium plate and a 0.045 (1.14 mm)-thick zirconium plate respectively.

While this approach was meant to address the large differences in clad thickness in the plates as indicated by the UT, there was enough error in the results that more development of this method is warranted. Optical microscopy (OM) on plate ARD10Mo1 revealed the thickest location predicted by radiography as ~20% thinner than was actually observed. The actual foil thickness on the same plate was ~30% thinner than the average from the density radiography of the non-end plate region.

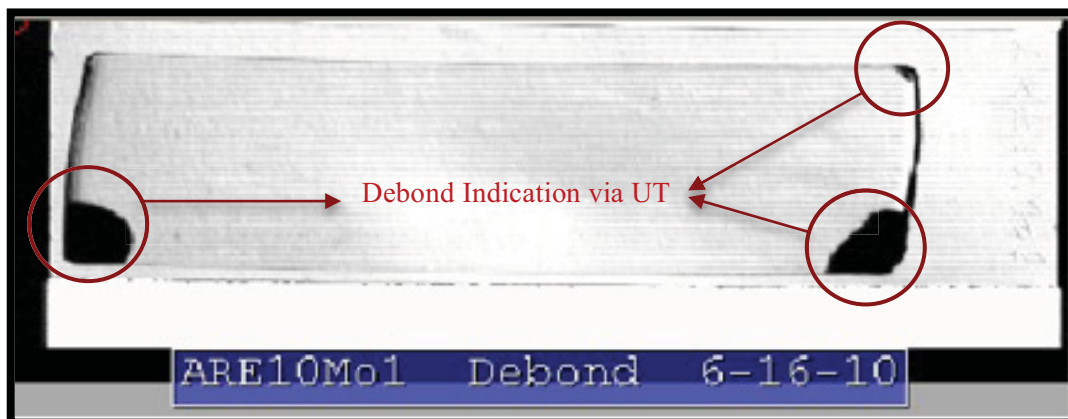
Figure 6: Plate ARE10Mo1 UT image.

Ultrasonic Testing (UT) was completed on the CNEA plates with result listed in Table 3. Plates ARE10Mo1 and ARE10Mo2 show debond indications that are greater than the tolerance of 0.06 inches (1.5 mm) stated in the specification for RERTR-13 plates. Additionally plate ARE10Mo1 has fuel out of zone (FOZ). A possible minimum cladding issue is noted on plate ARE10Mo1, where the fuel fabrication specification requires a thickness of 0.006 inches (0.15mm). All plates were included in the second phase (density and location radiography) of final processing fuel plate qualification with the assumption that Non-Compliance-Report might allow inclusion of some of the plates in the experiment. The plate naming methodology is described in Table 2.

Of the six CNEA plates, three have debond indications identified using UT. These Zircaloy clad roll bonded U-8Mo and U-10Mo plates were then examined using thermography to evaluate for debond indications. Figure 6 - Figure 8 show the debond indications as characterized using UT. Dark vertical areas at the end of the plate as shown in Figure 7 in green box and at opposite end are likely edge effects of the UT process and not necessarily considered debond indications. Areas can also be seen in Figure 6 & 7.

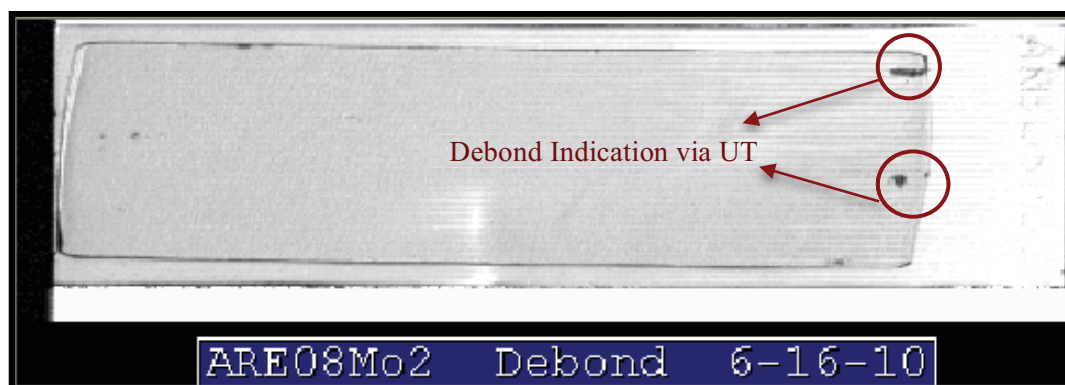
Figure 8: Plate ARE08Mo2 UT image.

An overlay analysis similar to that described in section 2.4 was performed on the blistered plates to define the blister areas as they relate to the UT images. These results are shown in Figure 19 for each of the plates blister annealed. Note that on plate ARE08Mo2 a blister formed in a location where there was a questionable debond indication as the darker region could have been taken as an edge effect as shown in Figure 8.

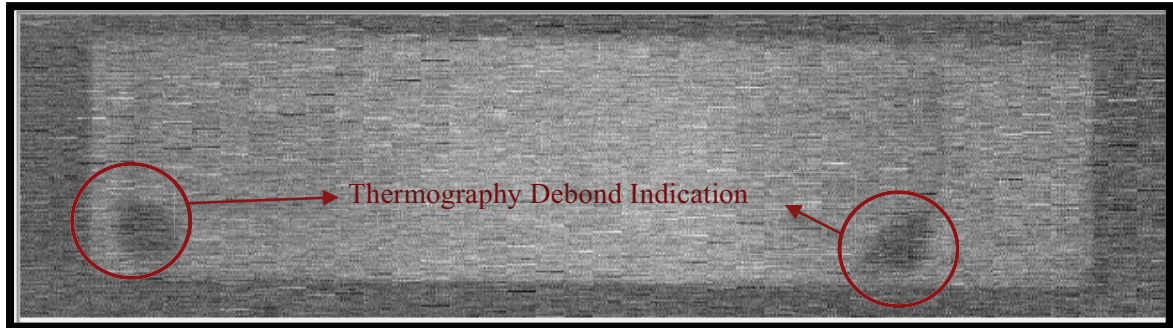
Figure 9: ARE10Mo1 thermography image.

Thermography results for debond indication analysis are shown in Figure 9 - Figure 11. Plate ARE08Mo2 shown in Figure 11 lacks the resolution to determine if the area of interest shown is the debond indication as shown in Figure 9. Further refinement of the Thermography evaluation method may improve the resolution, however, the current approach does demonstrate the current thermography process is able to resolve larger debond indications. As indicated on plates ARE10Mo1 and ARE10Mo2 shown in Figure 9 and Figure 10, it can be seen that the resolution is sufficient to identify the larger areas of interest.

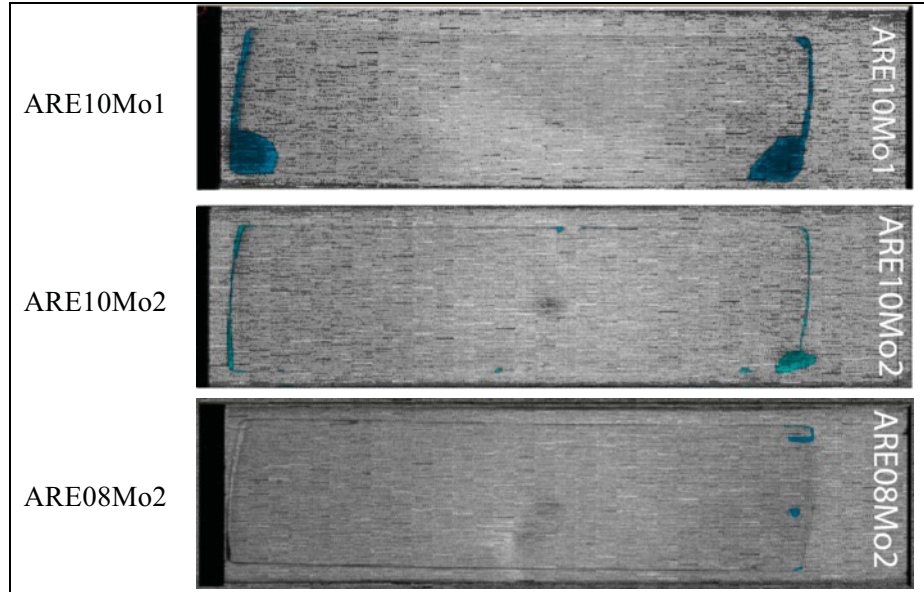
Figure 12: Thermography/UT overlays for plates, ARE10Mo1, ARE10Mo2, and ARE08Mo2.

Figure 12 shows the CNEA plates in question with the UT scans overlaid on the thermography images. This was achieved using photo editing software, where the UT debond indications (Figure 6 - Figure 8) were highlighted and overlaid onto the thermography images (Figure 9 - Figure 11) to illustrate the position of the debond indication. As indicated in Figure 11, plate ARE08Mo2 does not provide a suitable signal in the thermography analysis for detection of debond indications when the areas are smaller. This shortfall is expected to be resolved as the technology is further developed.

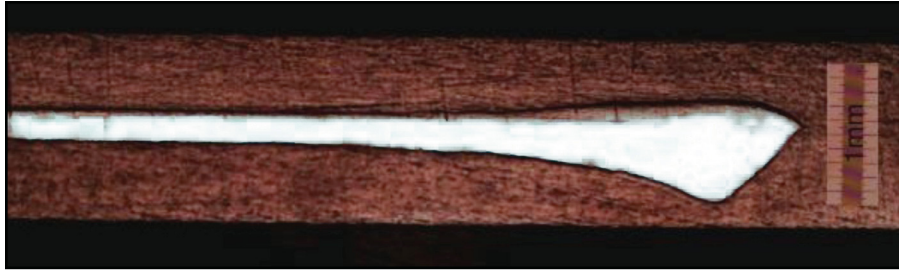
Figure 13: OM view of thickest end of CNEA plate ARD10Mo1.

Plate ARE10Mo1 was sectioned along the middle of the longitudinal axis to collect samples for the purpose of verifying foil thickness determined via radiography and minimum clad thickness. Figure 13 shows an optical image of the thickest dogbone fuel end of the sectioned plate. The fuel thickness at the end was determined to be $\sim 0.028''$ (~ 0.70 mm). This is $\sim 20\%$ thicker in the end region than was determined using the Zirconium plate of $0.030''$ (0.76 mm) in the density radiography shots. The minimum clad thickness in this thicker region is $\sim 0.007''$ (~ 0.18 mm) which correlates with the UT mid-clad data (see Table 3) for this plate. The main foil thickness in this section is $\sim 0.008''$ (~ 0.21 mm) where the density radiography predicted the thickness to an average in the non-end regions to be $\sim 0.012''$ (0.30 mm) across the plate.

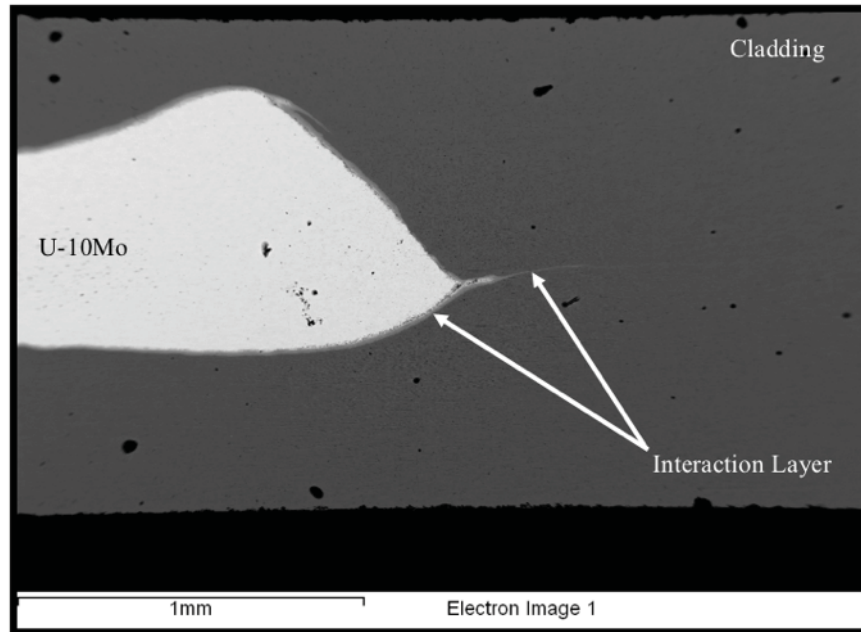
SEM analysis with energy dispersive and wavelength dispersive spectroscopy (EDS/WDS) was performed to generate higher magnification images of the U-10Mo/Zircaloy cladding interface. Figure 14 shows a backscattered electron image of the dog-bone fuel zone. Figures 15 and 16 show images taken away from the dog-bone region. X-ray maps generated using EDS and WDS are shown in Figure 17. An interaction zone is present between the U-10 Mo alloy and the Zircaloy cladding where some areas are enriched in molybdenum and others in zirconium.

Figure 14: ARD10Mo1, 50x-BSE - Low magnification SEM image of the dogbone fuel zone end with the interaction layer trailing into the cladding.

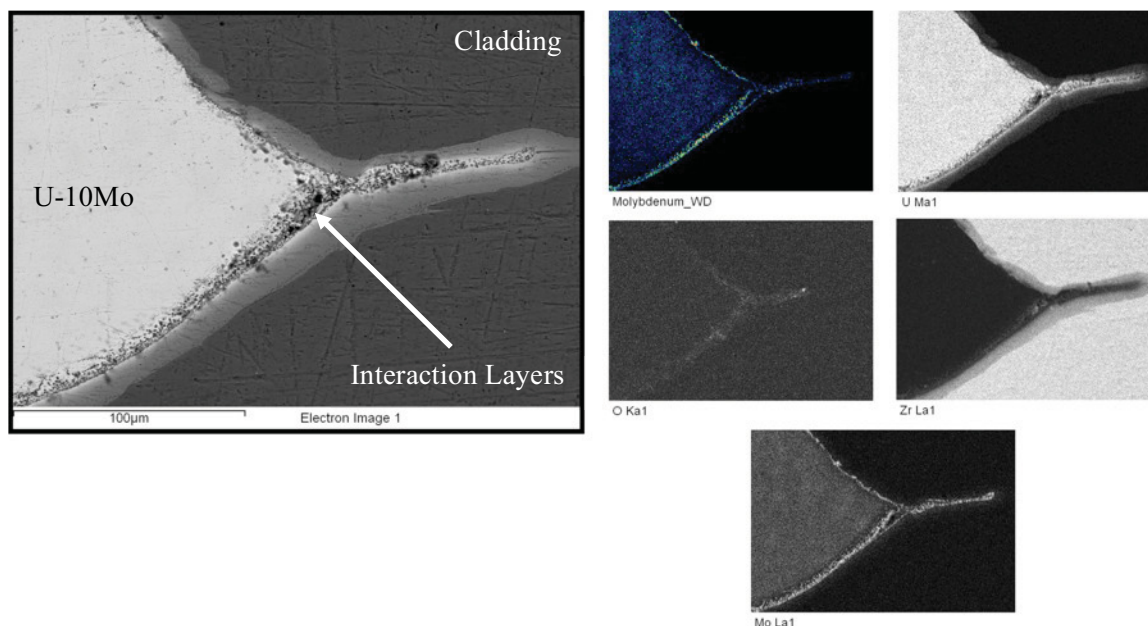
Figure 17: ARD10Mo1, 50x-BSE – SEM image with EDS/WDS spectroscopy of the fuel foil end. The diffusion barrier and interaction layers are extending into the cladding.

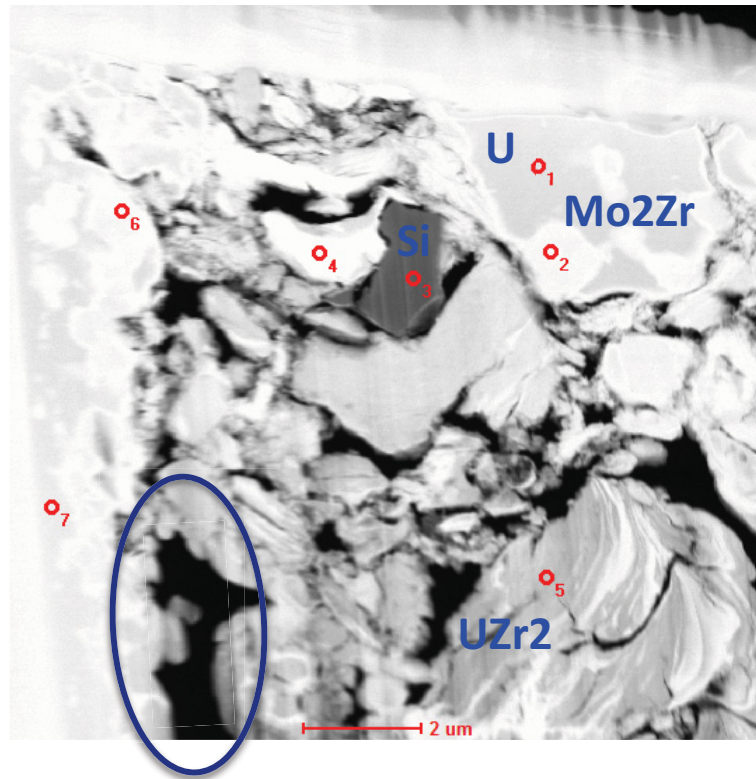
Figure 21: TEM image near the center of sample 3 showing the presence of many phases and some evidence of cracking (circled area).

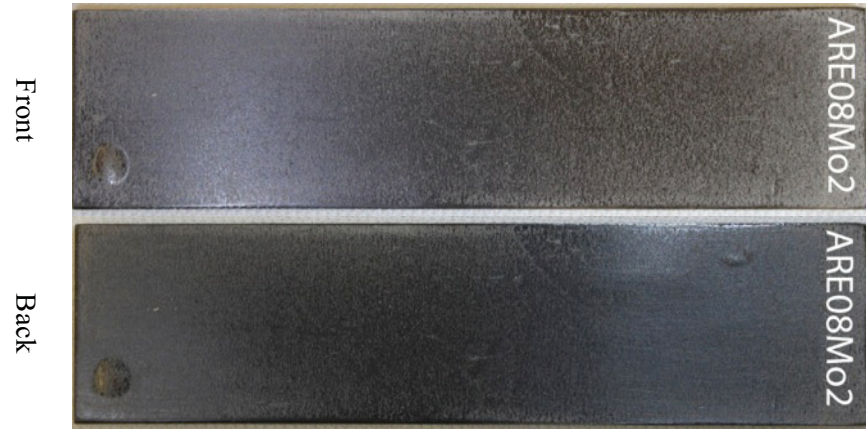
Figure 23: Blister images for plate ARE08Mo2.

Blister anneal testing was performed on the three plates with the debond images as indicated by UT and thermography. These plates are ARE08Mo2, ARE10Mo1 and ARE10Mo2 and the blister images are found in Figure 23 - Figure 25 (please note that backside images are flipped to line blisters up with front side images). The blister anneal test was performed in a tube furnace with plates placed in a quartz glass tube filled with air. Starting temperature was 700°C and increased in 25-degree increments until blisters formed. Hold time at each temperature was 30 minutes once temperature was reached. Ramp time between temperatures was ~5 minutes. Plates were visually inspected following the soak at each temperature but were not removed from sealed quartz tube to do so.

Plates ARE10Mo1 and ARE10Mo2 with the larger debond indication areas were showing discoloration in these areas during the inspection following the 700°C soak but the areas did not appear to be raised as would be the case if a blister had formed. Blister formation on all plates was confirmed at 825°C and the test was concluded at this point. Total test time interval was 3.5 hours.
