Lessons Learned from a Laser Injury Event

International Laser Safety Conference

March 2013

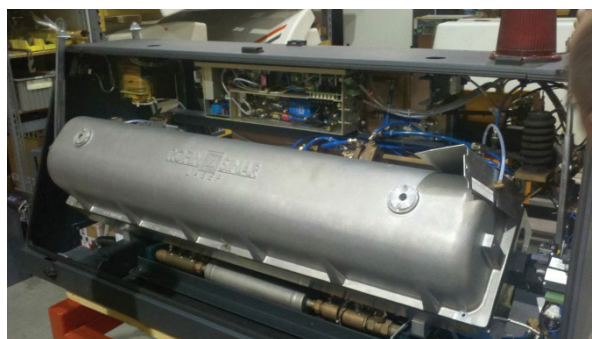
Figure 1. Optical cavity houses the slab and is equipped with sight glasses.

At this point, indicators were present which, if not overlooked, would have alerted the PIC to the possibility of an exposed beam throughout the beam-forming telescope and z-box (Fig. 3). The screen on the HMI console showed a power level of 2500 Watts and the phrase “beam on.” Visual indication through sight glasses on the optical cavity (Fig. 1) showed a bright optical glow. “Beam on” was assumed to be equivalent to “simmer.”

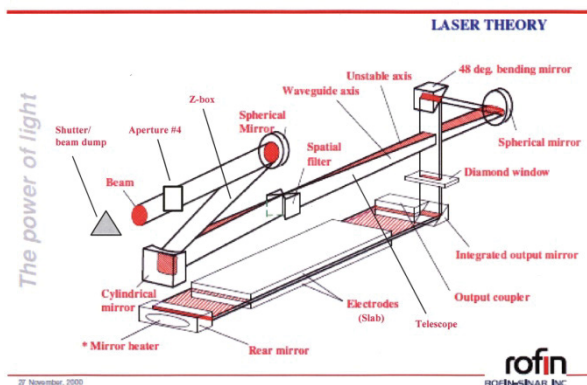
Figure 2. A schematic of the slab and internal optics.

Each of the electrical control technicians believed the laser system to be in “simmer” mode. In this mode, HV is on, power is sufficient to create a limited amount of optical radiation in the optical cavity; however, energy is insufficient for optical radiation to exit the diamond window and create a beam throughout the beam-forming telescope and z-box (Fig. 2).

After accessing the resonator platform and discussing where to take crosshair shots to verify or adjust the beam alignment, the technicians decided to start with the #4 aperture target (Fig. 2).

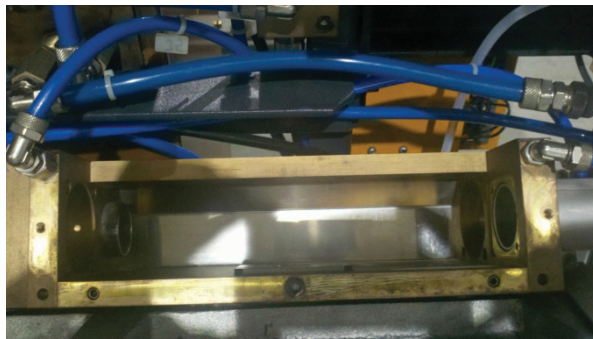
The system was placed under LOTO to continue with step 26, inspection of the spatial filter assembly and beam absorber for coating damages. The z-box (Fig. 3) cover was removed to inspect the cylindrical, spherical, and power mirrors. Burn spots were found on the cylindrical and power mirrors, and they were replaced with new mirrors. The spherical mirror was cleaned and reinstalled.

Figure 3. Z-box.
