# Instrumentation Performance During the TMI-2 Accident

**ANIMMA 2013**

Joy L. Rempe  
Darrell L. Knudson

June 2013

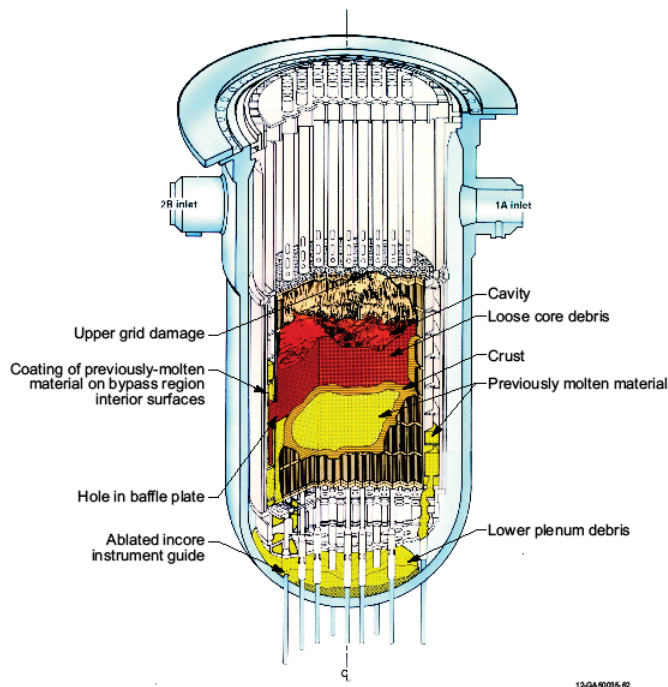
Limited damage to the CSA occurred as core material flowed to the lower plenum. Fig. 4 illustrates the currently-postulated final state of materials within the TMI-2 vessel based on integrated Fig. 3 evaluations.

Fig. 4. Postulated final state of materials within the TMI-2 vessel.[5]

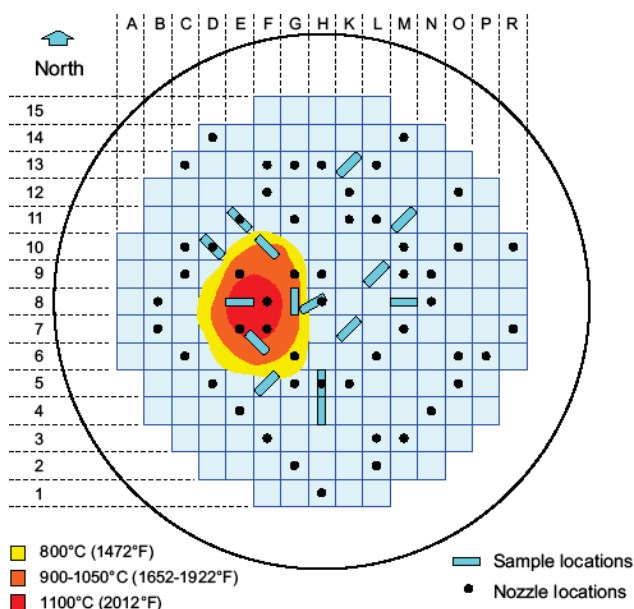
- Metallurgical examinations of the vessel steel samples in conjunction with visual observations suggest that an elliptical region of the vessel, approximately 0.8 m by 1.0 m, reached peak temperatures of 1100 °C during the accident (see Fig. 5). At locations away from this “hot spot”, there is no evidence to indicate that vessel steel temperatures exceeded 727 °C.

Fig. 5. Location of TMI-2 lower head vessel steel samples and “hot spot”.[5].

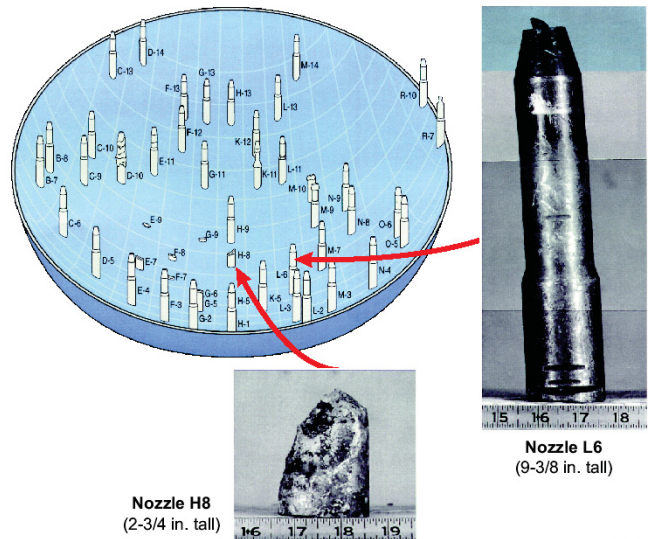
- Instrumentation nozzle damage (see Fig. 6) was caused by molten core material relocating to the lower head. The most severe damage was observed in nozzles located within the “hot spot” region of the vessel and was not related to the embedded debris height (e.g., nozzle L6 was submerged in debris, but remained undamaged).

Fig. 6. End-state of nozzles on the TMI-2 vessel lower head.[5]

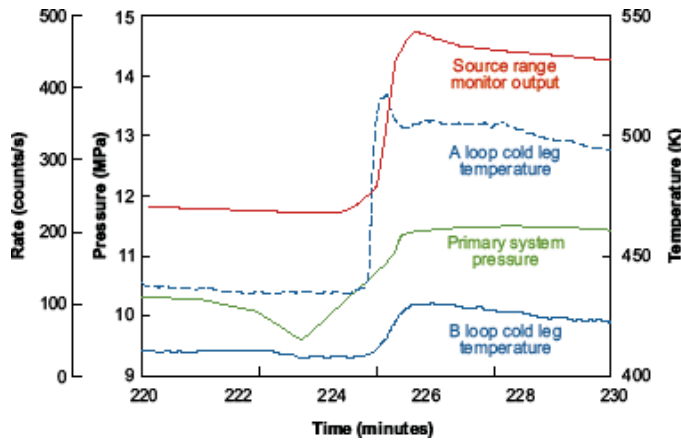
- The simultaneous increase in SRM count rate, RCS pressure, and cold leg temperatures, provided confidence about the timing of a major relocation of materials from the reactor core to the lower head (see Fig. 7).

Fig. 7. Overlay of SRM count rate, RCS pressure measurements, and cold leg temperatures.

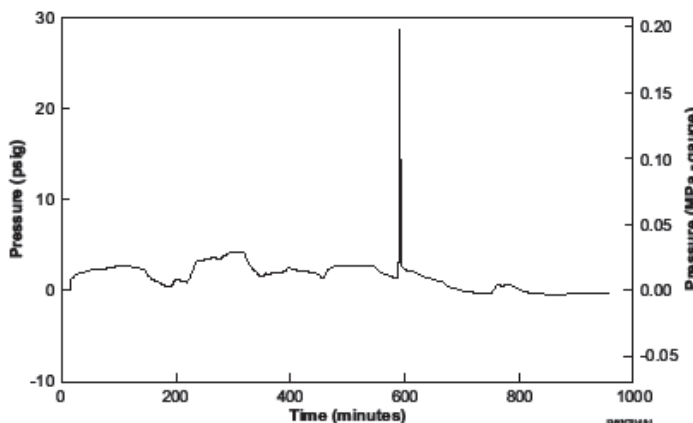
- Peak values for containment building temperature would not have been obtained without considering data from other sensors such as the containment building pressure transmitters. Calculations assuming peak containment pressures (see Fig. 8) yielded peak containment temperatures of 650 °C, which are much higher than the measured 93 °C peak temperature data (Fig. 9). Recognizing that the TMI-2 containment temperature data had a limited sampling rate, experts qualified the containment pressure and a modified set of containment temperature data.

Fig. 8. Containment building pressure.

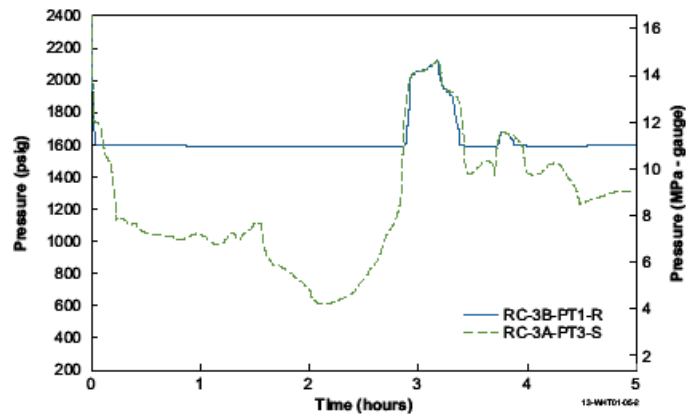
- Data unavailability was often due to computational limits, such as storage memory, inadequate paper or ink, insufficient sampling rates, and 'preset' limits associated with anticipated operating ranges (rather than sensor operating limits as illustrated by the RCS pressure data shown in Fig. 10). A wider range of limits and enhanced computational capabilities, with easy-to-read graphical displays, could alleviate such issues, as occurred with TMI-2 building resistance temperature detector (RTD) temperature and steam generator reference pressure transmitter sampling.

Fig. 10. RCS pressures at selected locations.

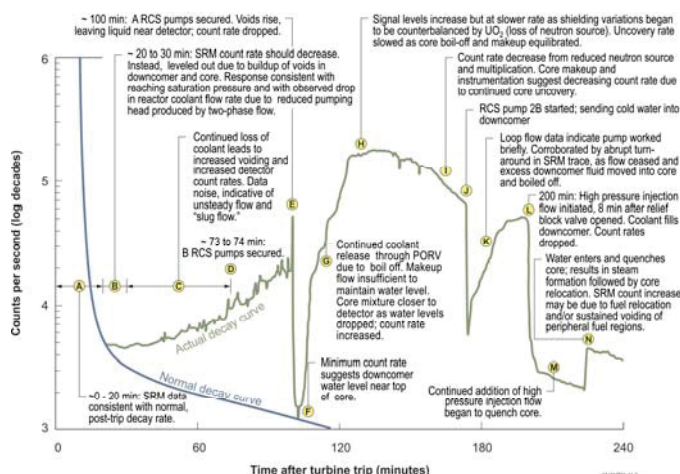
- Qualitative insights can be obtained by considering sensor response for alternate applications, e.g., ex-core source-range detector signals provide insights about RCS water levels, in-core SPNDs provide insights about RCS temperature and water levels. However, such interpretations often require detailed analyses and assumptions related to the status of the core, the RCS and containment (as evidenced from efforts to interpret SRM data in Fig. 11).

Fig. 11. TMI-2 SRM response during the first 4 hours of the accident.

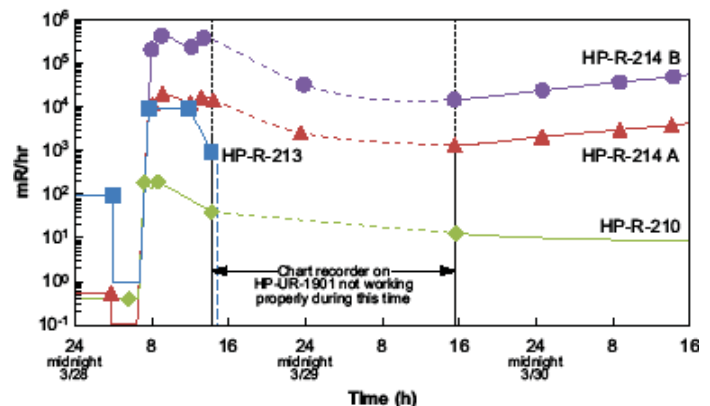
- Post-accident evaluations emphasized the need for more accurate containment radiation measurements. Identified Dome Monitor failures and data uncertainties (see Fig. 12) led to several recommendations for design improvements, such as better seals that are periodically leak tested, the use of moisture and radiation resistant components and cabling, and relocating electronics outside the containment so that the lead shield could be removed.

Fig. 12. Containment radiation monitor response (Two curves are provided for HP-R-214 to reflect upper and lower bounds associated with uncertainties in recording scale).
