Causal Analysis of the Uncontrolled Moderator in the HFEF Main Cell

Level 1 Cause Analysis

ORPS Number: NE-ID-BEA-HFEF-2012-0005

INL/EXT-12-27982

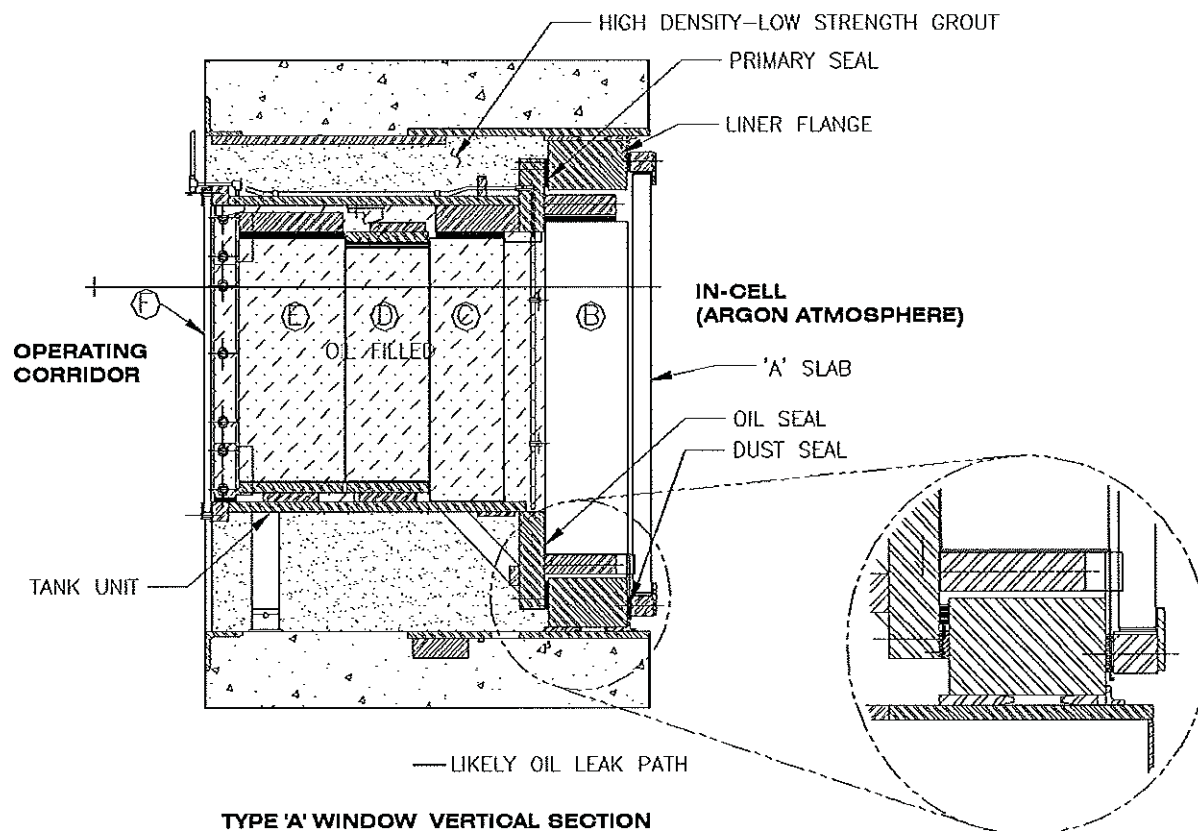
Figure 1. Type-A window vertical section.

For the oil to leak into the cell the window oil must leak past an oil seal and a dust seal (depicted by the red line in the figure below). First, the hot side of the tank unit is sealed between the B-slab and the window tank structure. This seal is an elastomeric flat gasket which is compressed by the B-slab mounting bolts. The second seal is the dust seal between the A-slab and the liner flange. This seal is not intended to be a leak-tight seal. The current leak rate is estimated at 8 fl. oz. per day. These seals are approximately 40 years old.

- There was an oil leak and loss of control of moderator material in the HFEF main cell.
- Why was there an oil leak?
- The window gaskets are approximately 40 years old which are 30 years past design life and leaking allowing the moderator to enter the cell. (A2B6C04, End of life failure)

As a temporary control measure, the argon purge pressure will be lowered on the window expansion tank oil. Reduction of the purge pressure is anticipated to reduce the leak rate by a factor of 3 to 4. This control measure is temporary until the oil leak can be corrected and will be implemented via Engineering Job Number EJ-1215, "Window 1M Expansion Tank Purge Modification".

- Design a replacement A-slab and gasket system. The replacement A-slab and gasket system will allow collection of the oil between the A-slab and tank unit until the oil leak is corrected.
- The window tank unit must be replaced or refurbished to correct the oil leak. Refurbishment of the tank unit can take 3-4 months and can be extended if glass is advertently damaged and must be replaced. A replacement tank unit is expected to be fabricated to reduce facility down time during the window tank replacement. The existing tank unit will be refurbished after removal to allow installation at another location for future repairs.
