TMI-2 – A Case Study for PWR Instrumentation Performance During a Severe Accident

Joy L. Rempe
Darrell L. Knudson

May 2014

Prepared for the
U.S. Department of Energy
Office of Nuclear Energy
Under DOE Idaho Operations Office
Contract DE-AC07-05ID14517

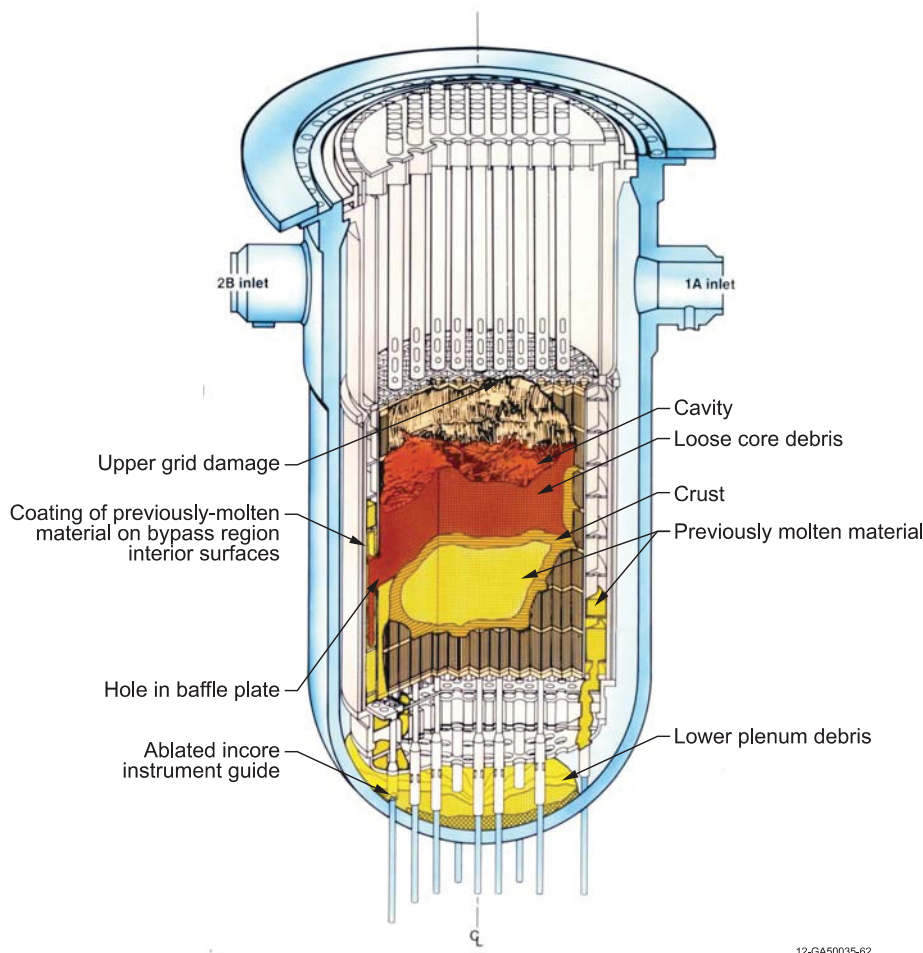
(see Section 2.2) failed near the top of the molten core region in the southeast quadrant of the reactor vessel. Limited damage to the CSA occurred as the core material flowed to the lower plenum. Figure 2-4 illustrates the final state of materials within the TMI-2 vessel based on available instrumentation, analyses, and post-accident examinations.⁸

Figure 2-4. Postulated final state of materials within the TMI-2 vessel.⁷

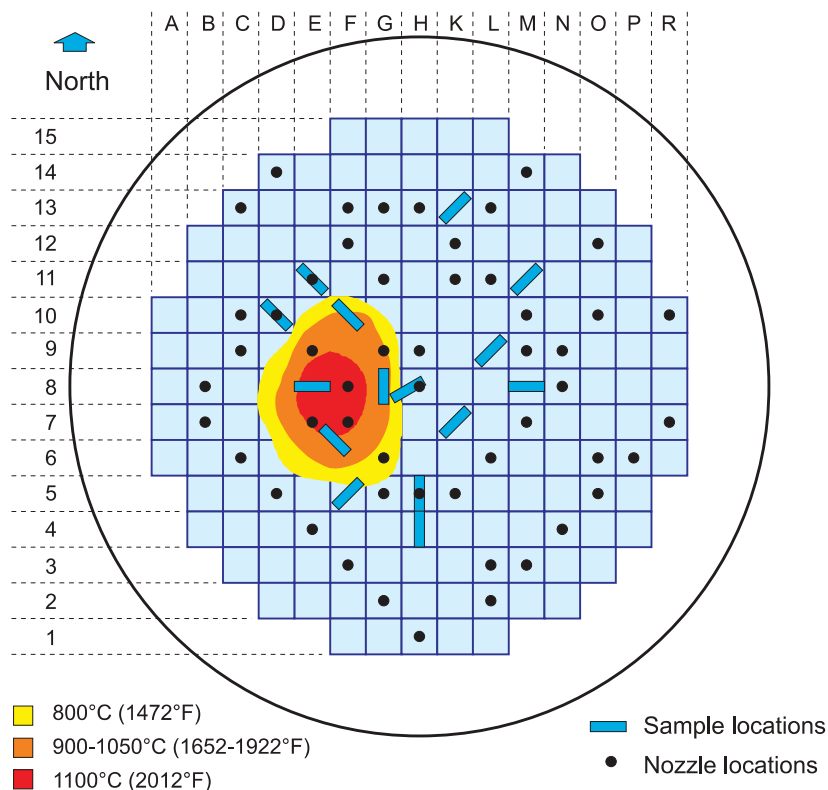
- Metallurgical examinations of cracks or 'tears' in the reactor vessel cladding (see Figure 2-6) in samples taken near the hot spot (positions E-6 and G-8) indicate that the damage extended down to, but not into, the carbon steel vessel.²³ Cracks were typically found near nozzles.

Figure 2-5. Location of TMI-2 vessel lower head boat samples and ‘hot spot.’⁷

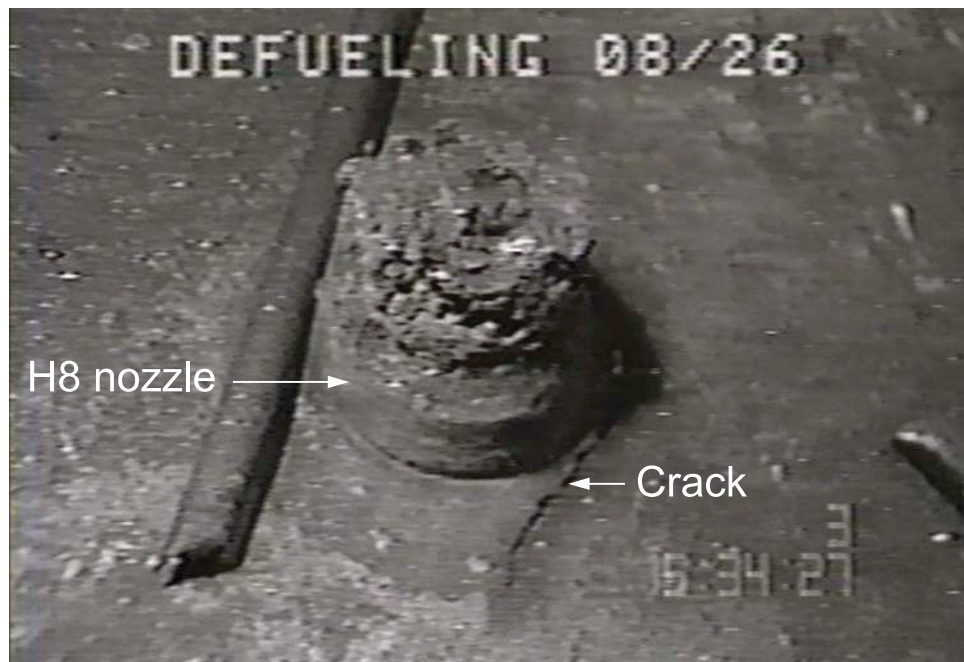
Figure 2-6. Video exams of the H8 instrumentation nozzle with crack on vessel.²

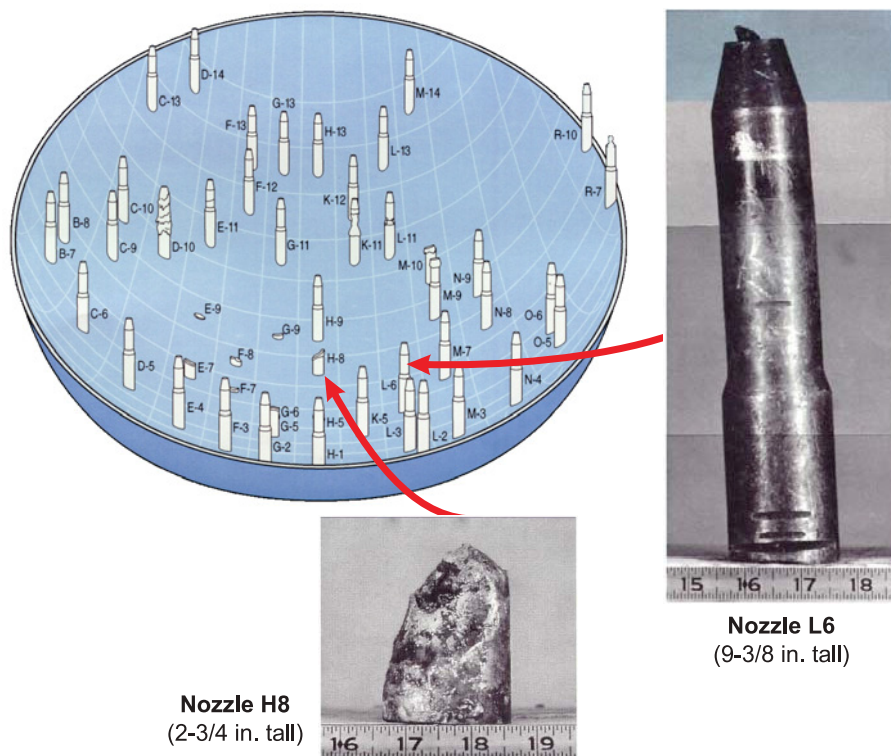
Figure 2-7. End-state of nozzles on the TMI-2 vessel lower head.⁷

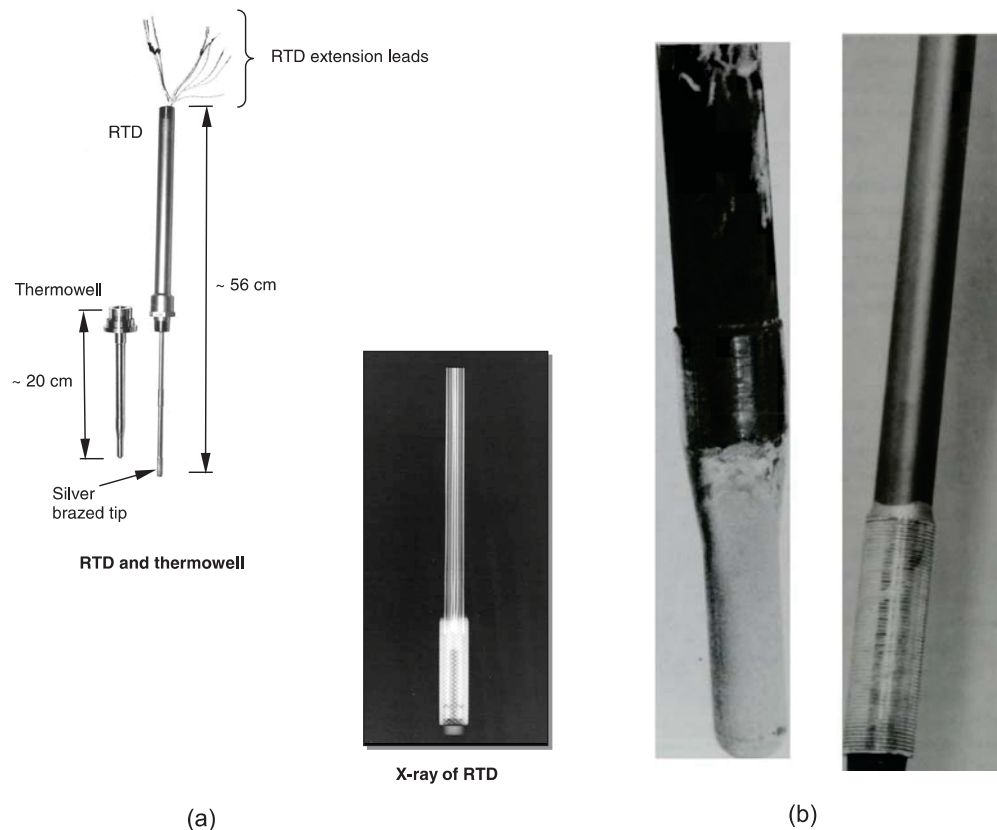
Figure 4-2. Rosemount Model 177HW RTD: (a) photograph and x-ray (b) thermowell and PRT from Rosemount Model 177HW PRT S/N 3670 removed from TMI-2 (the PRT appeared undamaged but radioactive deposits were found on the exterior surface of the thermowell).⁵⁹

During the accident, the TMI-2 PRTs were subjected to excessive temperatures, vibration, and radiation. After the reactor was shut down, the PRTs continued to be subjected to gamma radiation from the fission products deposited in the coolant loops. Reference 60 reports results from evaluations to assess the

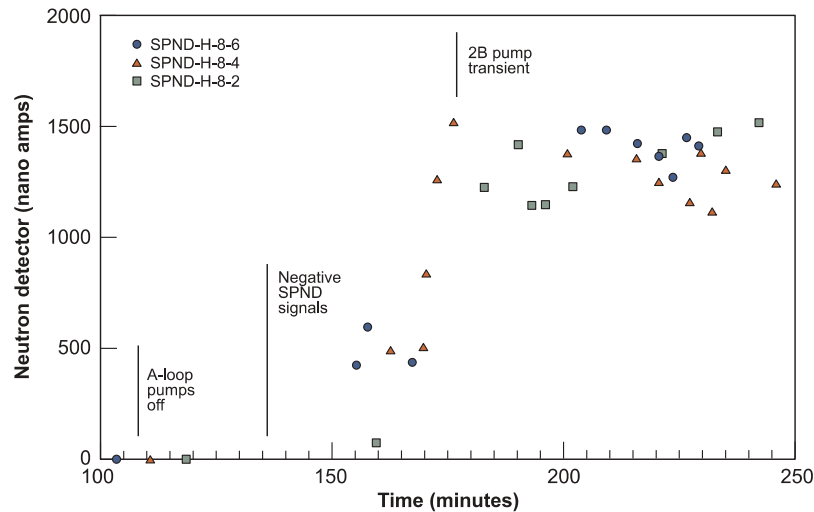
Both Warren⁶¹ and Yancey⁵⁸ measured the resistance of the in-core instruments as a method to diagnose the survivability of the SPNDs. A high resistance (e.g., $R > 10^8$ ohms) indicated an intact or operating SPND, whereas a low resistance (e.g., $R < 10^5$ ohms) indicated a failed SPND. Evaluations in 1982 by Yancey indicated that all of the thermocouples and the majority of the SPNDs (all but 22) were damaged to some extent.⁵⁸ Evaluations indicate that major damage occurred to the entire core above the first and second SPND level locations and throughout the central area of the core. This estimate of damage was based on the location of operational SPNDs as determined by the 1982 in situ testing. Later video examinations and probing confirmed that such extensive core damage had occurred.

Figure 4-7. Signals from the H-8 SPNDs at the 2, 4, and 6 levels.

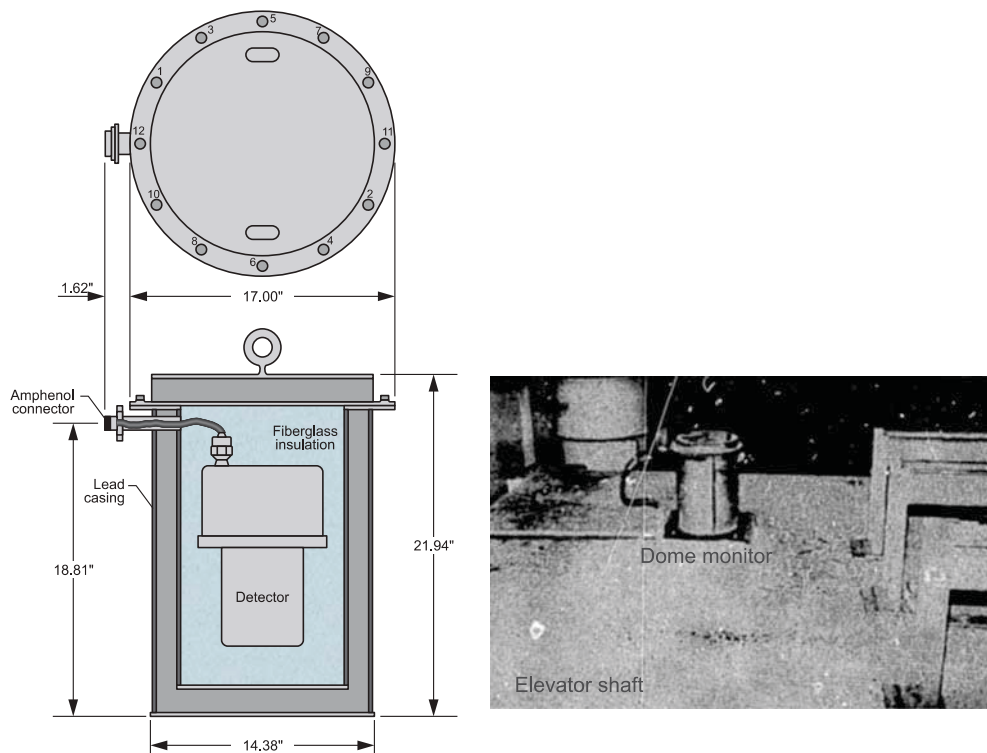
Figure 5-5. Photo and schematic of TMI-2 HP-R-214 dome monitor in stainless steel container.
