Idaho National Laboratory Quarterly Performance Analysis - 3rd Quarter FY2014

September 2014

INL/EXT-14-32891

FY-14 3rd Quarter

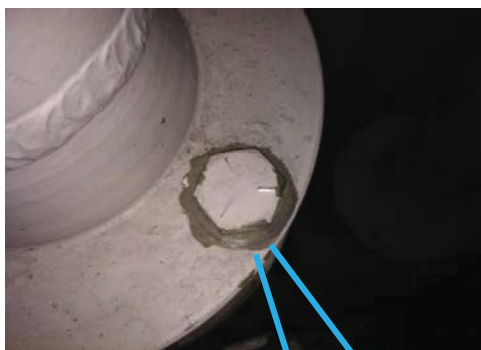
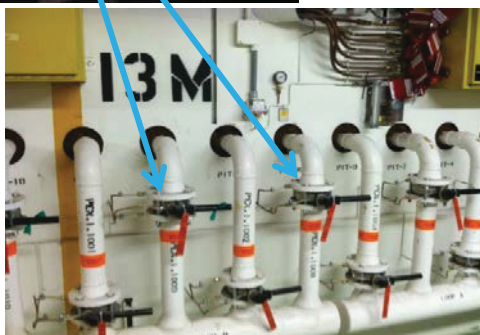
On June 16, 2014, at the Hot Fuel Examination Facility (HFEF), technicians were performing routine zone inspections when they identified potential suspect counterfeit fasteners (S/CI) in piping flanges credited as part of the Safety Significant Main Cell Confinement Boundary/Shielding System. The following day, Engineering completed the evaluation of the S/CI fasteners and also identified additional fasteners that were unmarked and, therefore, considered ungraded fasteners in an application that did not meet system design requirements.

The HFEF Main Cell was taken to REPAIR MODE until an operability review of the affected system components could be completed. A risk based evaluation for S/CI discovered in use was conducted. The evaluation directed that the items be marked and replaced once maintenance on the equipment is performed.

A lessons learned submitted on this event identified that plant personnel believed that the suspect or counterfeit bolts had been previously identified and evaluated, however, documentation supporting a previous discovery could not be located. The current INL process for identifying and controlling S/CI Items is LWP-13510 and includes processes to document the discovery and evaluation of suspect or counterfeit fasteners, as well as marking of suspect or counterfeit fasteners, as previously identified. To eliminate re-work, suspect or counterfeit items that are not immediately replaced, should be documented and appropriately identified in the field.
