Causal Analysis of the Inadvertent Contact with an Uncontrolled Electrical Hazardous Energy Source (120 Volts AC)

**Level 1 Cause Analysis
ORPS Number: NE-ID—BEA-HFEF-2013-0003
ICAMS Number: IO-029749
Event Occurred: September 25, 2013**

**Idaho National Laboratory
Idaho Falls, Idaho 83415**

INL/EXT-13-30442

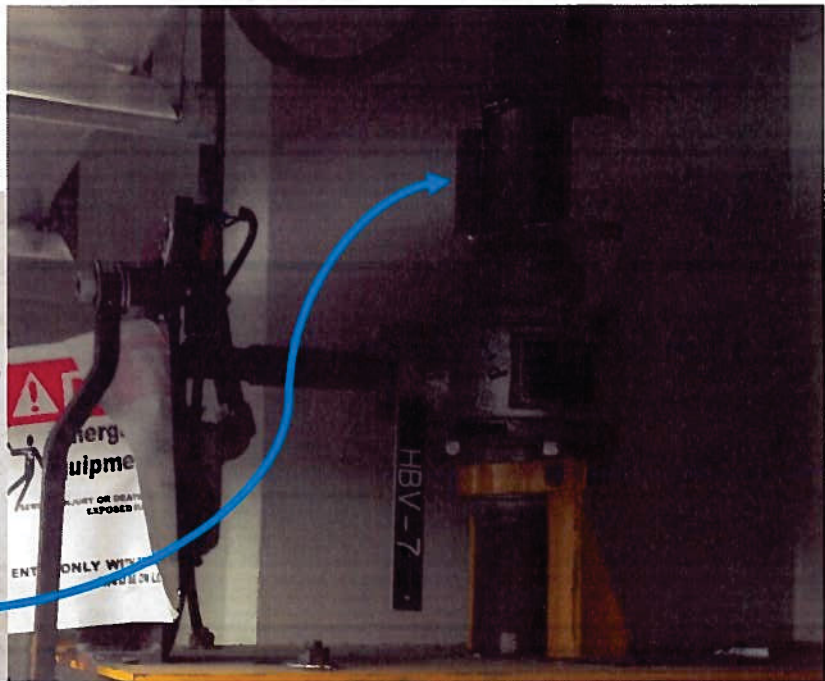
Figure 3. Side View, HBV-7 showing mounting clip for placement of probe

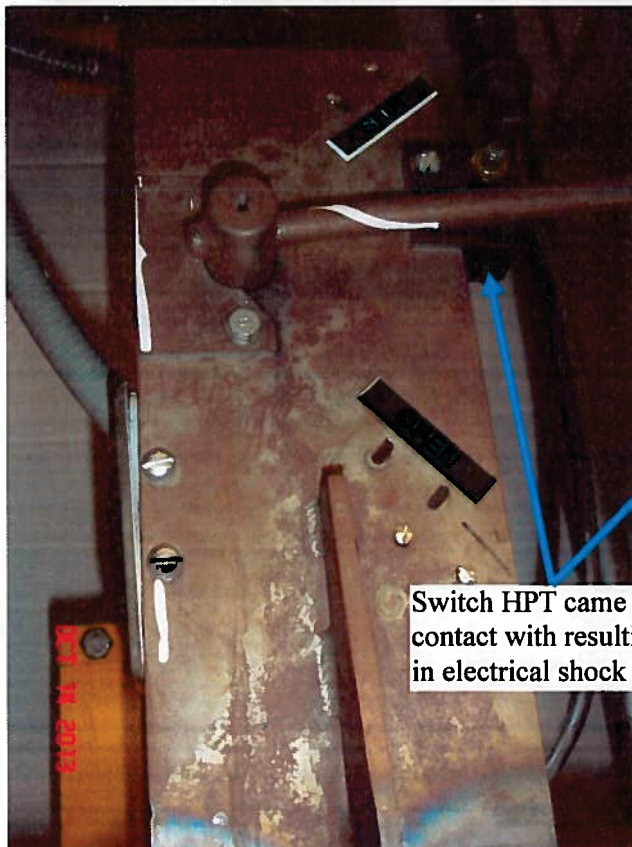
Figure 4. Front View, HBV-7 Valve Position Indicator Mounting Plate

- The mounting plate obscures the view of the hazard (see Figure 4).
- The mounting plate is between the hazard and room lighting, at or above the lighting fixtures.
- The hazard is located above Hood ID# 130 HP.
- The hazard is at or above 8 feet.

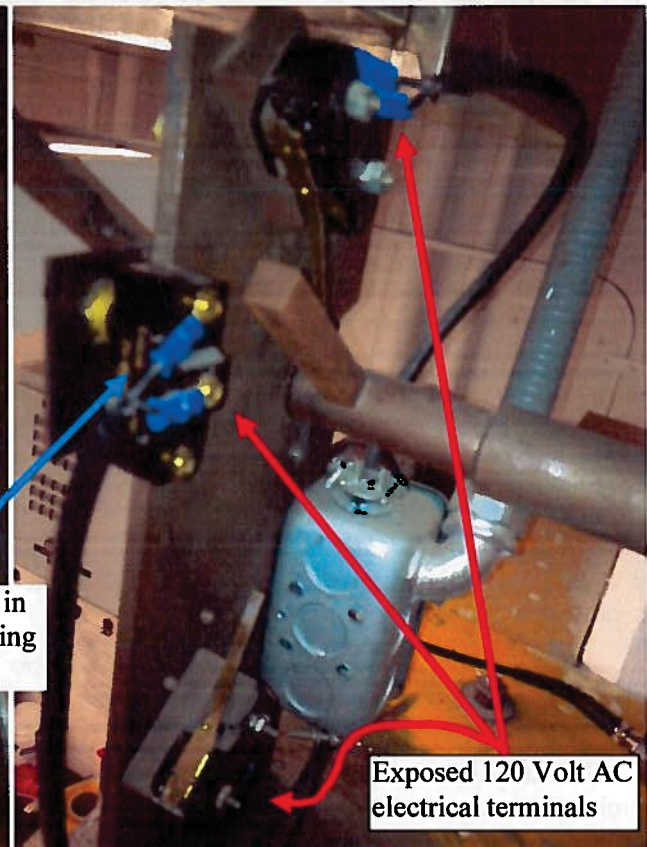
Figure 5. Back View, HBV-7 Valve Position Indicator Switches

Upon moving the arm following the shock the HPT noticed two exposed electrical connections on a switch (see Figure 5). The HPT then notified the HPT Supervisor, who in turn notified the MFC Radiological Controls Manager and HFEF Operations Manager of the situation. Work was stopped in the area and the hazard was roped off and posted to prevent access to the hazard.

An Instrumentation and Controls (I&C) Technician determined that the source of the electrical shock was exposed 120 Volt AC electrical terminal conductors on the valve position indication switches for HBV-7. Each of the three switches shown in Figure 5, have exposed electrical conductors. The System Engineer and facility operations personnel identified and opened the circuit breaker to de-energize this hazard and installed an administrative lock. The administrative lock is used to prevent unauthorized operation of equipment.

This new activity routinely placed workers in close proximity to the unidentified exposed electrical hazard (see Figure 5). The electrical hazard was not identified during walk downs of this work prior to restarting this activity in November 2012 and was subsequently not eliminated or mitigated.

5. Per EJ-1379, replace HBV-7 valve position indicator switches. (A3B3C01/A5B2C08)

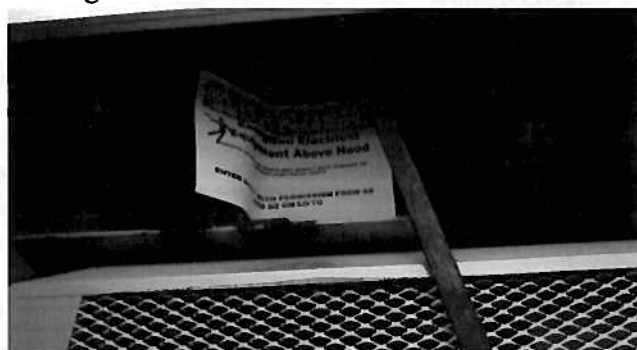
An Industrial Safety Engineer and I&C personnel walked the activity down after the event and stated that it was difficult to see the exposed electrical hazard even knowing where it was after the event. The exposed electrical hazard is difficult to see for the following reasons:

Figure 6. Poor visibility in area of HBV-7, including signage that was posted after this event
