Idaho National Laboratory – Quarterly Performance Analysis

INL/EXT-14-33707

QUARTERLY PERFORMANCE ANALYSIS

FY-14 4th Quarter

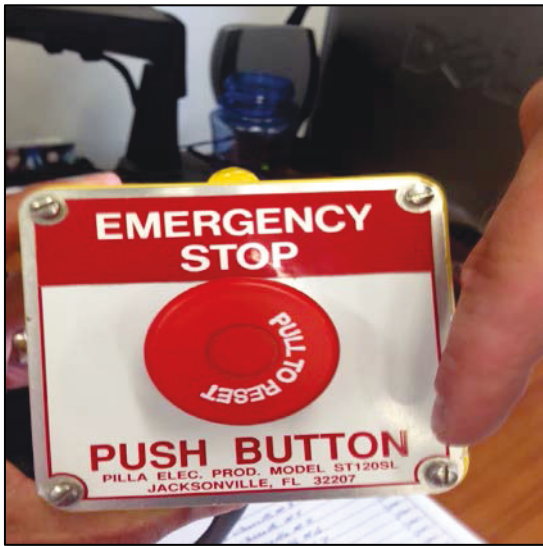
CO-2014-4162

On September 8, 2014, an operator at the Fuel Conditioning Facility (FCF) experienced a minor electrical shock due to a faulty ground wire in an emergency stop box. The operator notified his immediate supervisor and was immediately escorted to medical where he was evaluated and released to work without restrictions.

The area was barricaded and all E-stops were removed from the operating floor. Upon inspection, electricians discovered a broken ground wire inside the E-stop box; 113V potential was present.

An investigation into this event found that the wrong wire type for this application was used and the wire was not code compliant. Additionally, a lack of stretch relief was present on the wire and all stress was on ground wire. A practice of hanging the e-stop boxes by the cable also likely contributed to the broken wire. In general, the poor design of the e-stops (from early 1990's) was revealed. The E-stops were made compliant and were placed back in service.

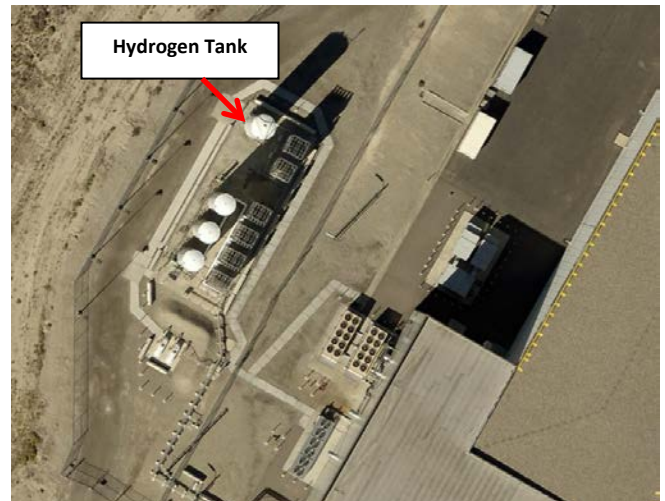
SMC-CO-2014-1138

On August 27, 2014, at approximately 0900, the flame detector on the Atmospheric Distribution System (ADS) Pad at the SMC, alarmed upon sensing a fire at the exit of the vent stack for the hydrogen storage tank. The ADS Pad contains storage tanks and distribution piping for hydrogen, nitrogen, and propane gases and is adjacent to TAN Building 679/679A, but is outside the physical boundaries of the SMC nuclear facility.

The tanks and piping themselves are owned by the gas vendor. A fire from the vent stack is an anticipated event with the response controlled by an SMC Abnormal Operating Procedure (AOP). The responsibility of extinguishing the fire falls upon the gas vendor; however, INL firefighters are available if help is needed. The INL Fire Department responded per that procedure, confirmed the location of the fire, and monitored the area. At 1100, the Fire Department returned to the station and preparations were under way to have the vendor assist in extinguishing the fire.
