IDAHO NATIONAL LABORATORY QUARTERLY PERFORMANCE ANALYSIS - 1ST QUARTER FY2015

DEEPER LEARNING THROUGH EVENT ANALYSIS

INL/EXT-15-34291

FY-15 1st Quarter

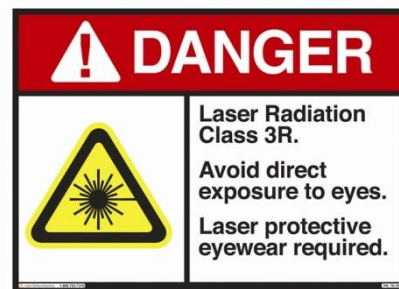
Recently, a facility operations technician at INL’s ATR facility contacted the INL Laser Safety Officer (LSO) about labeling on some recently purchased multi-function flashlights that contain a 3R laser. The items ordered were Streamlight Twin-

Task 3AAA LASER LED and Multi Ops flashlights. The technician explained that the “Caution” label identified it as a 3R/2 laser/LED with an output <55 mW, and wondered if they

could still use the devices. The LSO recognized that Class 3R lasers should have “Danger” labels and be <5 mW. The technician was instructed to remove the flashlights from service until further information was gathered to determine if the units were safe for use.

The lesson that can be learned from this situation is to be inquisitive and have a questioning attitude to ensure that the proper subject matter experts are engaged when questions regarding a products safe use arise. Laser pointer devices must be labeled correctly to properly communicate hazards to the user. Devices found with improper or illegible labels must be evaluated and relabeled to ensure they meet federal requirements and are safe for use.

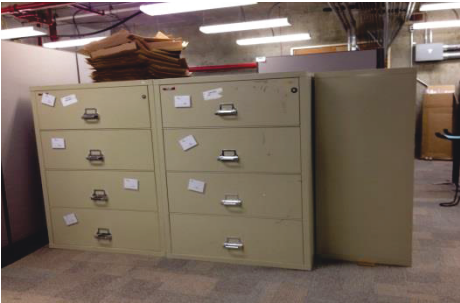
Injury While Moving Fire Rated Lateral File Cabinet

On 10/3/14, a heavy equipment operator was part of a five-man crew moving a fire rated lateral file cabinet when he injured his left arm. The crew was sliding the cabinet into place after removing it from a pallet jack when the employee experienced a 'pop' in his left forearm. Afterward, he experienced a burning type pain from his elbow to forearm and occasionally extending up to his shoulder.

pallet jacket and moved into a furniture-moving box. The box was then moved by forklift to a basement entryway at MFC-752 where it was lowered by crane into MFC-752. The cabinets were then placed onto another pallet jack to be moved to the final location where they were manually slid into place the final three to four inches. The cabinet in question was empty and weighed 750 pounds.

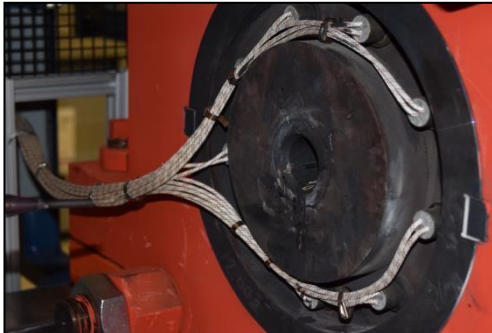
container block. A wire brush was used to remove debris and then a cotton brush and water for salt removal. Excess water from the brush ran down the front of the container block and onto the container block heater wire insulation.

Soon after the water contacted the wire insulation, a Science and Technology (S&T) Technician observed a flash and a loud popping noise. Initial investigation did not disclose any energized conductors that could have resulted in an electrical short. Upon further investigation, it was determined by design that the Dinamite contactors for both the container heaters and the die heaters have a "pass-through" on the middle pole (i.e., they do not open when control power is turned off). This allows voltage to the heaters but does not allow for a completed circuit which prevents the heaters from heating up.

An investigation found that the cleaning water and salt had seeped through the wire insulation causing a ground fault which resulted in a 40 amp fuse for the heaters to be blown although the heaters were in the off position. The Extrusion Press was placed in a safe configuration, de-energized, and tagged out of service.

Both the vendor supplied data and the procedure were ambiguous on how to clean the container block. The Hazards Table in the procedure did not identify dripping salt water or lubrication onto the heater lead wires with permeable insulation as a hazard. As such, it was not recognized that the heater wiring would be subject to an environment for which it was not intended.

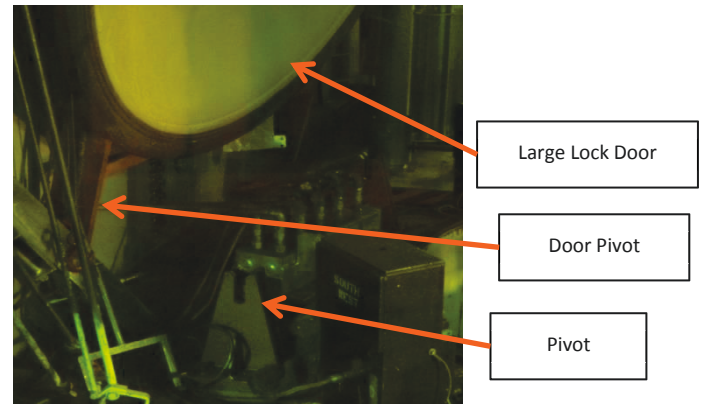
NE-ID--BEA-HFEF-2014-0003 (Significance Category 4)
On 10/10/14, during operations to transfer material between the HFEF Main Cell and the Decontamination Cell, the Large Lock Door was inadvertently opened too far and was lifted out of the door pivot mounts. As a result, the Large Lock Door swung out of place and could not be placed back into its pivot mounts and closed using currently existing procedures.

The Large Lock Door is credited in the HFEF SAR as part of the Safety Significant Confinement Boundary for the HFEF Main Cell. The inability to close the Large Lock Door means the confinement boundary of the Main Cell cannot be reestablished using currently existing procedures. The HFEF mode of operations was changed from the MAIN-CELL OPERATING MODE to the MAIN-CELL REPAIR MODE.

The controls for operating the Large Lock Door are located so that the persons operating the controls cannot see the progress/position of the Large Lock Door. The Operator opening the Large Lock Door became distracted while opening the door and did not comply with procedure use and adherence requirements and expectations. In addition, a spotter was not used to ensure the Large Lock Door operations were conducted in a compliant manner.

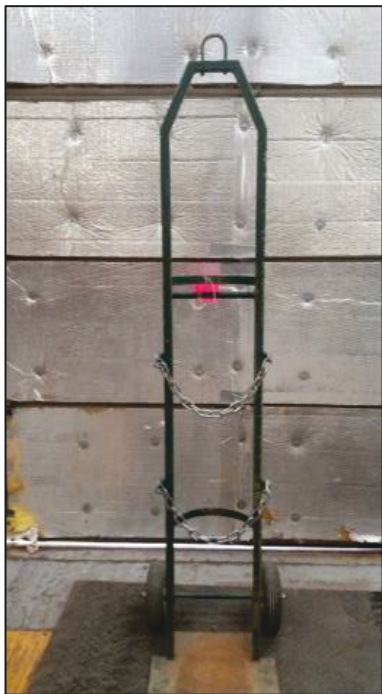
On 12/9/2014, equipment operators were performing an annual preventative maintenance (PM) load test on a gas cylinder handcart when the bolts for the safety chain mechanism that prevents the cylinders from falling off the cart were identified as potential

suspect/counterfeit fasteners. The cart has a lifting bail and can be used for rigging gas cylinders out of cells.

MFC Quality Assurance personnel validated that the bolts were listed on the suspect/counterfeit fastener list. The cart was manufactured at MFC in 1990; however, it is unknown when the bolts were installed. The equipment was placed out of service and a maintenance request was issued to replace the bolts.
