Idaho National Laboratory Quarterly Performance Analysis for the 2nd Quarter FY 2015

INL/EXT-15-34291

FY-15 2ND Quarter

This report is published quarterly by the Idaho National Laboratory (INL) Quality and Performance Management Organization.

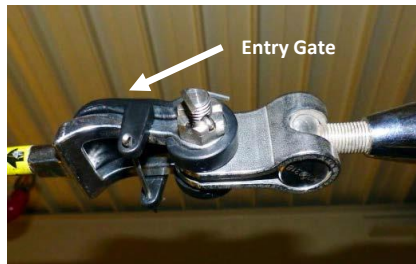
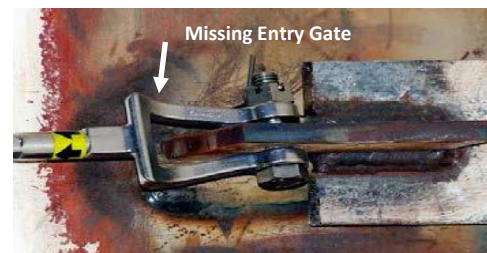
Mechanic Exposed to Fall Hazard during Crane Preventive Maintenance

ATR mechanics were performing preventative maintenance on the ATR Main Floor 40-ton overhead bridge crane. While a mechanic was inspecting the runway crane rail, approximately 40 feet above the main floor, the fall protection trans-fastener that rolls on the horizontal cable and connects the mechanic to the fall protection lifeline became detached due to a missing entry gate (the device designed to stop the trans-fastener from

disengaging the horizontal lifeline). It was discovered that the Entry Gate was not installed and in place at the time of the event.

horizontal lifeline and exit the crane rail without further incident, and immediately reported the condition to management. A stop work was put in place for all work that required the use of a horizontal or vertical lifeline system for fall protection until it could be verified that entry gates were in place. Some issues identified during the investigation showed that:

- Annual Inspections of the lifeline only included inspection for degradation, cable tension, trans-fastener operability, etc., as recommended by the manufacturer. Inspections did not check to ensure everything operated as designed.
- Each crane rail has one horizontal lifeline with one entry terminal body on each end for a total of four entry points. Neither lifeline contained the entry gates at the ends.

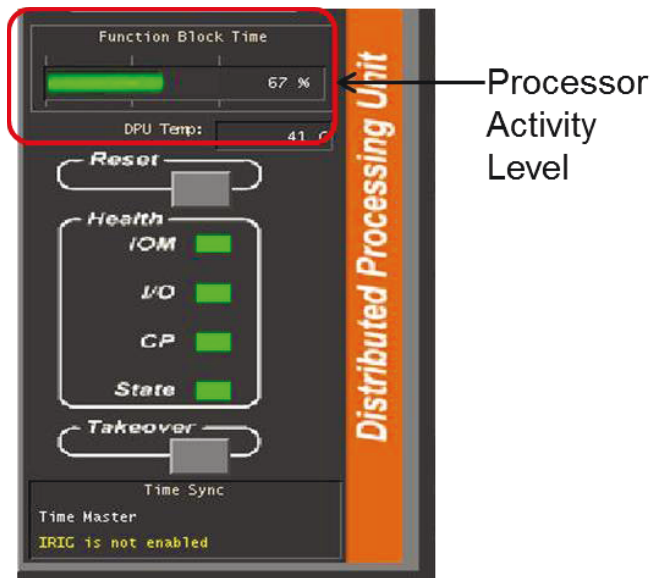
control power was likely caused by the control processor not maintaining the relay in a closed position, as a result of excessive processor activity. The excessive processor activity was due to the update interval (0.01 seconds) being too short for the number of configuration points being processed for the Loop 2B-SE processor. Some issues identified during analysis into this event include:

- The update interval being set at 0.01 seconds caused numerous errors indicating that configuration points were not being updated.
- Loop 2B-SE's configuration was changed after unacceptable time response testing was conducted to decrease the response time by setting multiple configuration points to use the 0.01 second update interval. The processor activity level was not checked after this change. If it had been checked, then the reactor SCRAM would have been prevented.
- The critical parameter's update interval for Loop 2B-SE processor was set to 0.01 seconds, a factory setting, compared to 0.04 seconds on four other processors on similar loops. If this difference would have been noted, the reactor SCRAM would not have occurred.

What Can We Learn: Process activity levels need to be monitored after changing settings to prevent processor overloading, which could cause critical errors. It is vital to review vendor default parameters to ensure proper settings to prevent unintended consequences.

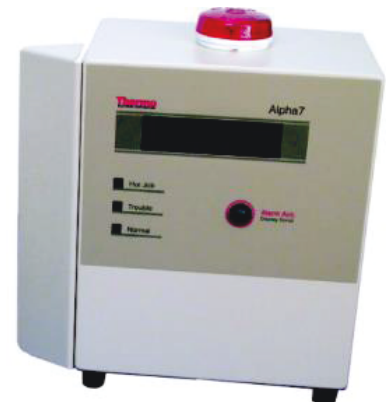
On September 24, 2014, a Continuous Air Monitor (CAM) filter analysis report indicated higher than normal activity of airborne contamination levels. Low levels of alpha contamination were detected on four separate filters taken

from two CAMs operating in the MFC area. It was later determined, based on the CAM spectra, that the activity was from Americium (Am)-241. The detectable amounts were less than the CAM alarm set point but greater than the limit for establishing an airborne radioactivity area.

There were no CAM alarms in this area. No contamination was found on personnel, PPE, or equipment, as determined by routine surveys, direct scans, and large area wipes. Multiple reports of CAM poor-fit alarms in the facility had been viewed as maintenance trouble alarms.

What We Can Learn: Facilities that have source terms with multiple isotopes or changing radionuclide compositions should consider configuring the Alpha 7A as a region of interest CAM rather than selecting a few dose isotopes for measurement to minimize the risk of the CAM not performing as expected. Air filter analysis, using another instrument, should be conducted on air filters associated with maintenance and failure alarms on CAMs. Instruments running proprietary software should be evaluated with caution to identify limitations.

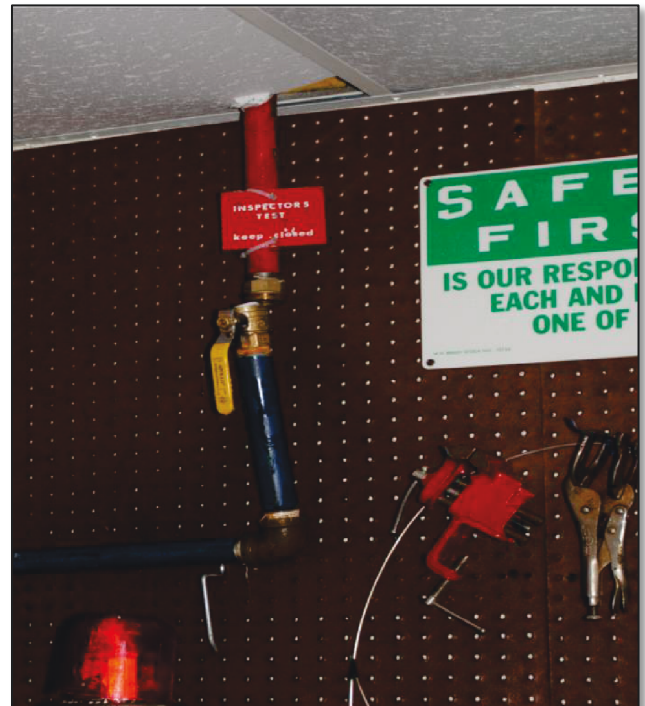
On January 5, 2015, MFC Balance of Plant (BOP) personnel discovered that the water flow alarm for building MFC-791, the Instrument and Maintenance Facility, did not actuate an alarm at the INL Alarm Center when a local water flow alarm was received the day prior. On January 4, 2015, at 1945 hours, a BOP technician was informed by security that there was water in the basement of building MFC-791.

Upon inspection, it was found that water was flowing from a fire water system pipe located in the northwest corner of the facility. The local water flow alarm had actuated. Then on January 5, 2015, while performing a follow-up to the water

flow alarm, it was discovered that while the local alarm actuated, the INL Alarm Center did not receive a water flow alarm as is expected. The failure of notification to the INL Alarm Center prevented immediate facility or off-site emergency response and resulted in the event being categorized as reportable. The fire water was isolated to the facility and a fire water impairment was implemented with a two-hour fire watch.

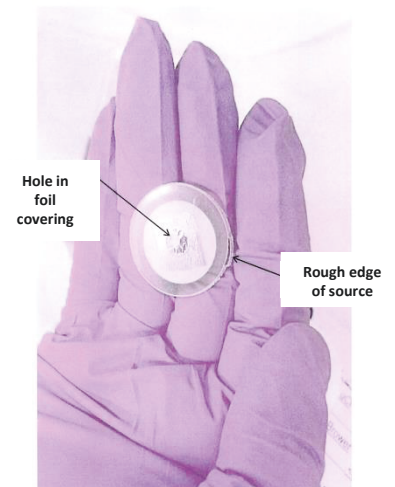
NE-ID--BEA-HFEF-2015-0001 (Significance Category 2)
Radioactive contamination was discovered outside of a controlled area at the Hot Fuel Examination Facility (HFEF) on March 11, 2015. During a survey to release a Carbon 14 sealed source from the facility, an RCT discovered 69,000 disintegrations per minute (dpm) beta gamma contamination on the source and 2,376 dpm beta gamma contamination on the inside of the source container. The source was being controlled in a radioactive source storage locker in radioactive materials area, but not in a radiological buffer area for contamination control.

An investigation into the discovery found that the edges of the Carbon 14 source cartridge were protruding, causing a tight source fit inside the source holder. The tight fit required the handler to use a push rod (provided by the vendor) to remove the source from the holder. Over time, the continued use of the push rod caused a failure in the foil covering the Carbon 14 source.

What We Can Learn: Users of similarly constructed sources should understand that they can be very flexible. If they do

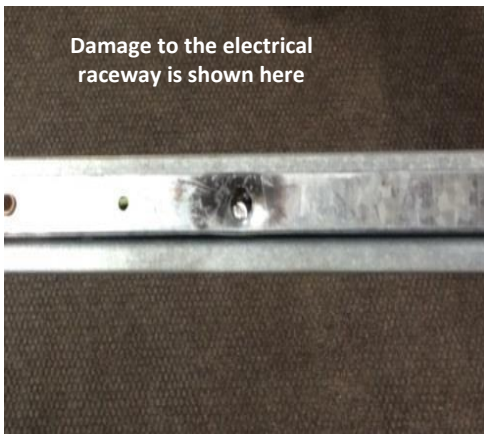
The investigation determined the worker had inadvertently positioned the lifting device directly under a bolt head passing through the partition wall electrical raceway. The

weight of the partition caused the bolt head to pass into the raceway compromising the conductor insulation. This resulted in an electrical short, as

evidenced by a mar on the electrical raceway and on the surface plate of the jack
