FY2015
4TH QUARTER
INL/EXT-15-37250

IDAHO NATIONAL
LABORATORY
QUARTERLY
OCCURRENCE
ANALYSIS

DEEPER LEARNING THROUGH
EVENT ANALYSIS

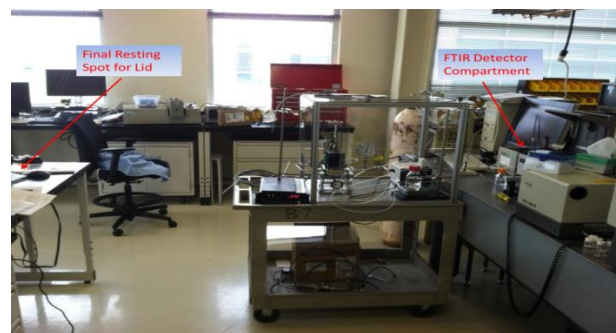
The researcher was concerned about the liquid nitrogen evaporation rate, as noted by a drop in sensitivity sooner than anticipated. To address this loss of sensitivity, the researcher refilled the detector dewar and slightly engaged the threads on the screw lid to attempt to slow the evaporation of the nitrogen. The researcher then left for the night.

During the night, pressure began to build in the detector dewar and, because of the manner in which the lid was attached, the pressure was unable to be released by the bellows between the detector and the compartment lid or through the screw threads. As a result of the pressure buildup, the lid blew off, coming to a landing several feet away from the detector. The laboratory was unoccupied at the time of the event and no one was injured; the instrument still functions as designed.

- Poor design: The bellows with the O-rings that are simply intended to keep air out of the sample compartment can also create issues as they expand under pressure, tightening the seal rather than releasing the pressure. Also as a means of preventing water from condensing in the detector, other vendors use a simple loose fitting plug rather than something with threads.

If a poor design feature is noted on a commercial instrument, if possible, take corrective action to fix the problem before a problem occurs. A simple loose fitting nylon "plug" to replace the screw cap would have eliminated the problem and been just as effective as the normally loosely placed screw cap.

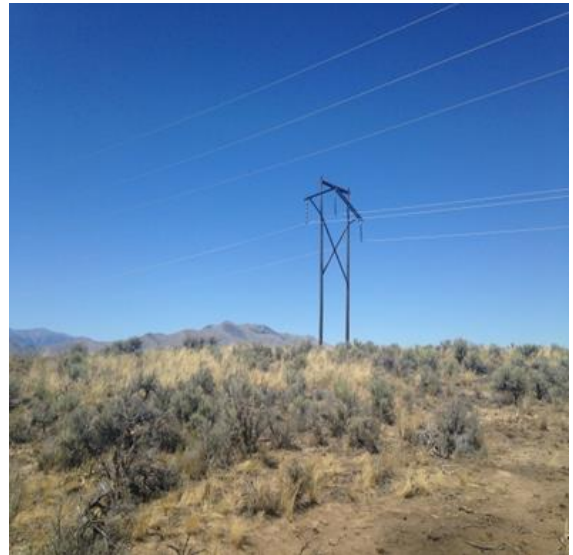
Incident Commander then briefed their crews and initiated fire suppression actions. As Wildland Unit #1 was advancing along the east flank of the fire, a low-hanging power line was observed by the Captain. All fire personnel were directed to fall back to the highway. Contact was not made with the line, however; fire department vehicles came within approximately 25 feet of the low-hanging 69 kv line.

- This was the first INL wildland fire of the 2015 season; and upon arrival, the fire was smaller than reported which may have provided a lessened risk perception. A number of environmental factors made it difficult to adequately assess power line condition including: dusk and the dark skies, storm clouds moved in, mountains on the horizon/backdrop, and a strong wind blowing from the north kicking up dust and smoke.
- Arco fire apparatus were already on scene and had initiated attack, which complicated communications. This may have led to Incident Command relaxing scene size-up and briefing responsibilities.
- There are two sets of lines that run parallel to the highway, a 230 kv line and a 69 kv line. When looking at these lines, it is difficult to distinguish which line is connected to which pole and recognize a line that has been disconnected from the insulator and sagging.

- Conduct face-to-face briefings with all workers regardless of situation and familiarity of the work. Ask if there are any questions from anyone at the completion of the briefing.
- Maintain situational awareness at all times during any type of hazardous work.

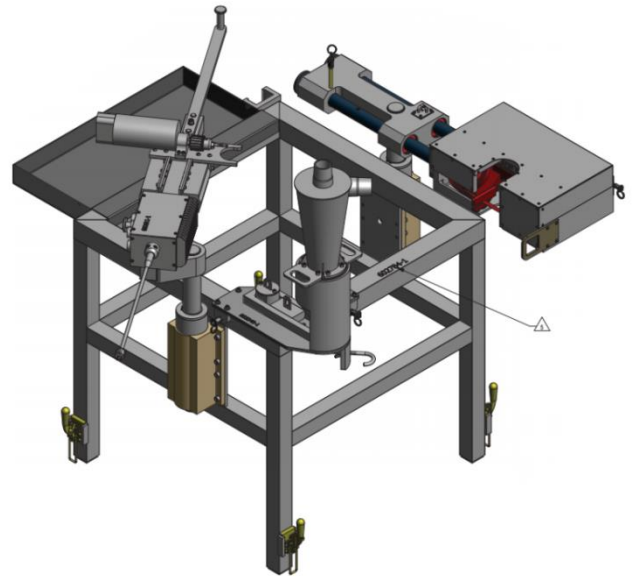
As shown in the illustration, the DTC Experiment Sizing Frame used a swivel arm that swings the bit into the experiment (not shown). Experiment Engineering determined a linear type drilling system would work better with the process. It was also found that a magnetic (type) drill had best potential to improve the drilling performance without adding a lot of design and fabrication costs.

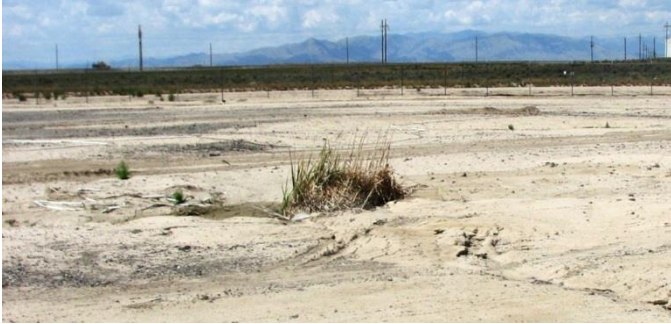
Some issues identified during the critique include: the ditch was not identified as permit required in the applicable Environmental Checklist; Construction personnel at the request of Security dumped slurry from earlier excavation

into the ditch; planning of the work did not identify as a potential issue as to where to dump the dirt; the ditch is not posted as a permitted area and, therefore, not easily identifiable as such; no facility area drawings, under configuration control, identify areas that are permitted; and, definition of “modification” is not clearly defined in the permit, hence the phone call to the State DEQ.

Configuration management is essential for work planning and as equally important as the need to identify permitted structures and/or areas to provide defense in depth.
