FY2016
1ST QUARTER
INL/EXT-16-37777

IDAHO NATIONAL
LABORATORY
QUARTERLY
OCCURRENCE
ANALYSIS

DEEPER LEARNING THROUGH
EVENT ANALYSIS

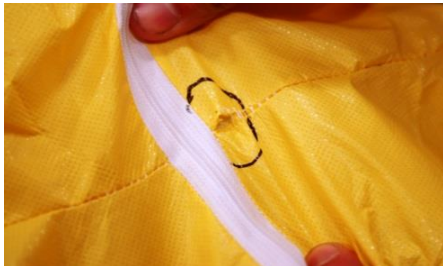
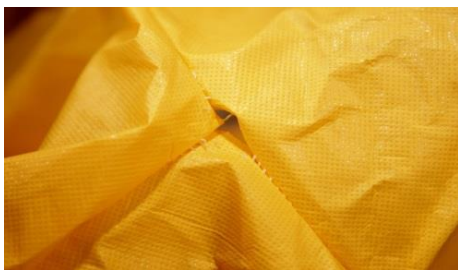
Failure of Seams in Zytron® 100 Level D Coveralls

On three separate occasions at the Materials Fuels Complex, It was discovered that multiple sets of Zytron® 100 Level D coveralls had stressed and /or incomplete stitching on the seams. The stressed and/or torn seams were found in multiple lot numbers. The holes were sizeable with a diameter roughly the size of a pea.

Notifications were made to management and the coveralls were rejected for use. INL Procurement was also notified of

the issue and will contact Kappler®, the manufacturer of Zytron®, on solutions and mitigations.

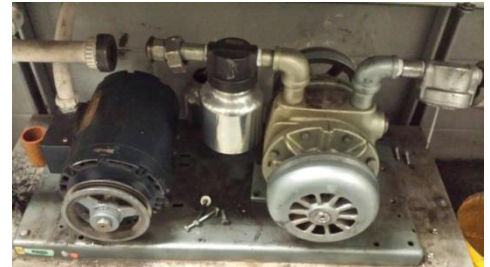
Investigation determined that preventative maintenance on the

vacuum pumps identified a seized electric motor for the pump system. The mechanic rationalized that there was no hazard with the motor as it was seized, cleared his LOTO and restore the other three vacuum pumps to service. However,

he did not replace the guards on the seized motor. Without the motor guards being installed, the mechanic inappropriately exited

If there is a potential that a hazard exists it must be mitigated. Procedure use and adherence, effective communication practices and a questioning attitude will help ensure safe and efficient facility operations.

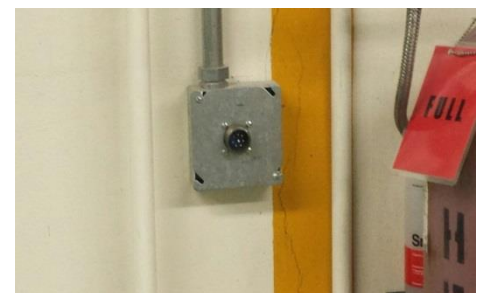
On November 24, an Instrumentation and Controls (I&C) technician at the HFEF discovered 120v AC electrical energy on an unprotected

male Amphenol connector. The connector was previously used to supply a continuous air monitor (CAM) that had been removed from the facility prior to June 2015. The I&C technician recalled this potential legacy issue on electrical

The cause of the deficient conditions was found to be inadequate legacy design/wiring which resulted in exposing 120 volt electrical when the Amphenol was disconnected.

- When removing/disconnecting equipment, performing a self check/STAR for the potential to expose hazards can mitigate the hazard before it is released from your control.
- The CAM/RAM became obsolete and all of the CAM/RAM's were replaced with a more modern unit. Work to remove legacy conduit and wire should typically coincide with the removal of equipment. A questioning attitude and more effective communication could have helped identify the creation of the hazardous electrical source when the CAM/RAM was disconnected.
- Because of their commitment to safety, the I&C technician and his foreman followed up on a "hunch" to ensure that fellow MFC personnel are not exposed to a hazardous electrical source.

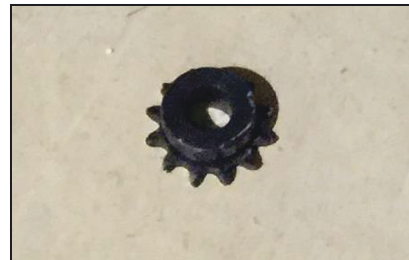
Failure of Facility South Roll-Up Door

The facility operator running the door controls pressed the close button to shut the door. As the door approached approximately 6 feet from the ground a sprocket disengaged from the motor above the facility operator's head. The door dropped closed and the sprocket fell landing approximately 2 feet from the facility operator. While sufficient barriers were in place to protect the operator from the falling door, there were no barriers to protect the operator from the falling sprocket.

Investigation by the subcontractor and HFEF personnel determined that one

or both set screws holding the sprocket on the motor drive shaft had not been properly installed and torqued. Failure to properly torque the set screws caused the door drive sprocket to disengage from the door motor shaft which allowed the door to fall in an uncontrolled manner. The investigation also found that the work was performed as skill-of-the-craft and that verification of completion of important work steps is not required or performed.
