Evaluation of Erosion of the Dummy “EE” Plate 19 in YA Type ATR Fuel Element During Reactor PALM Cycles

August 2016

Advanced Test Reactor

INL/EXT-16-38324
Revision 0

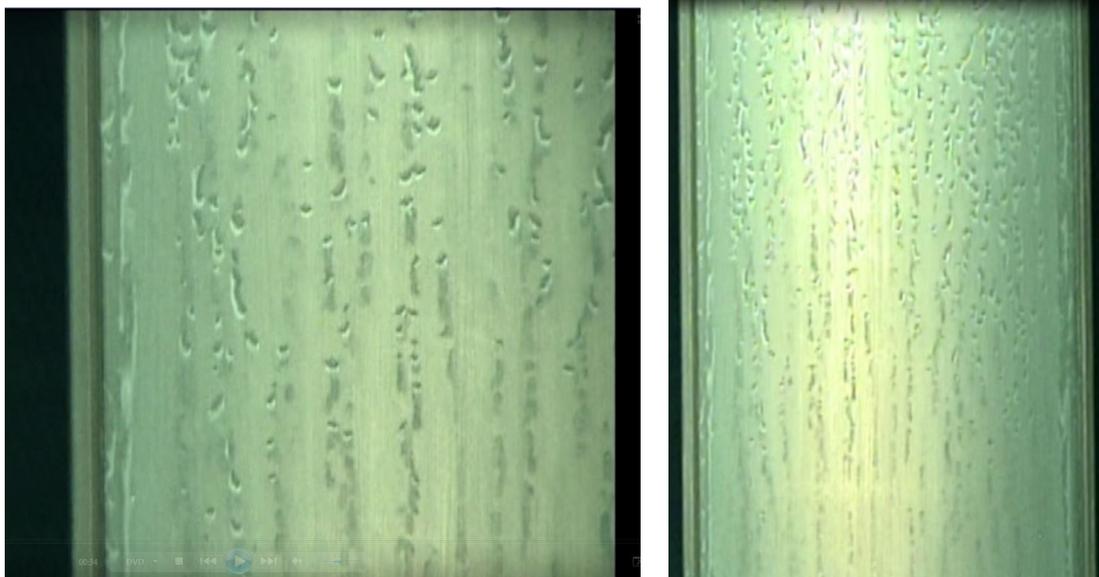
After 14 days of power operation, the reactor was shut down as scheduled to begin a planned refueling and maintenance outage. All 40 of the fuel elements loaded in the core were removed and visually inspected. Eight previously new YA-M type ATR fuel elements [1, 6, 7] were observed to have significant pitting degradation on plate 19. Plate 19 on a YA-M fuel element is an aluminum “dummy” plate, without any fuel material, fabricated to replace the fuel plate 19 in a standard XA/7F type fuel element. The fuel fabricator BWX Technologies, Inc. (BWXT) Nuclear Operations Group (NOG) in Lynchburg, VA identifies this aluminum “dummy” plate as an “EE” plate during fuel fabrication. The ATR Canal Operators described the dummy plates on these YA-M fuel elements as being “scaly” or “pitted” in appearance. Upon closer examination, thousands of flow erosion/corrosion pits were readily visible over approximately 40 inches of the 49.5-inch-long exterior surface of the EE plate on each of the previously new YA-M type fuel elements. The top 4 inches and bottom 4 inches of plate 19 were smooth. Similar pitting degradation was not observed on the exposed surface of plate 1 or the side plates of these YA-M type fuel elements, nor was any pitting degradation observed on any of the standard XA/7F fuel elements that had been loaded in the core, including those that were loaded immediately adjacent to the YA-M fuel elements [1-5]. The interior surface of plate 19 and none of the other fuel plates (plate 2 - 18) can be visually inspected [6-10]

Figure 1. Corroded dummy plate – photographs taken after the fuel elements were removed from the reactor.

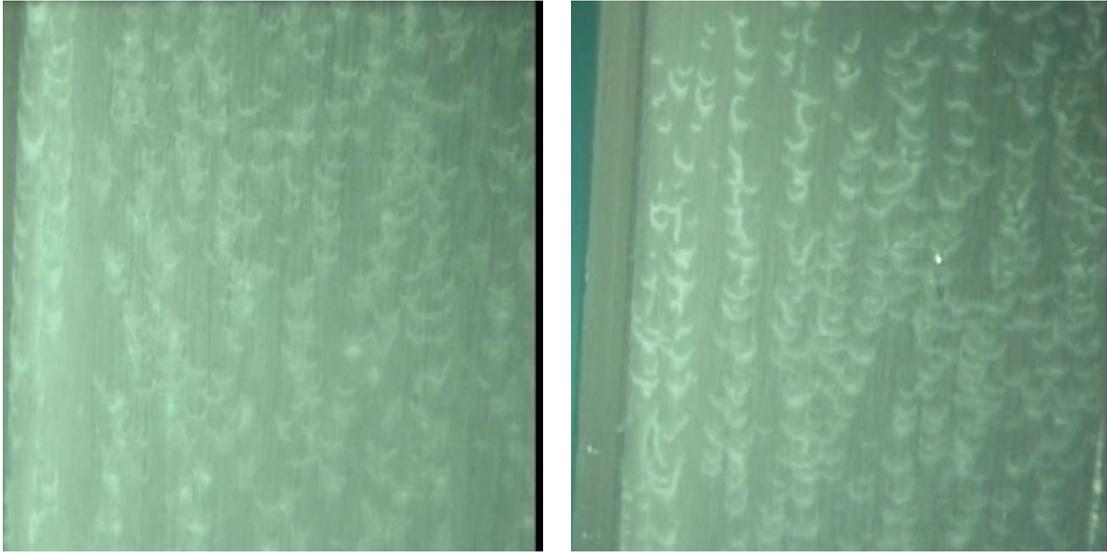
Yet another, very different type of erosion was also observed, see Figure 2:

Figure 2. “Scalloping,” or horseshoeing erosion - 6061 “dummy” plate

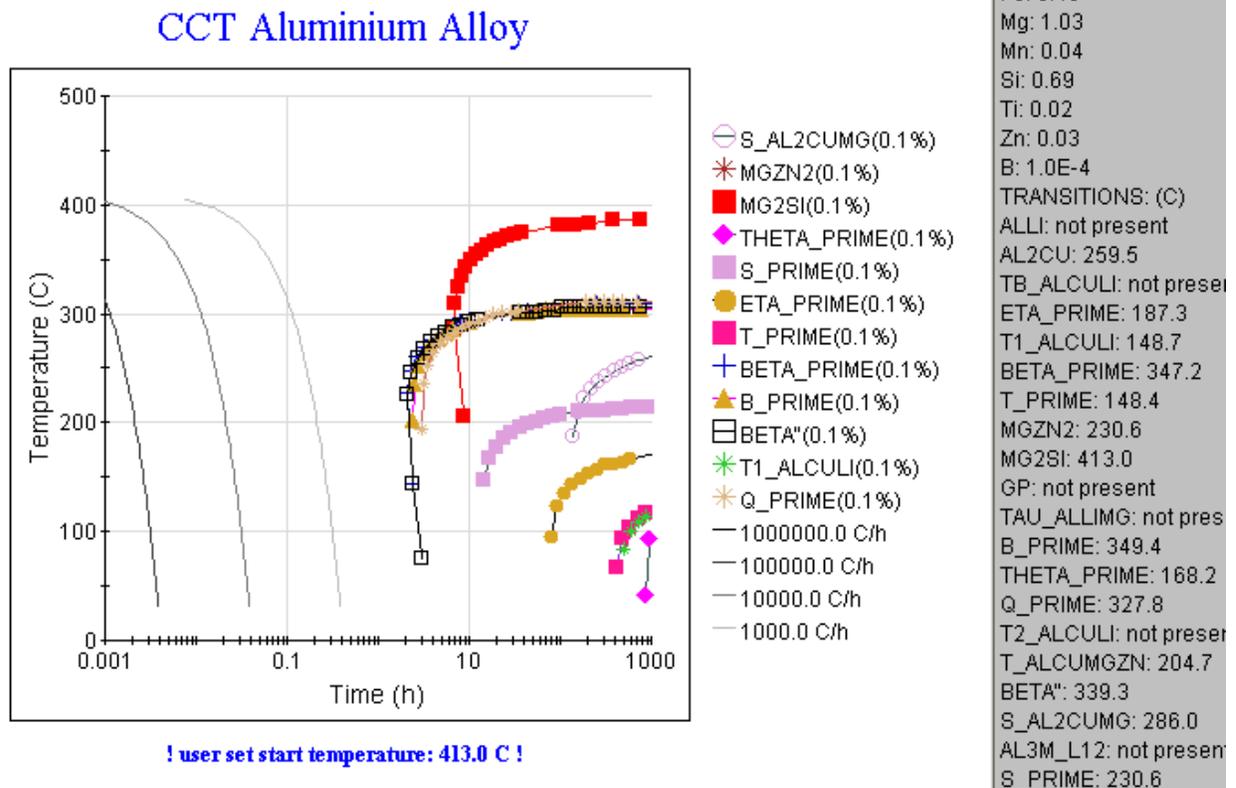
Figure 15. Continuous cooling diagrams from 413°C down to room temperature for different cooling rates, including cooling in the ambient air (1000 C/hour; light grey line).

One can see that the light grey line corresponding to cooling in the air (~1000C/h) is uncomfortably close to the CCT lines for precipitation of different metastable phases such as β' or β'' . Consequently, additional high temperature anneal seems attractive both from the complete recrystallization and the elimination of metastable phase point of view.

One possible solution to eliminate the flow-assisted erosion problem would be to cold roll, then add blister anneal (2 hours at 900°F), then follow up with program anneal (2 hours at 775°F). Probably it could even be possible to drop temperature of the 2nd anneal down to 700°F. This was suggested to the fuel fabricator, BWXT. The annealing procedures were revised to add the higher temperature blister anneal to the EE plate fabrication procedure.

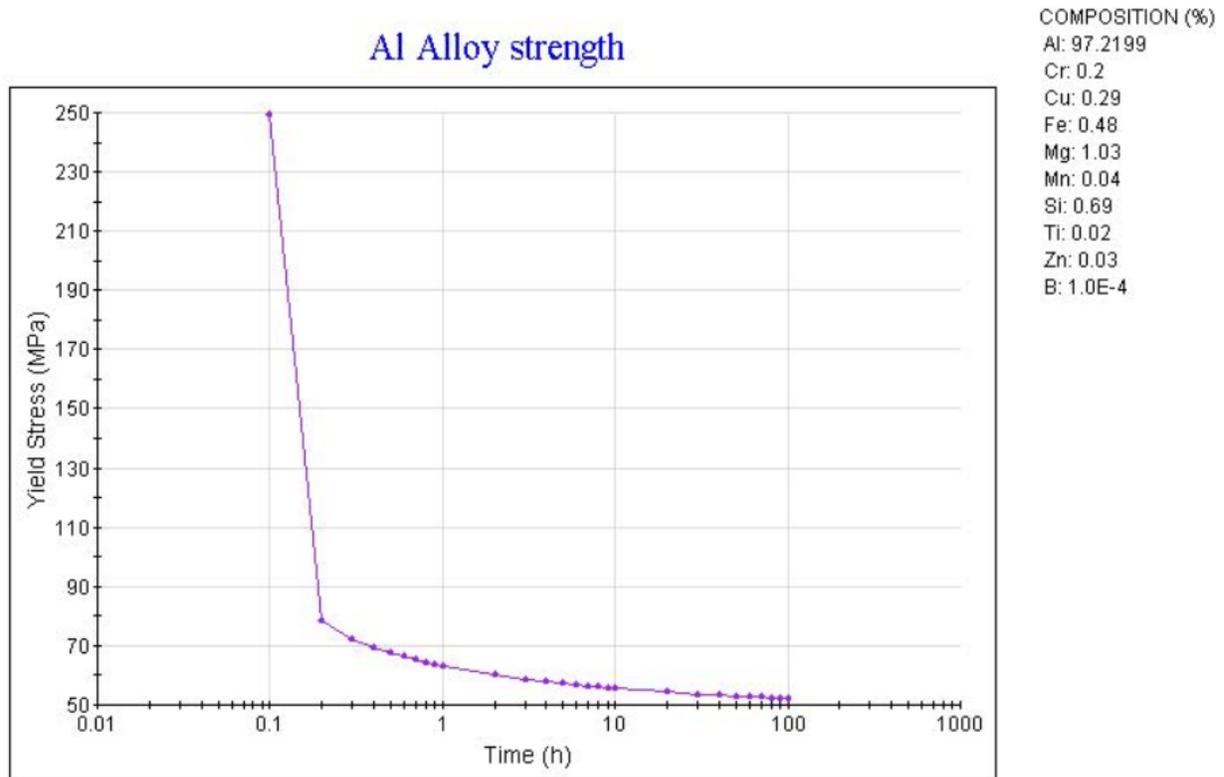
Figure 16. Modeling of residual AA6061 alloy strength: after 2 hours of heat treatment at 413°C sheet still has about 62MPa residual strength. This is higher than 55MPa for AA6061-O. Strength can further increase as a result of natural aging during cooling in the air.

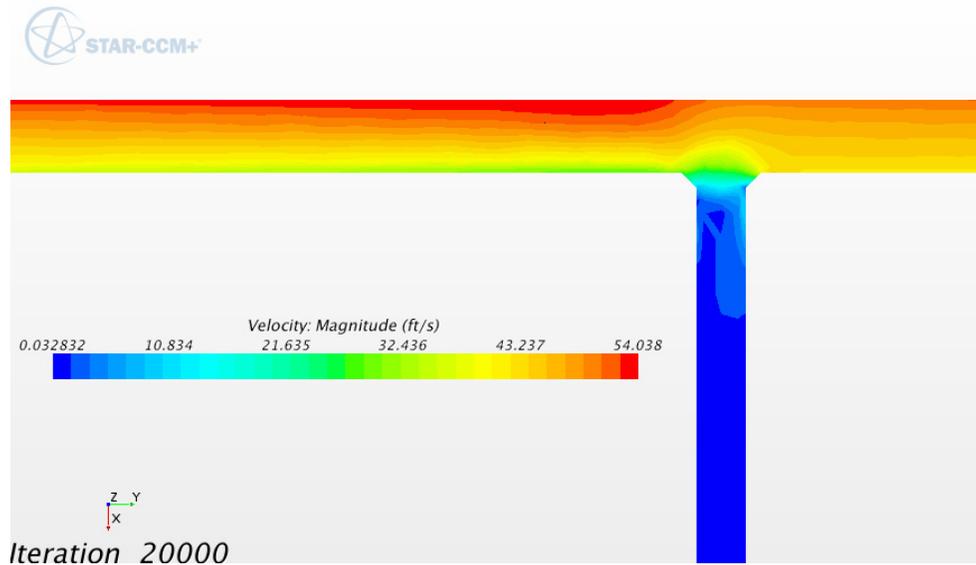
In this expression D_o stands for the channel diameter, Re is the Reynolds number and x_o stands for the distance (from the perturbation site) at which the flow stabilizes hydro-dynamically. This distance turned out to be equal to 1.063 – 1.181 in from the exit surface of the cut. Applying this idea to the analysis of the graph in Figure 28, one can come to the conclusion about validity of this statement. Indeed, this is well confirmed by the appearance of the secondary peaks in the areas in between two adjacent cuts. Note that the distance between cuts, shown in Figure 6, decrease in distance when closer to core mid-plane. The closest cuts (7 and 8) are only two inches apart, whereas the distance between the first and second cut is five inches apart. While the flow stabilizes roughly after an inch per the formula above, the short distance (as low as two inches) between cuts near the mid-plane may still prevent the flow from stabilizing.

Figure 26. Flow structure: velocity distribution field around the cut in beryllium reflector block.

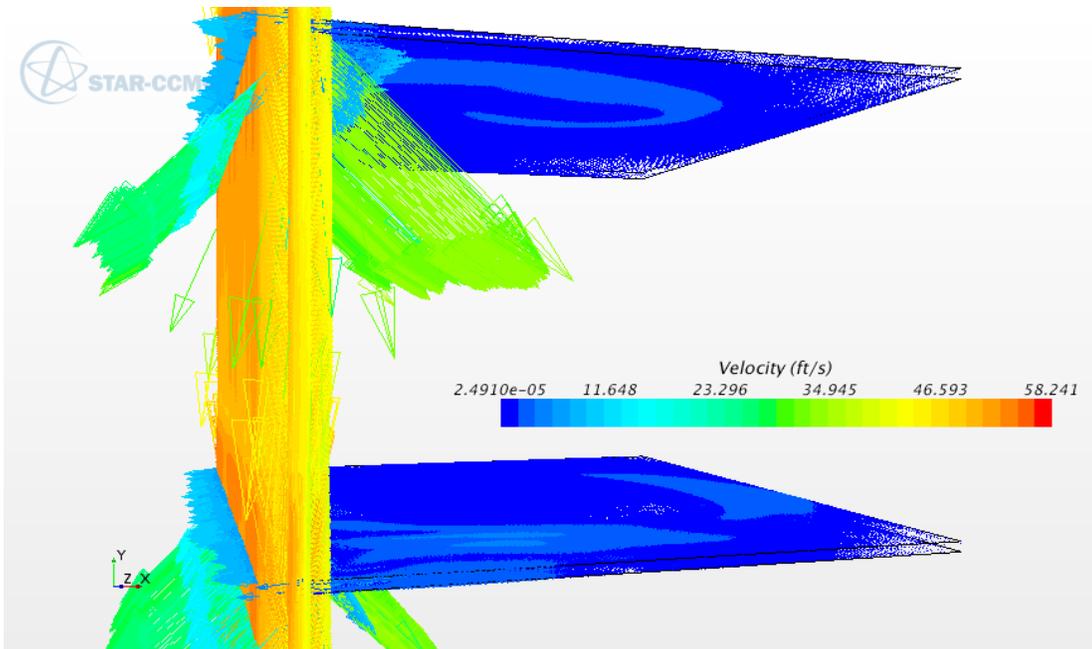
Figure 27. Flow Structure in 3D: the same as the previous figure, but with a vector field distribution for flow velocities in the direct vicinity of the cut. Perturbations from the stress-relief cuts cause the coolant to flow into the plate face at up to 35 ft/s.

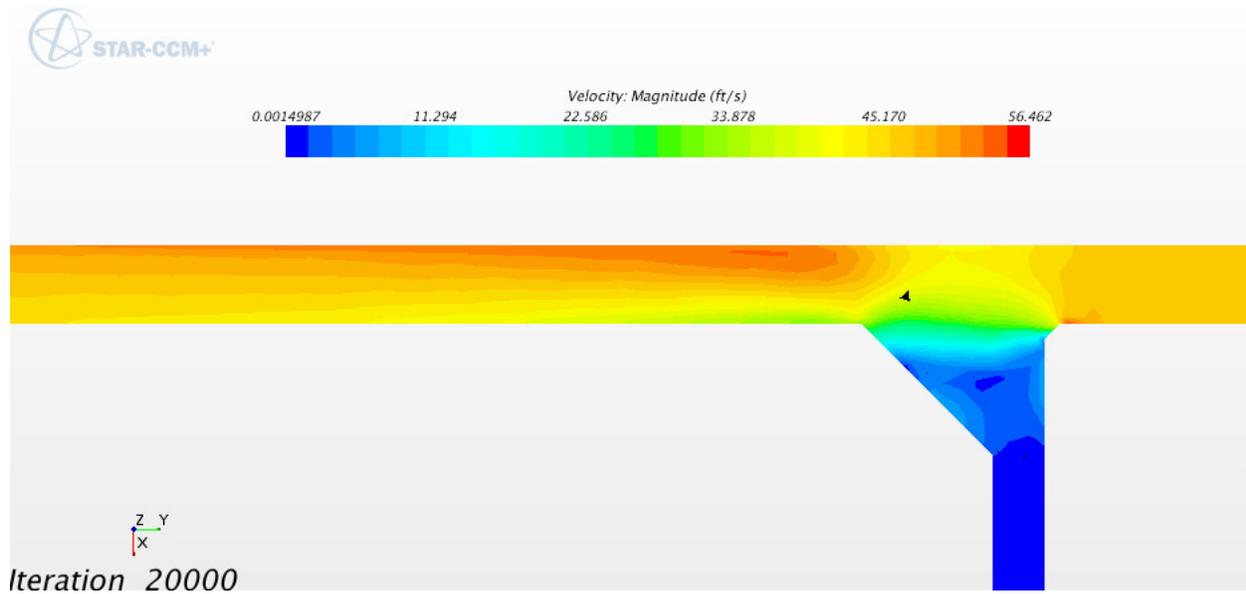
Figure 30. Flow structure: velocity distribution field around the cut in beryllium reflector block with a modified (1/8 in.) bottom chamfer.

The chamfer modification had a modest impact on the coolant velocity vectors. There are still velocity vectors toward the plate, but these are reduced in number and much more spread out axially.

As these simulations identified erosion as a possible primary contributor to the YA-Plate 19 pitting degradation issue, the channel geometry was further modified to attempt to find a solution to the post-cut flow perturbations. A proposed solution was to exaggerate the chamfer on the bottom of the cut to observe how this change affected the solution, even though this change would likely not be beneficial as the reflector block ligaments are only 1/8 in. thick. Figure 30 shows the model geometry at a single cut site and the velocity magnitude as a result of the modification. The new bottom, “deep” chamfer is 1/8 in. deep, compared to 1/64 in. in the standard case.

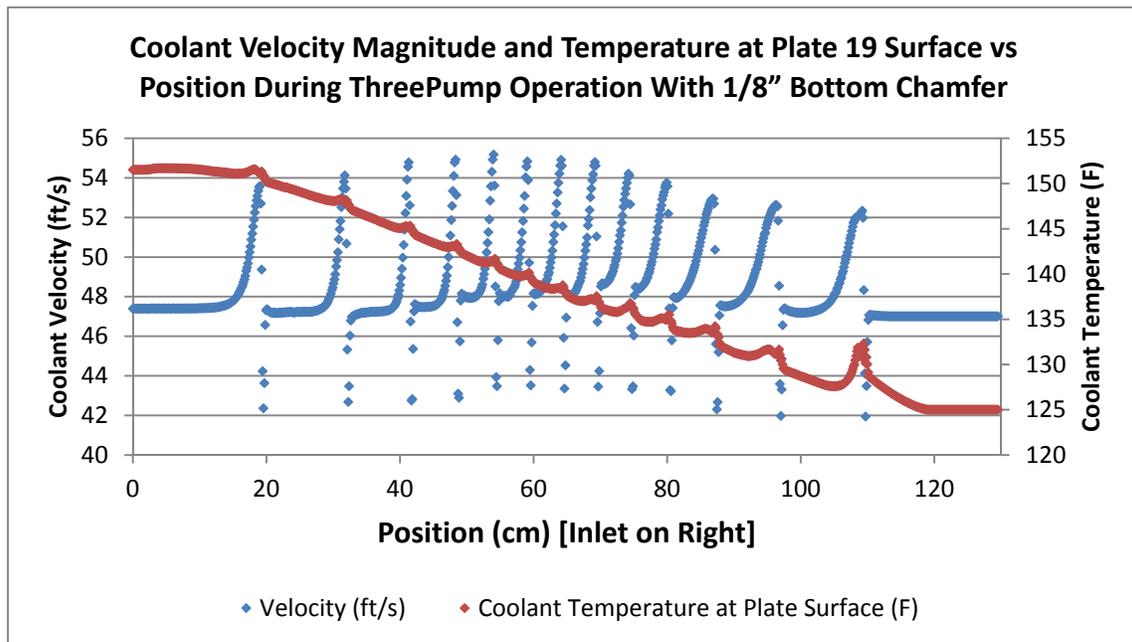
Figure 32 shows the velocity and temperature profiles versus axial position with the modified chamfer. While the magnitude at the discontinuity is not markedly different than the standard case, it is important to note that the temperature is significantly more linear and is lacking the dual-maxima of previous cases.

Figure 32. Velocity magnitude/temperature at the Plate 19 surface. While the discontinuities still exist with the modified chamfer, it is important to note that the magnitude does not say anything about the direction of the flow.
