FY2016
3RD QUARTER
INL/EXT-16-39633

IDAHO NATIONAL
LABORATORY
QUARTERLY
OCCURRENCE
ANALYSIS

DEEPER LEARNING THROUGH
EVENT ANALYSIS

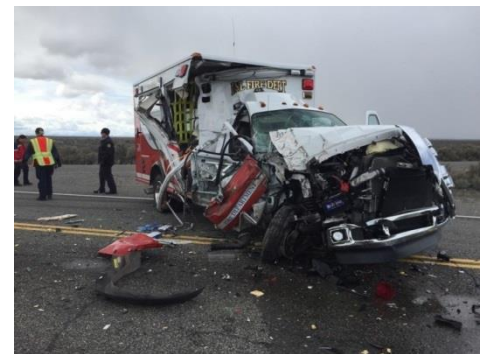
Lesson 2016-0019

On March 15, 2016 at approximately 1245 hours, an engine company consisting of five firefighters and two apparatus – a fire engine and ambulance - deployed from the Central Facilities Area (CFA) Station 1 northbound on Lincoln road for a routine facility tour. The engine was leading

with the ambulance following. While following the engine, the ambulance driver observed a coyote approaching the roadway from the east (right side of the road). The ambulance driver observed the coyote run in front of the engine causing the ambulance driver to momentarily remove his foot from the accelerator pedal anticipating the engine might need to break to prevent colliding with the coyote.

- The fire engine driver rapidly reduced his traveling speed to 20-25 MPH in a posted 65 MPH zone.
- The ambulance driver's attention became distracted by the animal and did not recognize that the engine had slowed significantly, creating an unsafe following distance.
- The auxiliary engine brake did not illuminate rear brake lights to signal deceleration of the fire engine.

- Brake lights on fire apparatus produced prior to 2009 do not typically illuminate when the auxiliary engine brake is engaged (ref. NFPA 1901).
- Driver/operator training should incorporate skills for managing wildlife hazards and other distractions and consider the use of driving simulators to reinforce desired behaviors.

- Never swerve to avoid wildlife in the road – swerving can confuse the wildlife, lead to collisions with other vehicles, cause the car to leave the roadway and greatly increase the chances of injuries.

- If wildlife is seen, do not slow excessively or stop/pause in the roadway if the animal does not pose an immediate threat to safety.
- If at any time drivers feel the need to slow down for a road hazard, including wildlife, consider turning on hazard signals to warn other motorists.

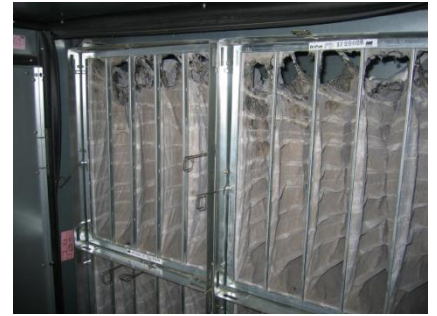
Facility Ventilation Modifications Testing Cause Overheating of Sock Filters

Upon partial completion of the Zero Power Physics Reactor (ZPPR) facility ventilation modifications at the Materials and Fuels Complex (MFC), the contractor performing the modifications energized the facility supply fans and heater element for testing. The supply system had been shut down for approximately five months. It was discussed in the job briefing that odors or smoke may be detected during the test. Moments after startup, strong odors and

more smoke than expected were released into the ZPPR workroom. The supply fans and heater were secured immediately and all personnel relocated to the ZPPR control room to discuss what had just happened. Two individuals expressed difficulty breathing and were taken to MFC medical then to Central Facilities Area for further evaluation. They were cleared and returned to work without restrictions. It was determined later that the sock filters downstream of the supply fan and heater had melted from the excess heat.

- Even though the facility fire alarm did not activate, there was enough smoke to present a potential health hazard to the employees. Personnel must respond properly to the situation presented and not only to an alarm condition.
- A hidden system response occurred when the heater ramped up to full power rather than ramping up in smaller increments.

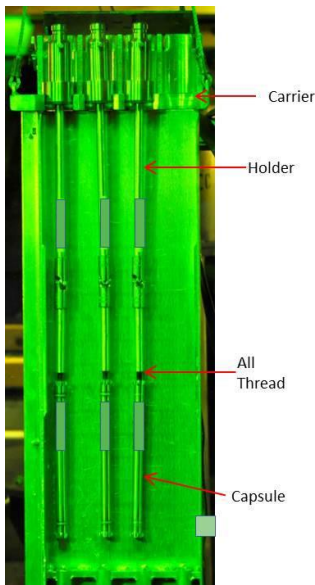
On March 23, 2016, at the Material and Fuels Complex (MFC) Hot Fuels Examination Facility (HFEF) Neutron Radiography Reactor (NRAD), while developing film a worker discovered that one of three fuel capsules had come loose from the mount. The capsule became balanced on a fixture 18 feet down a 29 foot remotely operated neutron radiography elevator shaft. Retrieving the pin remotely was not a viable option.

The capsules were threaded onto a holder for positioning in the NRAD neutron beamline. The elevator was lowered to the beamline when the vibration during travel caused the capsule to unthread from the holder and drop onto the carrier.

- A prototype holder design was tested with each capsule, the threads held successfully. The actual holders used differed slightly from the prototype.
- After the first neutron radiograph, the capsules were checked to see if they were still tight; however, they were discovered to be loose. This was an opportunity to call "Time Out." The capsules were retightened and lowered into position for the second radiograph. It was during this evolution of lowering the elevator when the capsule came off the holder.

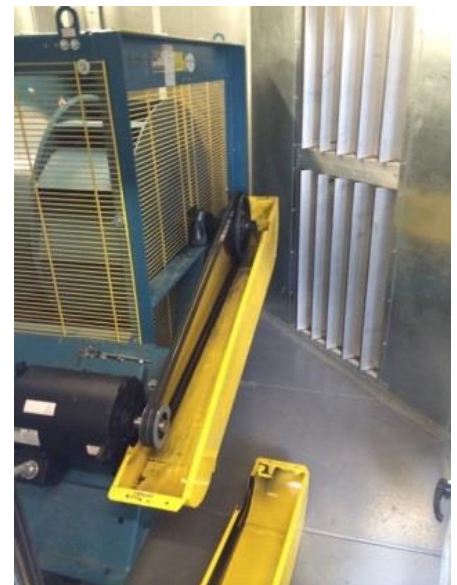
Inadequate LOTO Results in Hand Injury

A subcontracted mechanic received an injury to the ring finger on his right hand while performing work on a Heating Ventilating and Air Conditioning (HVAC) Unit at the Energy Innovation Laboratory (EIL). The accident occurred at approximately 1530 hours on June 15, 2016. The mechanic had performed a lockout/tagout (LOTO) on the Variable Frequency Drive (VFD) disconnect for Air Handling Unit (AHU) number 5, observed the system's return fan slow to a stop and observed the lack of digital display on the fan operating panel.

The mechanic then completed zero energy checks by attempting to start the fan. When the equipment was verified to not start, the mechanic removed the safety guard from the belt and pulleys and turned around to set the guard on the ground. While the mechanic's back was toward the HVAC unit, the fan began to rotate; the rotation was not

Following the event, INL Facilities and Site Services (F&SS) personnel attempted to replicate the event to determine if the fan started moving due to air flow cause by fluctuations of outdoor wind speed, because of building pressure differentials, or because of an inadequate LOTO. During replication, work was performed in the exact manner as it had been done on the day of the event. F&SS learned that approximately 2 ½ minutes following re-energization of the AH-5 supply fan, the return fan began to slowly rotate, gradually picking up speed. Although the return fan was tagged out of service, the building HVAC control system sensed the need to cycle the supply fan which in turn resulted in movement in the return fan due to building pressure changes. This scenario was repeated several times and each time, return fan began rotating approximately 2 ½ minutes after energy was restored to the supply fan.

- This event emphasizes the importance of identifying all the hazards of an activity, and appropriately implementing controls for those hazards.
- Determine the optimum safe methods to identify, isolate and mitigate all potentially hazardous energy (electrical and mechanical) associated with moving parts. Assure the work planning and job hazards analysis incorporates these methods.

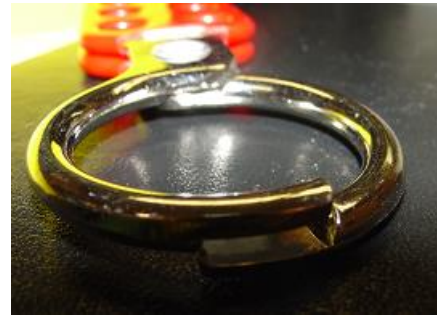
While a worker was applying a personal lock and tag to a multi-person locking device (commonly called gang locking devices), the locking device became disengaged from the lockbox. Upon further examination, it was observed that this was a new gang locking device that appeared to have weaker hasp arms than the devices regularly used at the facility. The weaker hasp arms allowed a sufficient enough gap that the lock could become disengaged easily.

lockout/tagout, and there was no loss of exclusive control of the isolation.

The FAS re-established the lockout/tagout with a gang locking device that has been used previously that does not have this issue. An extensive

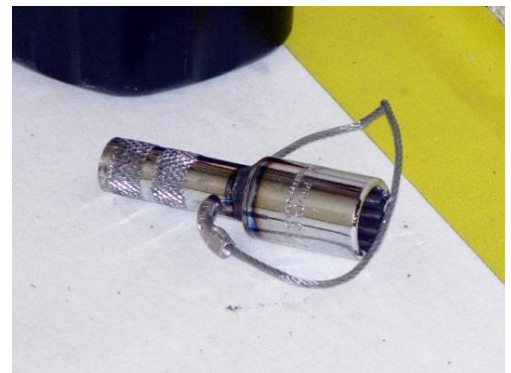
Attachment to Drill Socket Causes Severe Finger Trauma

The injury required surgery and resulted in the partial loss of the finger. The mechanic was operating a

pole hoist powered by a portable 18 volt battery operated drill equipped with a modified ½ inch socket. While operating the drill, M1's finger became entangled in a wire rope lanyard that had been attached to the socket. The entanglement resulted in severe trauma to the mechanic's finger.

The lanyard had been added to the socket to prevent it from becoming lost. Although many people identified a hazard associated with the lanyard, none identified the entanglement hazard and as such did not recognize the risk to safety the lanyard posed.

- Additional attention is needed when working with rotating tools/equipment.
- Perform an extent of condition in your work areas. If any modified tools are found, evaluate and take out of service if unmitigated hazards are present or if modifications have negatively compromised the tool(s).
- Equipment must be used per manufacturer's instructions and be maintained in a safe condition. When modifications are needed, they must be evaluated, and approved to ensure hazards are fully mitigated.

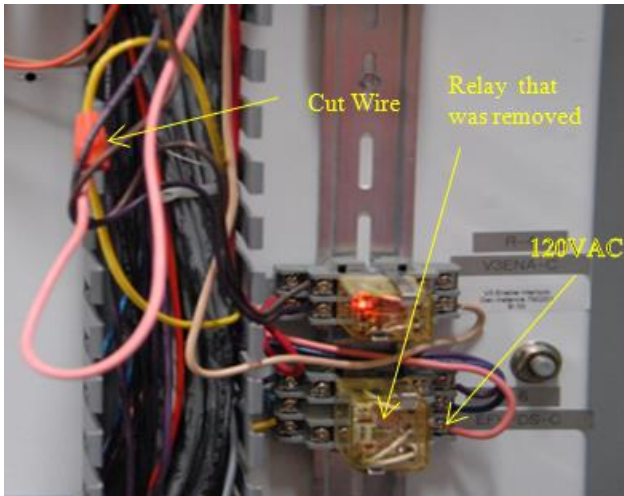
Personnel Performing Work in an Electrical Control Panel without Proper Hazard Mitigation

Facility personnel were performing a configuration control inspection of the Space and Security Power Systems Facility (SSPSF) exhaust system control panel. Drawing discrepancies had been noted based on recent activities and personnel were attempting to verify configuration of the panel versus the documentation on the 'as built' drawing. This panel had been upgraded during the NORESKO Energy Savings Performance contract and had been labeled as having "No Exposed Electrical Hazards." After removing a raceway cover to trace the wiring, a conductor was discovered in the raceway with a frayed end that led back to a 24V relay (that appeared to be abandoned in place).

At this time, an Instrumentation & Calibration (I&C) technician entered the room while on another job. Operations personnel discussed the issue with the I&C technician. Personnel present felt that the frayed end should be removed and a wire nut installed. The I&C technician removed the 24V relay and cut off the frayed end of the wire, then re-installed the relay. Personnel then notified the facility Shift Supervisor (SS) of conditions and actions taken. The SS called a time out and notified facility management, knowing that this work had been performed outside of the approved work control for this activity. Subsequent inspection by facility management and the I&C technician revealed there was exposed 120VAC inside the cabinet. No voltage was on the cut wire.

- Exercise Time Out/Stop Work when conditions are not as expected, ensure management is properly notified prior to taking actions, and ensure hazards are mitigated prior to proceeding.

- For panels that have previously been evaluated as <50 volts AC, trust but **VERIFY** the voltages are truly <50.
- The process for evaluating the operator access to electrical cabinets should be reviewed to determine if improvements are needed.

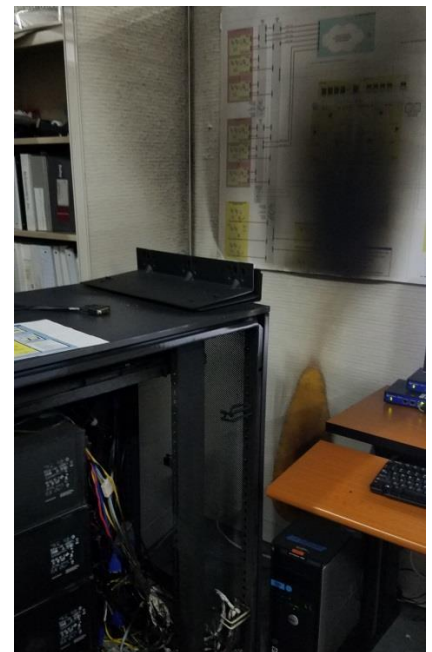
Electrical Fire in a Moveable Server Rack Cabinet

On April 10, 2016, in University Boulevard Building 4, a fire occurred in a portable electronics cabinet with rack mounted server equipment installed. The fire self-extinguished after a short circuit caused the breakers to trip and available fuel was consumed. There was extensive fire damage to the wiring and server inside of the cabinet. External damage was limited to some melting of an adjacent PC case and charred surfaces on the cubicle wall. Both of these damaged items were in contact with the cabinet. Soot was found through-out the electronics laboratory and adjacent spaces.

The cause of the fire in the cabinet was the failure of a non-industrial fan that had been mounted inside the cabinet near the top to aid in heat removal from the equipment. The fan fell from its clip-mounted location to the bottom of the wires in the cabinet and overheated. The fan was intended to be clamped to a desk for personal use, not for cabinet installation. It did not have impedance or thermal protection.

The two power distribution strips in the server cabinet were powered from two different power distribution strips in adjacent electronic cabinets. Although this condition did not contribute to this incident, this practice is not permitted by most manufacturers of these power strips. The “daisy chaining” can lead to excessive current loads and failure of surge protection systems to properly operate in fault conditions.

- Match equipment with its intended purpose. Fans installed in electronic equipment or other systems should be designed and listed for the intended purpose. They should also be sized for the expected load. Consideration should be given to thermal and/or impedance protections systems.
- Maintain proper clearance around the electronic cabinets per the manufacturer’s recommendations and requirements.
- Plug power distribution strips and surge protection strips directly into a building receptacle. Do not use with an extension cord or “daisy chain” unless it is specifically evaluated by the electrical authority having jurisdiction or permitted by the manufacturer.

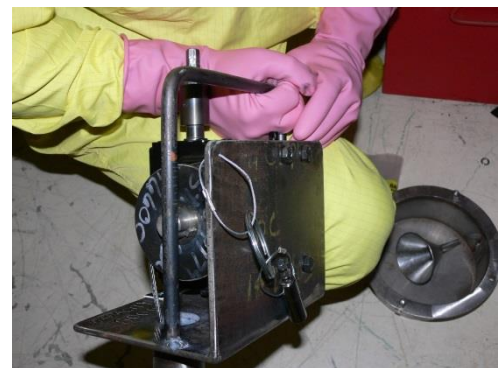
While operating the drill, M1's finger became entangled in a wire rope lanyard that had been attached to the socket. The entanglement resulted in the severe trauma to the mechanic's finger. A photograph of the pole hoist showing how the socket was attached with the lanyard is shown above.

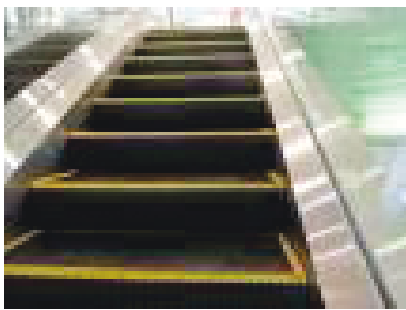
Lockout Tagout On Escalator Repairs

Subcontract technicians were repairing the escalators under a simple electrical LOTO. In order to access the area under the escalators to perform the repairs, the workers also had to

remove a number of the escalator treads. The subcontract workers applied a come-along to block potential unexpected movement of the escalator, as required when removing more

It is important to be cognizant of changes that occur during performance of work and how these changes may impact or challenge the hazard controls that are in place.

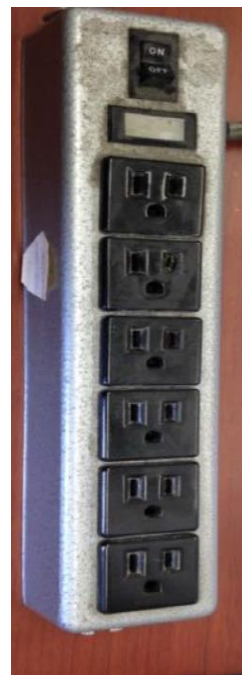
failed power strip and the area around the power strip, the Shift Supervisor authorized unplugging the power strip which eliminated the electrical hazard. The power cord to the power strip was rendered unusable and disposed of.

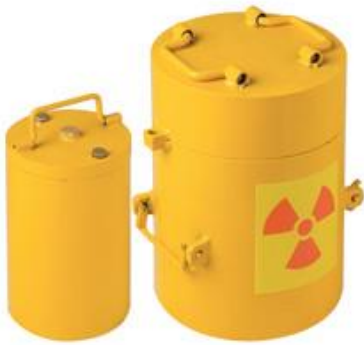
While attempting to remove two one-curie (Ci) Cobalt(Co) 60 sources received from a vendor, it was discovered that the cap on the source pot had become loose and fallen out during shipment. This allowed the sources to fall to the bottom of the shipping container.

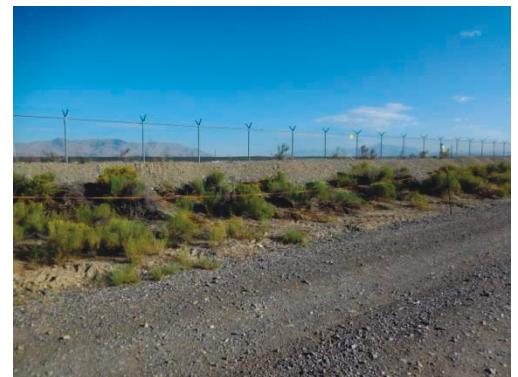
On May 12, 2016, a construction worker at the ATR evaporation pond lowered a Radiological Buffer Area (RBA) boundary rope and entered the area with a forklift without radiological controls personnel present.

When radiological controls arrived, the radiological controls technician (RCT) counseled the worker on the need to have an RCT present and that he could not drop the rope on his own.
