**IDAHO NATIONAL  
LABORATORY  
QUARTERLY  
OCCURRENCE  
ANALYSIS**

**DEEPER LEARNING THROUGH  
EVENT ANALYSIS**

## INL/EXT-17-43652 – 4<sup>th</sup> Quarter FY-17

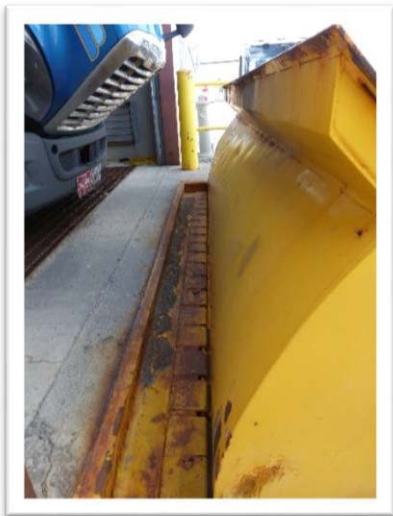
On the morning of June 14, 2017, a delivery truck driver was closing the hood of his truck and preparing to enter the ATR Complex through the Vehicle Monitoring Facility (VMF) when he was struck in the back of the leg by a descending active vehicle barrier. The Security Police Officer who was processing the driver through the VMF lowered the barrier without first verifying the area around the barrier was clear of equipment and personnel.

The delivery truck driver suffered significant injury to his lower right leg as a result of being struck by the barrier. In describing the event, the driver stated that the front of the truck was very near the active vehicle barrier. In order to close the hood, he placed the toes of his right foot

on the edge of the barrier opening. This action placed his right heel in the barrier's downward path of travel.

- Engineered controls were not in place. There is no safety interlock to prevent motion of the active vehicle barrier if someone were in the travel path of the barrier. In addition, administrative barriers such as warnings or markings were not used. Posted exclusion areas could have warned personnel of the hazard present with the active vehicle barrier.

- Exhaust all reasonable means to eliminate or mitigate hazards through engineered controls rather than relying on administrative controls.

- Ensure administrative controls adequately address all hazards. In this case, security controls were addressed but safety controls were not adequately addressed.
- Ensure training is thorough and demonstrated as effective through follow-up management observations.
- Legacy work practices should be scrutinized even if a process is historically successful. Maintain a questioning attitude at all times and exercise stop work authority.

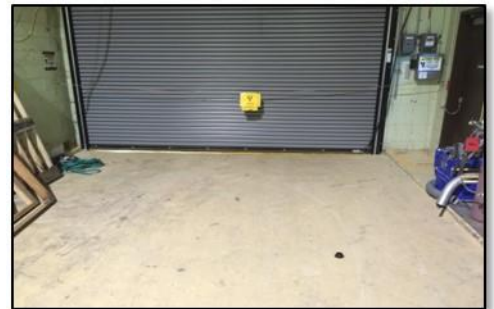
On October 26th, 2015, the Hot Fuel Examination Facility (HFEF) south roll-up door experienced a mechanical failure. The operator running the door controls pressed the "close" button to shut the door. As the door approached approximately 6 feet from the ground, a sprocket disengaged from the motor above the operator's head. The door dropped closed and the sprocket fell, landing approximately 2 feet from the operator. Because of the measures put in place, the operator was not in the vicinity of being struck by falling parts.

concerns raised in the operating experience, are credited with the prevention of possible injury to workers who were in the area when the sprocket fell.

Organizational learning must be embraced. When the operating experience was shared with MFC personnel, they were instructed to not walk under a roll-up door when it was being operated. To serve as a reminder, warnings signs were posted adjacent to roll-up doors to inform personnel of the potential hazard.

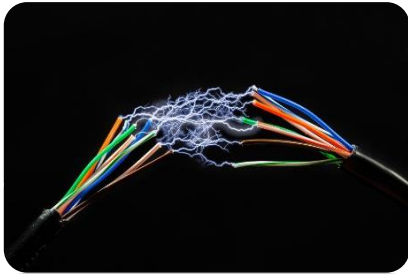
A utility area operator (UAO) was working with an electrical engineer to investigate a LOTO. The individuals were tracing a conduit that runs through the M-6 emergency diesel generator (EDG) under-voltage relay cabinet. This cabinet is opened monthly to initiate an under-voltage signal to test the functionality of the EDG. The individuals observed an electrical spark between the wire bundle and the inside of the cabinet when the door was opened beyond 90 degrees. Electricians investigating the spark found a place on two wires where the insulation has been worn off due to years of rubbing against the lip of the cabinet door.

Work was stopped, a caution tag was placed on the cabinet door and the area immediately in front of the cabinet was posted. A piece of electrical tape was placed on the lip of the cabinet door to prevent further contact. An operability

review was conducted and found the M-6 EDG, a technical safety requirements (TSR)-related piece of equipment, as operable.

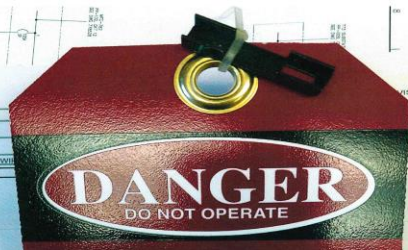
In early August 2017, a LOTO was installed using a “zip tie” on a common trip bar for a ground fault circuit interrupter (GFCI) breaker. The trip bar is used to connect two single-pole breakers into one double-pole breaker. The GFCI breakers were located inside a breaker panel at the MFC. Due to the configuration of the breaker, a standard lockout device could not be used and “tag only” isolation is acceptable in certain situations by the INL LOTO procedure.

The morning of September 19, 2017, during a pre-job walkdown, the MFC-725 building manager discovered that the GFCI breaker LOTO

tag had fallen from its installed location on the breaker. The breaker connection trip bar had become dislodged from the two single-pole breakers. When the tag was discovered, it was still zip tied to the trip-bar.

Alternative methods for energy isolation should be thoroughly explored *before* relying on a tag only LOTO. In addition, core human performance improvement tools such as having a questioning attitude and taking a minute to think about the actions you are going to take, would likely have identified an aftermarket lockout device to provide positive control of the electrical hazard.

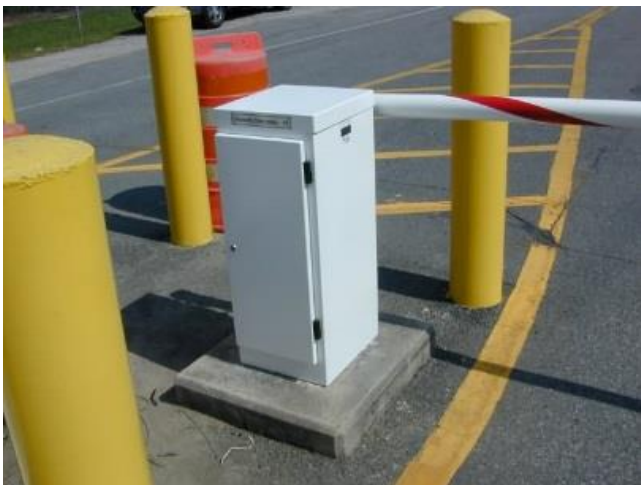
**LP-CO 2017-0398**

A security police officer inadvertently activated (lowered) a traffic control drop arm gate at an INL vehicle ingress point. The arm made contact with a dump truck as it was proceeding through lane No. 1 at INL Gate 1. As engineered, when the drop arm contacted the dump truck, the arm immediately reversed and raised back to the up position. There was moderate damage to the drop arm but none to the

dump truck. The drop arm has been replaced and traffic is continuing through lane No. 1.
