**IDAHO NATIONAL
LABORATORY
QUARTERLY
OCCURRENCE
ANALYSIS**

**DEEPER LEARNING THROUGH
EVENT ANALYSIS**

INL/EXT-18-44410 – 1st Quarter FY-18

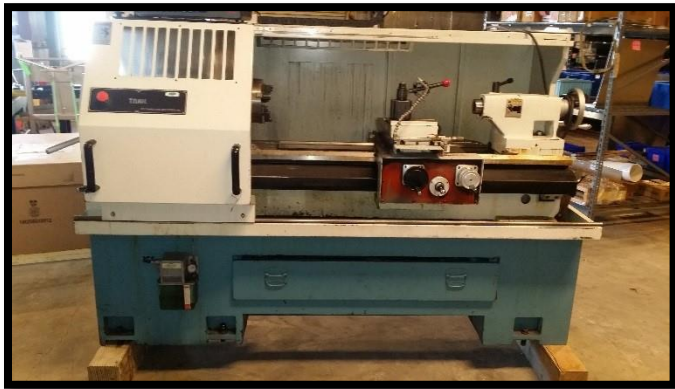
Professional riggers were transferring a 4,500-lb lathe in the MFC Fabrication Shop when the sling failed. The lathe was being removed from the facility, destined for excess, and was no higher than 2 inches off the floor. The load dropped to the floor without adverse consequences to people or the facility. The sling was rated for 12,800 lb; workers had followed rigging best practices of ensuring the lift height of the equipment was minimized throughout the move and workers were safely positioned away from the load. Re-creation of the event and inspection of the load surface with a mirror revealed sharp edges on the load surface that was in contact with the sling when loaded.

- Following INL hoisting and rigging procedure, demonstrated by HPI core tool, procedure use and adherence, in conjunction with training, is why there were no adverse consequences.
- When load surfaces are being inspected during rigging walk-downs, the entire contact surface should be inspected for material conditions that could challenge the lifting-equipment's physical integrity. The HPI core tool self-check, using STAR, might have helped detect the sharp edges in contact with the sling.

- Glove removal to allow proper physical inspection of load surfaces would be consistent with the HPI core tool questioning attitude, to reduce a rigging task's largest potential risk of lifting-equipment failure when under load.

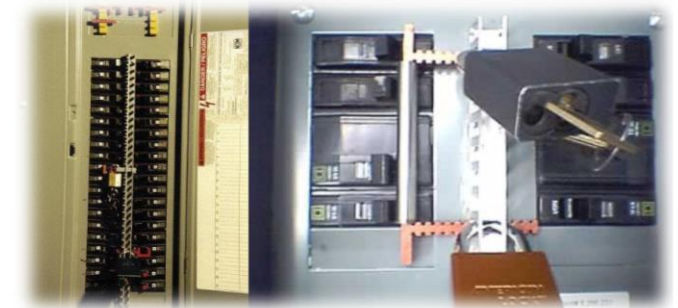
A danger tag was installed on a two-pole GFCI breaker to support work in Materials and Fuels Complex (MFC) building MFC-725 as part of a complex lockout/tagout (LO/TO). Due to the configuration of the breaker, a locking device could not be installed. This prompted the use of "tag only." Over a month later, during a pre-work walk-down, the building facility manager discovered the danger tag on the inside floor of the breaker panel. The breakers were found in their required LO/TO position of Off.

MFC personnel contacted a representative from General Electric (GE) and confirmed that, due to the configuration of these breakers, a standard GE lockout device cannot be used.

Following the event, an aftermarket PowerBloc device was identified and installed on the breaker panel. This new device prevents normal or GFCI single- or double-pole breakers from being operated. This method allows for positive control of the energy source with the use of a lock.

- Plant personnel should explore additional available options to provide supplemental means of protection for breakers that cannot be locked out using equipment on hand.
- Core HPI tools questioning attitude and take a minute may have identified the aftermarket PowerBloc device (<http://www.powerbloc.com>) that can be installed on the breaker panel to ensure positive control.
- Core HPI tool procedure use and adherence would have caused workers to look for supplemental means as stated in Laboratory Wide Procedure (LWP)-9400, "Lockouts

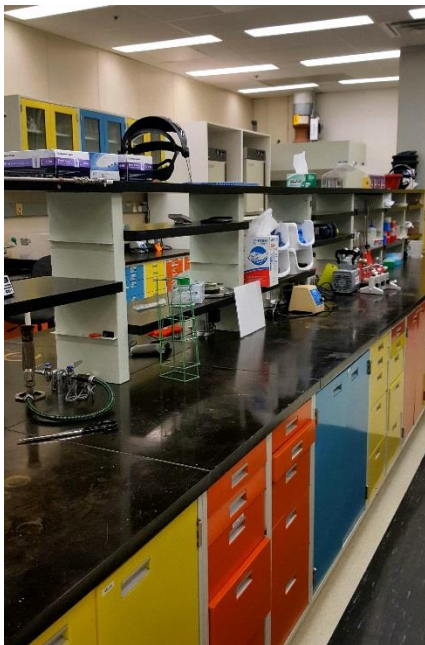
A researcher was drying a research sample inside a laboratory benchtop oven using an approved “performer-controlled activity.” The researcher left the laboratory and, after a short period, returned to witness smoke coming from the oven. The researcher informed their principal researcher (PR) about the situation. The oven was de-energized, the sash on the chemical fume hoods was opened to expedite smoke dissipation, and the laboratory was evacuated. There was no visible fire or evidence of flames. The PR consulted with a colleague about a possible fire concern. Collectively they chose a conservative approach and called 911 and management.

The Idaho Falls Fire Department responded and, upon investigation, found no fire or carbon monoxide concern. The researcher and PR were experiencing a slight irritation in their throats, so they were accompanied to INL medical for evaluation.

followed up with their colleagues who heat similar materials; no other concerns comparable were reported to have been observed. It is possible that an abnormal sample was dried or other materials were present in the oven. laboratory management will continue to monitor heating abnormalities.

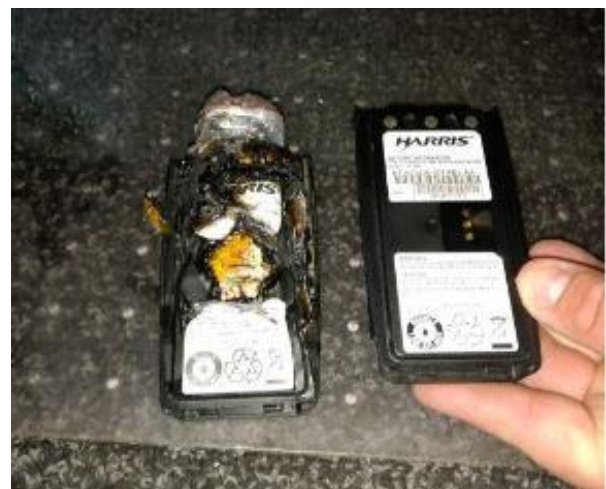
A lithium battery for a portable radio self-ejected from a battery charger and caught fire in the guard post for the Specific Manufacturing Capability (SMC) facility at INL. The security officer on duty at the post saw the battery eject from its charger and land on the floor with a small flame coming from it. The officer extinguished the flame with a bottle of water. The photo shows both the affected battery and an intact battery.

- If possible, monitor batteries as they are being charged; although battery failures are infrequent, they can come with little or no warning and could result in damage to facilities if not identified promptly.

- Other batteries may remain in the charger until needed, even when fully charged. Again, follow the manufacturer's recommendations.
- Other considerations:

- Charge batteries on a non-combustible surface and away from other combustibles
 - If a battery has been dropped or if there is any concern for physical damage, it should be removed from service

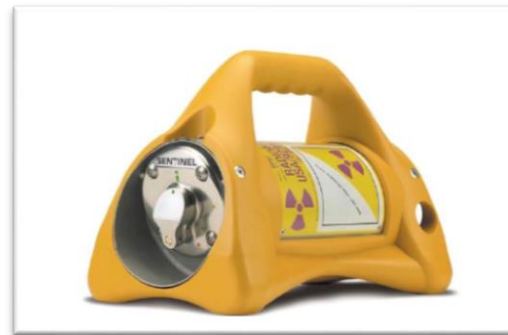
After the lock mechanism was reassembled, a functional safety test was performed on the automatic lock. During this test, the new spring failed to engage the lock with an audible click. The manufacturer instructions state “if a smooth operation is not attained and/or the lock slide can be forced into the secured position by testing for positive engagement, disassemble and thoroughly re-inspect for faulty components.”

The old spring was found to be slightly shorter than the new springs which is expected from a years' worth of use, but still engaged the lock with an audible click. The 6 springs listed as

new were all purchased at the same time during October 2017. Two shorter springs

were installed into the camera and tested during the lock challenge. After the challenge tests failed, the new springs were removed and found to be 3/32 in. shorter than the installed length.

The failure of the lock spring could result in a loss of control of a radiography source by failing to auto-lock the source in place. QSA Global, the manufacturer and supplier of the springs was notified of the problem, and new springs were shipped overnight to INL. Notifications were made to other BEA owners of QSA-Global 880 exposure cameras, Fluor Idaho Radiological Control Management, and the Department of Energy-Idaho Operations Office (DOE-ID). The radiography source is not re-installed in the 880 camera during this maintenance evolution, so no radiation exposure to involved personnel occurred.

- Operability tests are crucial to ensure equipment is functioning properly after modifications or maintenance.
- Users should be aware that even though equipment is new, it is still subject to failure.

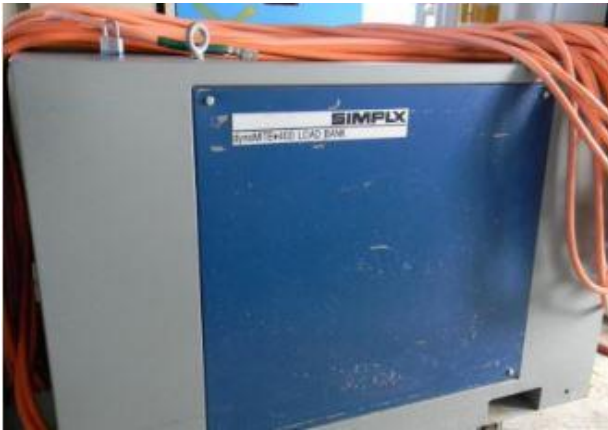
- Previous success using this and other load banks diminished any concern over heat output. The same load bank had been used in the same location, as well as other locations with no adverse results. Similar load bank equipment had been used in different locations for the same purpose with no adverse results.

- Locating the battery rundown equipment in close proximity to fire protection heads was not in accordance with manufacturer's warnings.
- Work control documentation did not contain any warning about placement of equipment near fire protection equipment.

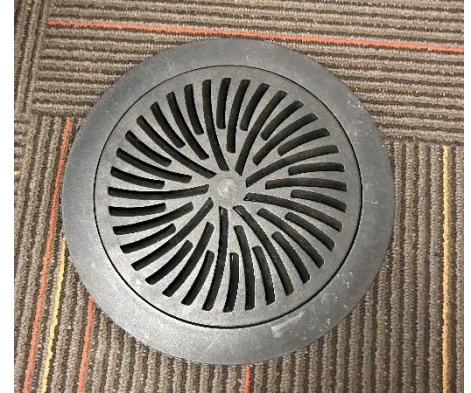
Extra rings were ordered to keep on hand, and facilities staff personnel were informed to watch for this type of issue on an ongoing basis as they vacuum or walk through the facility.

- Ensure that any floor grating, vents, or vent housings are inspected for cracks and failure.
- Wearing appropriate footwear in this case prevented injury and is important, even in office settings.

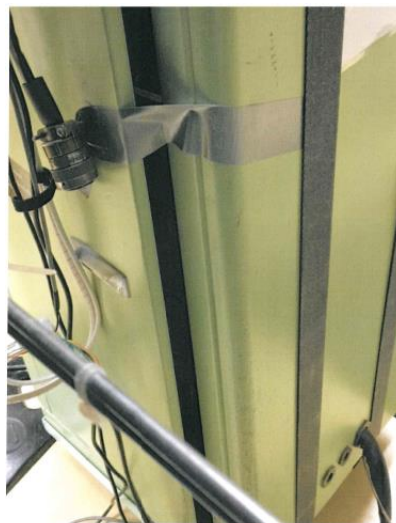
A critique of the event found that communication line installation activities performed in the spring of 2016 left the NRAD elevator control console in a modified and noncompliant condition. An extent of conditions was initiated to look for similar problems that may have occurred during the communication line installation project.

The critique found that the engineering work package was signed off as completed even though an electrical code non-compliant condition existed following work. The process engineer approved the working system with the non-compliant configuration with the understanding that

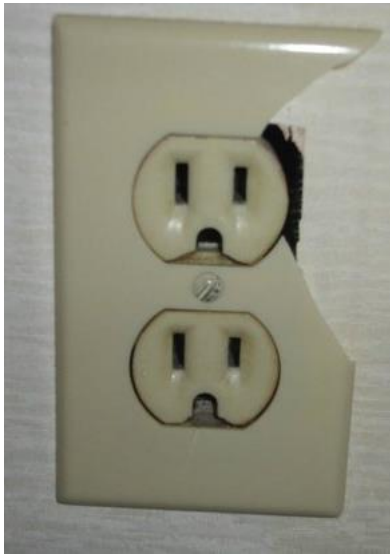
Manipulator Repair Group (MRG) personnel were working in the MRG room when one of the workers noticed the outlet

cover was broken on a 120 volt duplex receptacle and the electrical conductors were visible. The area around the damaged receptacle was barricaded to prevent entry to the area until further evaluation could be completed. Electricians evaluated the area and determined that the damaged outlet cover was not "finger safe,"

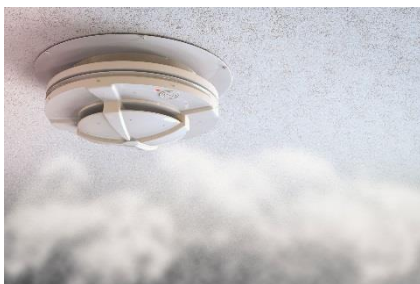
An intern in Idaho Research Center (IRC) Laboratory A5 was drying crushed magnetic material in an oven. He stepped out of the lab for a few minutes and, upon re-entry, noted a slight haze in the lab. He walked to the back of the lab where he

encountered smoke coming from the oven. The intern immediately turned off the oven and opened the sashes to the hood to remove the smoke.

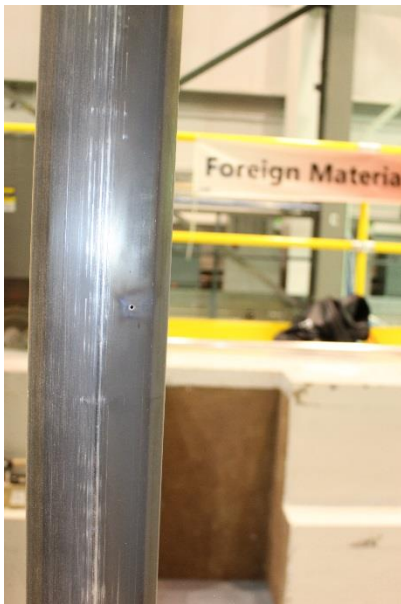
NE-ID--BEA-TREAT-2017-0001 (Report Level Low)

While moving a TREAT fuel assembly to a new core location, a visual fuel evaluation identified a small hole (~1/8 in.) in the fuel cladding. The RCT monitoring the task was directed to perform a contamination survey, which indicated contamination of 90,000 dpm/100 cm² beta-gamma. This was above RWP limits for the task, so the fuel
