Neutron Imaging of Transient Irradiated Nuclear Fuels

June 2023

Jason L Schulthess

Idaho National Laboratory Idaho Falls, Idaho 83415

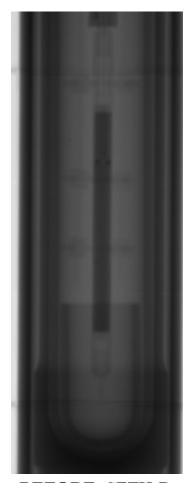
BEFORE: SETH-D neutron radiograph before transient testing

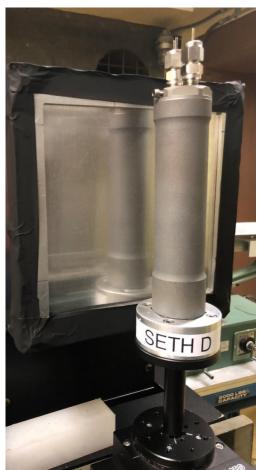
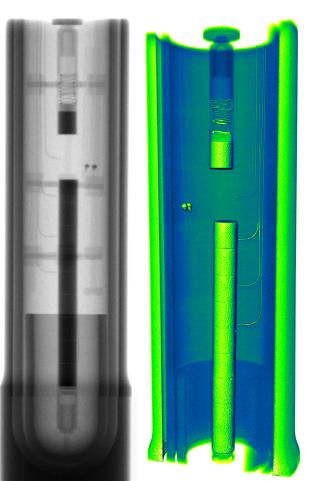
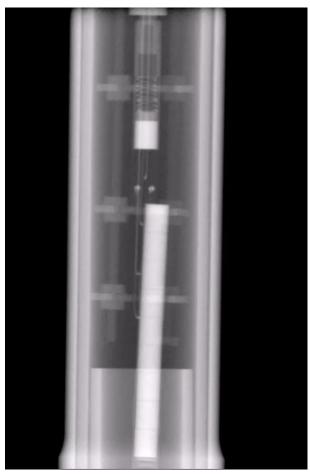
AFTER: (left) Picture of SETH-D experiment mounted in front of the nCT system, (center) example neutron radiograph, and (right) tomographic reconstruction of the SETH-D experiment capsule.

Blisters in the cladding along the length of the pin. 10

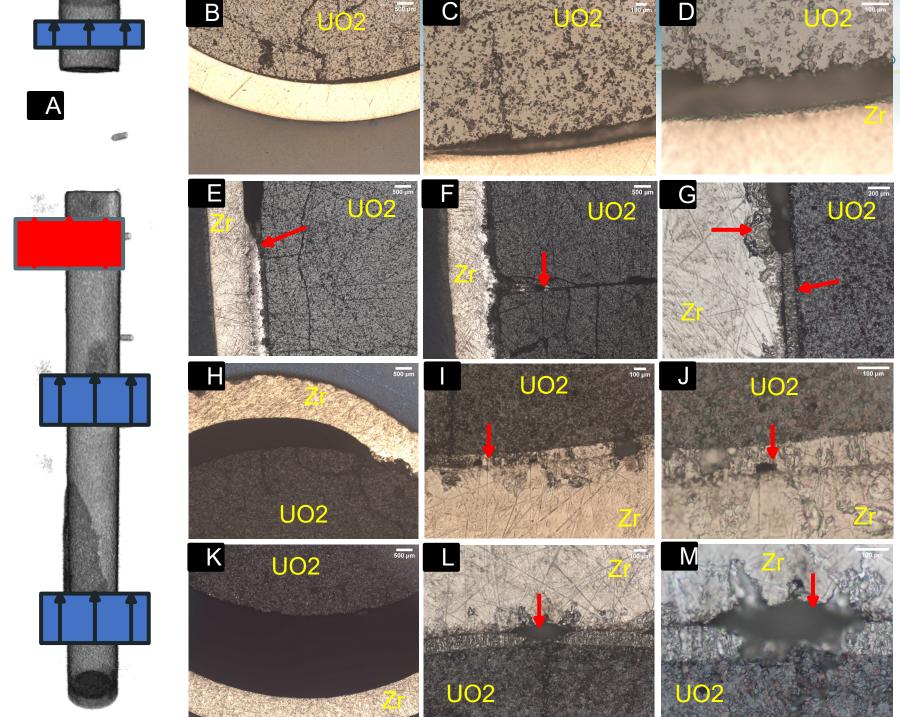
- Axial Temp profile
- No cracks in balloon regions
- Large amount of strain in balloon regions
- Previously molten cladding region
- U-Zr duplex region ~90-100 um thick (G, I, J, L, M)
- Voiding (I, J, L, M)
- Smaller voids in I and J
 - 69 um X 51 um, 60 um X 30 um,
- Medium void in I
 - 214 um X 140 um
- Large void in L and M
 - 466 um X 134 um
- Zr wicking or capillary action
- No gross clad relocation, likely not long enough above melt temp for viscous flow

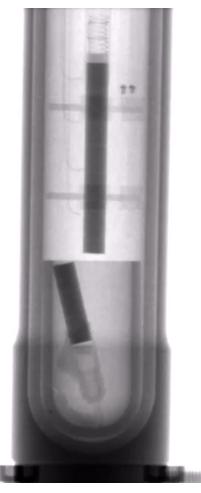
Neutron radiographs of the transient irradiated ATF SETH-E experiment.

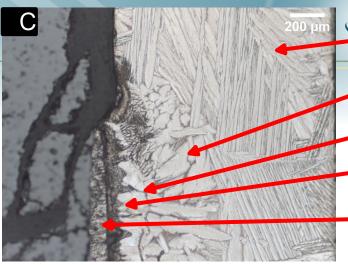
Oxygen stabilized α -Zircaloy (~280-350 um)

Melt/freeze front

Zr-rich (U, Zr) duplex reaction layer (~200-270 um)

U-rich (U, Zr) duplex reaction layer (~100-170 um)

Cladding thickness increase (~300

um) Void formation in (U, Zr) duplex reaction layer (~148 X 155 um)

Remnant (U, Zr) duplex reaction layer on to pellet surface (~134 um)

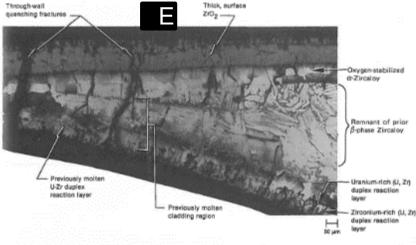
Fig. 12 Cladding cross section at the 0.354-m elevation showing partial wall melting during test RIA-ST-1 (peak enthalpy deposition of 250 callg $\rm UO_2$).

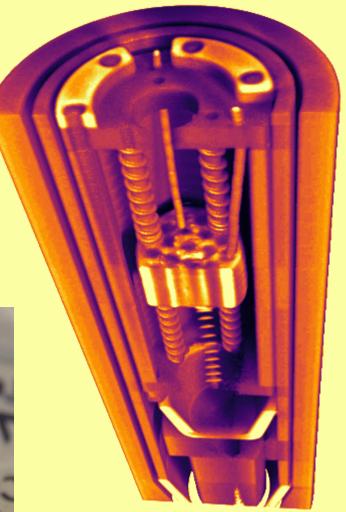
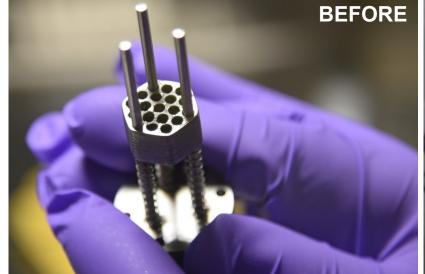
- SIRIUS-1 capsule irradiated at TREAT and nCT performed at the NRAD Reactor.
 Reconstruction revealed a crack in the
- Reconstruction revealed a crack in the fuel and distortion of the fuel's surface.
- Detection of a crack months before the capsule was opened allows M&S time to evaluate failure mechanisms.

(Left) A 3D rendering of the SIRIUS-1 capsule. (Top Right) A reconstructed slice of the SIRIUS-1 capsule showing cracking in the fuel. (Bottom Right) A 3D rendering of the fuel region with the crack emphasized in red.

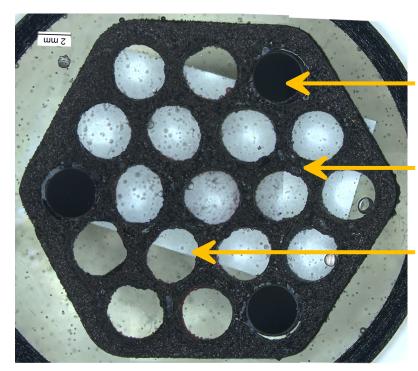
Tungsten rod

from holder.

Porosity

Coolant channel distortion.

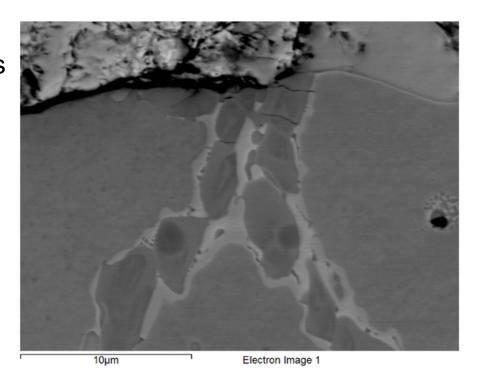
- Diffusion zones identified near interfaces between fuel particles and matrix
- Microcracking observed in the matrix, very near the fuel particle

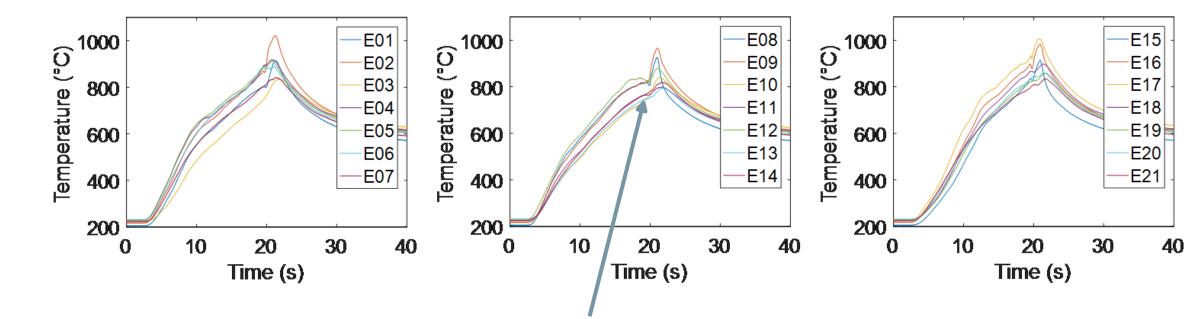
Indicates significant disruption to heat flow – potential rupture and fuel dispersal...
