Advanced Test Reactor Sub-Core Internals Inspection Report

Idaho National Laboratory

INL/EXT-05-01055

March 2006

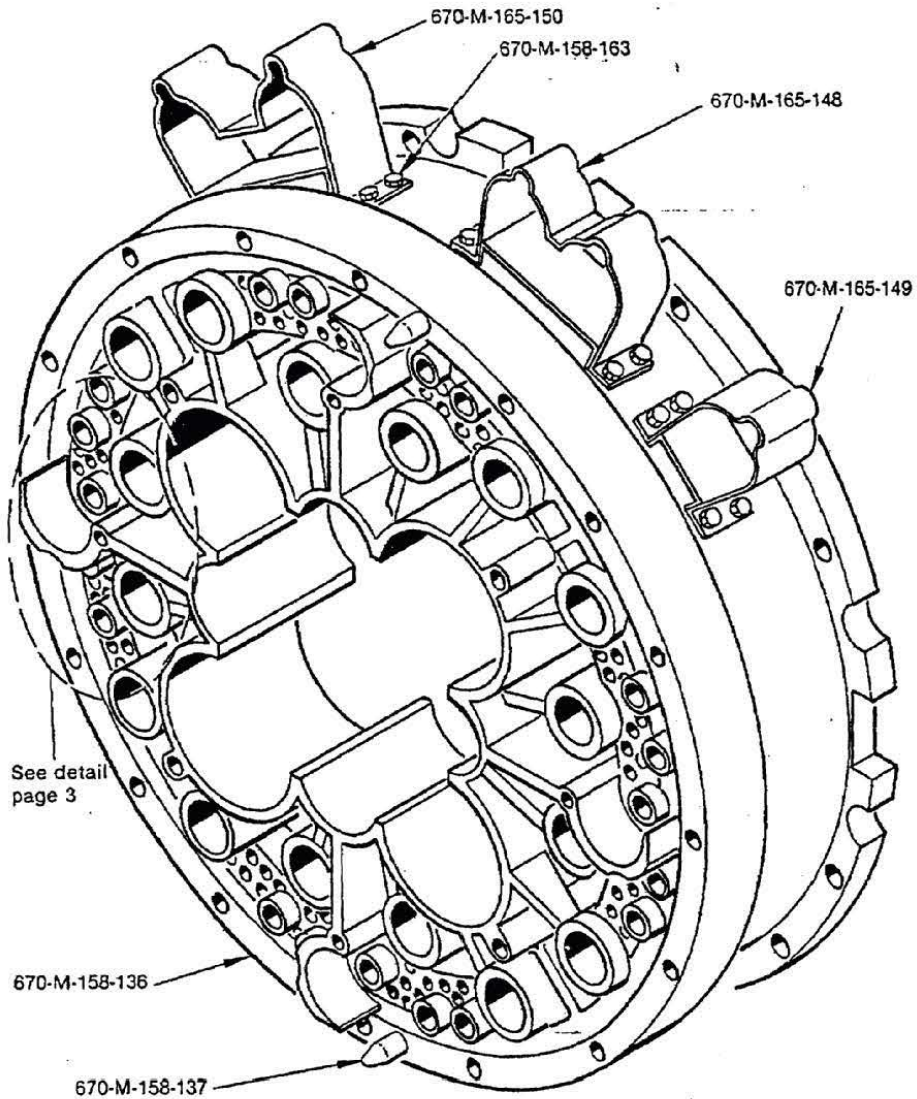
Figure A-8. Reflector support tank assembly 670-M-158-135.

The reflector support tank was observed to have indications of localized corrosion or surface anomalies. An ICARE was submitted to have the reflector support tank video reviewed by a material/corrosion specialist to determine what action, if any, should be taken. A metallurgist concluded that this corrosion was galvanic in nature and was creating the conditions for pitting (ICARE 39268). ATR Operations and Engineering reviewed and accepted, in DOP-7.10.72, this condition for continued operations without restriction. Inspection criteria should be developed to evaluate the condition of the reflector support tank in subsequent sub-core internals inspections to get a better understanding of the corrosion mechanism.

The only action recommended to be taken for any of the components inspected via the ATR Sub-Core Internals Inspection concerned the reflector support tank, which was observed to have “substantial” signs of corrosion. An ICARE was submitted to have the reflector support tank video reviewed by a material/corrosion specialist to determine what action, if any, should be taken. A metallurgist concluded that this corrosion was galvanic in nature and was creating the conditions for pitting (ICARE 39268). ATR Operations and Engineering reviewed and accepted, in DOP-7.10.72, this condition for continued operations without restriction. Therefore, inspection criteria should be developed to evaluate the condition of the reflector support tank in subsequent sub-core internals inspections to get a better understanding of the corrosion mechanism.
