# **AFCI Glovebox Radiological Release – Evaluation, Corrective Actions and Testing**

INL/EXT-15-36996  
Revision 0

December 2015

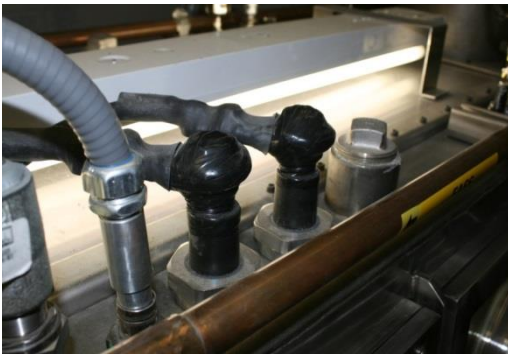
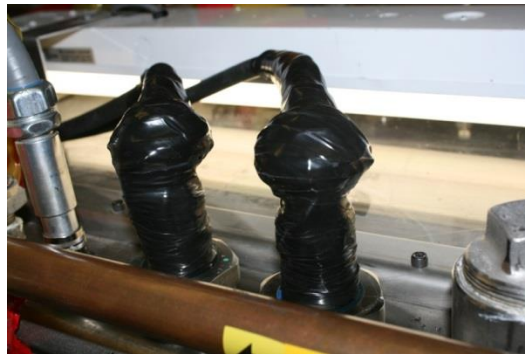
Figure 9. Welding Lead Feedthroughs for Arc Melter (Top of Compartment A).

During the glovebox component testing, air sampling around the welding lead feedthroughs identified potential leaks. Delayed count air filter surveys using the iSolo for the bagged welding lead feedthroughs were recorded up to 1472.3 dpm alpha and 65.2 dpm beta.

- Welding Lead Feedthroughs - Air sampling of the bagged welding lead feedthroughs identified contamination during arc melting
- Oxygen Analyzer System – Helium leak testing identified several components
- Primary Pressure Control Filter Housing – Helium leak testing identified a fitting

After Test #1, the two welding lead feedthroughs were replaced. (They were installed several years prior.) At the same time, a thermocouple feedthrough for the americium distillation furnace was also replaced for other reasons.

<b>Arc Melting System</b>			
Welding lead feedthroughs	5/21/2015 (identified from arc melt test #1)	Feedthroughs were replaced	7/28/2015

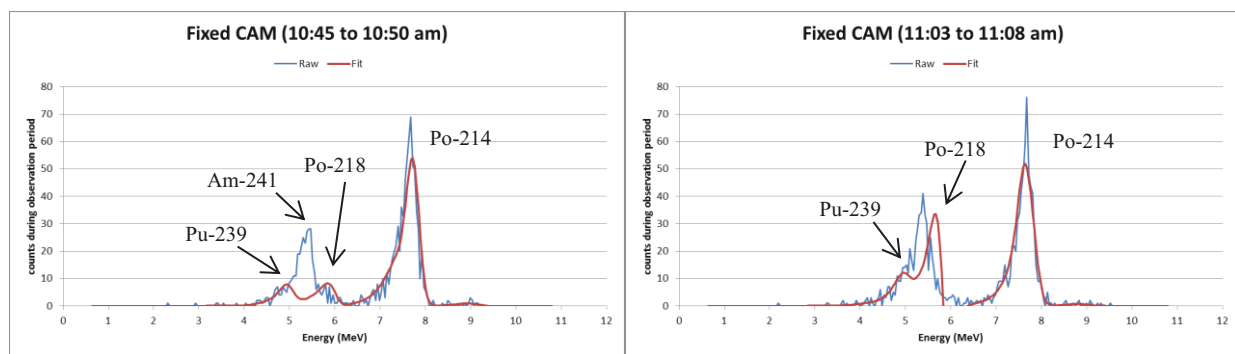
The largest contributor to the poor CAM performance was the release characteristics being dominated by Am-241 and not having Am-241 selected as an isotope of interest (i.e., those quantified by the CAM which are used to trigger to alarm). This had the following effects on the overall performance.

- In some instances, Am-241 was treated as the radon progeny Po-218 (background) by the CAM algorithm. This was a non-conservative response. The algorithm “shifted” the curve fit causing the CAM to no longer function properly (illustrated in Figure 11).
- In some instances, the “tail” of the Am-241 peak was treated as Pu-239 by the CAM algorithm and caused a concentration alarm after the suspected releases. This was the expected (conservative) response.
- In some instances, the CAM responded with a “poor fit” alarm after the suspected releases subsided.

Figure 11. CAM algorithm shifting the Po-218 peak fit to Am-241 on 8-27-14.

Details about how the peak curve fitting algorithm occurs are proprietary so its limitations were unknown prior to the event. Had Am-241 been selected as an isotope of interest, the CAM would have alarmed sooner after the onset of the release, not resulted in poor fit conditions, and better quantified the magnitude of the release.

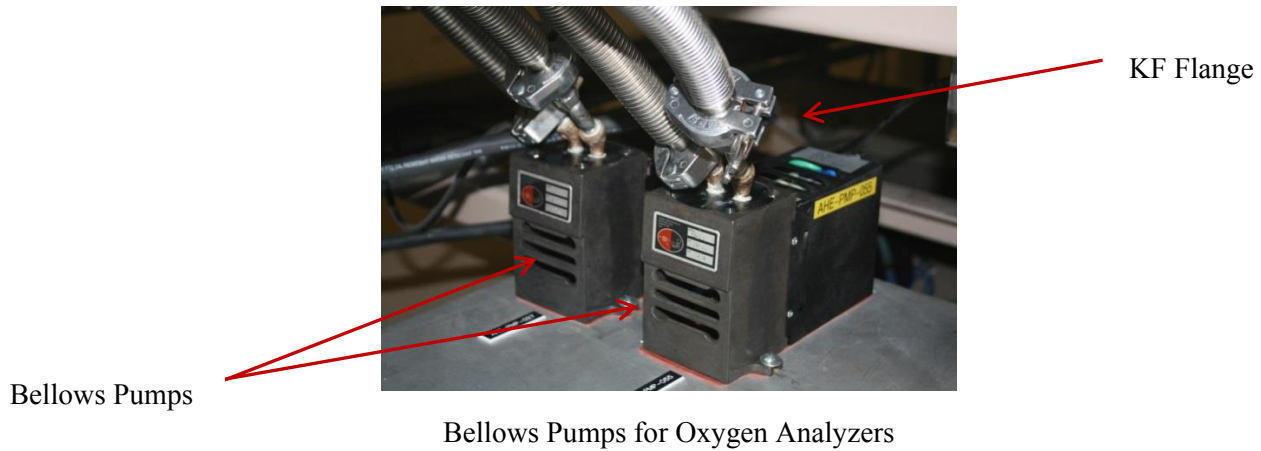
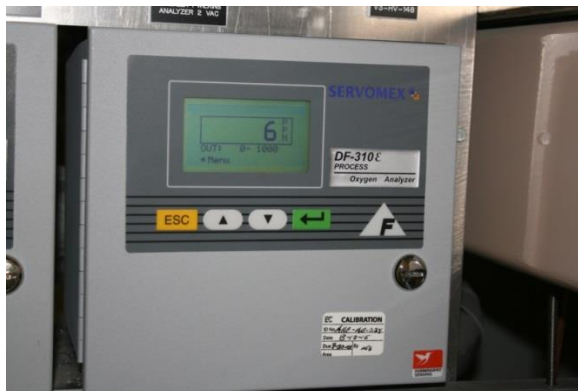
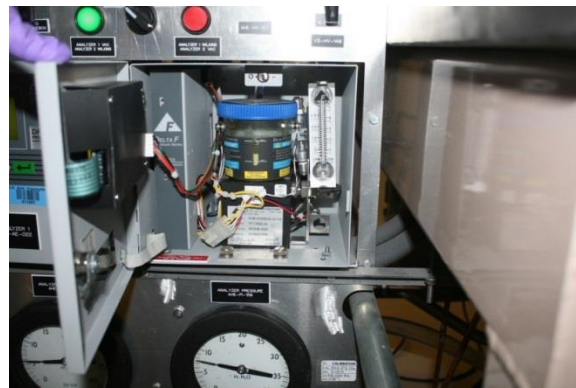
Oxygen Analyzer (AHe-AE-034) – front view with panel closed and open

Component with Leak	Date Leak Identified	Description of Repair or Replacement	Date Successfully Helium Leak Tested
<b>Oxygen Analyzers (Integrated Gas Analyzer System)</b>			
Bellows pump (AHe-PMP-055) for oxygen analyzer (AHe-AE-034)	7/28/2015	Bellow pumps (AHe-PMP-055 and AHe-PMP-027) for both oxygen analyzers were replaced	8/17/2015 & 8/24/2015
KF flange on exhaust line for bellow pump (AHe-PMP-055)	7/28/2015	O-rings were replaced on the KF flange.	8/17/2015 & 8/24/2015
Lower intake fitting on the oxygen analyzer (AHe-AE-034) cabinet	7/28/2015	Fitting was tightened.	8/17/2015 & 8/24/2015
Fitting on exhaust line on oxygen analyzer (AHe-AE-034)	8/17/2015	Fitting was tightened.	8/24/2015
Fitting on eight way valve (AHe-MV-001)	8/17/2015	Fitting was repaired/tightened.	8/24/2015
<b>Primary Pressure Control System</b>			
Filter housing in pressure control cabinet	7/28/2015	Bolts were tightened.	8/17/2015 & 8/24/2015

The oxygen analyzer system appears to be the main source of leaks based on the results of both the glovebox component testing and the helium leak testing. The path for the gas sample is from the glovebox through a filter located inside the glovebox, eight-way valve, sample pump, oxygen analyzer, eight-way valve, and either through a filter located outside the glovebox leading back into the glovebox or to suspect exhaust. In the AFCI glovebox design description<sup>8</sup>, it was noted that “there are filters at the boundary of the gloveboxes to limit the migration of powders out of the glovebox.” It is suspected that a portion of volatilized Am-241 from the arc melting process was released into the glovebox and passed through the filter into the gas analyzer system. This could be due to either a failed 0.2 micron filter or due to the ability of the volatilized Am-241 to permeate the filter. This is discussed further in section 7.3.

The immediate corrective actions were to replace the welding lead feedthroughs, repair or replace leaking oxygen analyzer system components, tighten the fitting on the primary pressure control filter housing, and replace all 0.2 micron filters. After the repairs, helium leak testing of the AFCI glovebox (including associated systems) indicated no leaks in excess of  $1.0 \times 10^{-5}$  standard cc/sec.

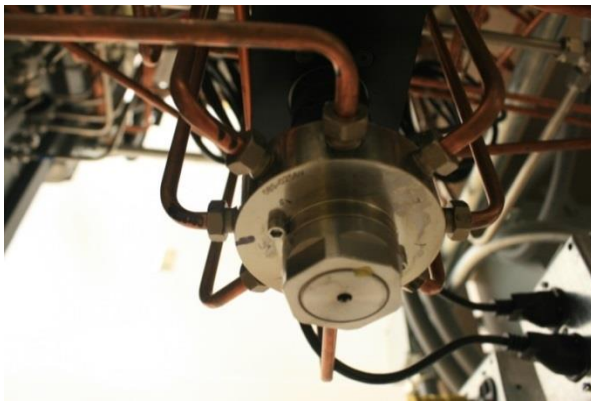
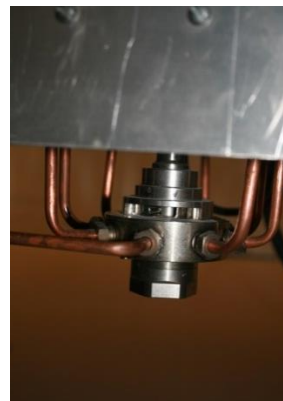
8-Way Valve for Oxygen Analyzer System

A third leak test of the AFCI glovebox (oxygen analyzer, sample pump piping, feedthroughs, and HEPA filter housing) was performed on August 24, 2015 with no further leaks detected. Prior to the test, a smear on the eight way valve showed 43 dpm/100 cm<sup>2</sup> and was decontaminated to less than LRD-15001 Table 2-2 limits.
