3D Reconstruction of M11A2 from the SELENIUM Experiment

B. D. Miller, M. Abir, A. Aitkaliyeva,
A. Leenaers, B. J. Hernandez,
W. Van Renterghem, S. Van den Berghe,
A. Winston, D. D. Keiser, Jr.

January 2017

**Idaho National Laboratory
Idaho Falls, Idaho 83415**

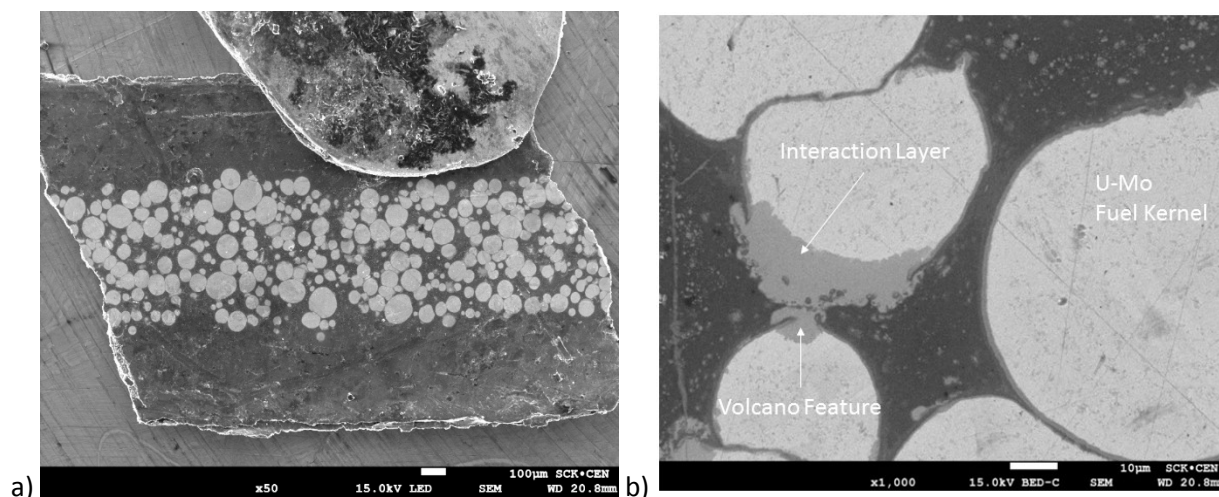
Figure 3: SEM micrographs of M11A2.

Basics SEM characterization of M11A2 was provided to the INL from SCK-CEN personnel to assist in the preparation of TEM and FIB samples. Figure 3 shows two SEM micrographs of sample M11A2. In Figure 3b), the target volcano feature can be seen in the bottom left fuel kernel. Additional SEM characterization of the SELENIUM fuel plates can be seen in (2).

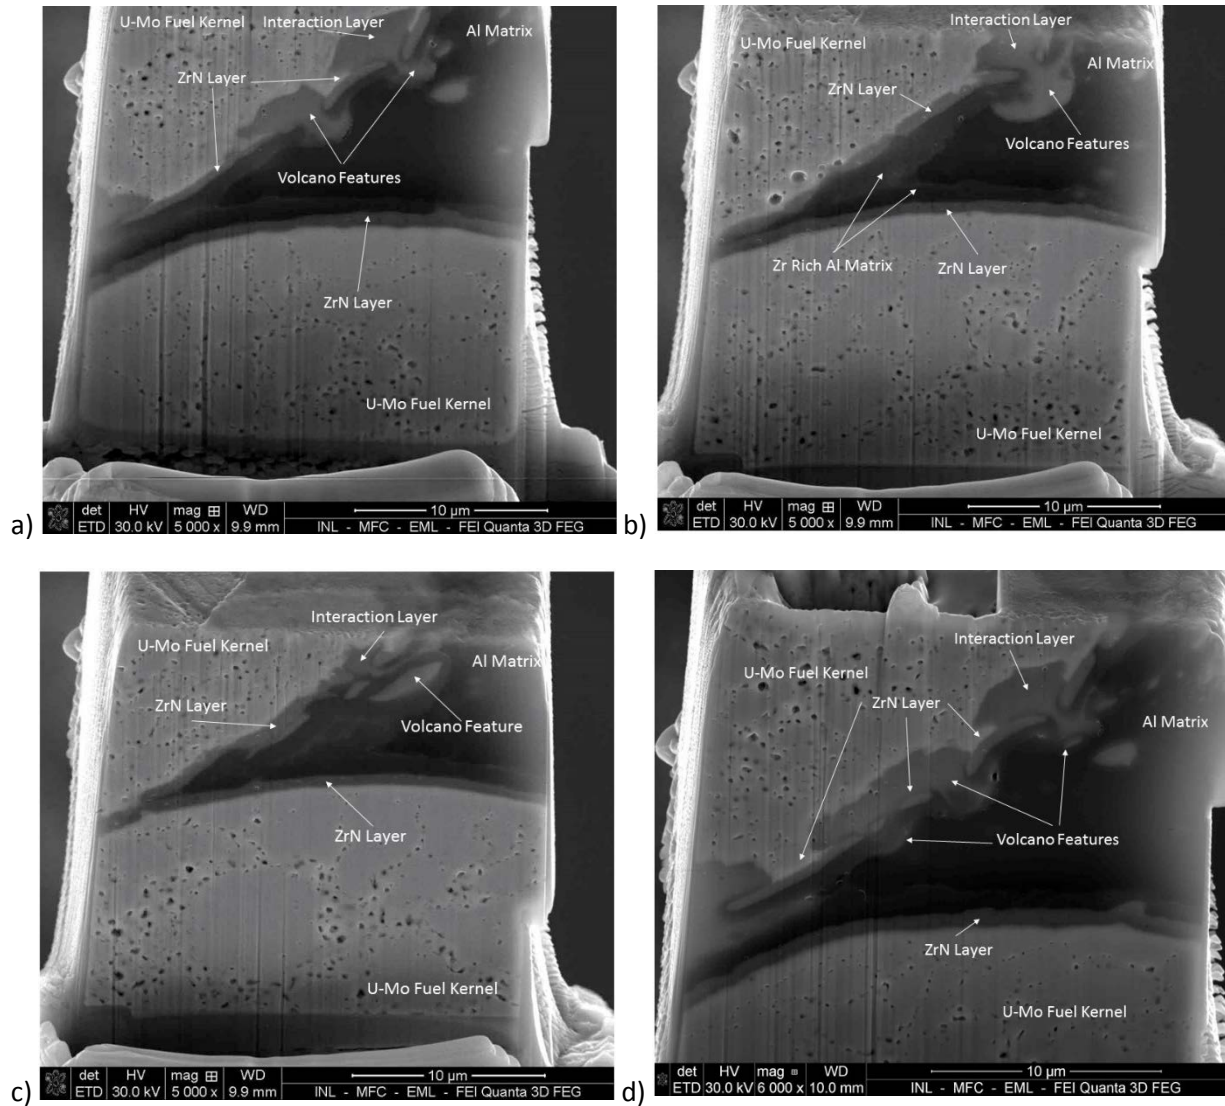
Figure 6: SEM micrographs showing various FIB slices of the 1st cube of M11A2.

The general microstructure of the fuel region is as expected with fission gas bubbles decorating the residual fuel grains. As seen in the bottom fuel kernel in Figure 6c), the ZrN layer around the bottom fuel kernel is preventing the Al matrix from interacting with the U-Mo fuel. When the ZrN layer has failed, as in the volcano feature areas, traditional interaction layer is formed. This layer can be present on the fuel side of the ZrN layer. Additionally, U and Mo appear to diffuse out of the U-Mo fuel kernel at the ZrN breach and form the “volcano” features seen in Figure 6. There is a light halo region towards the Al matrix on the outside of the ZrN layer. This is shown as the Zr rich Al matrix in Figure 6b). This area is Zr rich nano crystalline Al. This has been confirmed in TEM results seen in (3). This layer was likely the original ZrN layer that has decomposed with increasing burnup likely due to the Al that has mixed with the ZrN layer in this region and formed the Zr rich Al matrix layer.

Another variable in the failure of the ZrN coating is the burnup that the fuel has undergone. As seen in Figure 6b), there is a Zr rich Al matrix region that has formed on the outside of the ZrN layer towards the Al matrix. This layer seems to be effected by the fission density in the material. Characterization of the fresh fuel does not show this layer forming with only the ZrN layer present in a thickness of $\sim 1 \mu\text{m}$ (4). The thickness of the Al-Zr rich region and the ZrN layer is approximetly the same size as the original ZrN layer thickness.

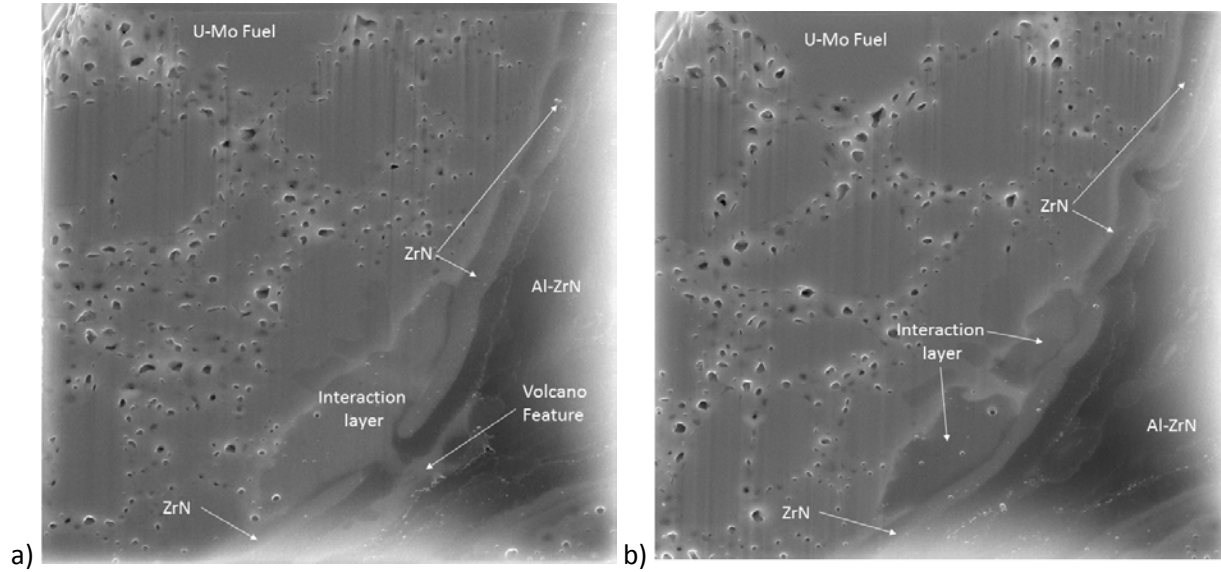
Figure 7: SEM micrographs showing various FIB slices of the 2nd cube of M11A2.

shows various SEM micrographs of the sectioning of second cube of M11A2. As seen in the images, only one volcano feature was seen in this sectioning. This data set does still provide useful data on the behavior of the ZrN layer.

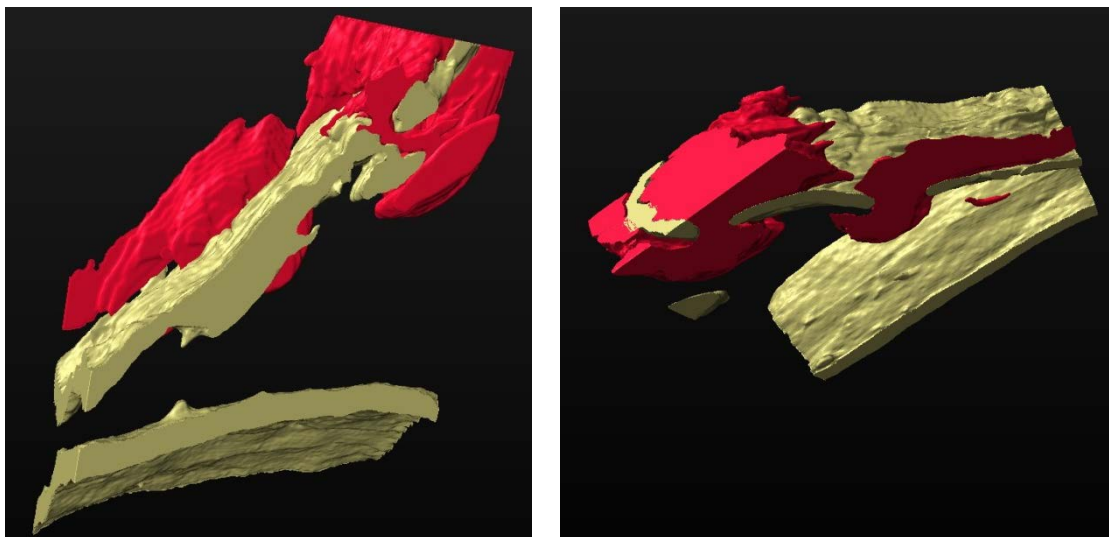
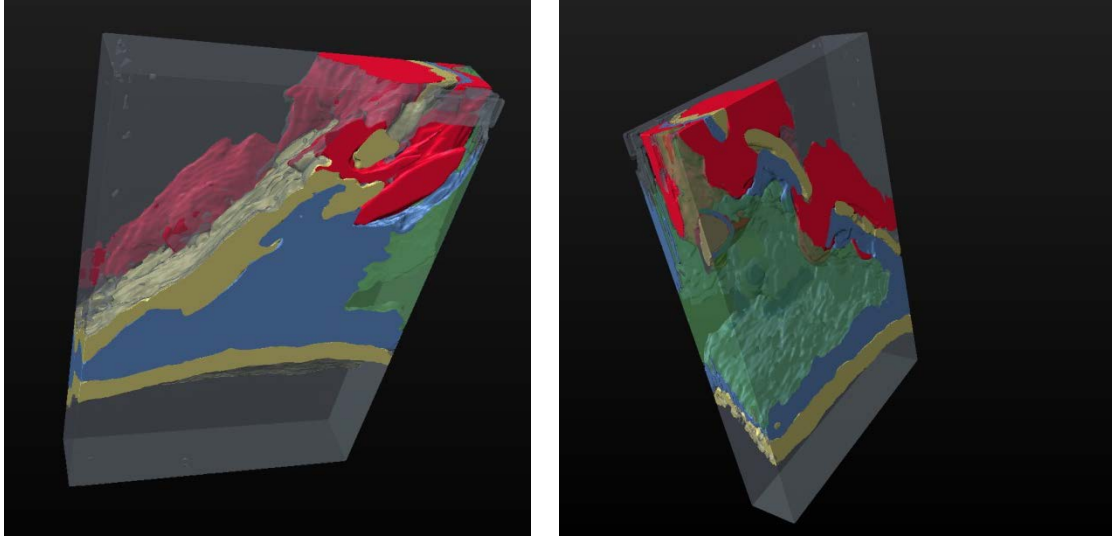
Figure 9: 3D reconstructions of the FIB/SEM images from the first cube showing the interaction layer (red), the ZrN layer (gold), Al-ZrN layer (blue), and Al matrix (green).

Figure 9 shows results of 3D reconstruction of the 1st cube (200 nm slices). Cracks in the ZrN layer can be easily noticed in the images, providing the pathway for diffusion of U, Mo, and Al and creating the traditional interaction layer that forms in U-Mo/Al matrix fuels. What is interesting is the ZrN layer that shows no cracking or interaction layer formation. The layer shows relatively constant thickness throughout with a few peaks throughout where extra deposition occurred. This indicates that the deposition process is fairly constant and the ZrN's irradiation performance appears to be stable, though cracks do appear to fail in various locations, causing the “volcano feature”.

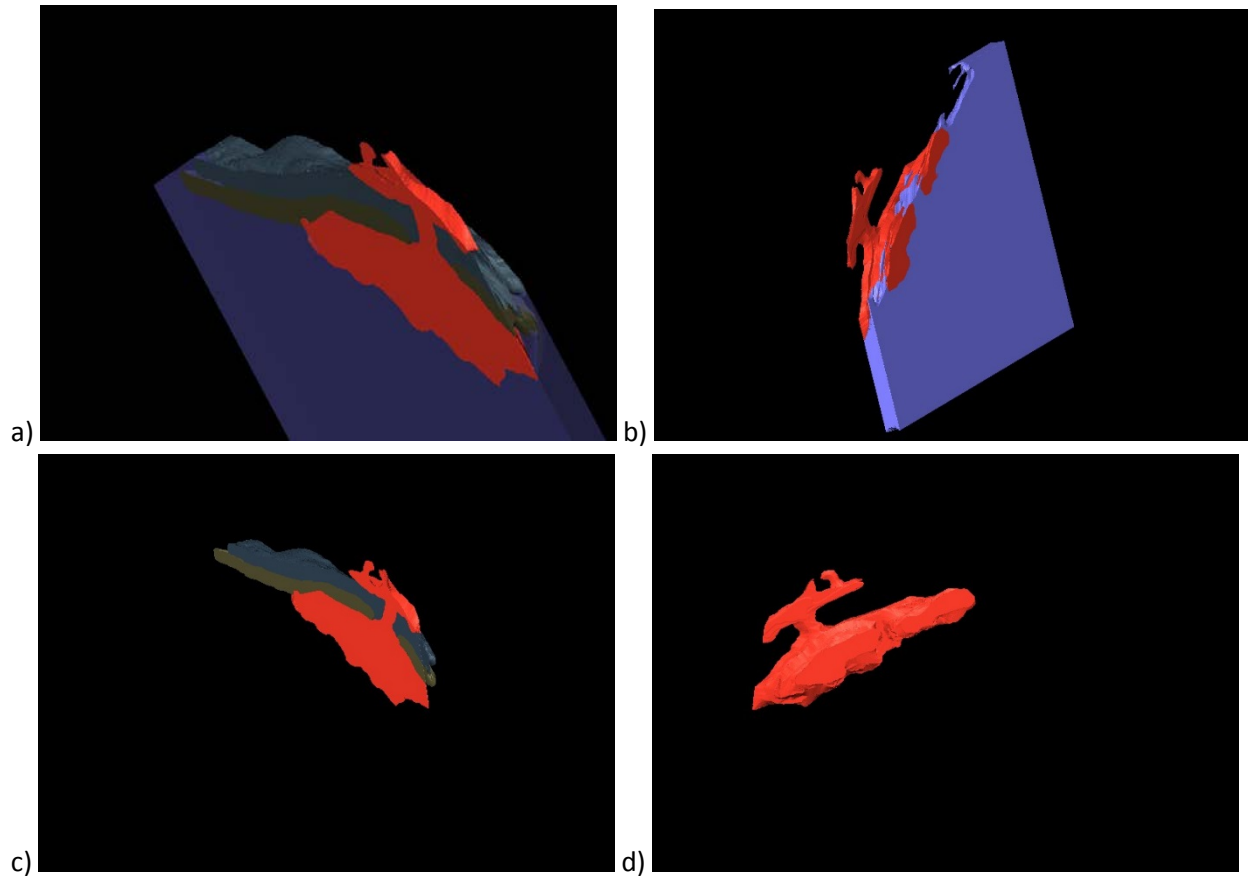
Figure 10: 3D reconstructions of the FIB/SEM images from the 2nd cube showing the interaction layer (red), ZrN (gold), Al-ZrN layer (grey), and U-Mo (blue)

Figure 10 shows 3D reconstructions of the 2nd cube. Though less volcano features are seen in this reconstruction, the one present in this reconstruction shows clearly the formation of the volcano feature on the Al side of the crack in the ZrN. On the fuel side of the crack, the interaction layer diffuses away from the crack in all directions, even if there is intact ZrN present between the fuel and Al matrix. With this diffusion of the interaction layer away from the crack in the fuel side, interpretation of SEM data that showed interaction layer growth but no cracks is solved. It is likely that a crack is present below or above the plane that the SEM characterization was being performed.
