CHARACTERIZATION OF EPICOR II PREFILTER LINER 3

Nancy L. Wynhoff V. Pasupathi

Published April 1983

Battelle Columbus Laboratories 505 King Avenue Columbus, Ohio 43201

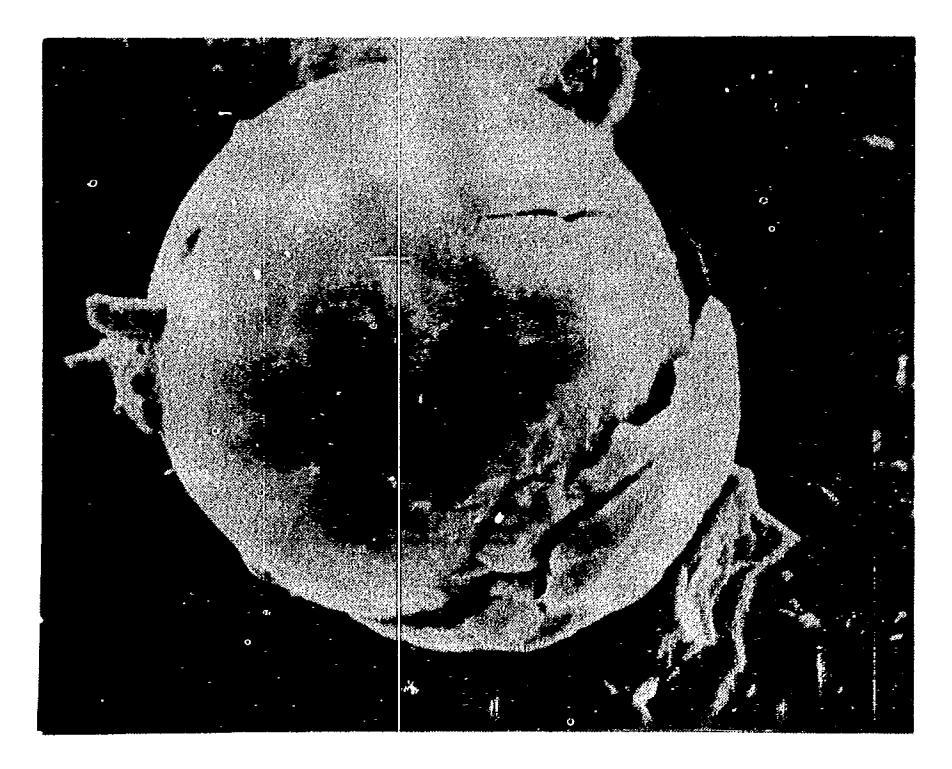
The particles in this region (the lower 16" of the media bed) were all spherical in nature. Many of the particles were fragmented and on all intact particles surface defects were observed. Figure 20 shows the typical distribution of intact particles and particle fragments in this region of the media core sample. Figures 21 through 24 show examples of surface defects and fragmented media particles. EDAX analysis was performed on several particles

Figure 21. SEM photomicrograph detailing fractured media particle, Bottom Region, 0-4" segment, 150X.

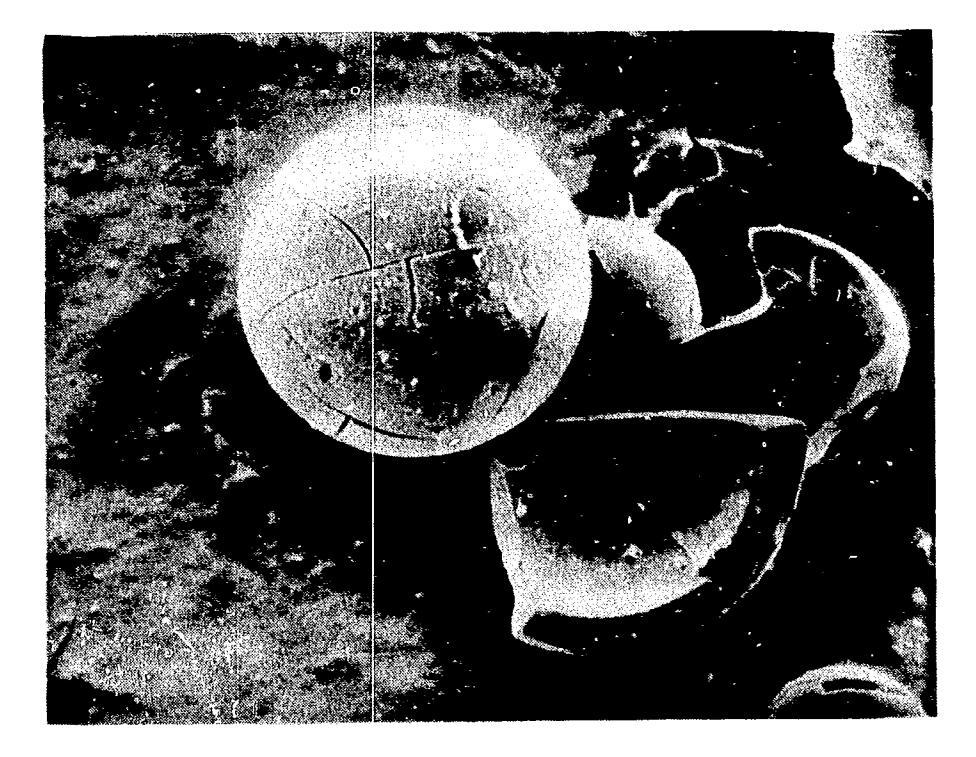
Figure 22. SEM photomicrograph detailing surface defects in media particle, Bottom Region, 4-8" seg,emt. 70X.

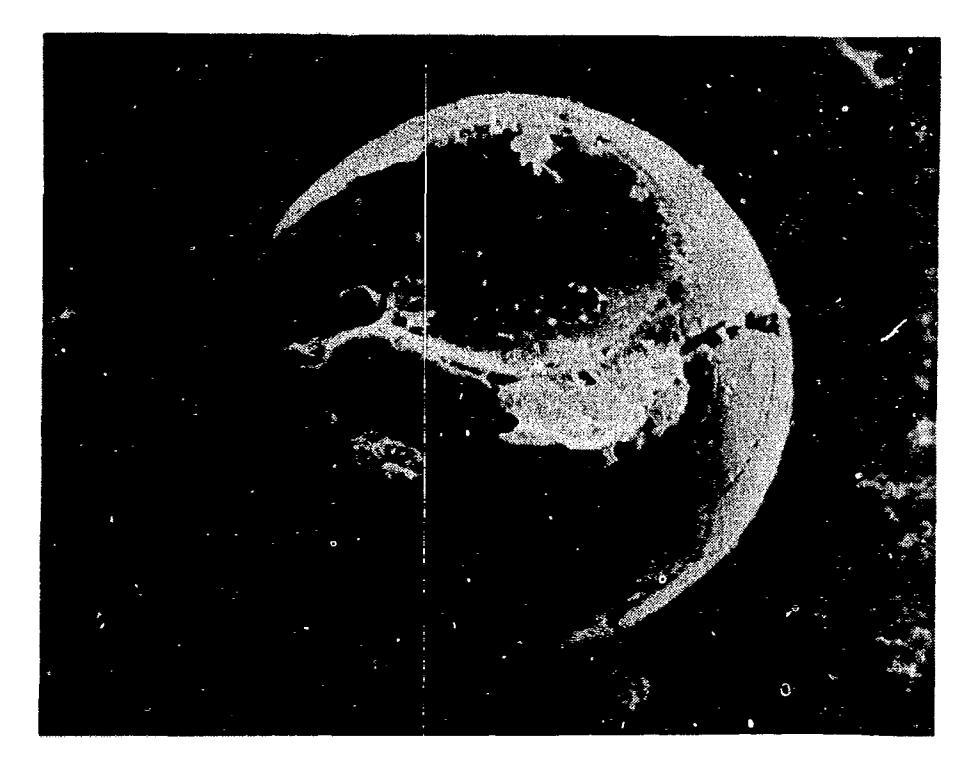
Figure 24. SEM photomicrograph detailing surface defects in media particle, Bottom Region, 12-16" segment, 100X. (White deposits on the media particle are silver mounting material.)

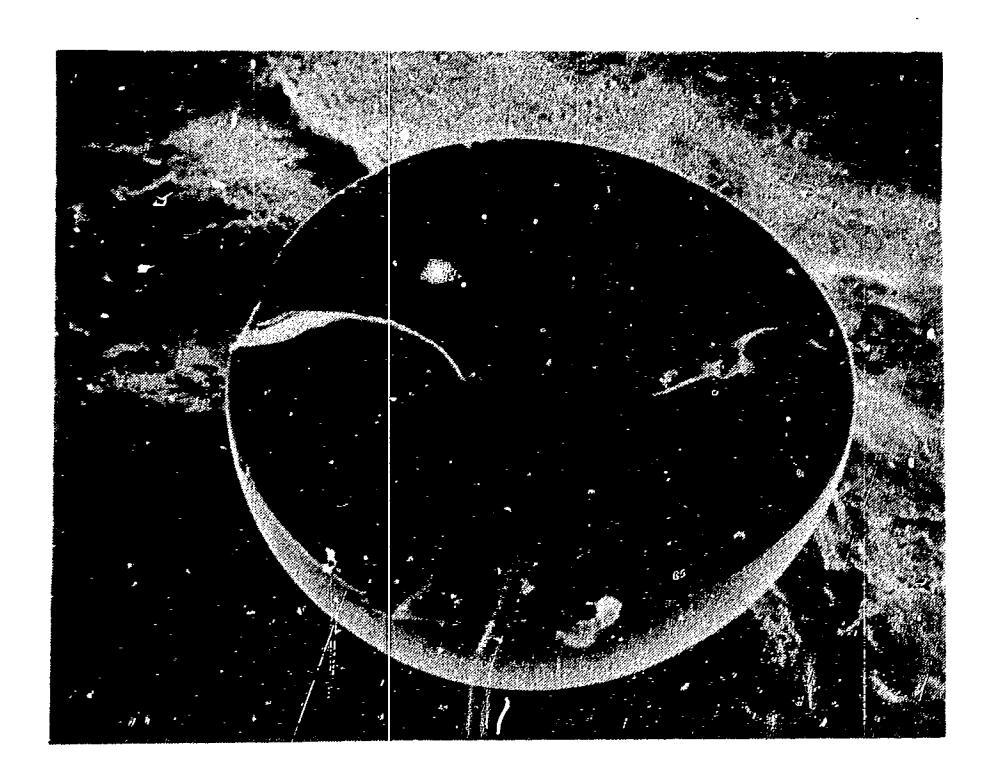
Figure 32. SEM photomicrograph detailing surface of fragmented particle, Top Region, 20-22" segment, 100X.
