Quick Look Inspection: Report on the Insertion of a Camera into the TMI-2 Reactor Vessel through a Leadscrew Opening Volume I

March 1983

QUICK LOOK INSPECTION: REPORT ON THE INSERTION OF A CAMERA INTO THE TMI-2 REACTOR VESSEL THROUGH A LEADSCREW OPENING, VOLUME I

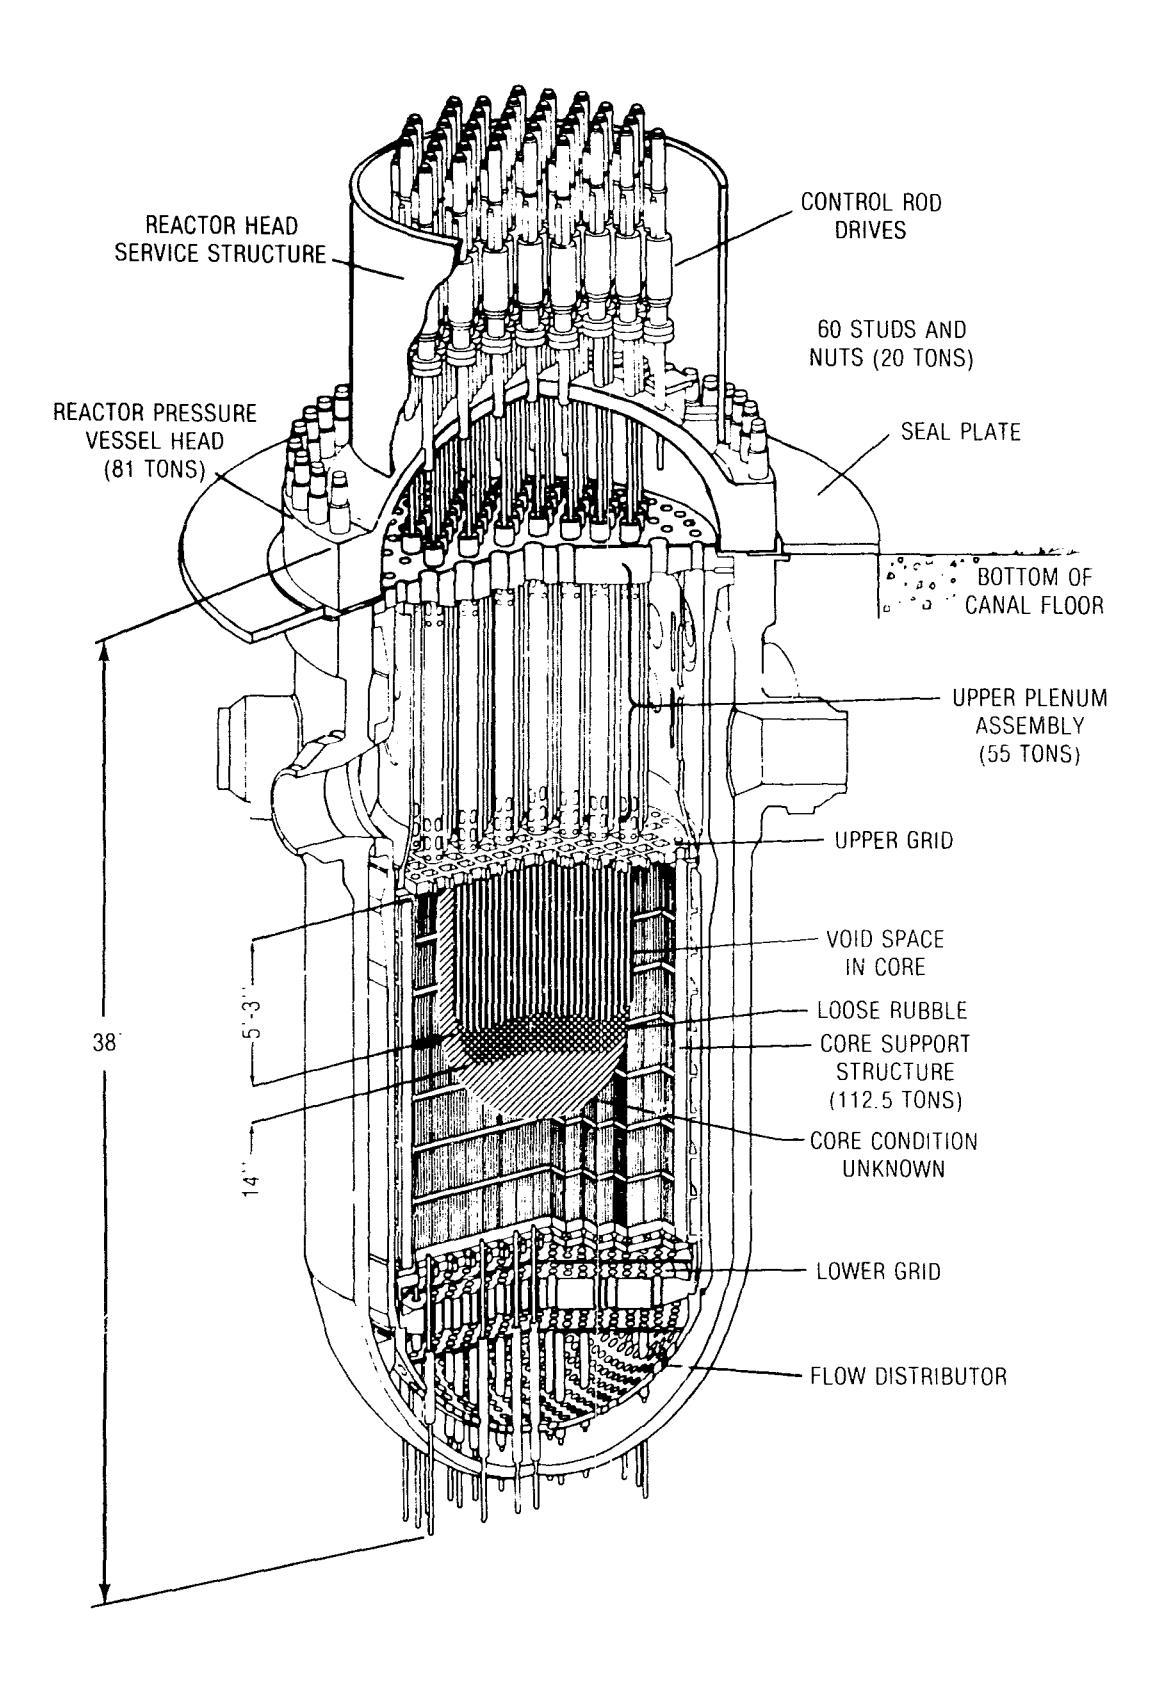
Postulated core damage is shown, which is based on camera inspections and core probes in locations 8H and 9E.

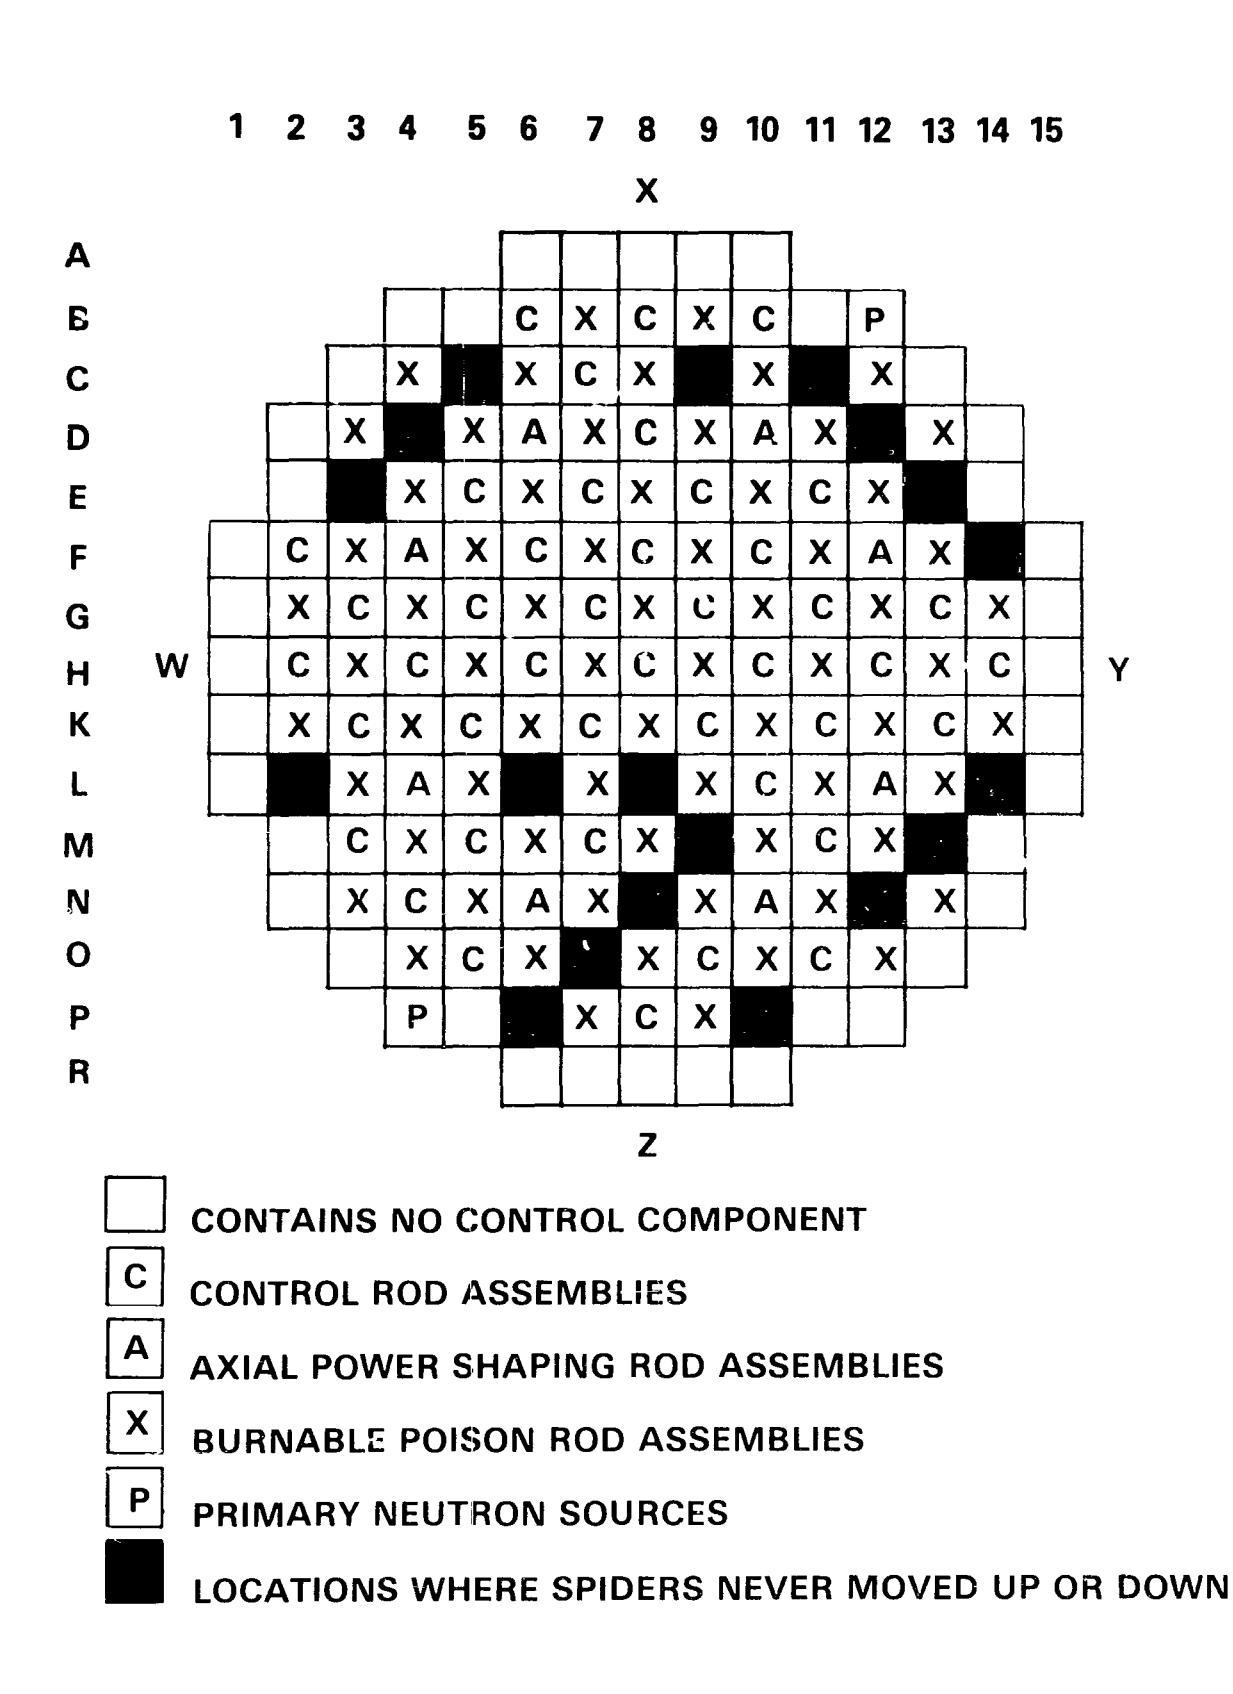
Figure 3-10. Locations where the control rod spiders never moved up or down.

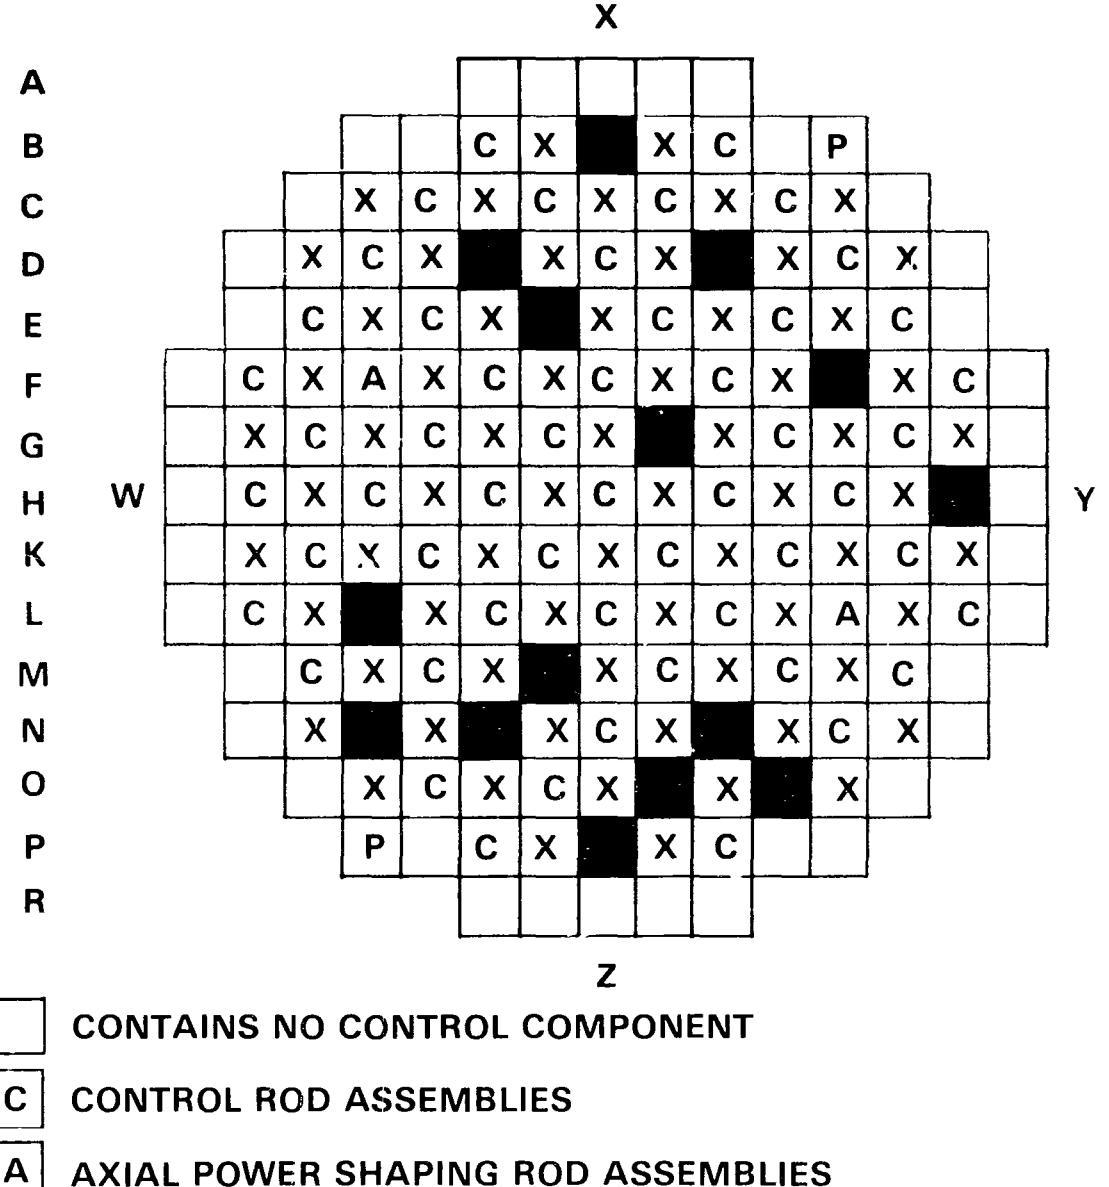
Figure 3-12. Locations where the spiders moved up when lifted, but did not move down after uncoupling.

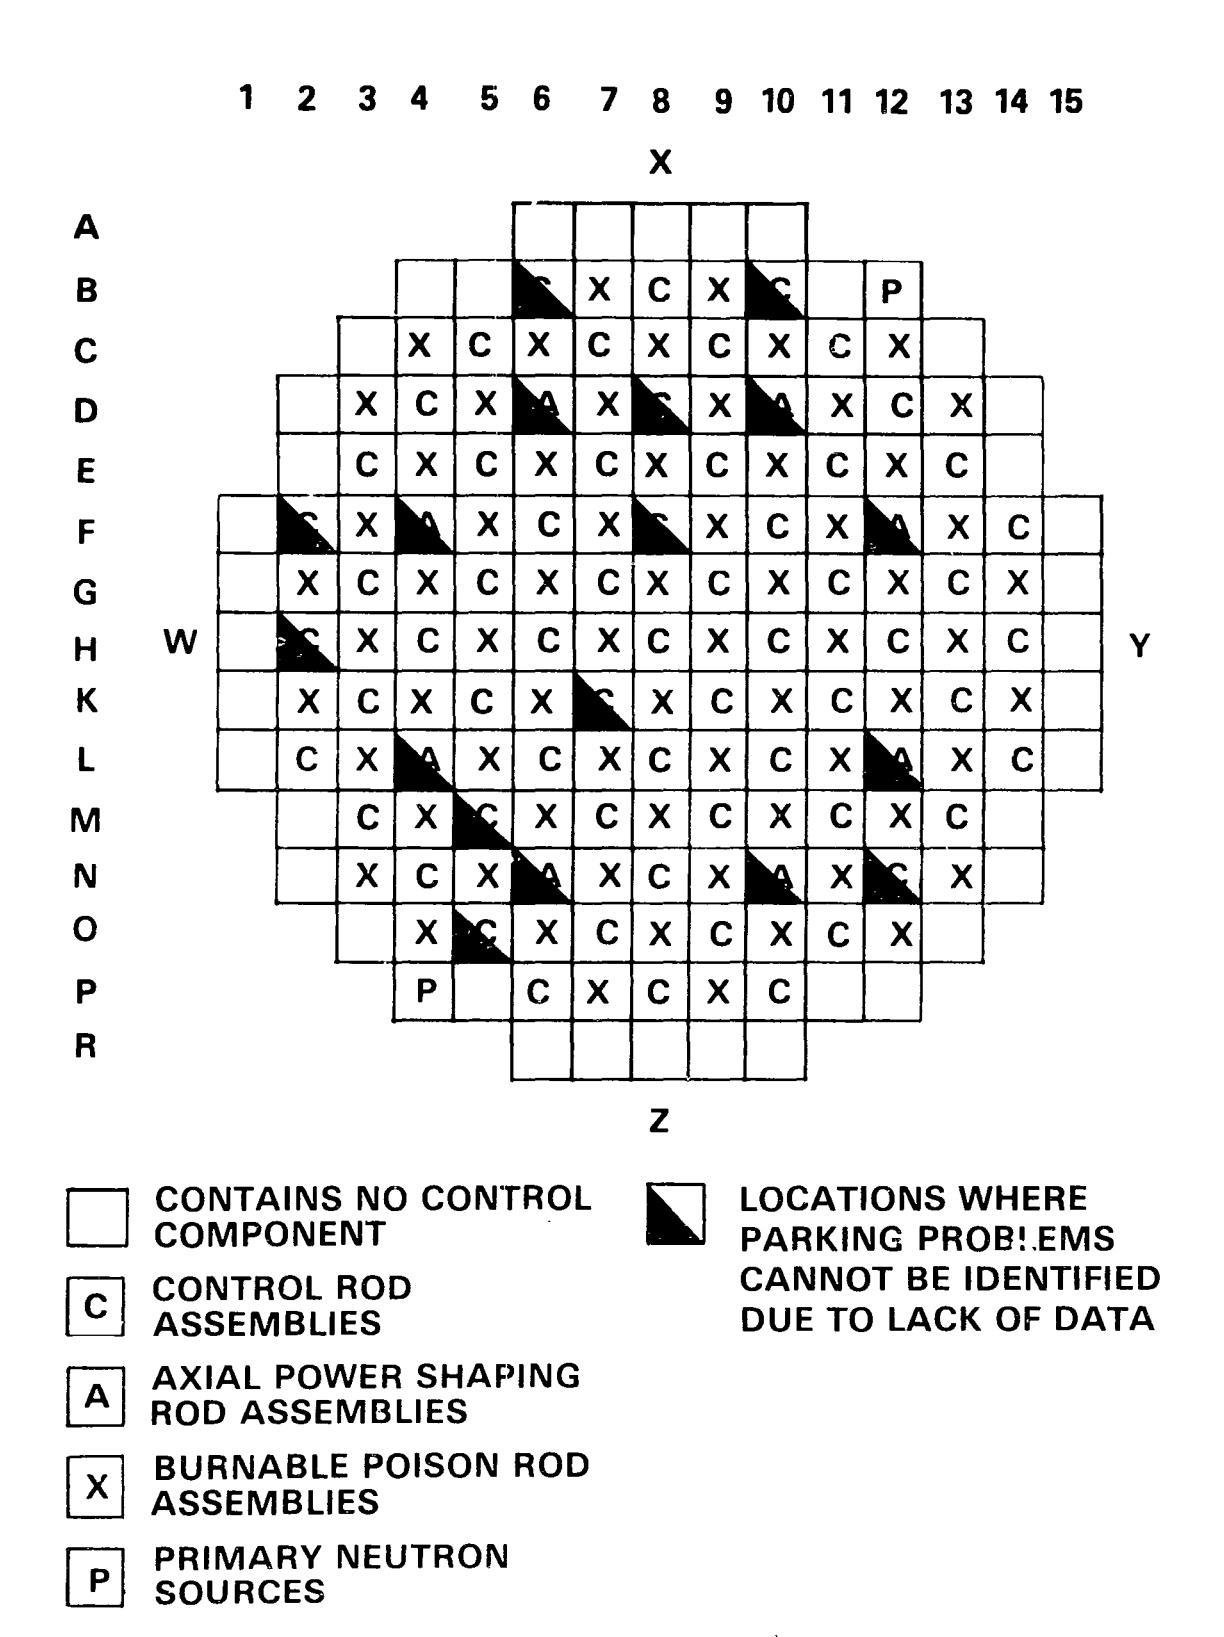
Figure 3-16. Locations where parking problems cannot be identified due to lack of data.
