QUICK LOOK REPORT ON HP-RT-0211 MULTIVALUED BEHAVIOR

James W. Mock, EG&G Idaho, Inc. Florante T. Soberano, United Engineers and Constructors Michael B. Murphy, Sandia National Laboratories

GEND-INF-008

Published July 1981

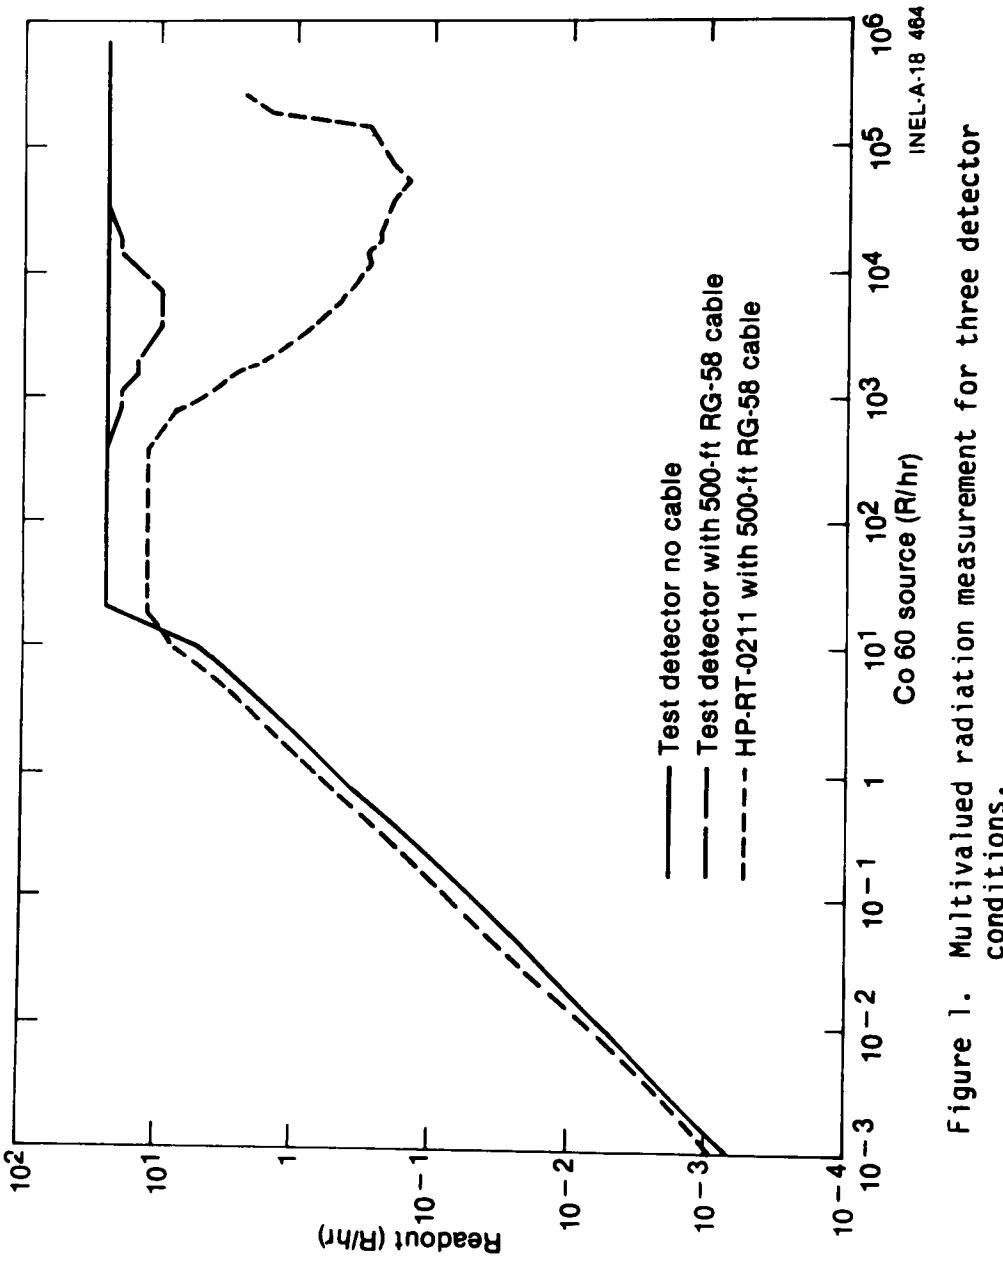
All four detectors exhibited idosyncratic behavior when exposed to very high radiation fields. The degree of depression, however, was not as pronounced as on the HP-RT-0211. The Sandia test unit, because it had been exposed earlier to some appreciable dose, exhibited a lower depression than did the three new and previously unexposed units.

The approach toward recovery shown above 100,000 R/hr in Curve C of Figure 1 was presumably due to fewer GM tube interactions, and a lowering of output frequency. The frequency stabilized at a value determined by the antijam/free-running multivibrator combination. The cable drive was still inadequate and reflections still occurred; however, the lowered frequency signal was not "filtered" as much.

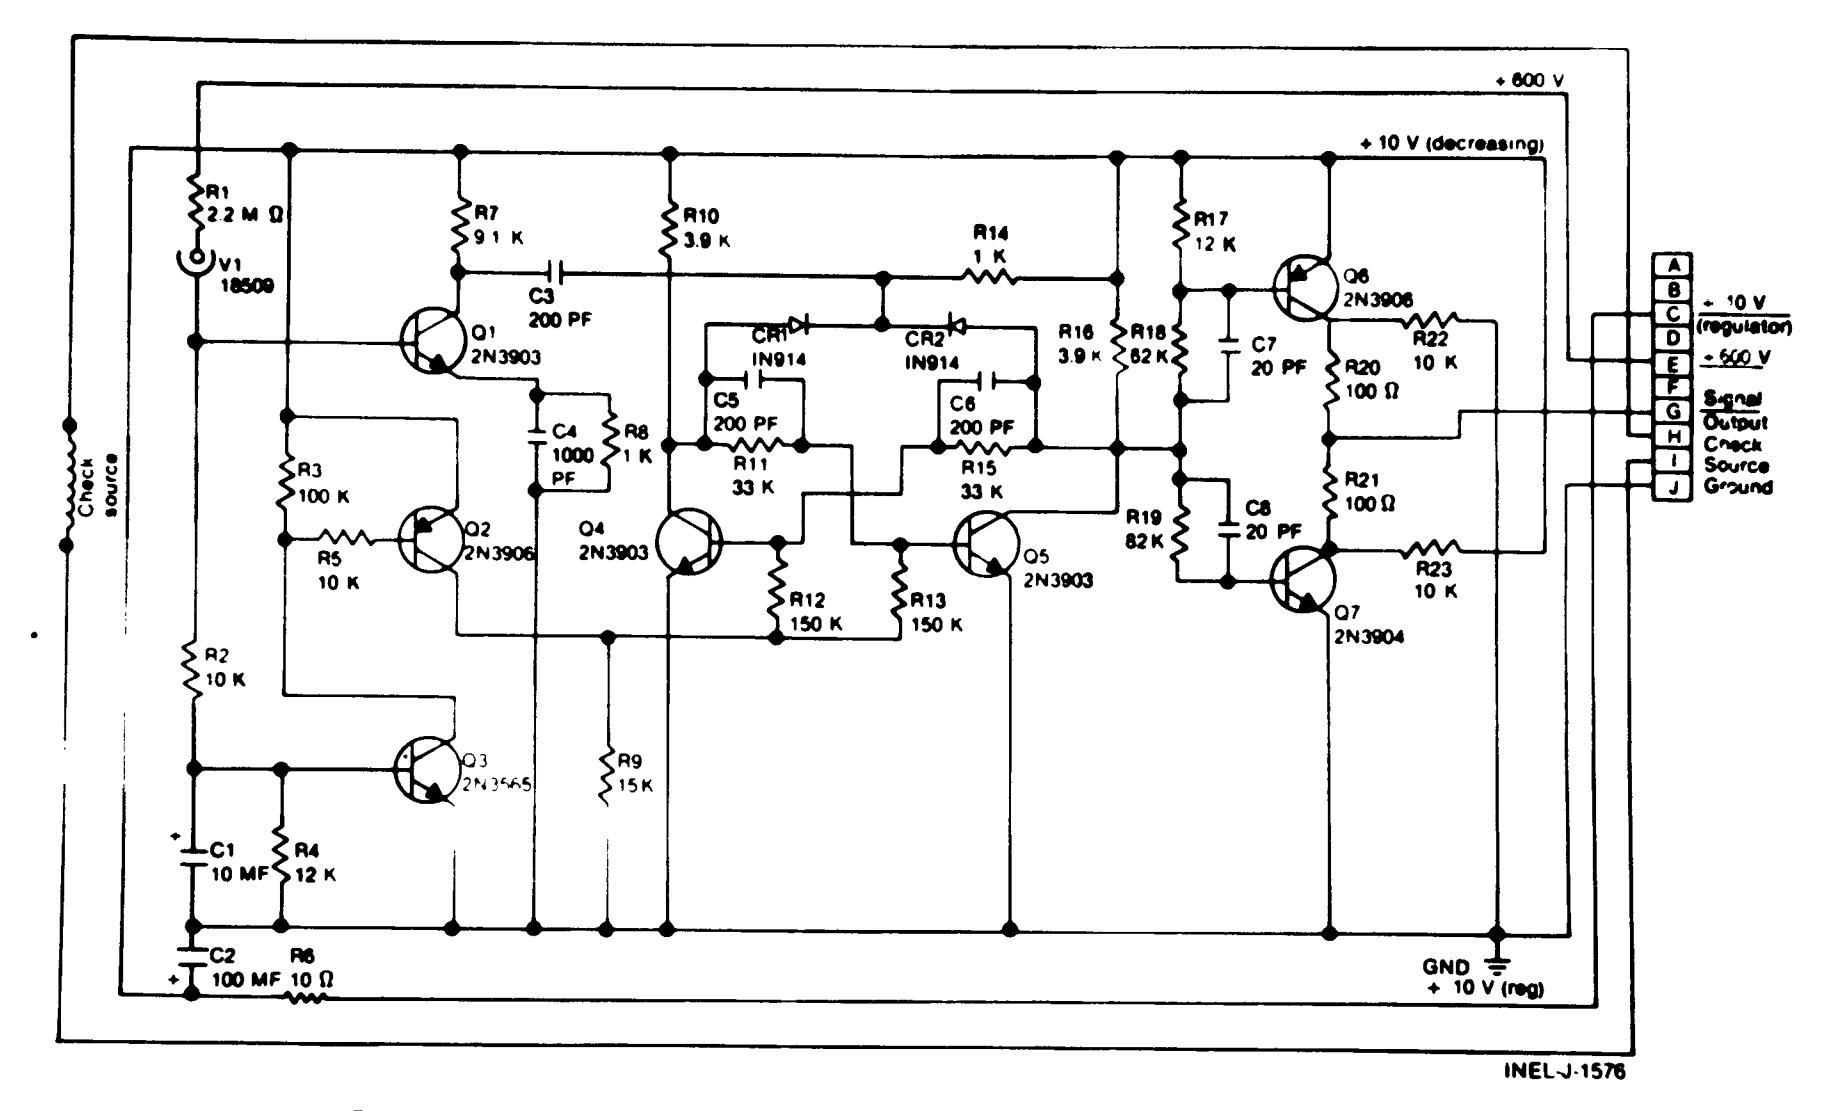
Impedance mismatch between the detector ouput drive and the transmission cable was determined to be one cause of the multivalued behavior of the Victoreen GM radiation monitors. The output drive resistors R2O and R21 (see Figure 2) are 100 ohms while the cable characteristic impedance is 50 ohms.⁴ At low frequencies the mismatch did not affect the detector output; however, at very high radiation rates, the frequency approached 100 kHz and hence, the output.

Figure 2. Detector schematic--GM tube and antijam circuits on the left, flip-flop in the center, and the output driver on the right.⁵

- Reduce R20 and R21 to approximately 50 ohms to properly match the 50-ohm coaxial cable
- Employ higher radiation-tolerant transistors in the Q6 and Q7 transistor slots
- 3. Increase the base drives to Q6 and Q7
- 4. Disable the GM tube pulse output to the multivibrator when the antijam circuit is operational.

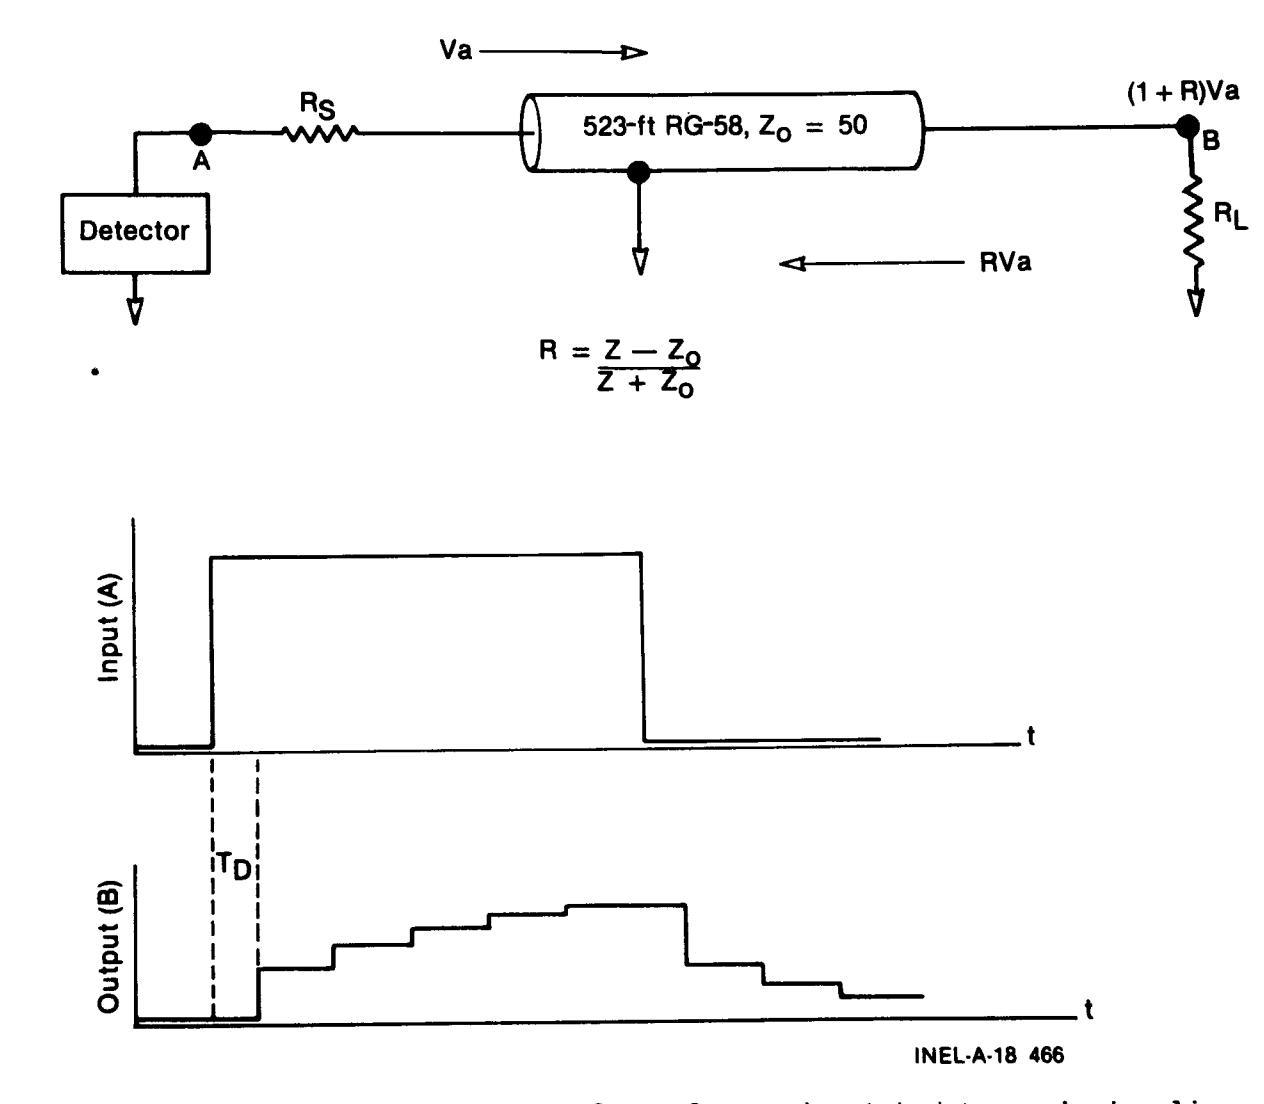
The ratemeter input appeared as an open circuit for the steady-state signal from the detector. This open circuit, combined with the mismatched driver, set up reflections in the cable that produced the same effect as filtering the signal. Since the ratemeter circuit is a linear log pump, both the amplitude and the frequency of the signal affect readout accuracy. Figure 3 illustrates the effects of the mismatch on the waveform. Mathematically, for a voltage, Va, propagating down a coaxial cable of characteristic impedance, Zo, the voltage across the load resistor, R_L , is equal to (1 + R) Va. R is the reflection constant and is equal to

where Z is the termination impedance. A voltage, RVa, is reflected back down the cable. With a value of $R_L = \infty$, R is equal to 1, and Va is reflected. This voltage travels the length of the cable and impinges at the detector end where it is only partially reflected due to the improper termination. The process continues, and for a voltage step at the detector end, the resultant waveform at the ratemeter shows a series of upward (or downward) steps. The width of each step is equal to $2T_D$ where T_D is the time required for the signal to propagate the length of the 500 feet of cable. If the detector output square wave reaches a frequency high enough to have a period that is of the same order of magnitude as T_D , a substantial rolloff of the waveform will result. Figure 4 shows an oscilloscope picture of this condition.

Figure 3. Input and output waveforms for a mismatched transmission line $(R_{L} = \infty)$.

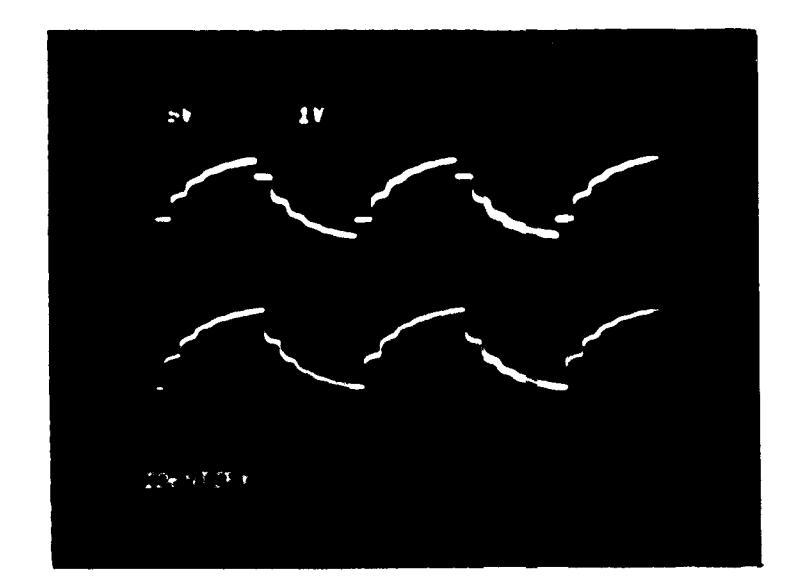
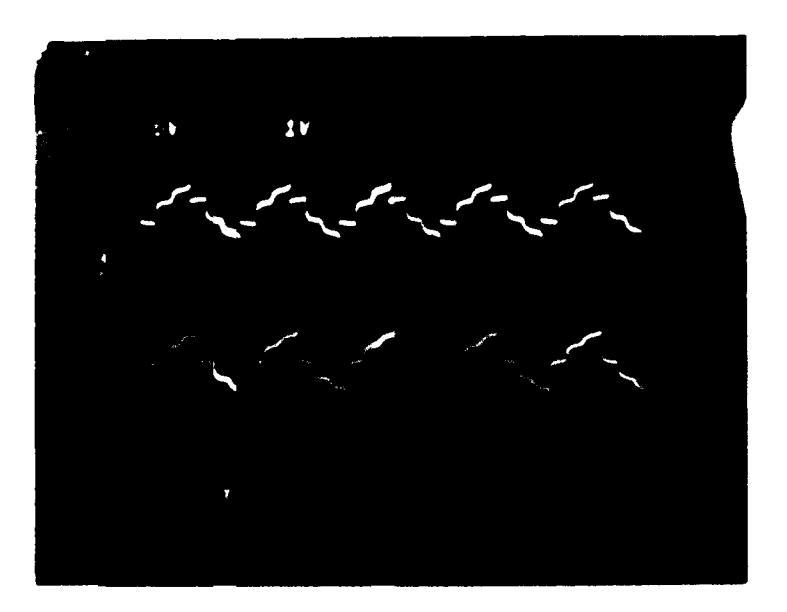
Figure 4. Mismatch filtering: Top trace of both photos in the transmission line input; bottom trace is the output voltage. Input frequencies: 50 kHz for left photo; 100 kHz right photo. $R_s = 250$ ohms and $R_L = -$ for both photos.
