EXAMINATION OF SOLENOID VALVES AH-EP-5037 AND AH-EP-5039 AND LIMIT SWITCHES AH-KS-5037 AND AH-KS-5039

GEND-INF-018

Published December 1984

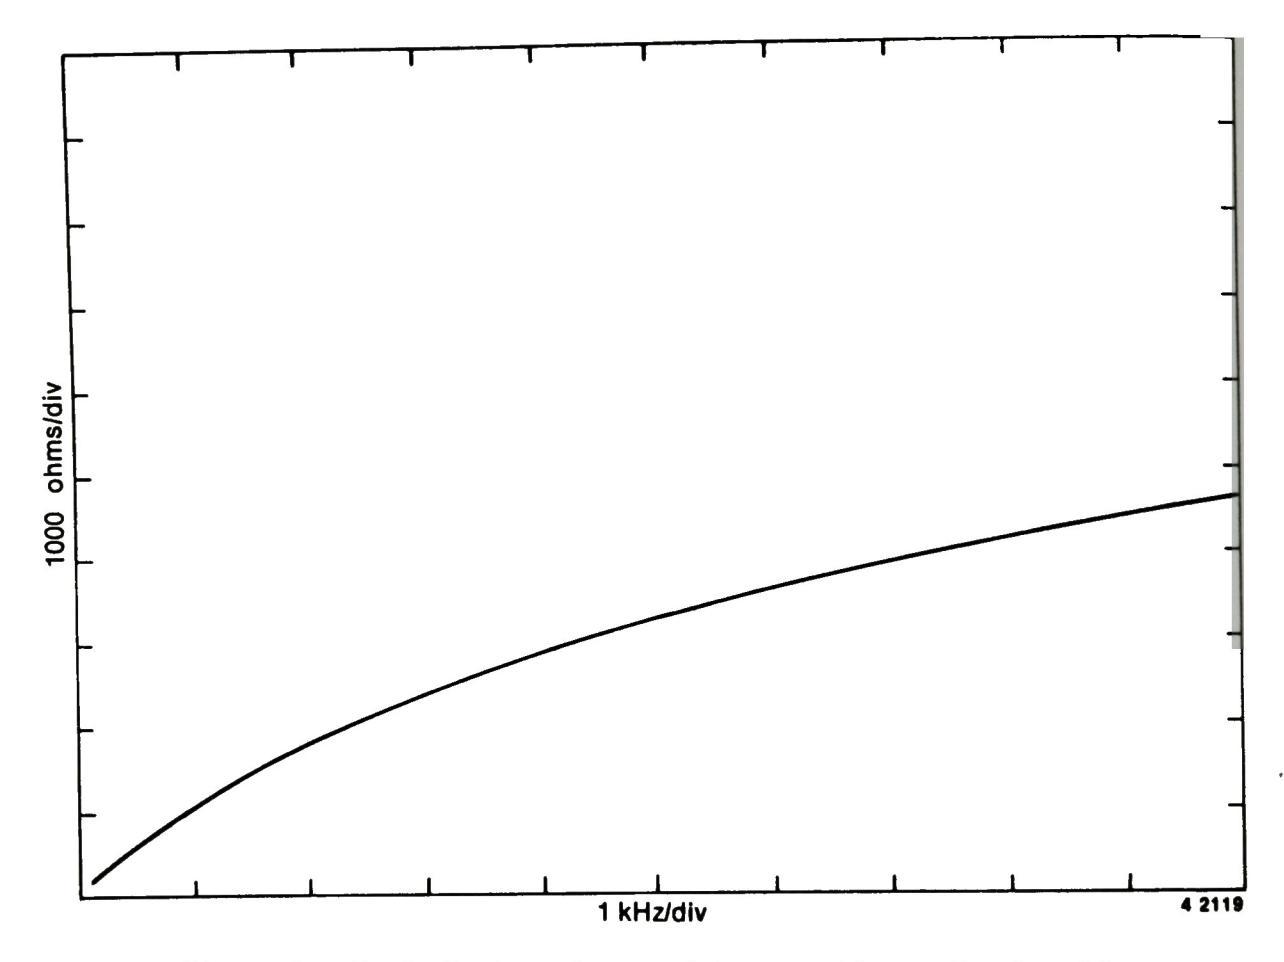
Figure 8. Equivalent series resistance pattern of solenoid valve AH-EP-5039.

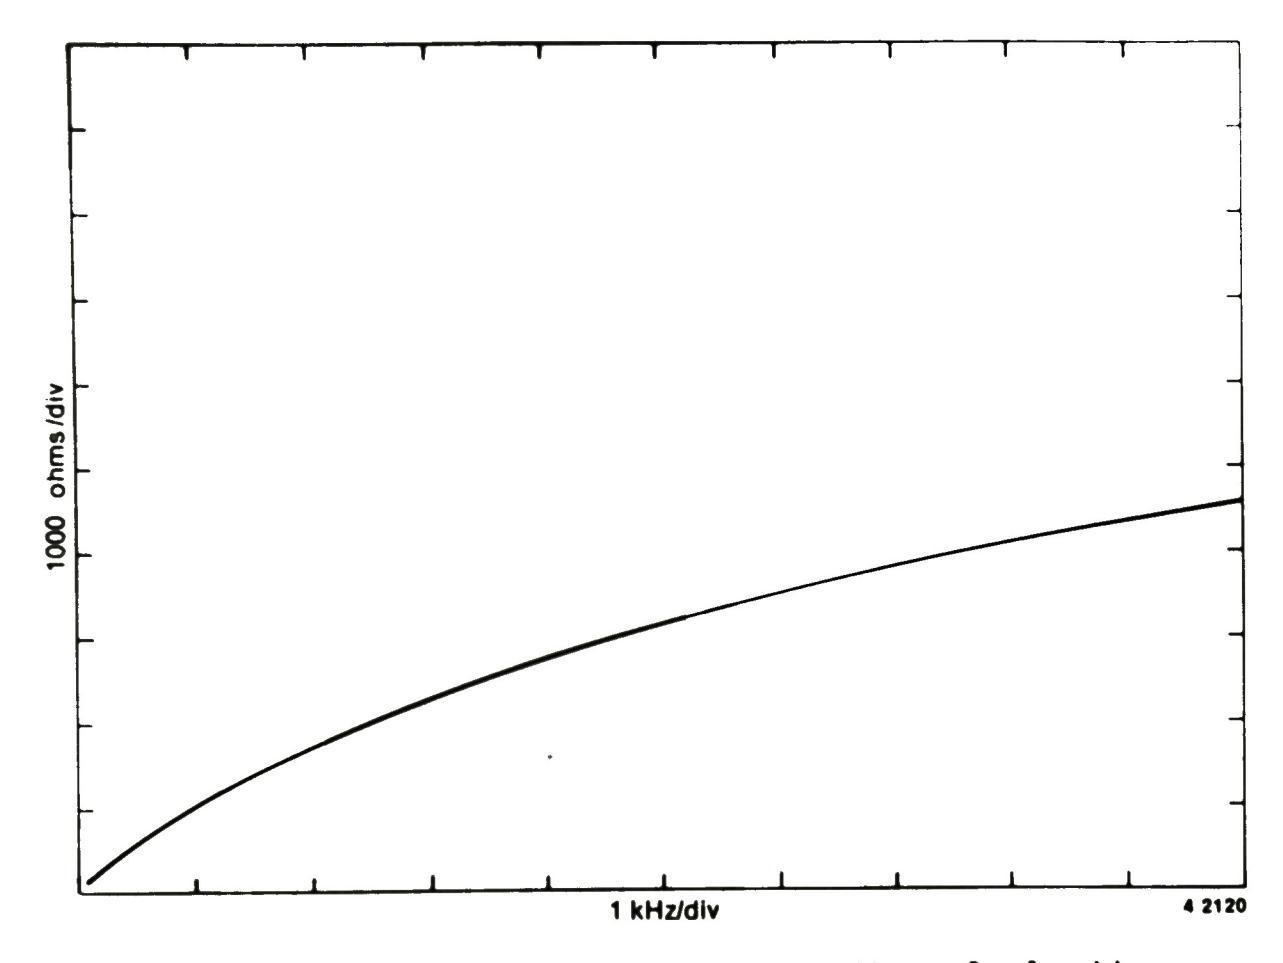
Figure 9. Equivalent series resistance pattern of solenoid valve AH-EP-5037.

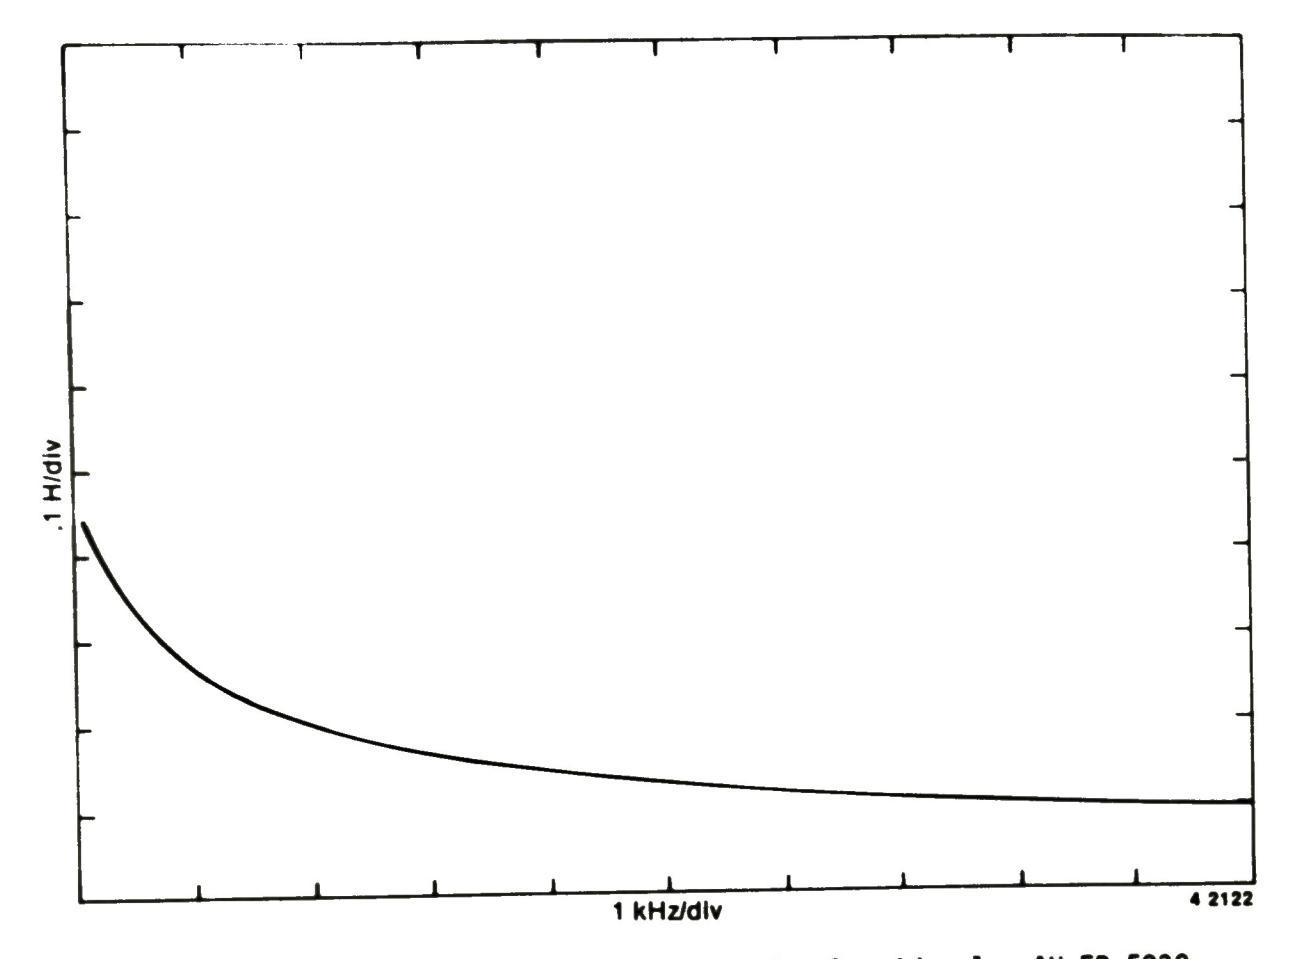
Figure 11. Effective inductance pattern of solenoid valve AH-EP-5039.

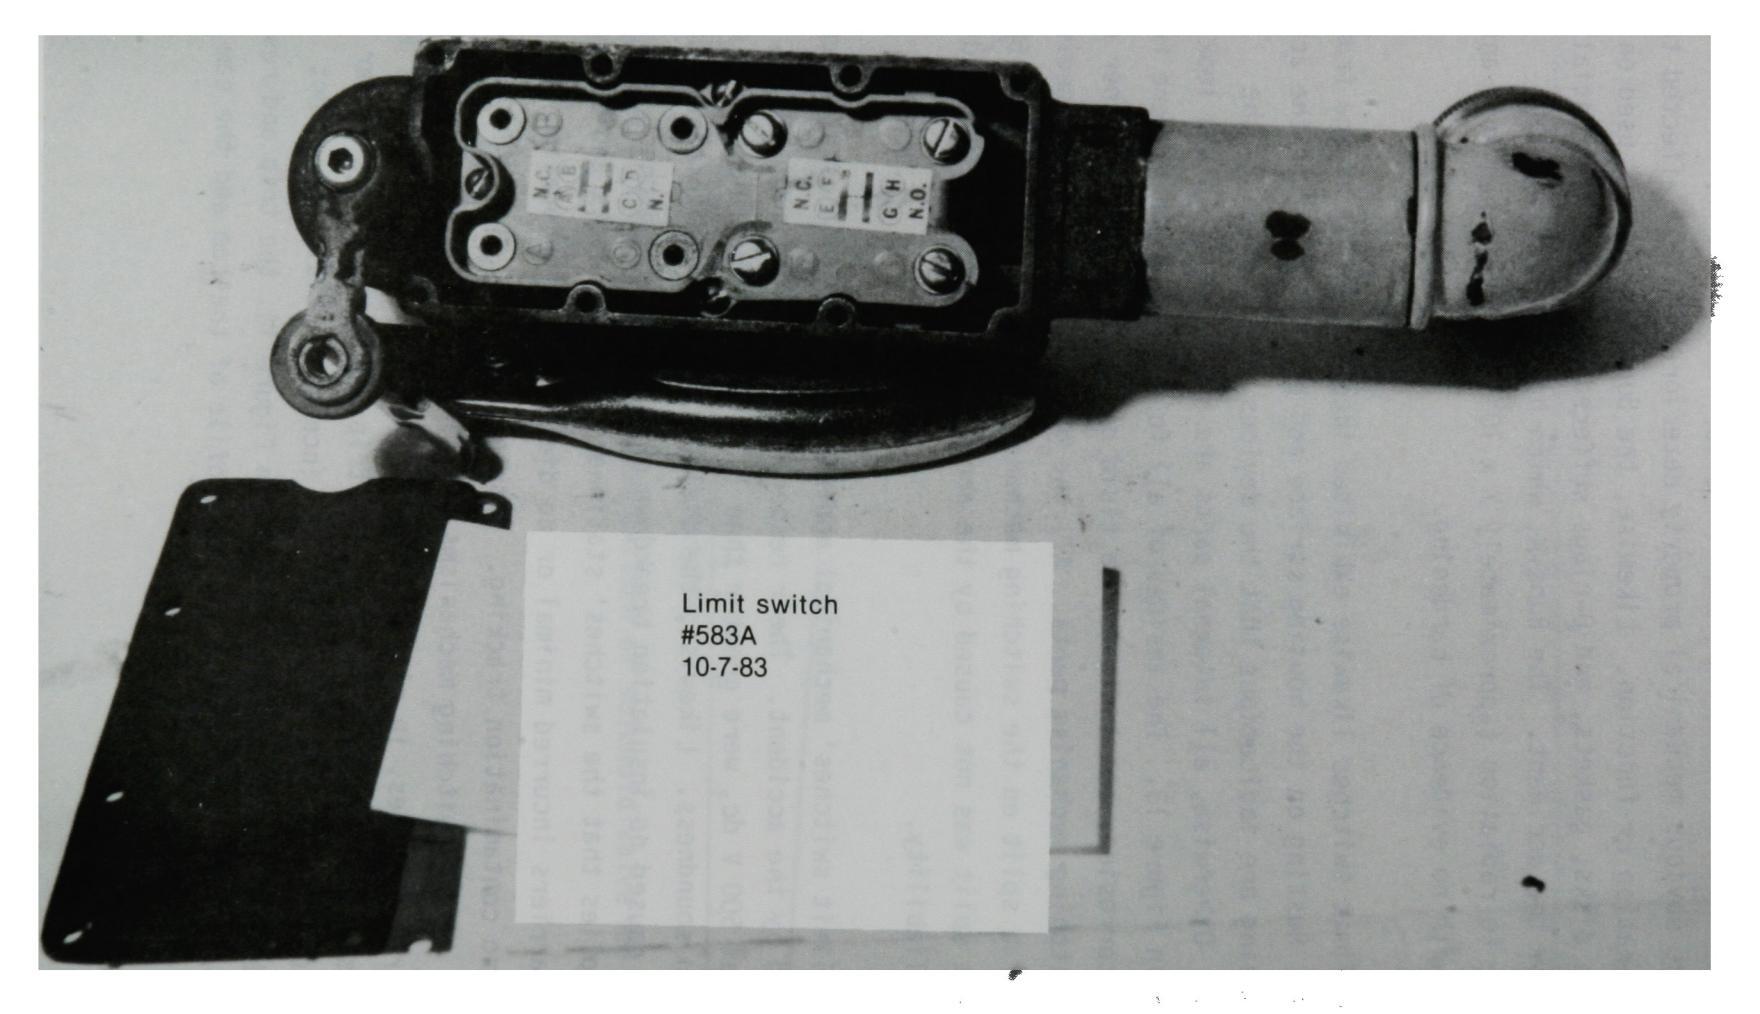
The limit switches likewise exhibited inconsequential damage from the accident. Rusting on the housing surface and embrittlement of the actuator shaft bushing are indications that the devices were exposed to the accident. Otherwise, all internal parts are shiny and clean and look new, as shown in Figure 13. The insides of all four limit switches were free of dirt and corrosion, and indicated no fluid damage, warping, or other damage to the switching mechanism parts. All the gaskets were in good condition except for a split on the switching mechanism cover gasket of AH-KS-5039. The gasket split was not caused by the accident--the gasket exhibited no loss of pliability.

Figure 13. Exposed terminal block of limit switch AH-KS-5037A.

A break of the contact barriers on the contact block of three limit switches was also noted, as seen in Figure 13. Judging from the way the limit switches were wired in the field, with AWG #12 conductors terminated on terminals C and D by AMP PIDG ring torque terminal lugs, it appears that the barriers were probably intentionally broken by construction electricians to provide room for the wires and lugs and allow ease of termination. The action degraded the dielectric property of the device; however, it did not cause degradation below the minimum requirement of 2200 V ac.
