GEND-INF--023 Vol. 1

INVESTIGATION OF HYDROGEN-BURN DAMAGE IN THE THREE MILE ISLAND UNIT 2 REACTOR BUILDING

N. J. Alvares and D. G. Beason Lawrence Livermore National Laboratory and G. R. Eidam EG&G Idaho, Inc.

Published June 1982

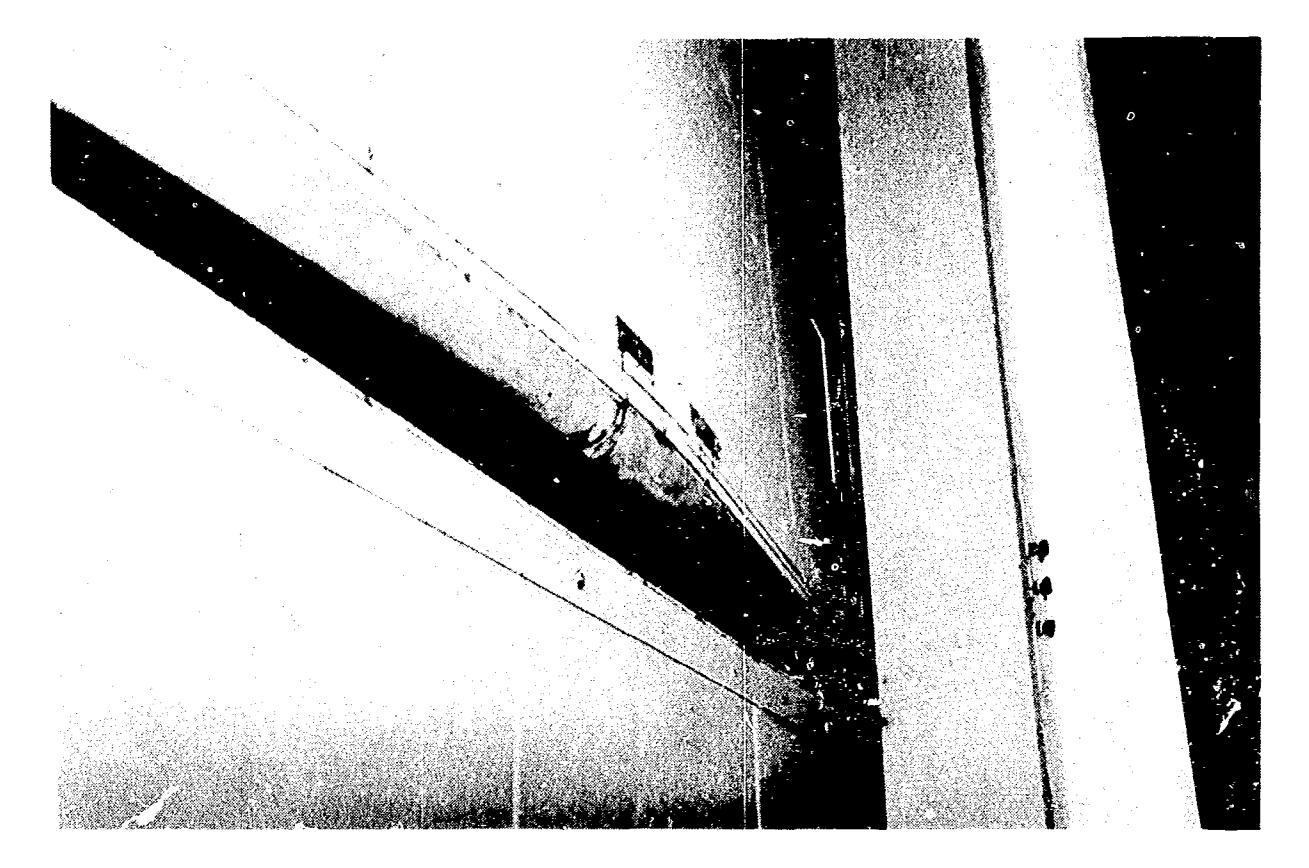
Figures 1 through 5 show overpressure damage in the reactor building. Most overpressure damage was in the vicinity of the elevator and enclosed stairwell complex on the 305- and 347-fcot elevations. Since no other photographed region of the reactor building showed any overpressure damage (e.g., crushing of switch boxes, collapse of hermetic enclosures, light bulb or fluorescent light breakage, translation or knocking over of untethered items) we conclude that forceful overpressure was localized to interior elevator and stairwell locations and nearby regions.

Figure 2. Elevator door on the 347-foot elevation indicating overpressure damage.

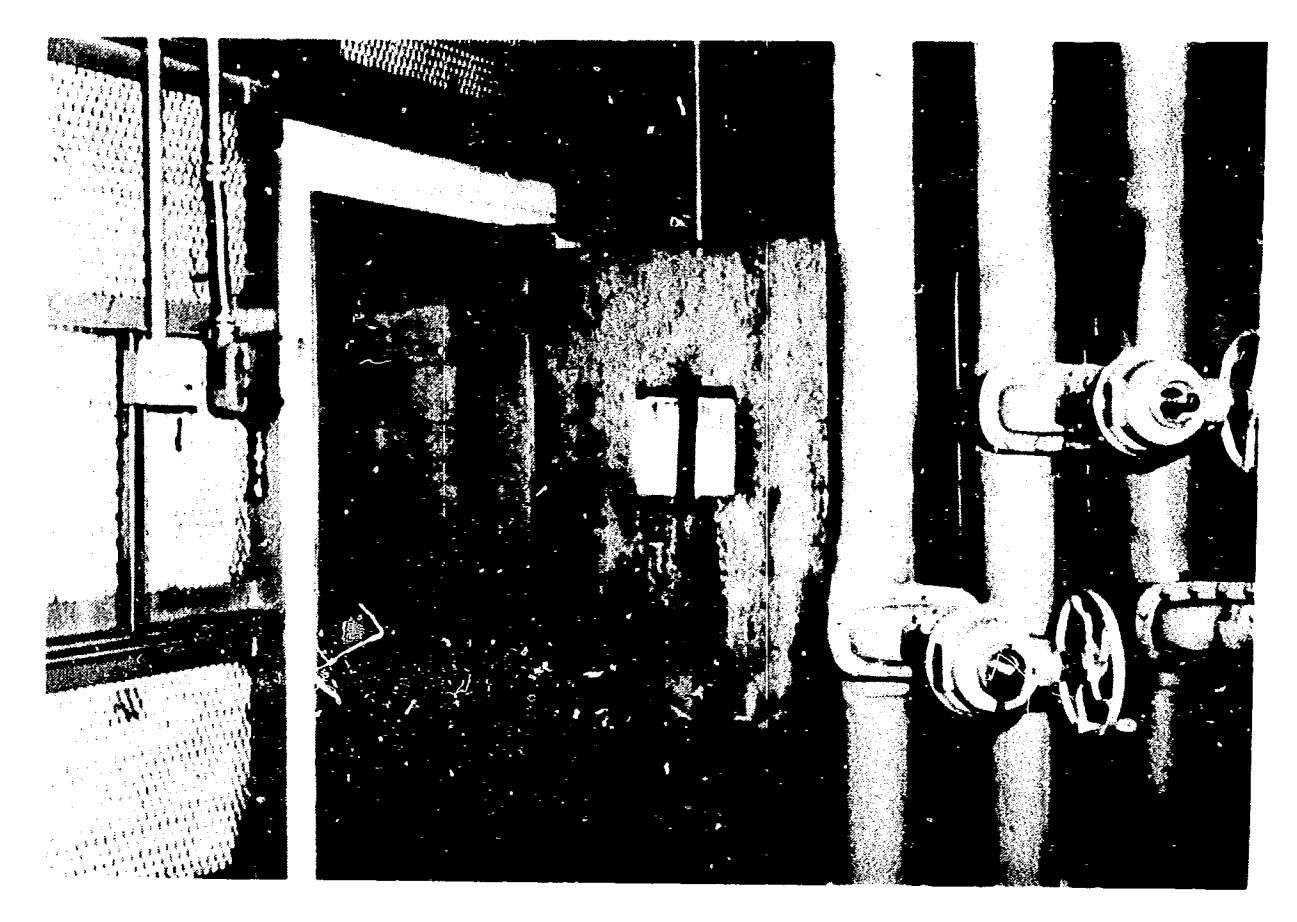
Figure 3. Enclosed stairwell door on the 305-foot elevation indicating overpressure damage.

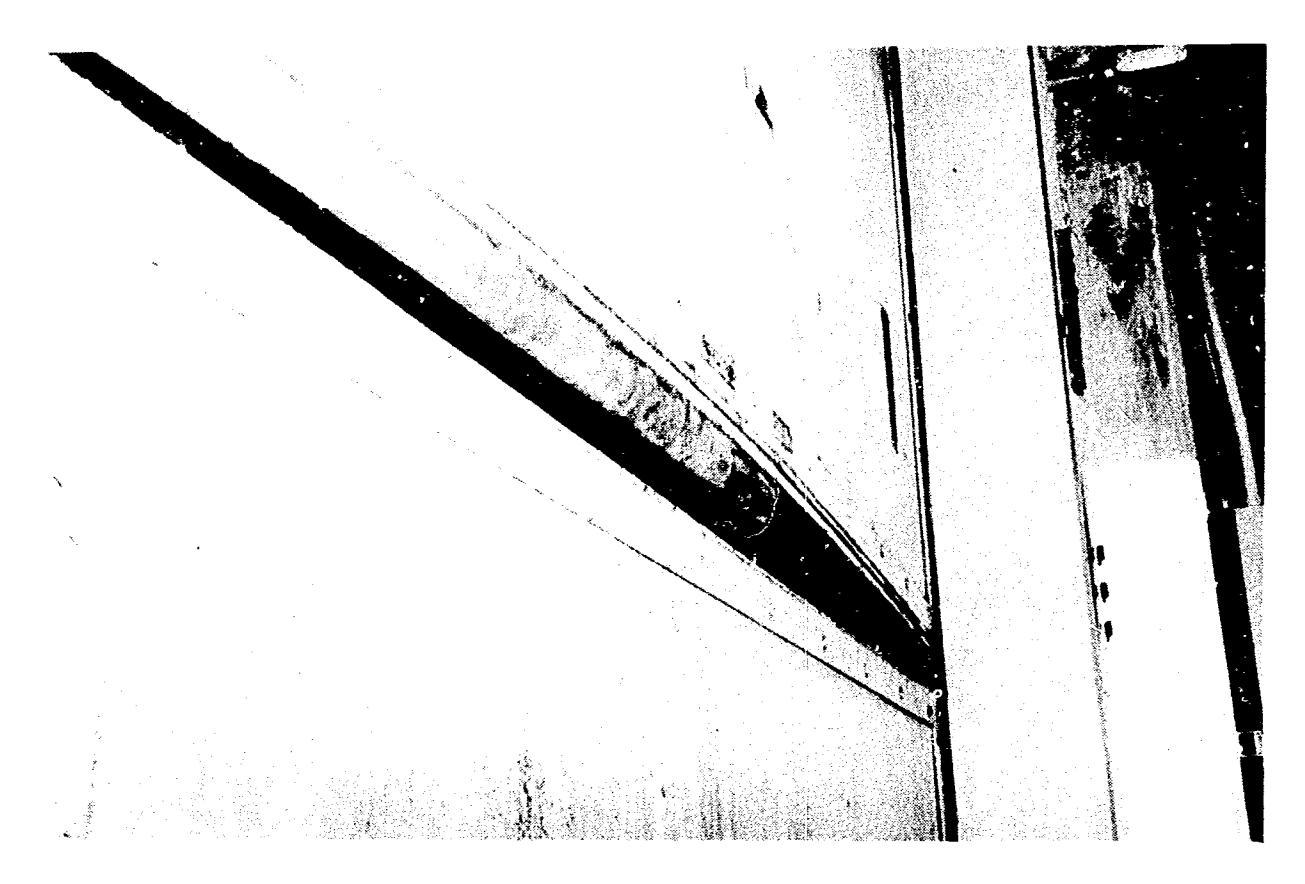
Figure 4. Elevator door on the 305-foot elevation indicating overpressure damage.

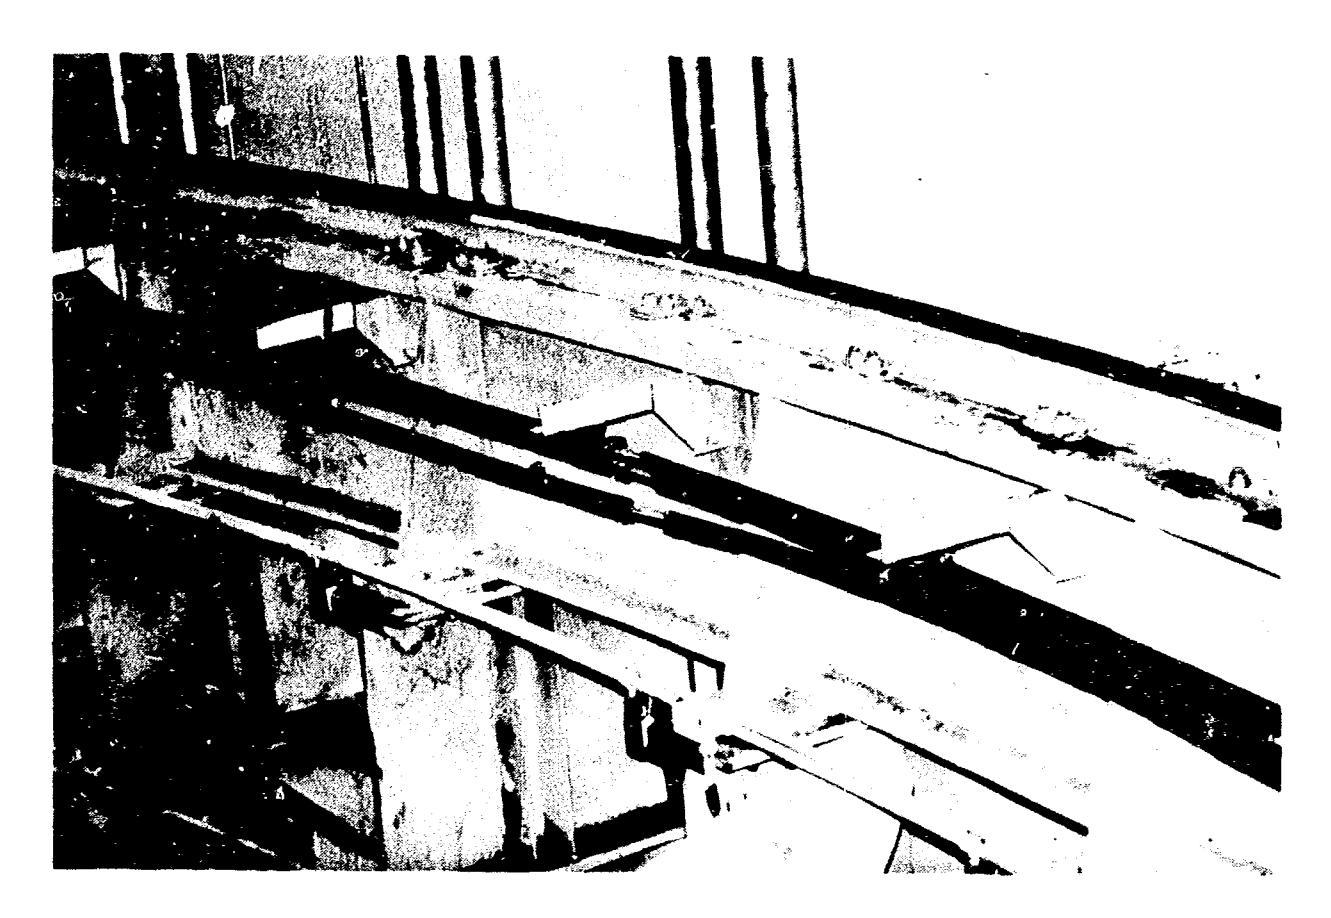
Figure 7. Charred insulation on the containment bus.

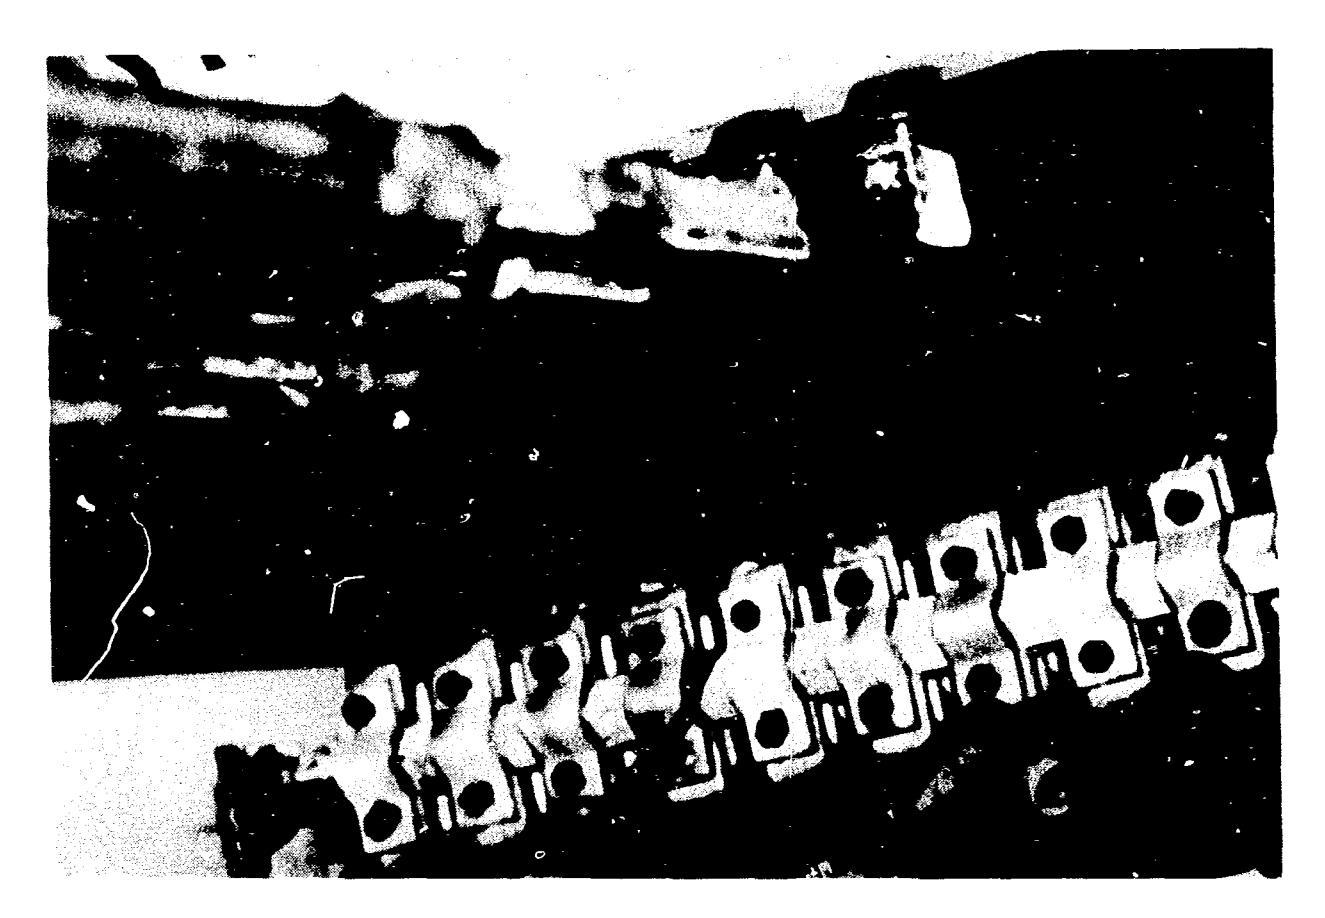
Figure 8. Damage to polar crane bus insulation.

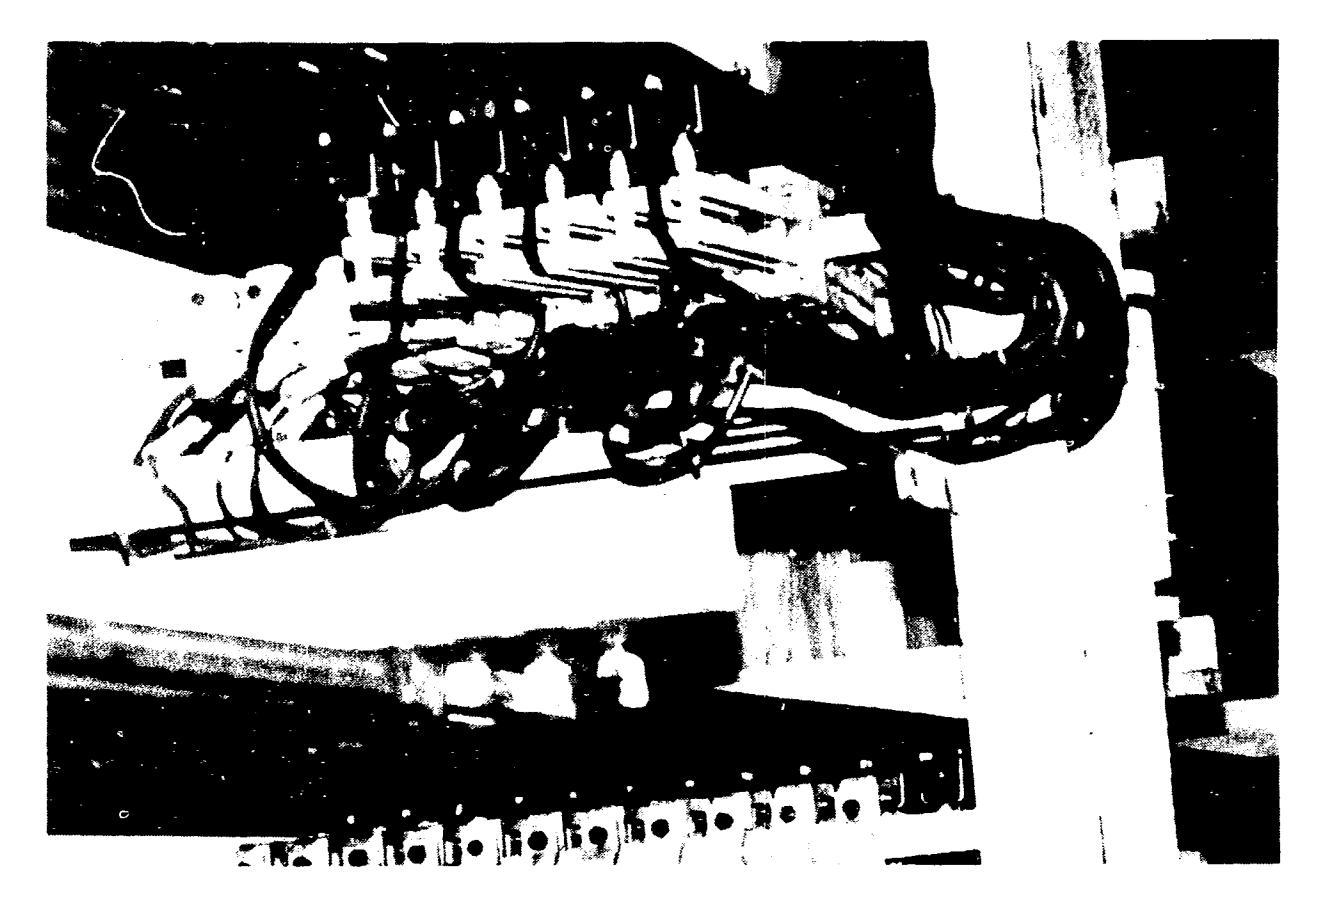
Figure 9. "Scalloped" damage to polar crane bus insulation; appears to decrease close to crane.

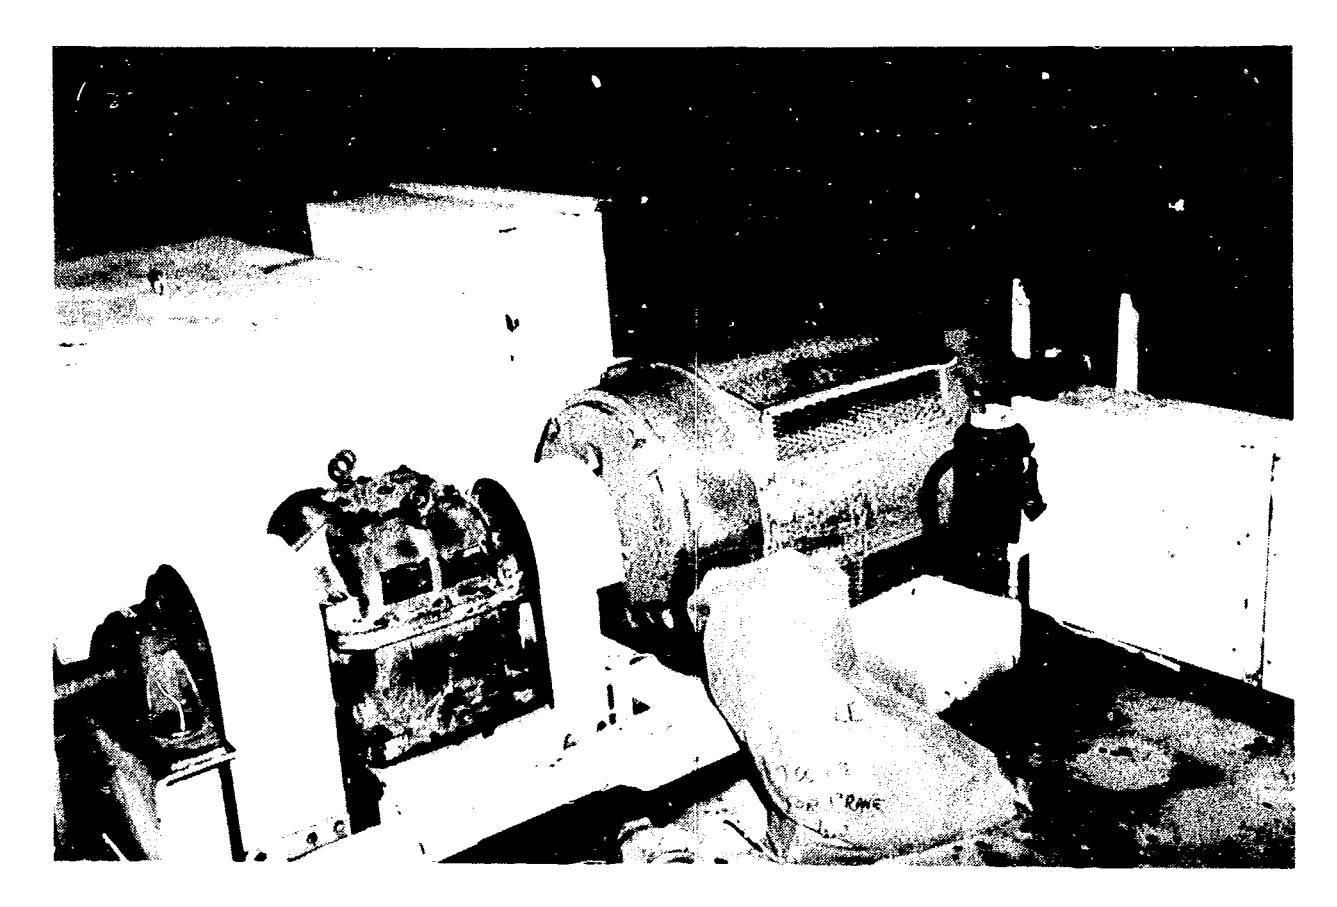
Figure 10. Charred hose and charred label on fire extinguisher.

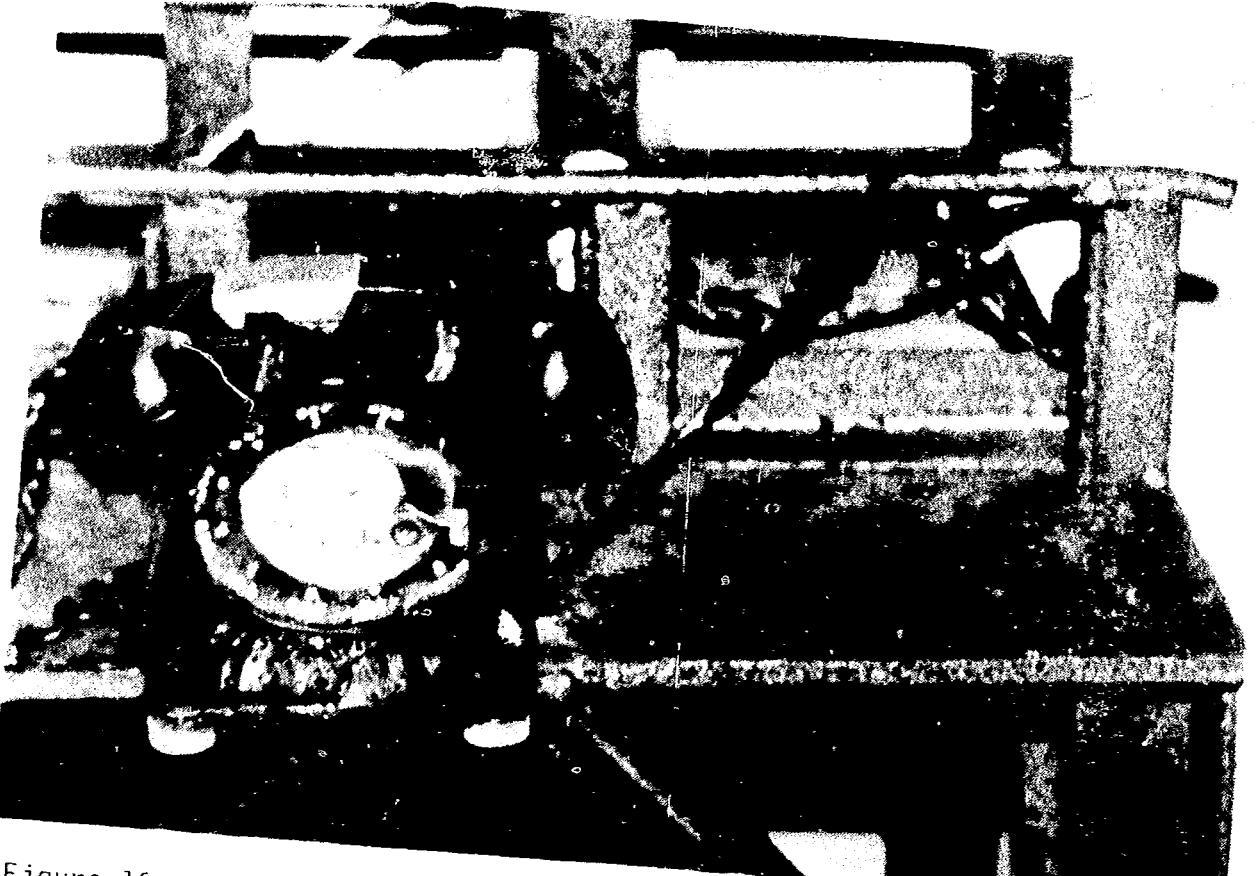
Figure 16. Melted telephone with charred cord along the south wall of the 347-foot elevation.

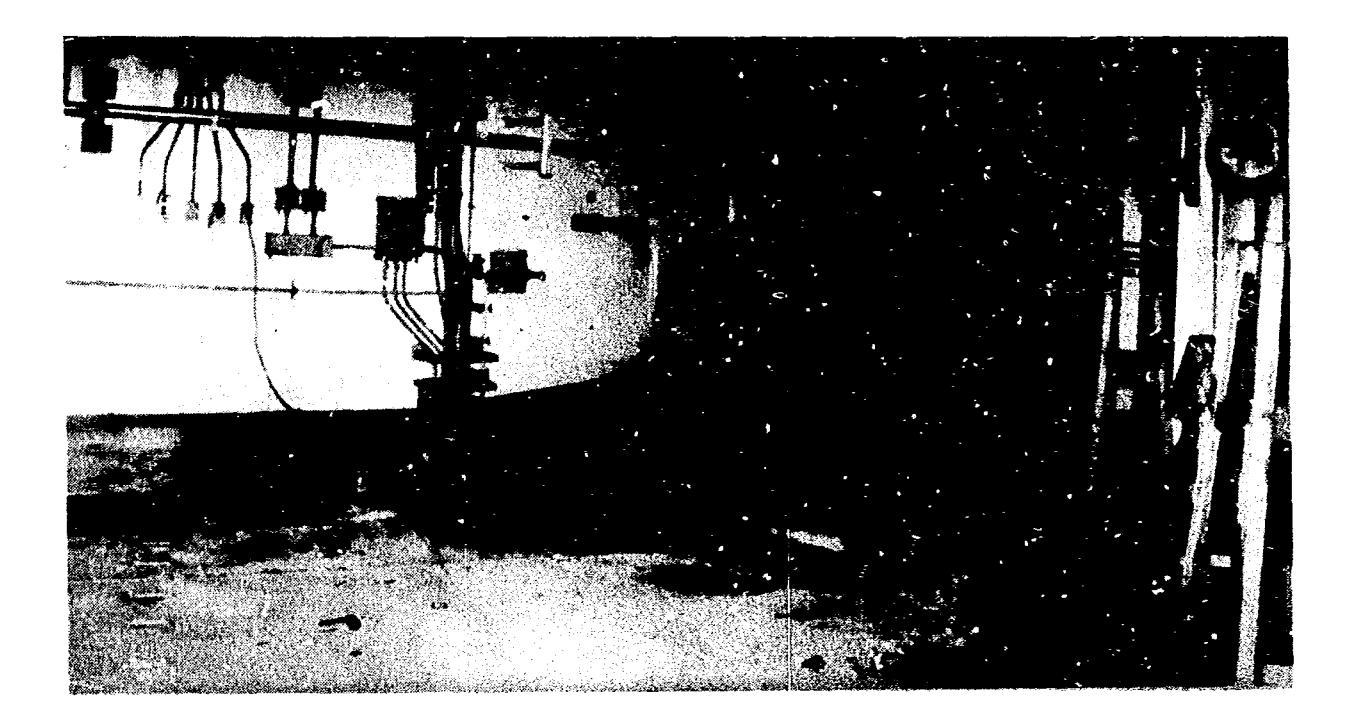
Figure 18. Uniformly charred plywood box against D-ring wall in the southeast area of the 347-foot elevation.

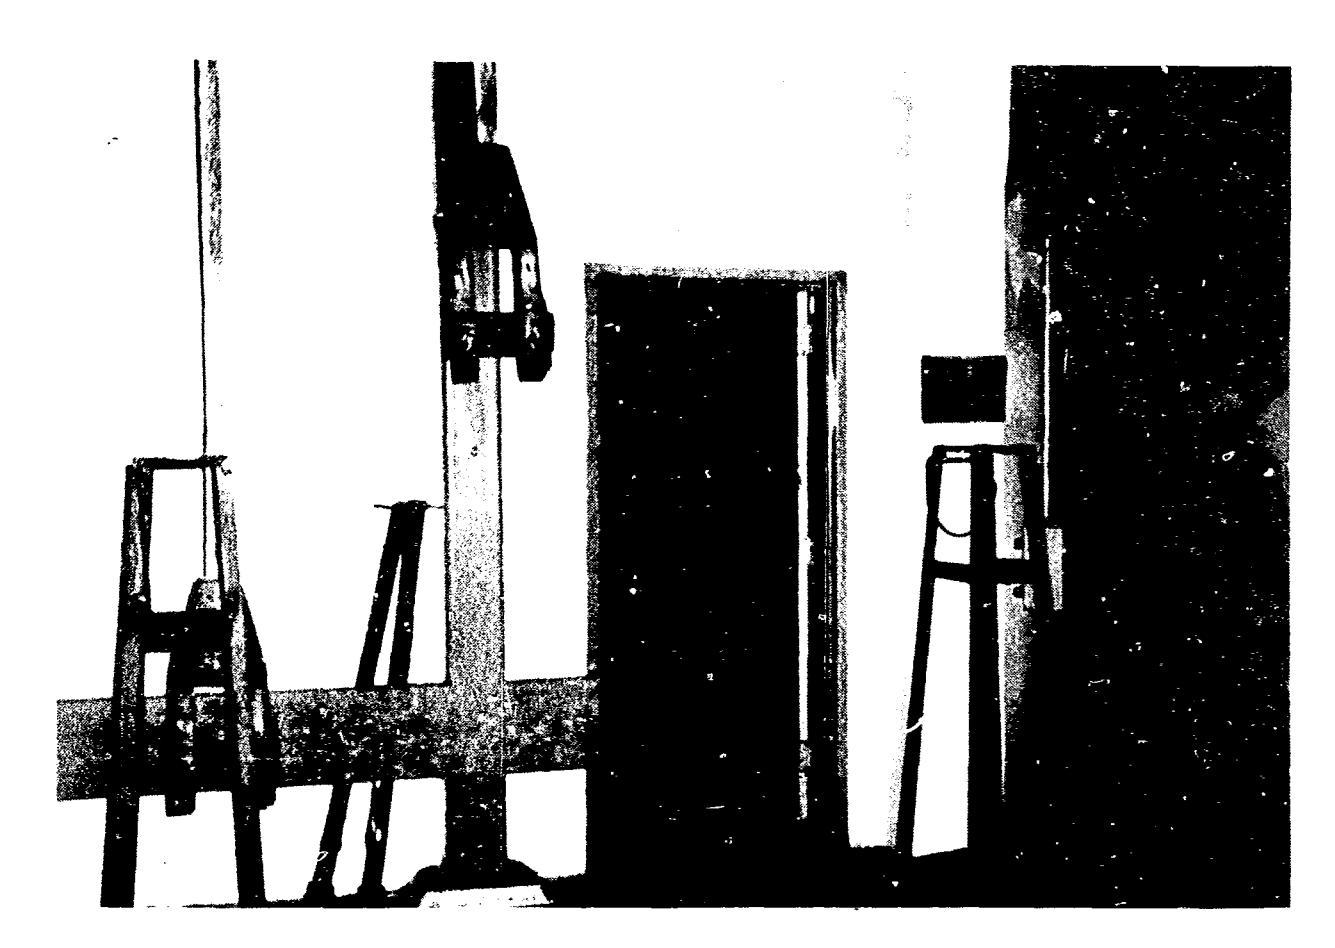
Figure 19. Discolored exit sign, burned in right top corner; located in the southeast area of the 347-foot elevation.

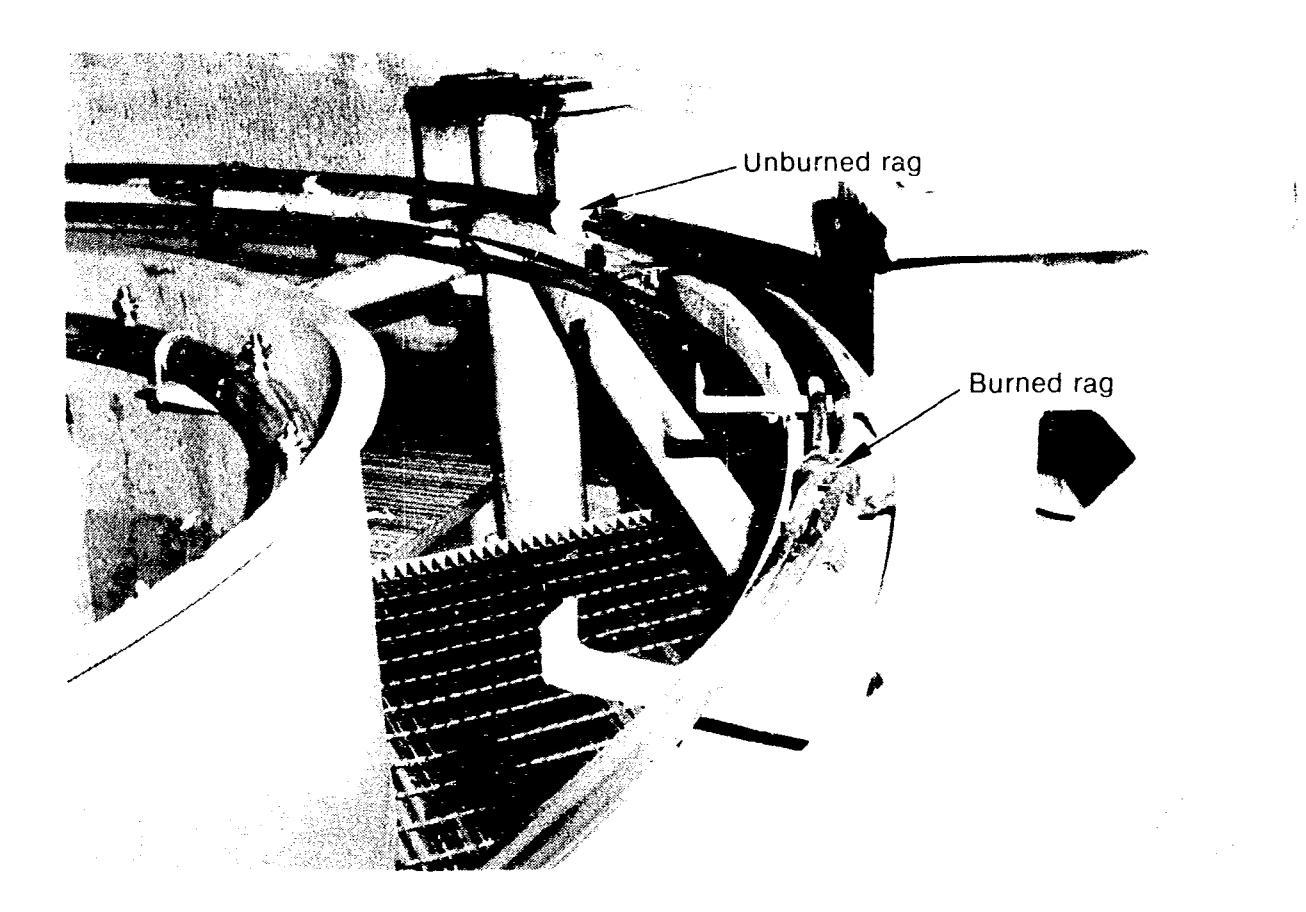
Figure 20. Random fabric char inside the head storage stand on the 347-foot elevation.

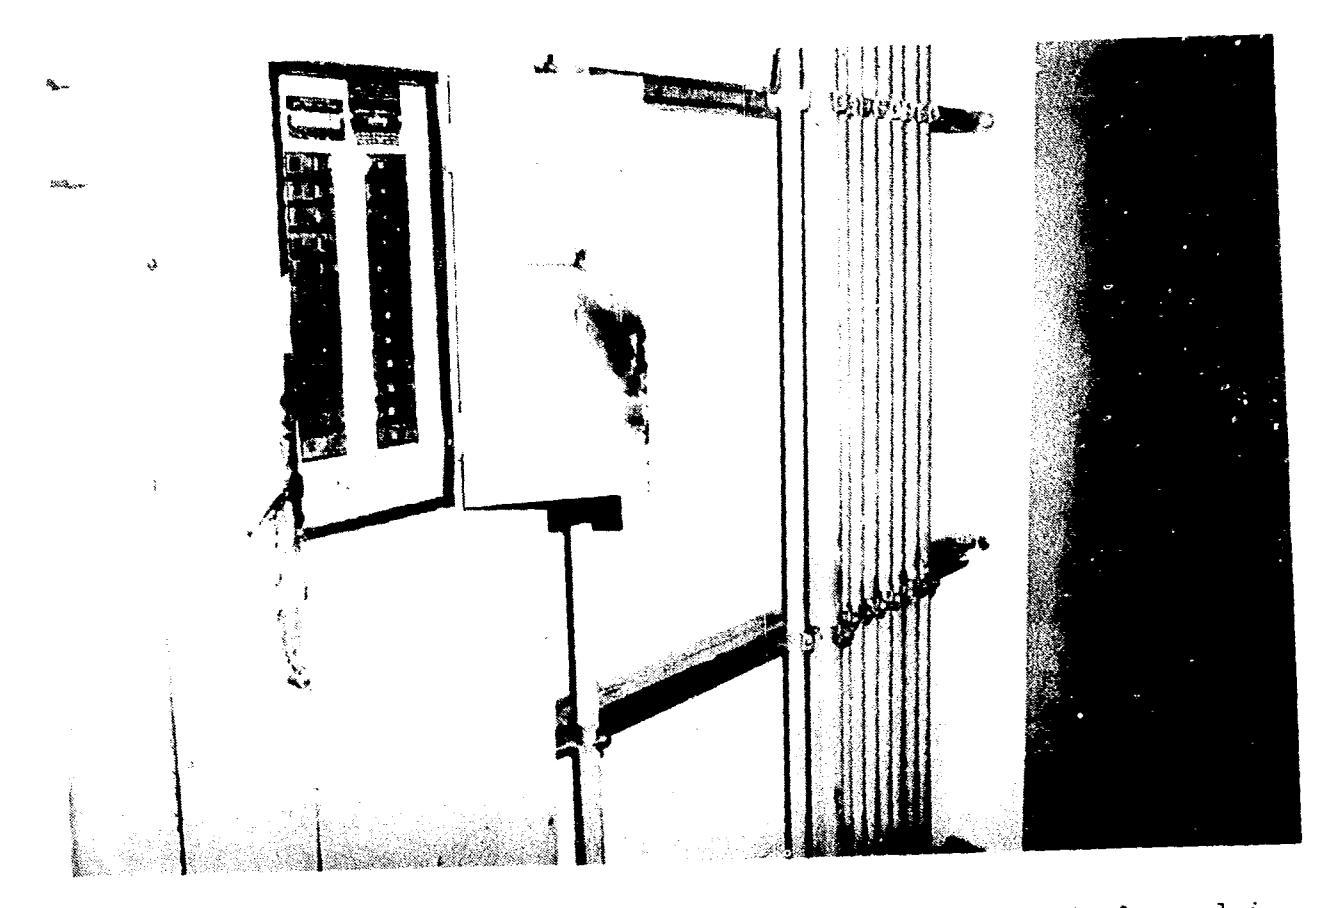
Figure 22. Charring and melted door seal material on electrical panel in southeast area of the 347-foot elevation.

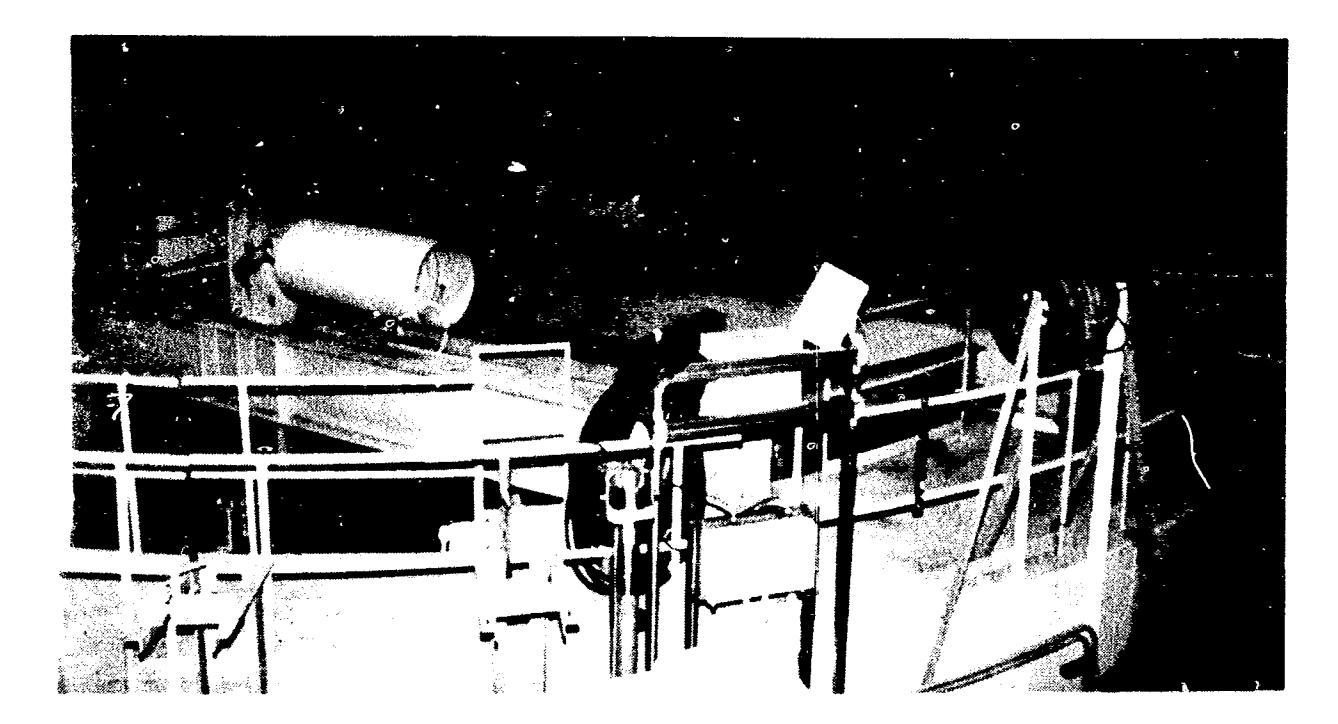
Figure 23. Charred paper in metal box in the east D-ring on the 347-foot elevation.

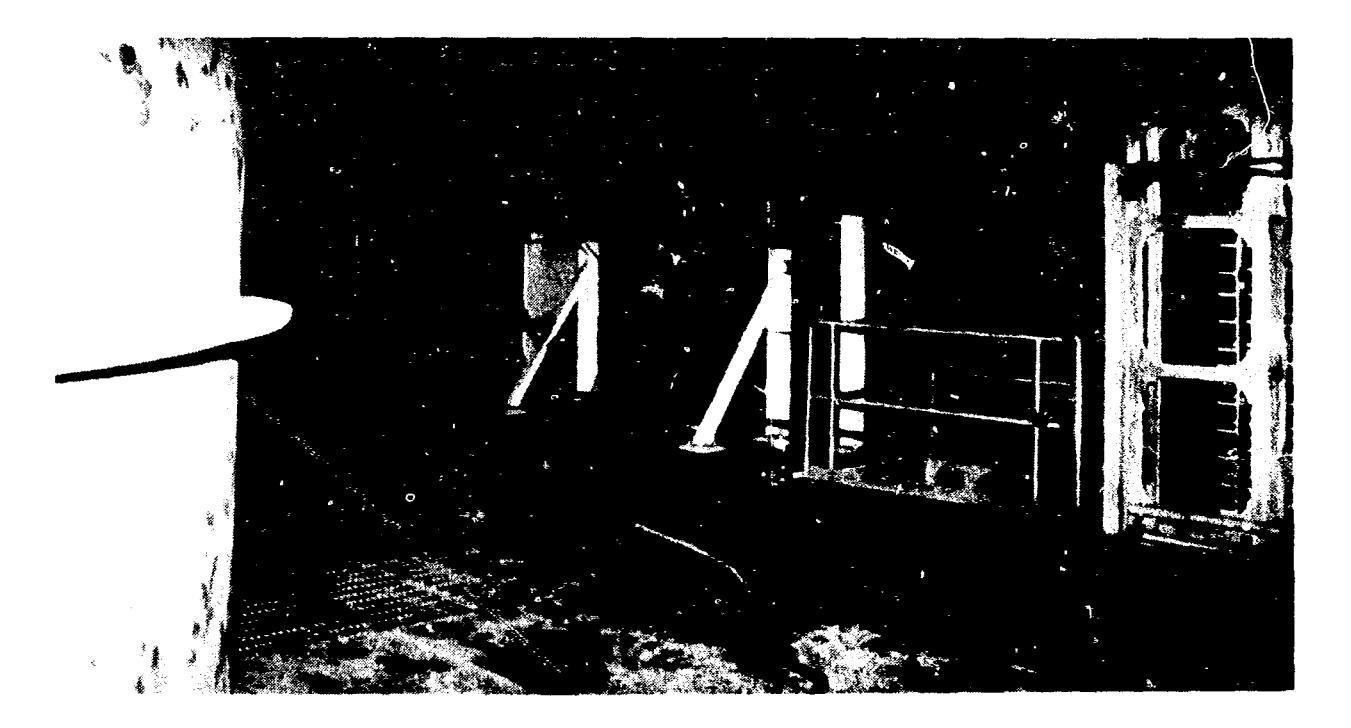
Figure 24. View towards the refueling canal on 347-foot elevation showing fallen bus bar from polar crane and charred electrical insulation.

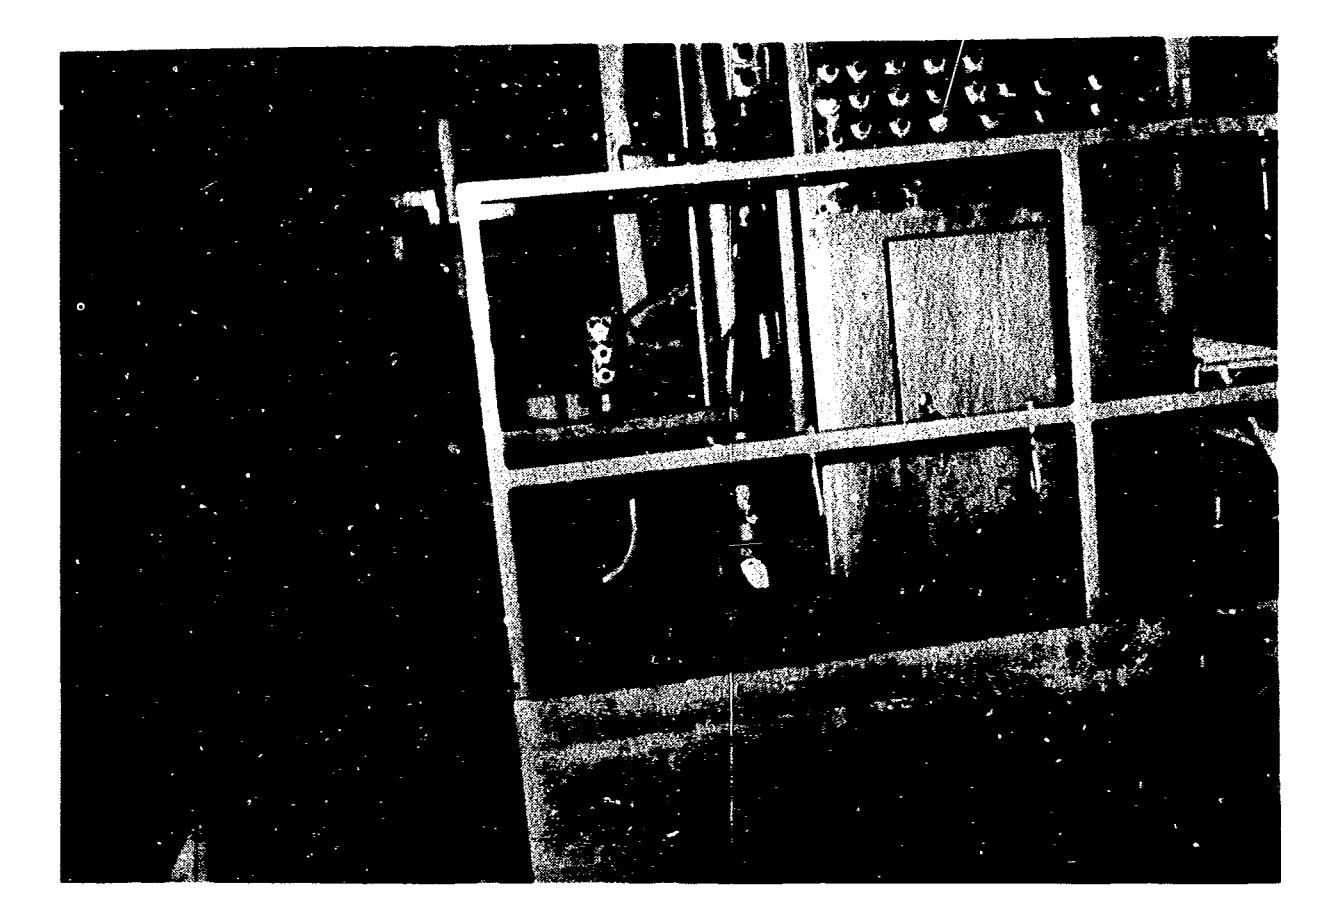
Figure 26. Burned manual and melted earphones on the auxiliary fuel handling bridge on the 347-foot elevation; just below view in Figure 25.

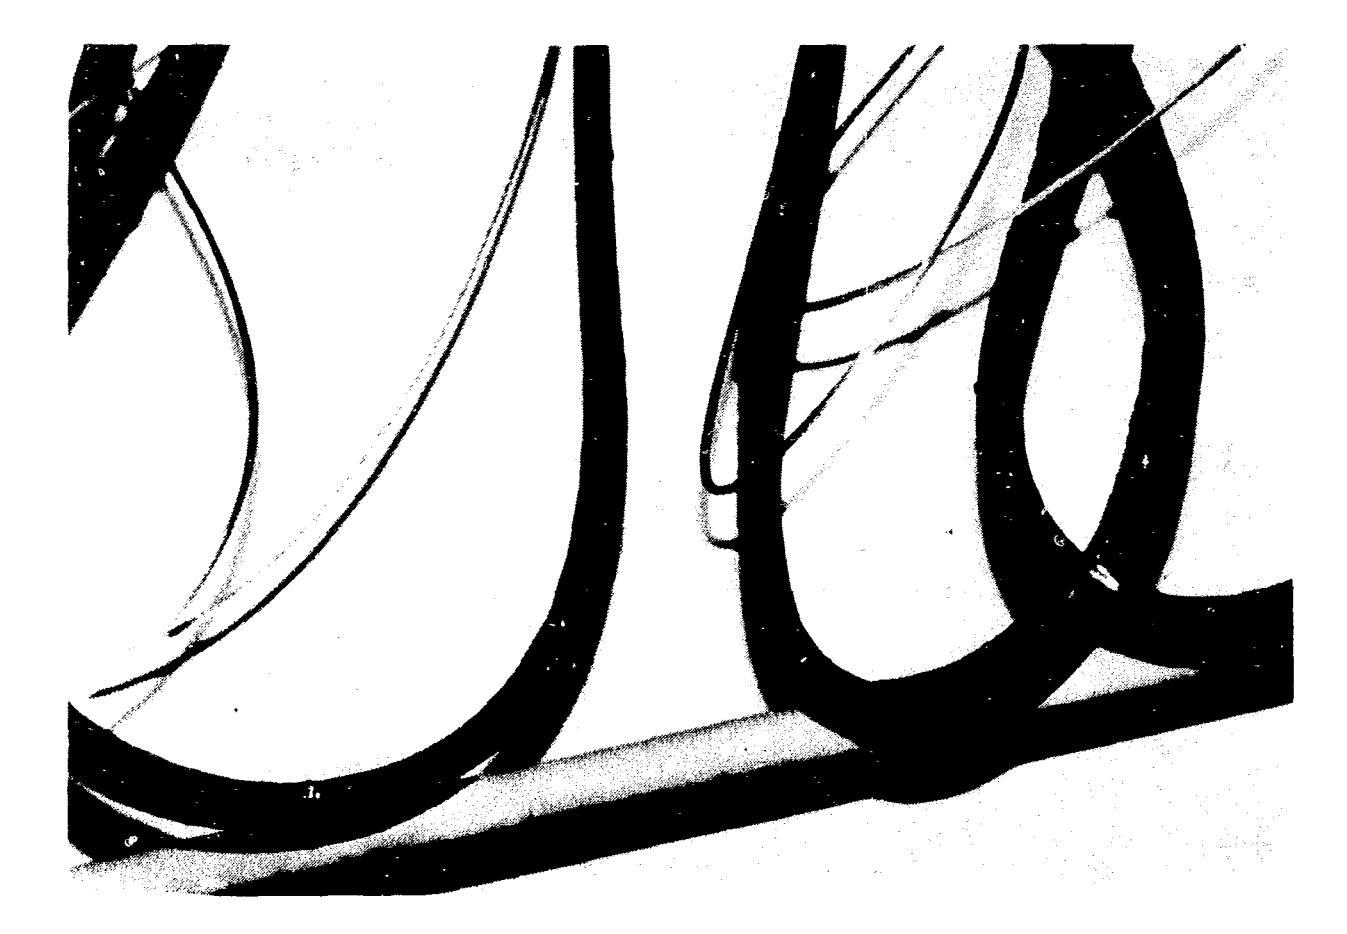
Figure 27. Electrical festoon for fuel handling bridge, on the 347-foot elevation; charred on the exposed surface.

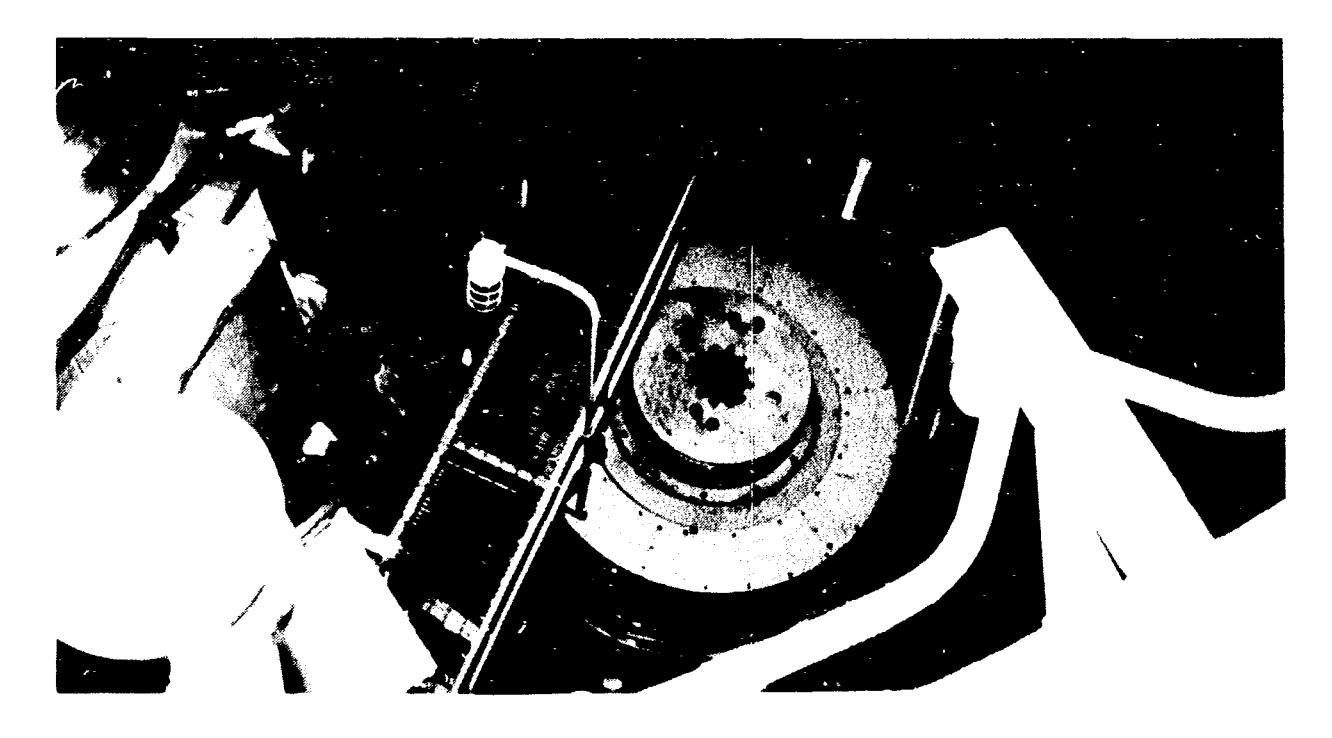
Figure 28. Darkened edge of junction box inside east side of west D-ring.

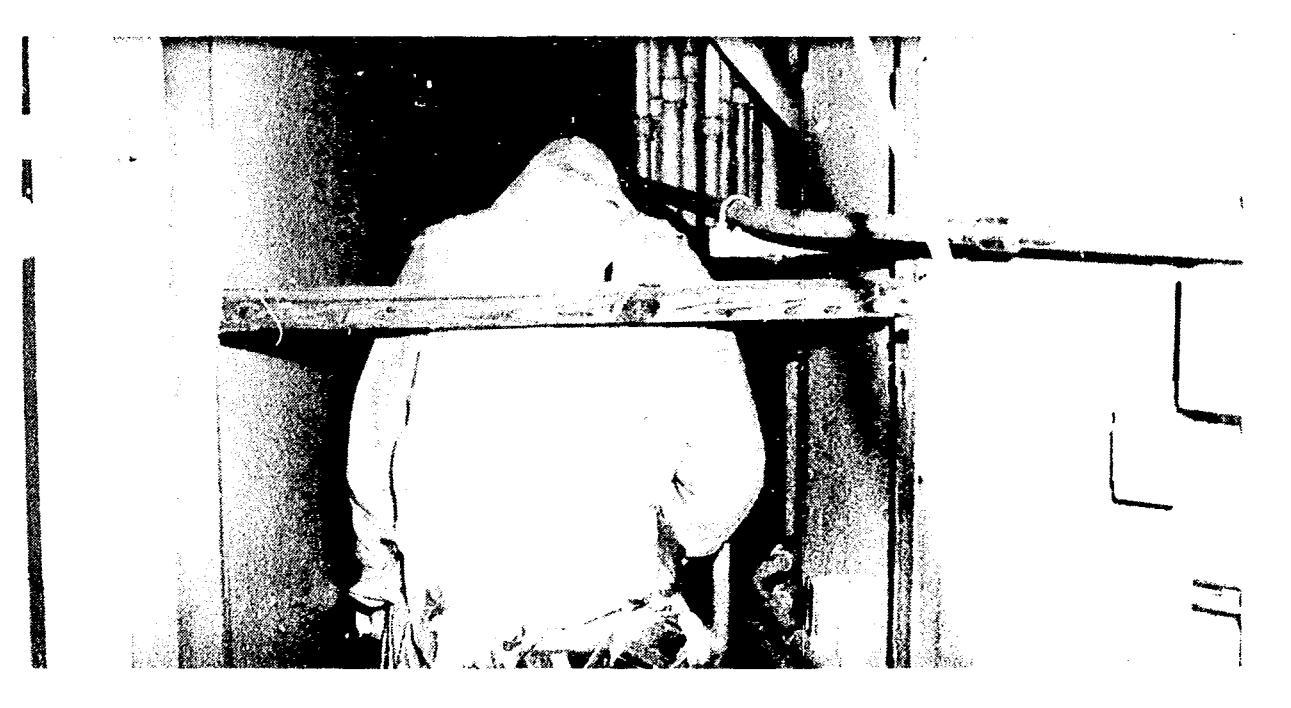
Figure 30. Undamaged wood shoring on 305-foot elevation.
