ASSESSMENT OF EXTENT AND DEGREE OF THERMAL DAMAGE TO POLYMERIC MATERIALS IN THE THREE MILE ISLAND UNIT 2 REACTOR BUILDING

N. J. Alvares

Published February 1984

Lawrence Livermore National Laboratory Livermore, California

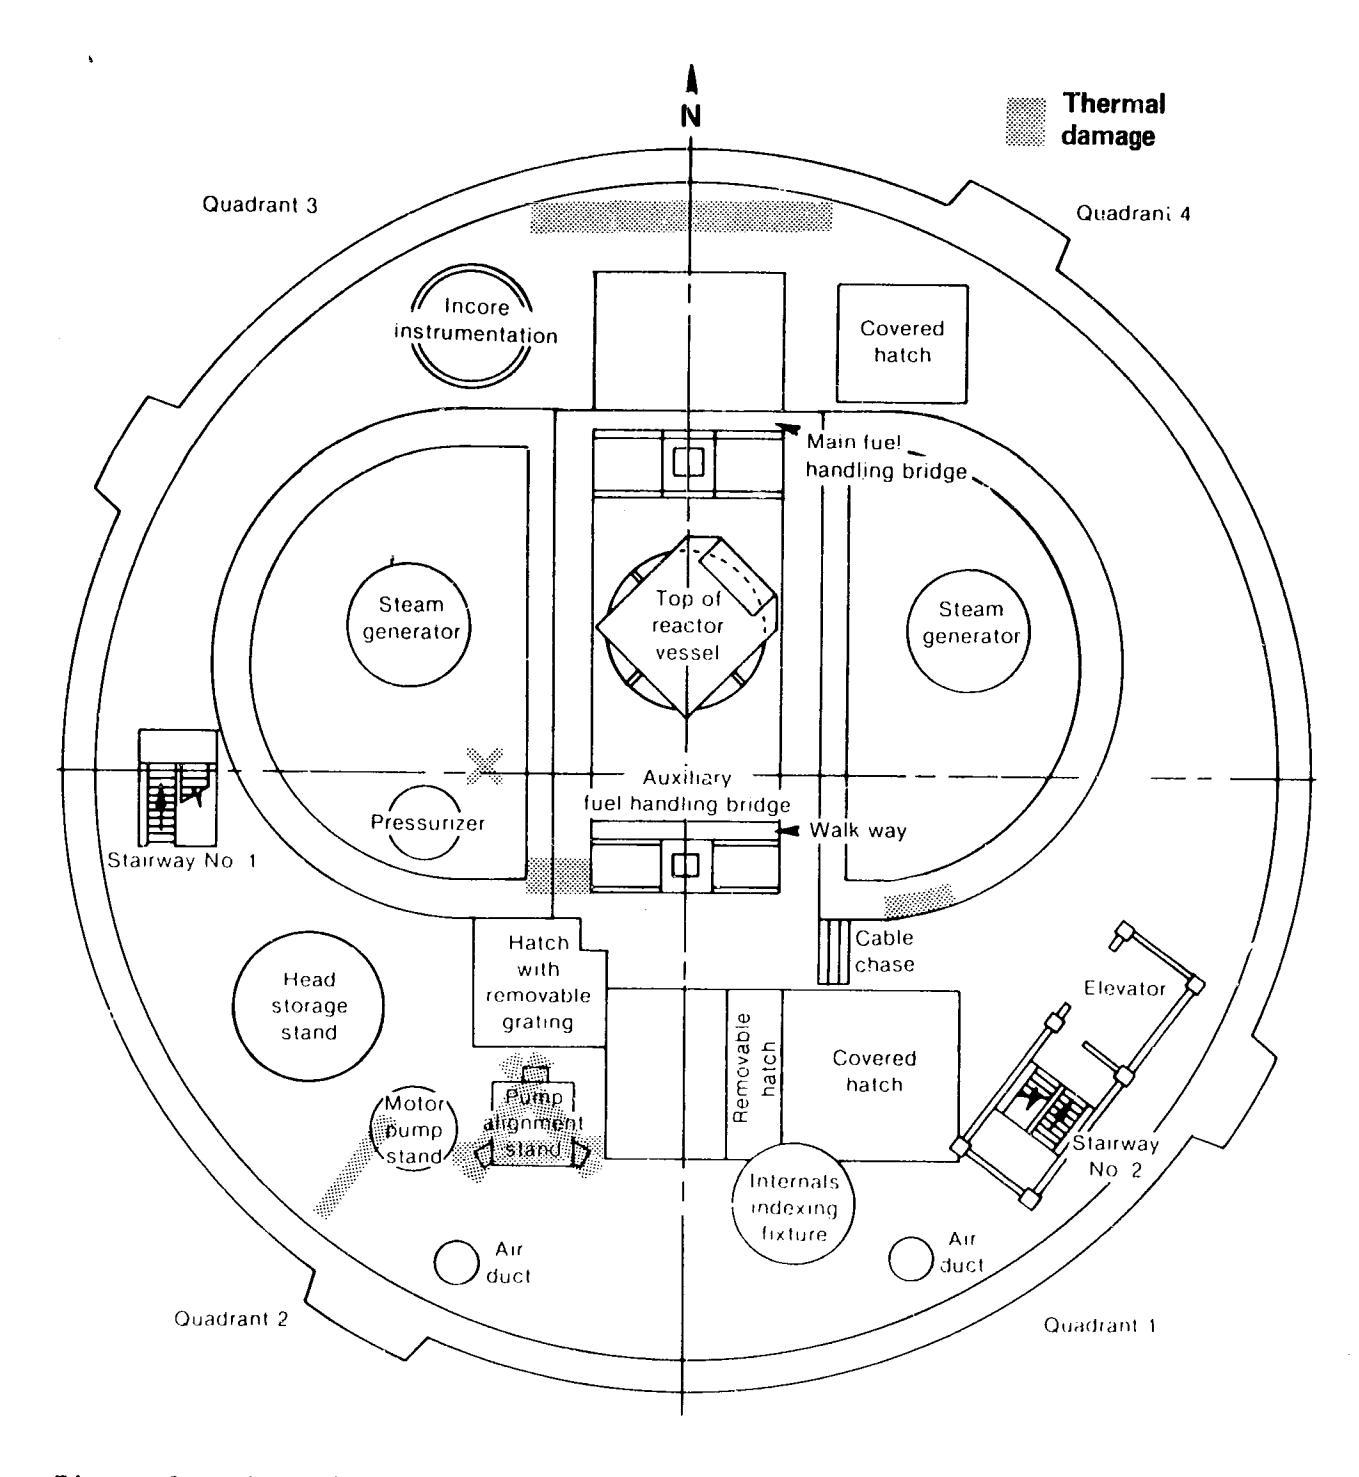
Figure 3. Thermal damage in the same plane as the D-rings.

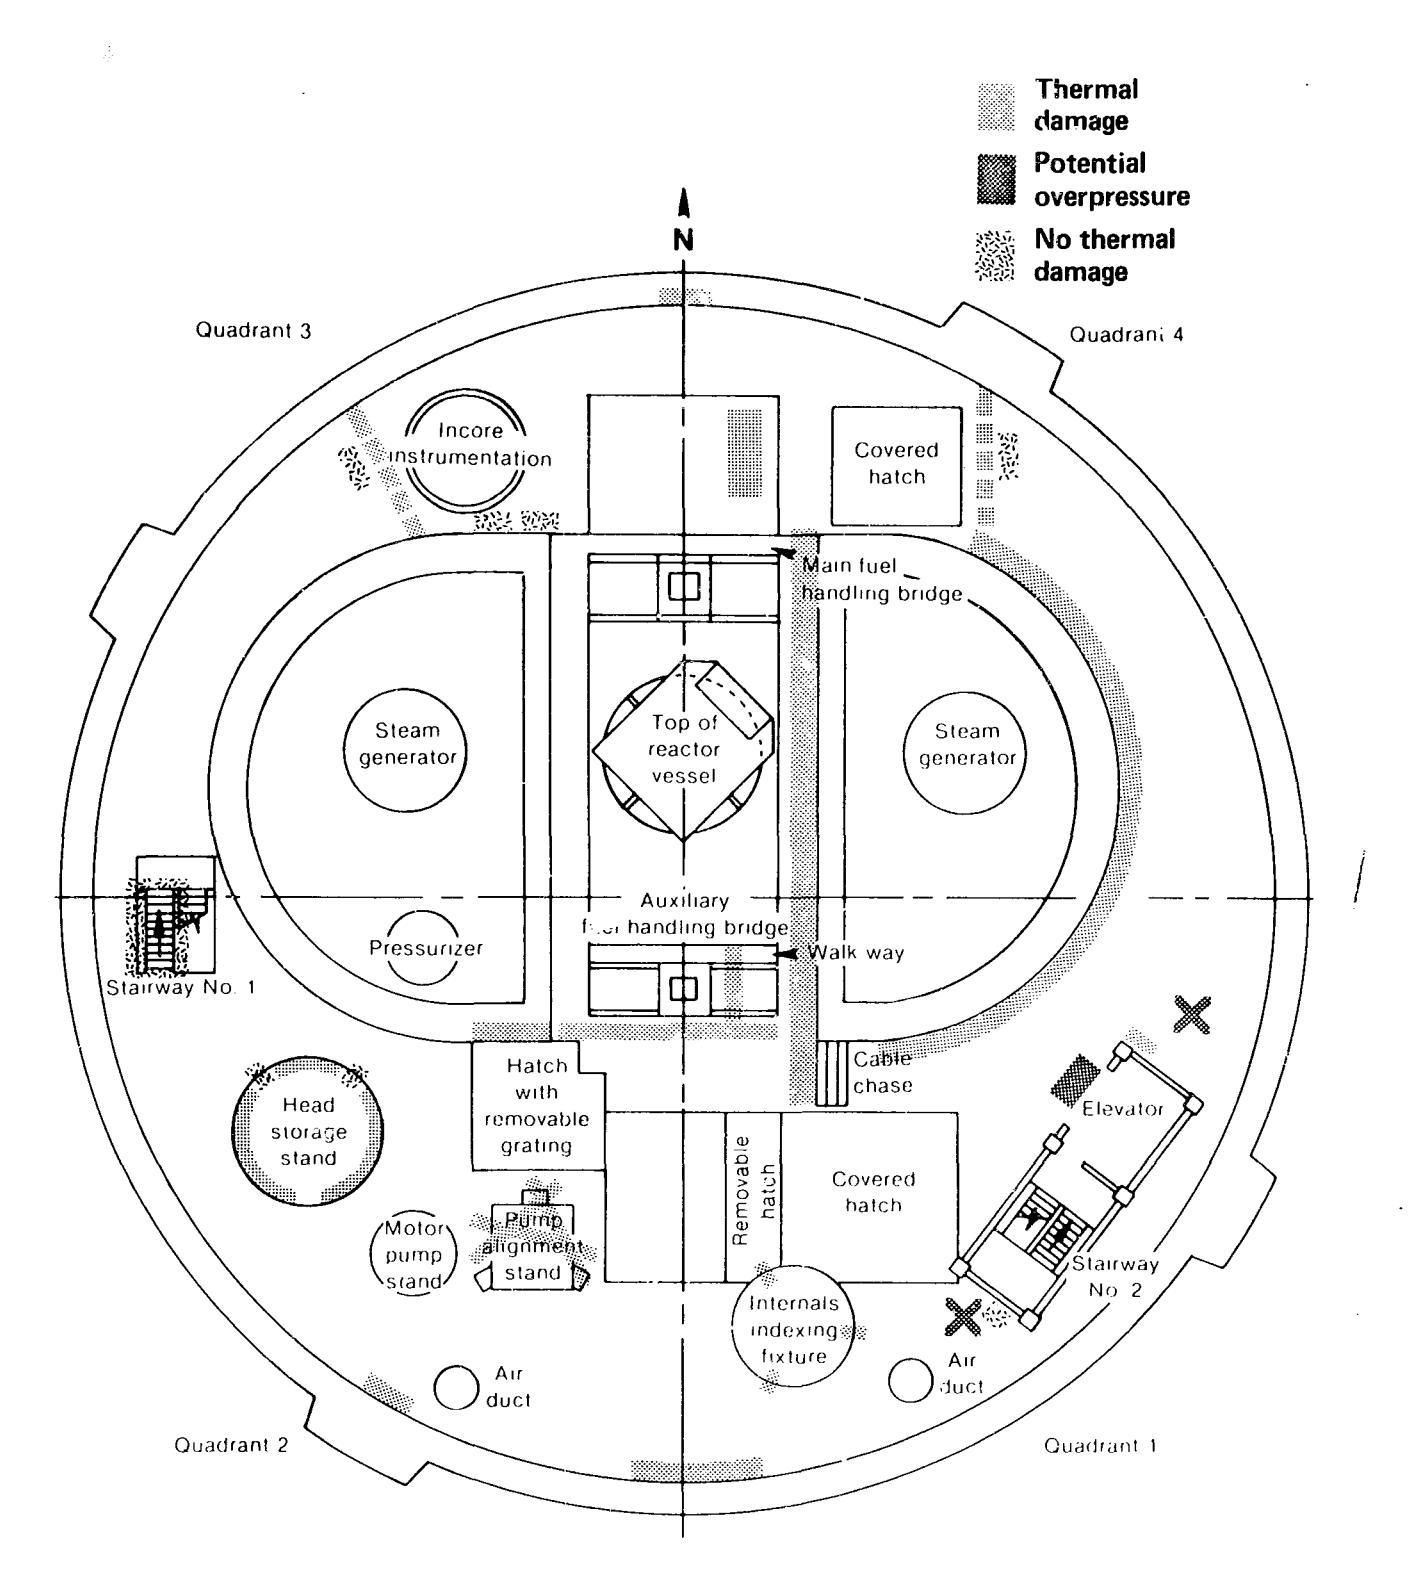
Figure 4. Thermal damage and potential overpressure on the 347-ft level.

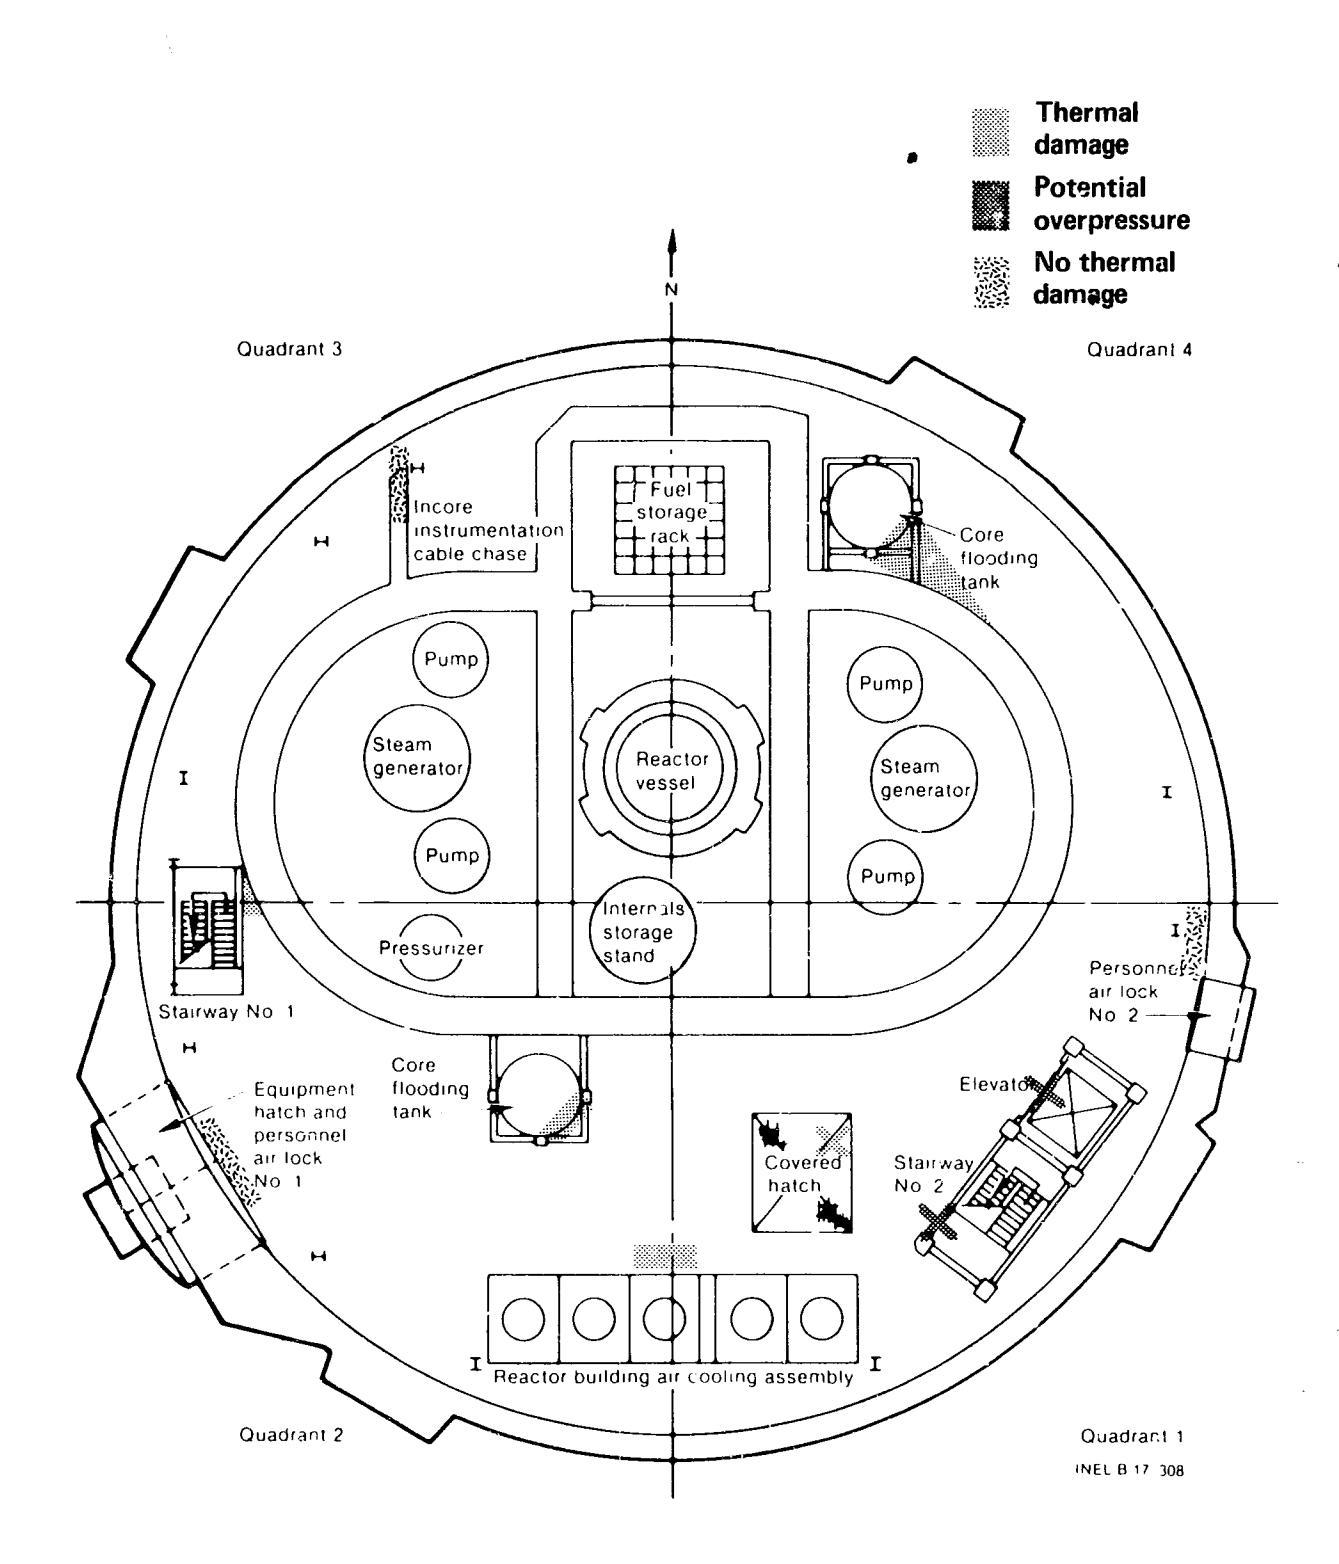
Figure 5. Thermal damage and potential overpressure on the 305-ft level.

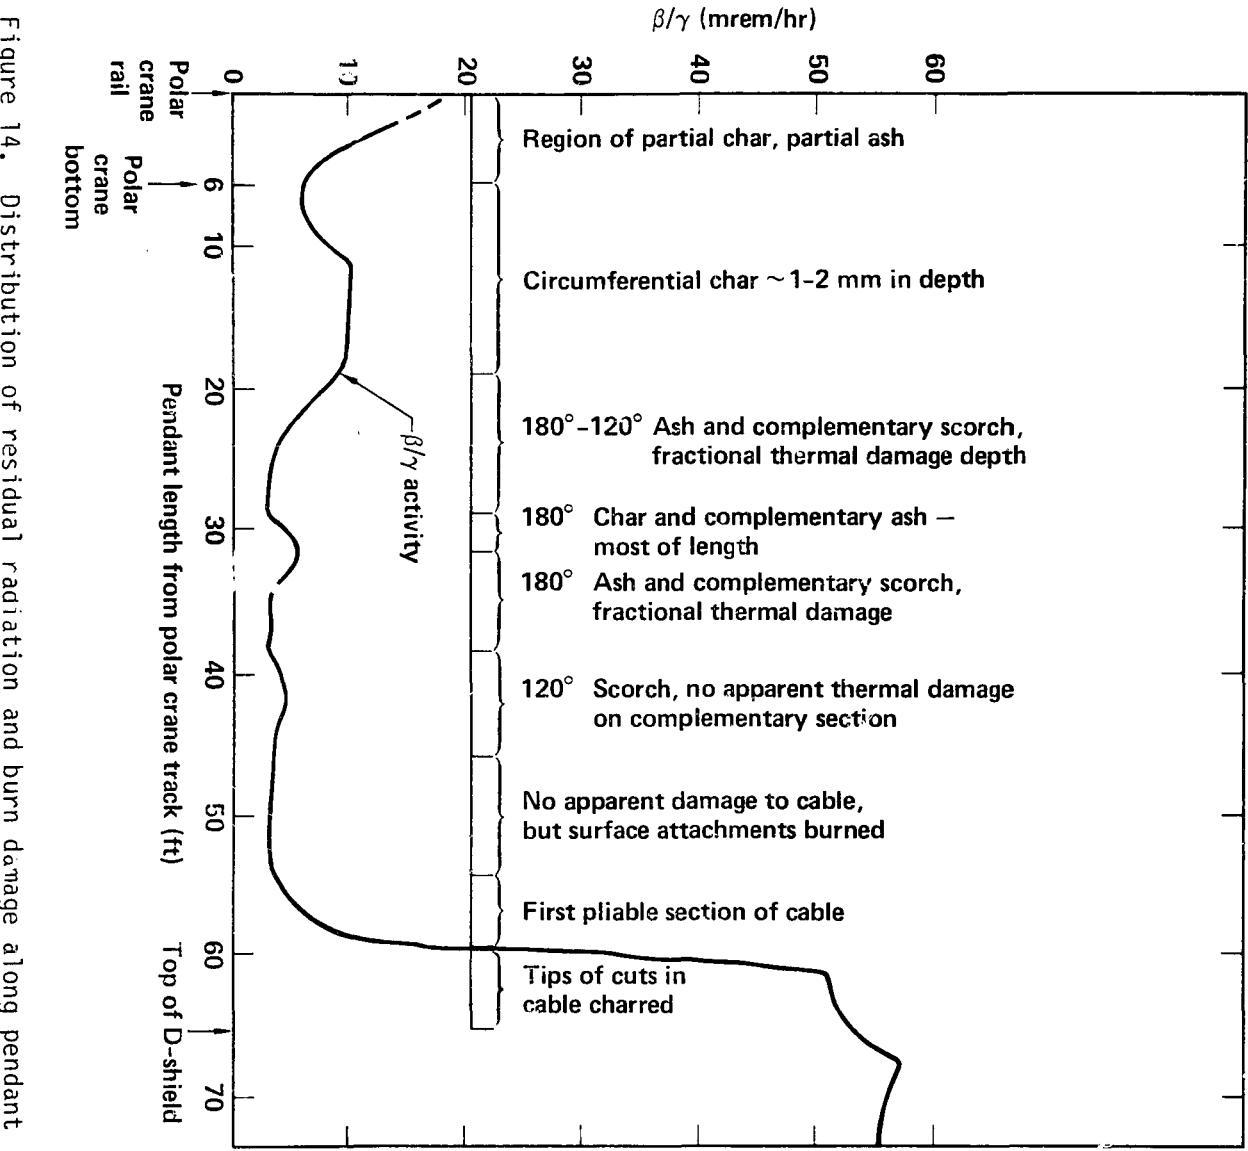
Figure 14 plots thermal damage with pendant length from polar crane level to the top of the D-shield level. Superimposed is the level of β/γ radiation (as determined and constructed by Mr. Trujillo). Maximum thermal damage occurs in the region from 6 to 10 ft below the polar crane girder (from about the 420-ft level down to about the 406-ft level). This region shows locally high β/γ activity, which may correlate to physical absorption by porous, charred insulation. Thermal damage is severe and circumferentially equal in this region. Char depth on the polymer surface averages 1 to 2 mm. We have no clue as to the composition of the insulating cover for the pendant, so we cannot define the intensity of exposure. However, it was definitely intense and uniform, an indication that this region was bathed for a substantial period in an intense combustion zone.

Figure length from the polar crane track. 14. Distribution of residual radiation and burn damage along pendant

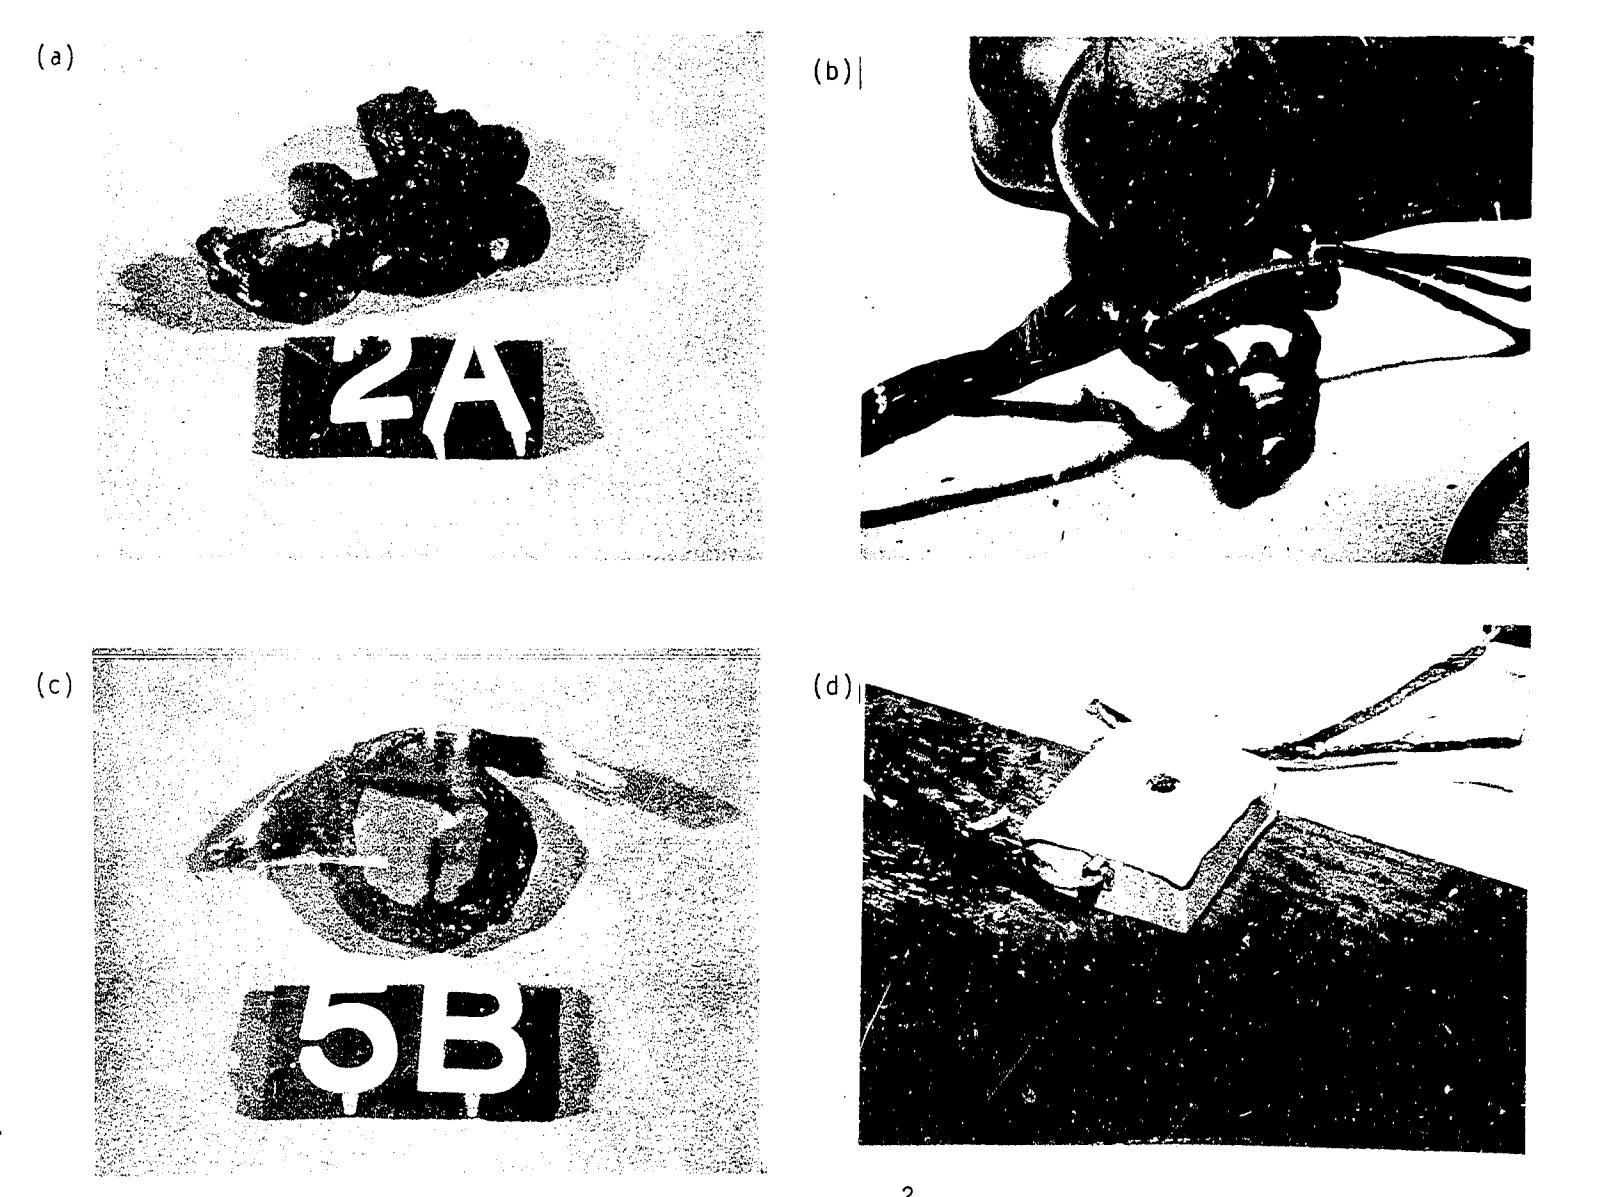
Figures 17 through 21 illustrate the correlation between the damage to exemplar and TMI materials of the south-wall telephone stand on the 347-ft level. The similarity of thermal damage is encouraging and the duration and intensity of thermal exposure is in the range of estimated thermal fluxes attained during the reactor building burn. Note that these are very simplistic tests. No attempt was made to refine temperature or thermal energy measurement. Moreover, we had no illusions as to the distribution of convective or radiative contribution from the test burner. However, the results give data trends which are intuitively acceptable. Description of other materials' responses are contained in Table 4.

Figure 17. Comparison of exemplars exposed to 180 J/cm² for 30 s and TMI materials: (a) Exemplar telephone receiver cord. (b) TMI receiver cord. (c) Exemplar extension cord. (d) TMI extension cord.

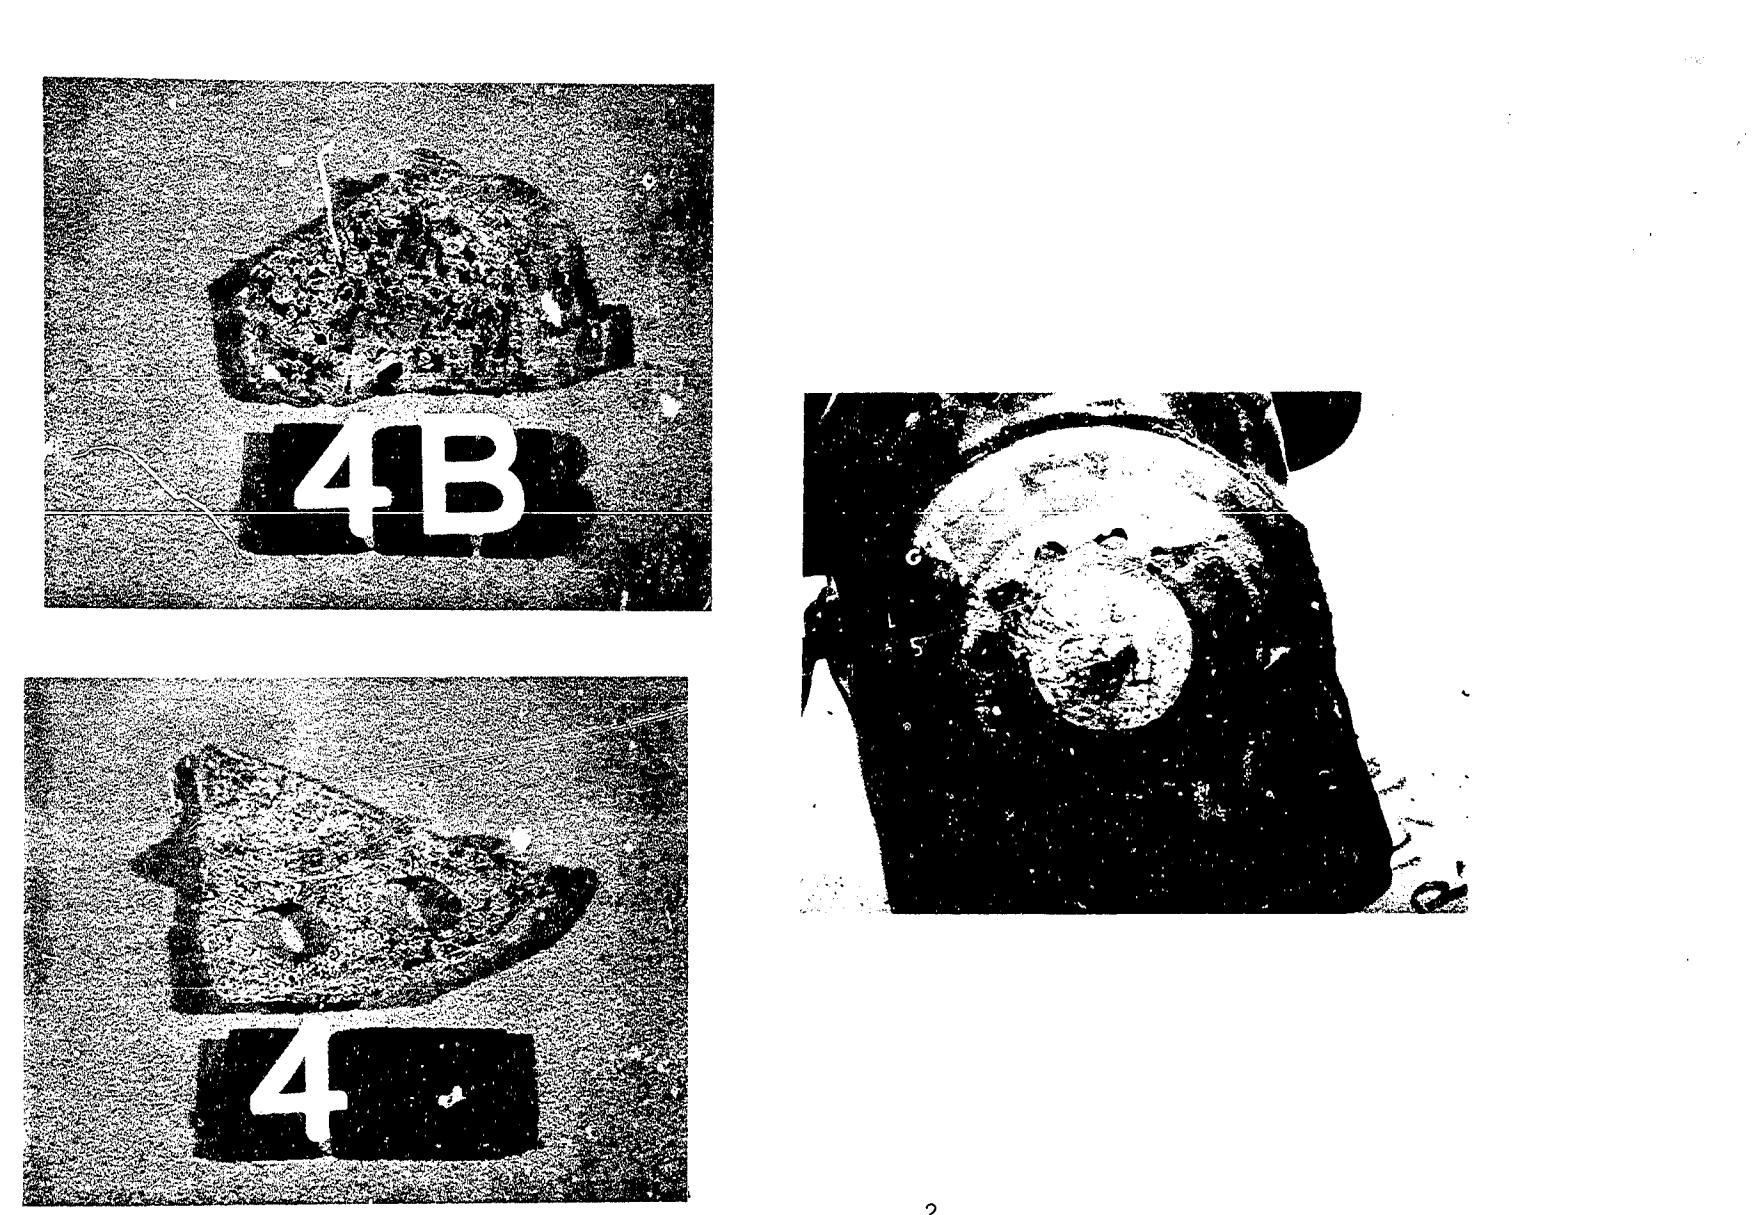
Figure 18. Comparison of exemplar acrylic exposed to 180 J/cm² for 30 s (left) and TMI-2 telephone dial.

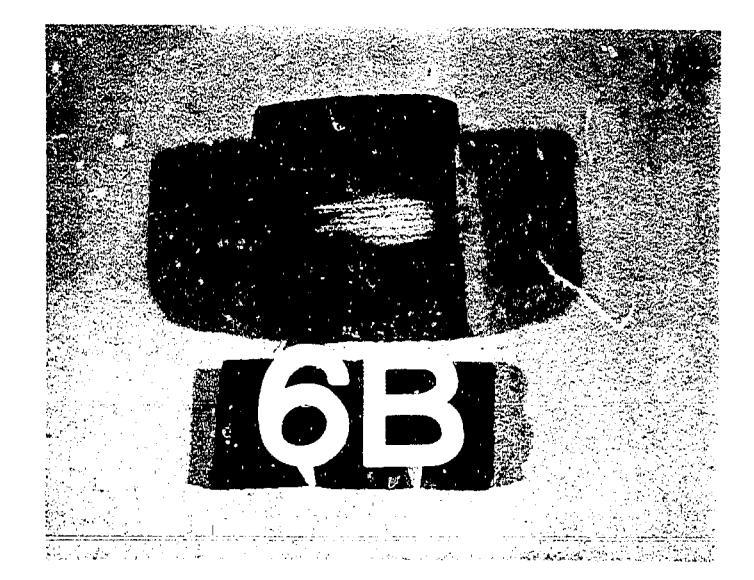
Figure 19. Comparison of exemplar plywood (fir) emposed to 180 J/cm² for 30 s (left) and plywood from TMI.

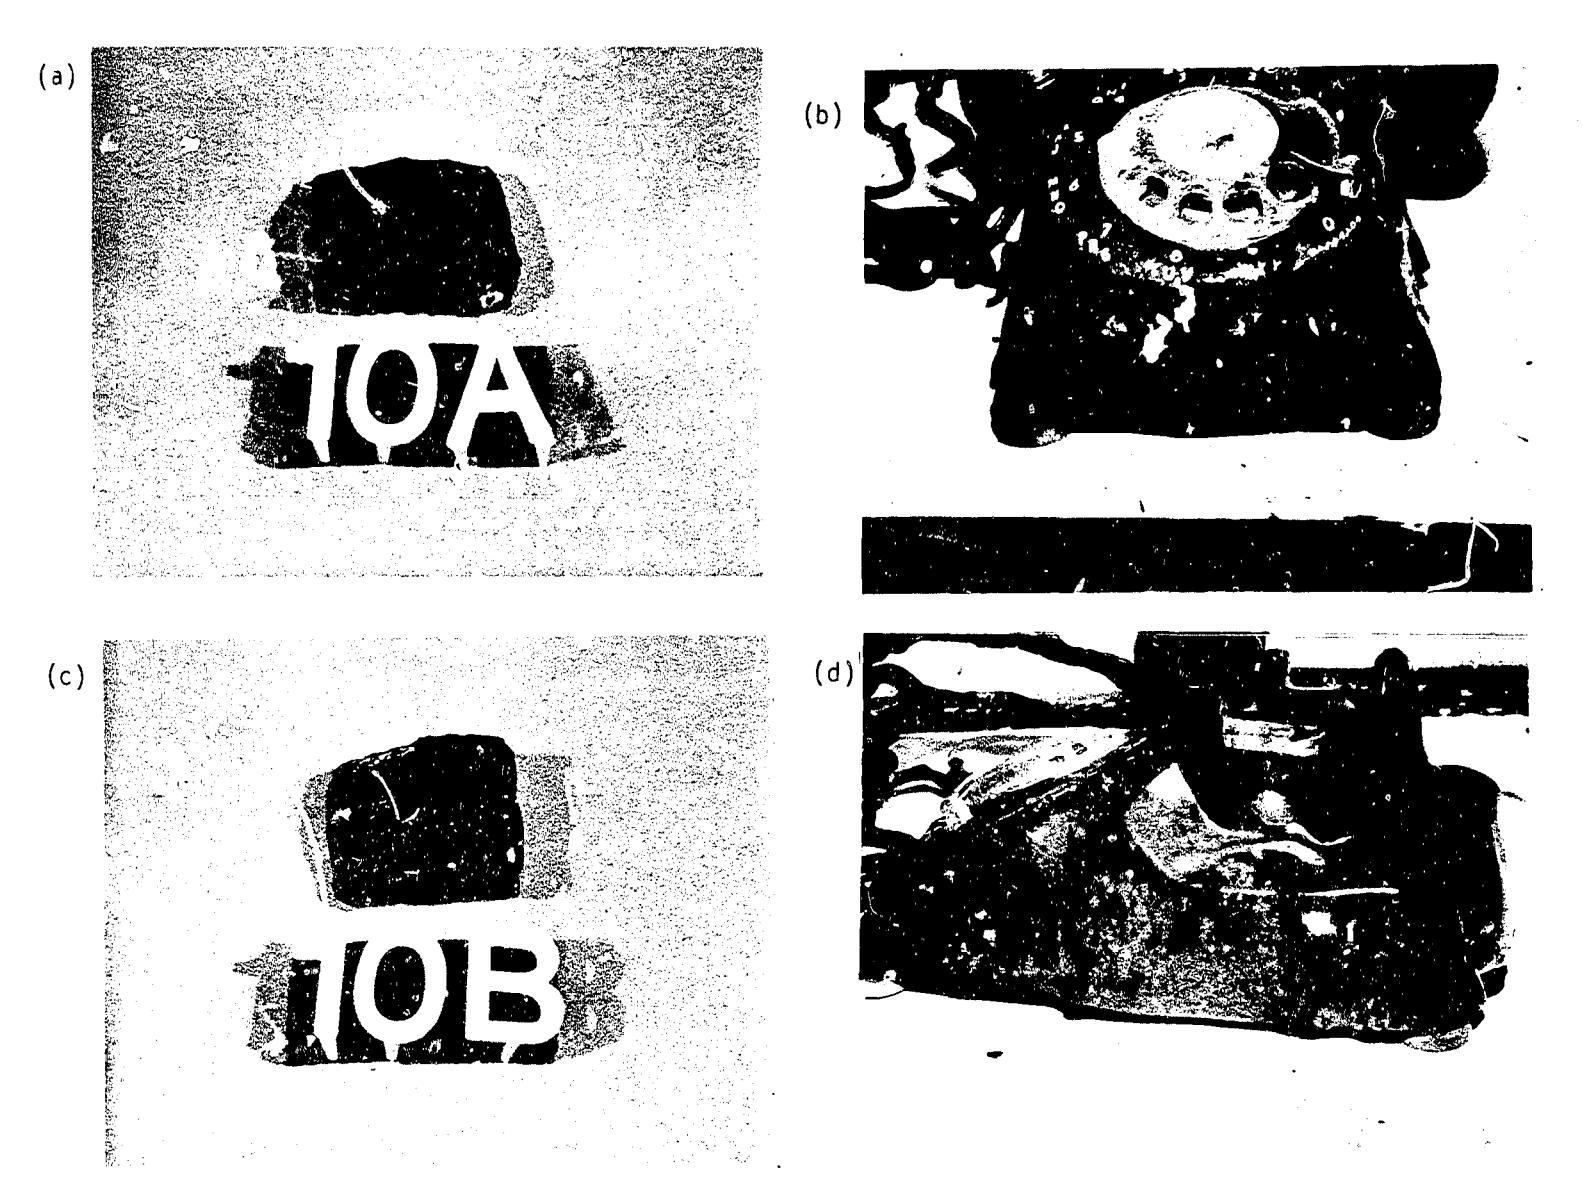
Figure 21. Comparison of exemplar telephone body pieces and TMI-2 ABS telephone body: (a) Exemplar exposed to 120 J/cm^2 for 20 s. (b) Telephone from 'MI. (c) Exemplar exposed to 72 J/cm² for 12 s. (d) Telephone from TMI.

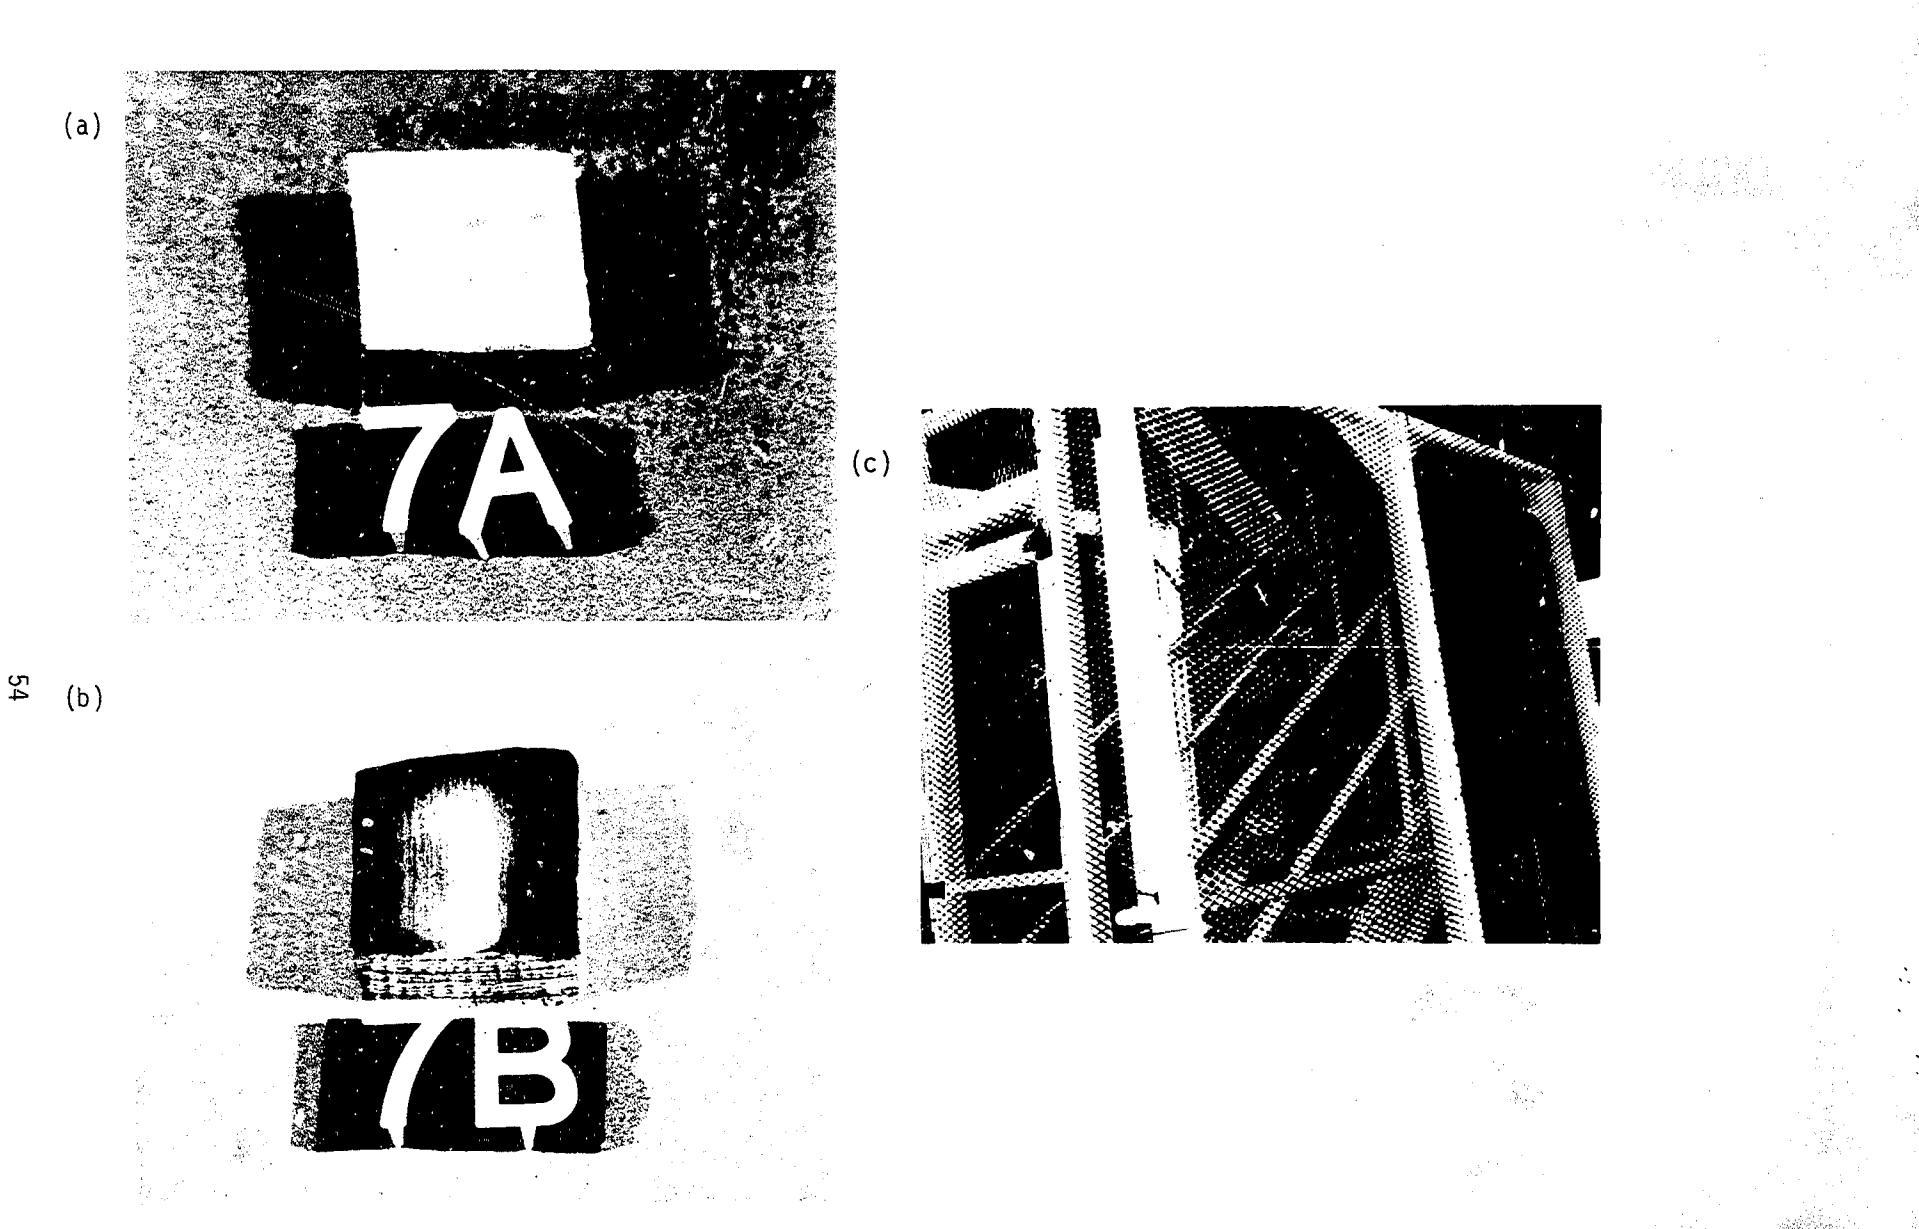
Figure 23. Comparison of exemplar wet plywood and TMI-2 wet plywood: (a) Exemplar exposed to 180 J/cm^2 for 30 s. (b) Exemplar exposed to 360 J/cm² for 1 min. (c) Plywood-framed cage at TMI.

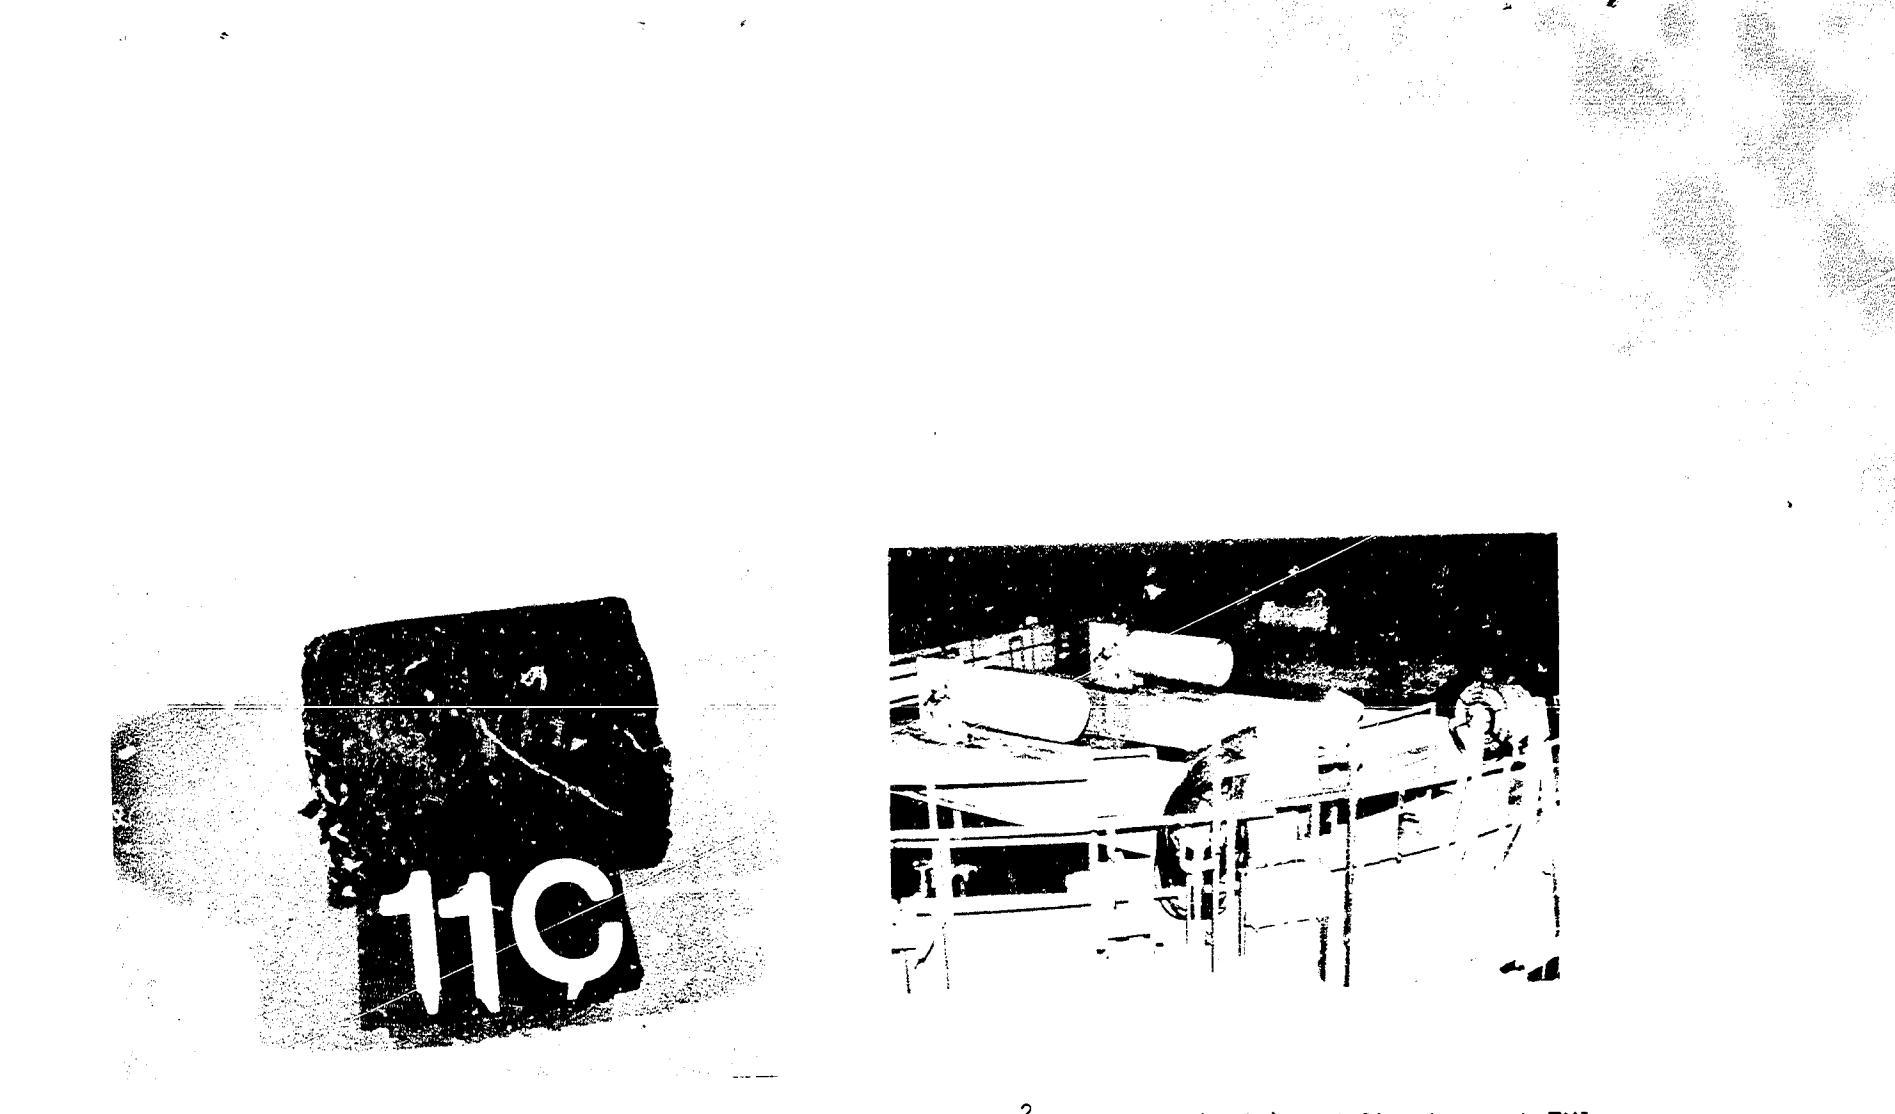
Figure 24. Exemplar red rubber fire hose exposed to 360 J/cm² for 1 min (left) and fire hose at TMI (right).
